STRUCTURAL INSPECTION

FIELDS FARM BARN, MEARLEY, PENDLETON

STANTON ANDREWS

Project No.: 12094				
Issue Date	Revision	Status	Issued By	Checked By
08.05.2025	---	First Issue	SJ Reid	E Jones

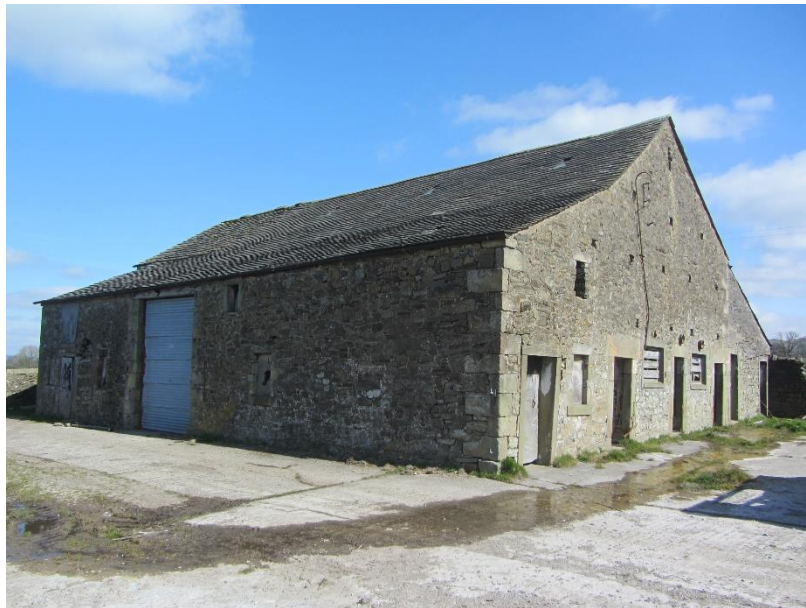
The barn is a traditional stone-built agricultural building, dating from the 1700s or early 1800s (photos 1, 2, & 3). The main part of the barn provides double-height storage space to the north west, with the part to the south east occupied by cattle stalls with a hay loft above. At the front are further two-storey sections on each side of a wagon entrance, with animal houses at ground floor and hay lofts above. To the rear is a single-storey lean-to shippon, located to the east of the rear wagon entrance.

Photo 1 – View of front of barn from south

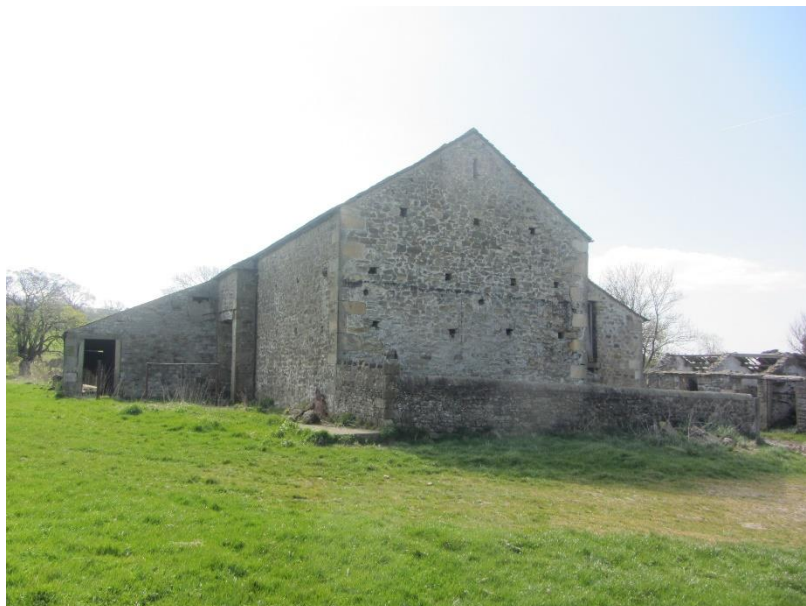
Photo 2 – View barn from north west

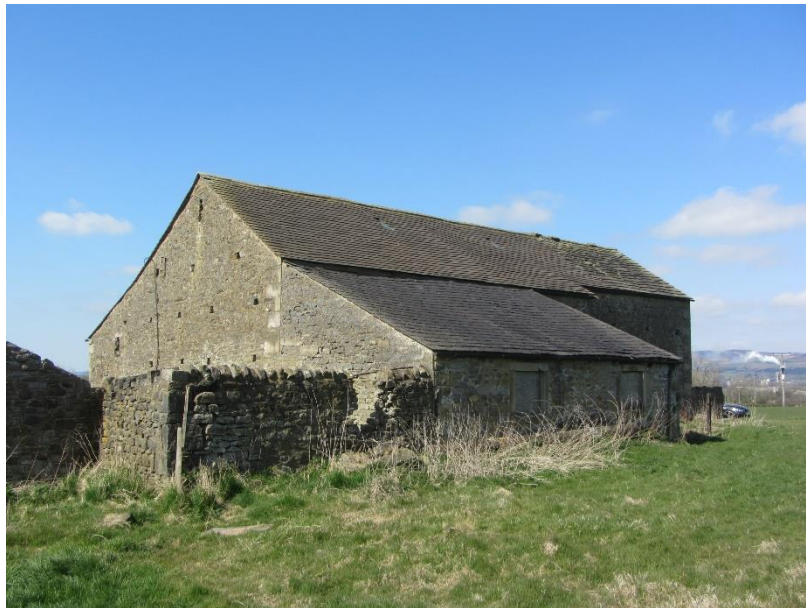
Photo 3 – View of barn from east

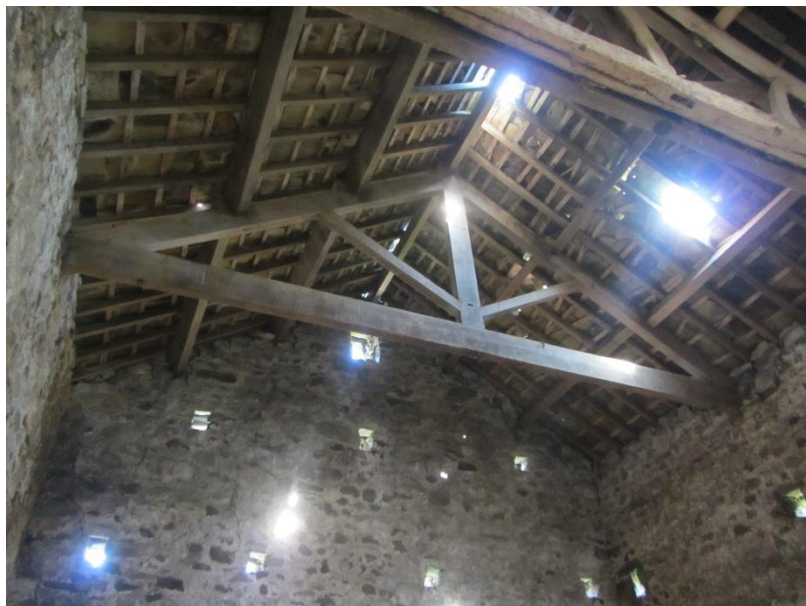
- One timber truss close to the north west gable wall is of relatively modern sawn timber (photo 4), and a further modern truss has been installed alongside the next truss from the wall (photos 5 & 9). The four original oak trusses are in an advanced state of decay due to insect infestation (photos 11 & 12).

Photo 4 – Internal view, looking north west

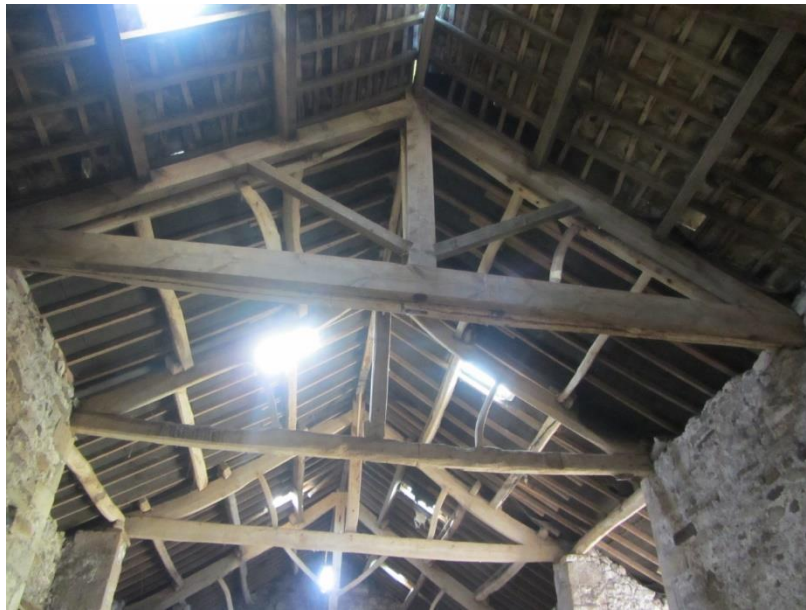
Photo 5 – Internal view – looking south east

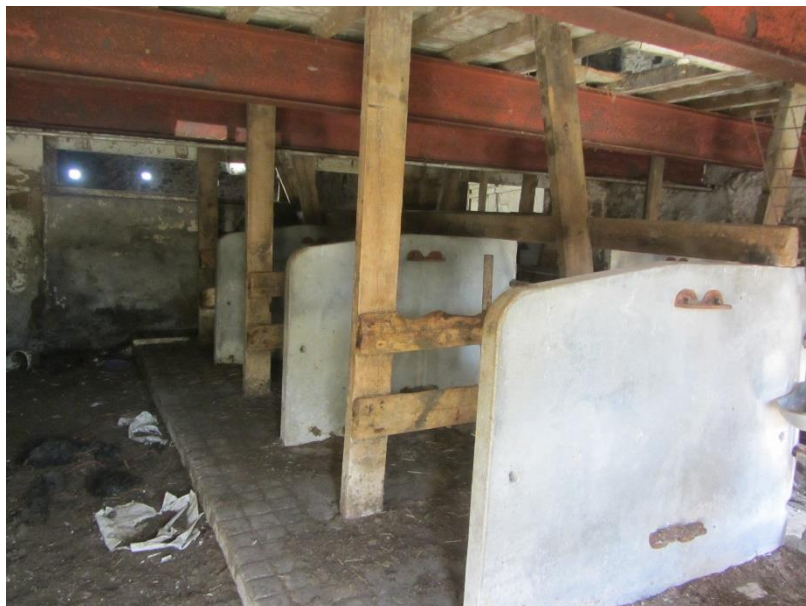
- Inspection of the hay loft floors from below revealed widespread timber decay due to insect infestation in all timber boarding, joists and beams (photos 6 & 7).
- Vertical cracking was noted in the main barn walls, at the north west corner (photos 13 & 14), and at the opposite south east corner (photo 15). Separation between the internal wall and the south east gable wall was noted (photo 16).

Photo 6 – Cattle stalls below main hay loft

- The barn should be re-roofed, complete with new roof trusses and purlins. It may be possible to re-use some rafters and the two more modern roof trusses, subject to detailed inspection and evaluation.
- The loft floors are severely decayed and not suitable for re-use. They should be removed.
- Cracks in the stone walls should be stitched using stainless steel helical bars epoxy-grouted into the stone bedjoints, or at corners, drilled and grouted into the stones. Surface-fixed straps could be used internally, in areas where new lining walls will be provided.

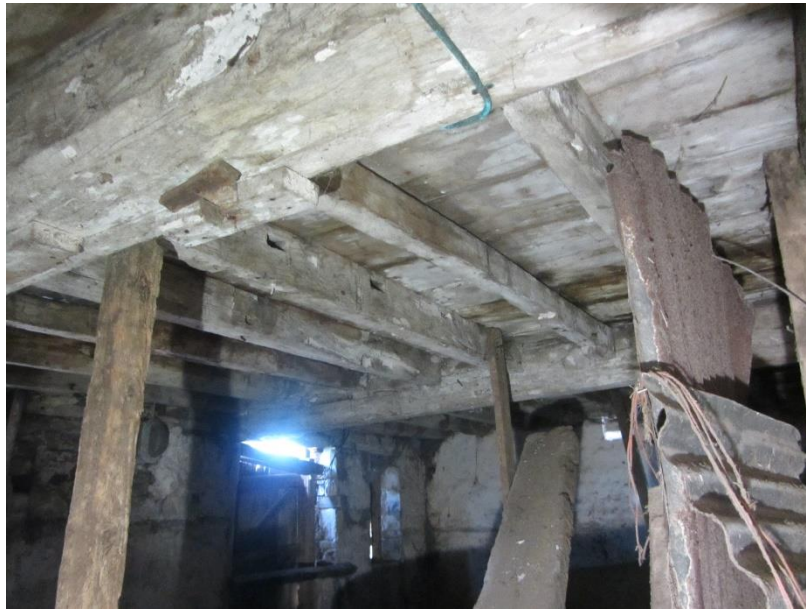
Photo 7 – Timber loft floor (front)

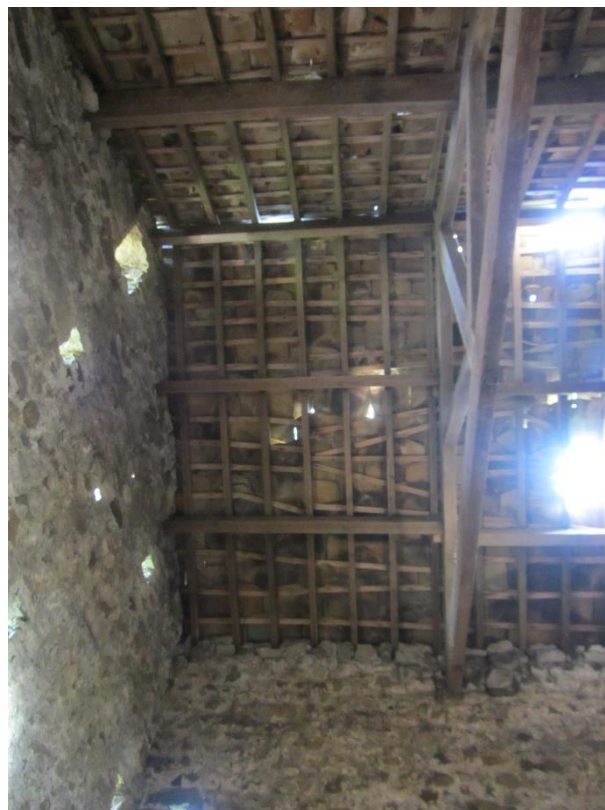
- To the north end of the main barn space, in the end bay, the timber battens have moved, and the stone slates have slipped (photo 8). Elsewhere the roof has been re-covered with relatively modern concrete tiles on new rafters and battens over roofing felt.

Photo 8 – Slipped slates and battens

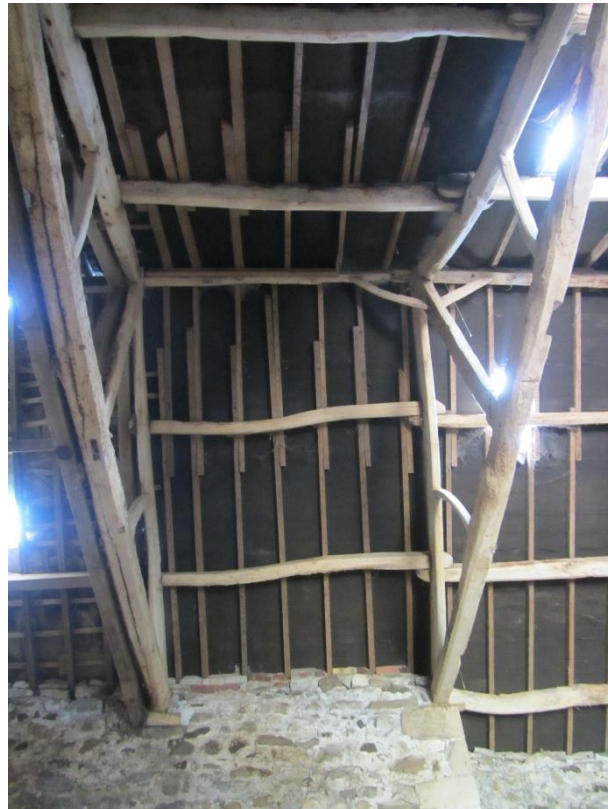
- Some original oak purlins have been replaced, but most remain. Several are severely twisted (photo 9), others are decayed, particularly near roof lights or where slates are missing (photo 10).

Photo 9 – Twisted purlins

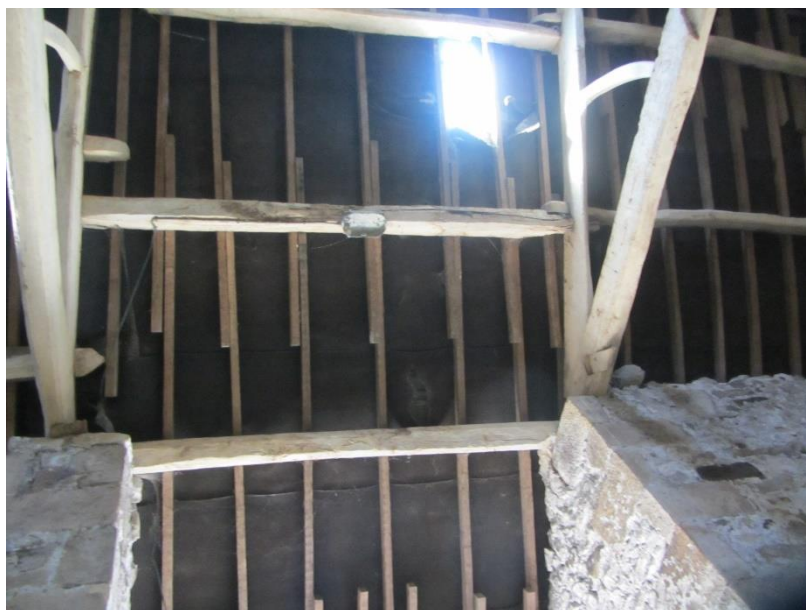
The original oak purlins and roof trusses show signs of advanced decay due to insect infestation and wet rot. The two more modern sawn timber trusses appeared to be in reasonable condition when viewed from ground level, but some decay may be present at the outer ends where they rest on the solid stone walls.

Photo 10 – Decayed purlin

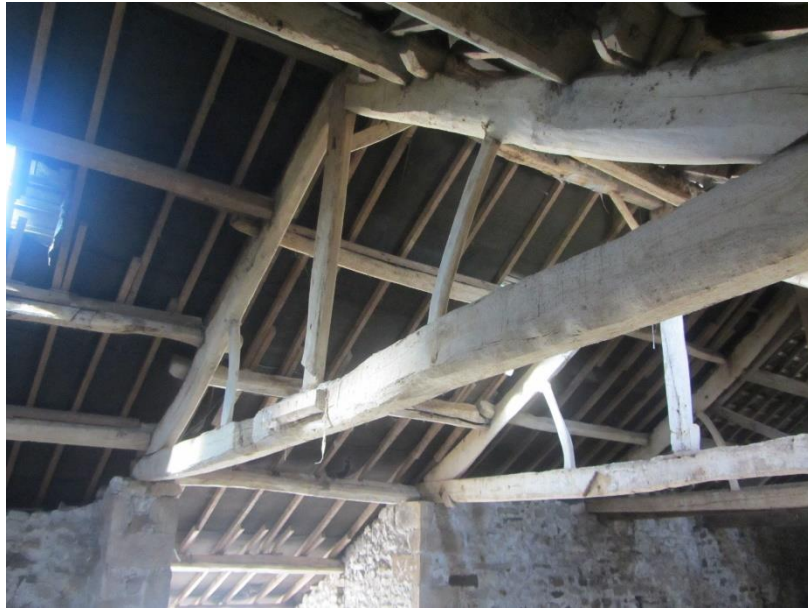
Photo 11 – Oak roof trusses

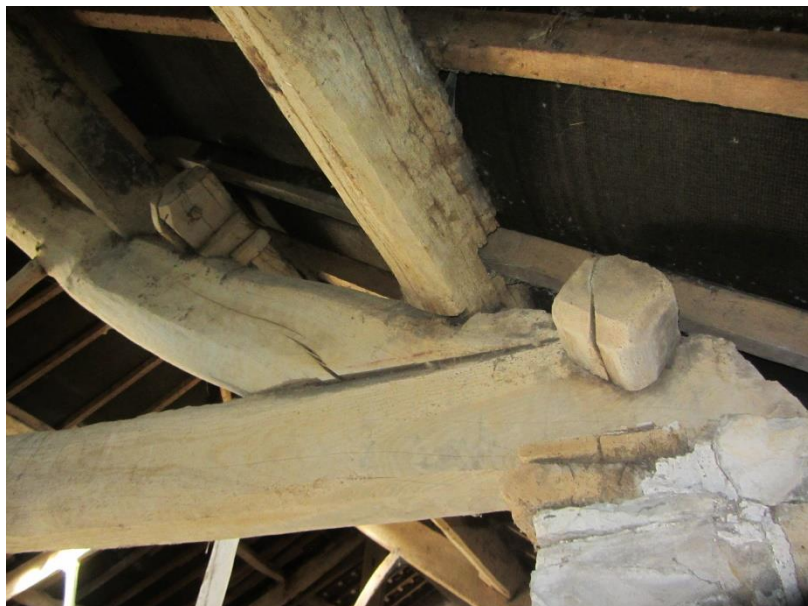
Photo 12 – Decayed roof truss

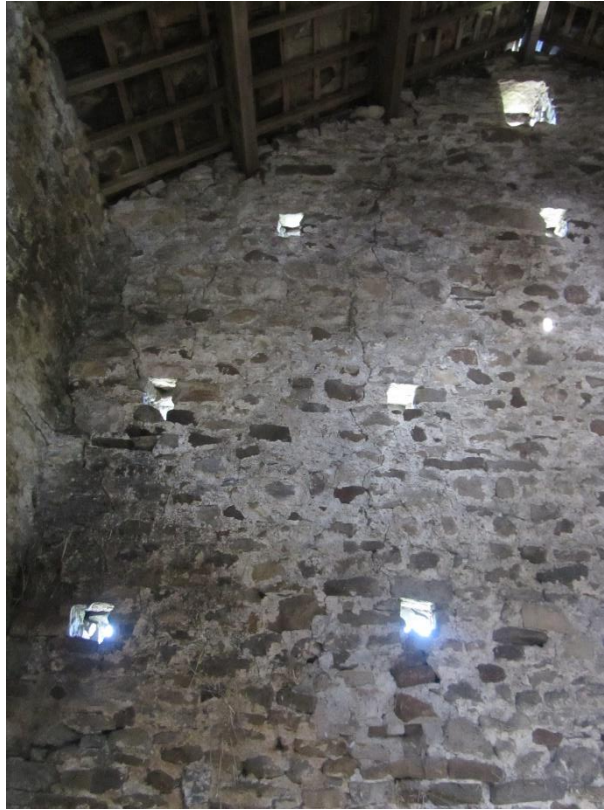
The four main external walls are generally straight and vertical. The vertical cracking noted, mainly on the internal faces, is due to thermal and moisture movement of the poorly bonded stonework. At the south east gable, the internal wall is not bonded to the external wall, allowing separation to occur. Localised collapse on the front wall is due to decayed embedded timbers, and the bulging at the south corner most likely due to thermal movement, delamination of the outer stone leaf from the rubble core and lack of connection to internal buttressing walls or floors. No significant foundation movement was noted.

Photo 13 – Vertical cracking – north west gable wall

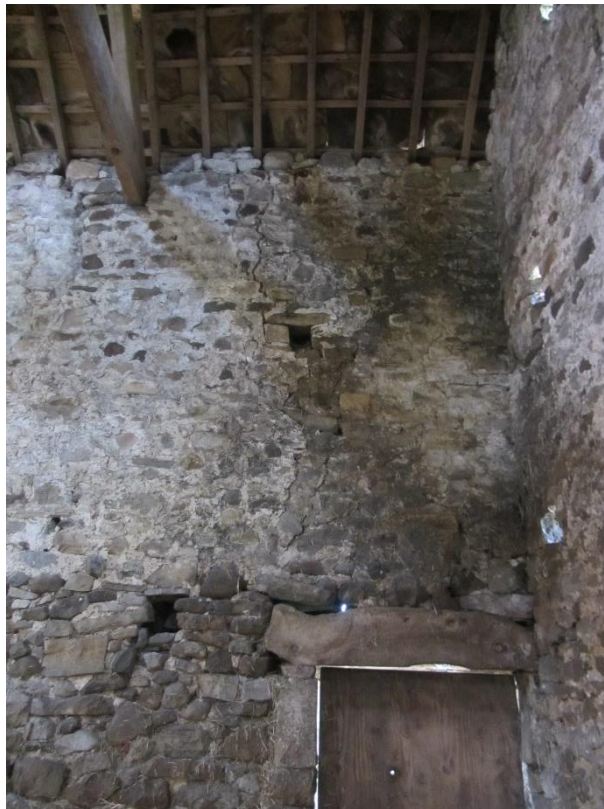
Photo 14 – Vertical cracking – north west corner

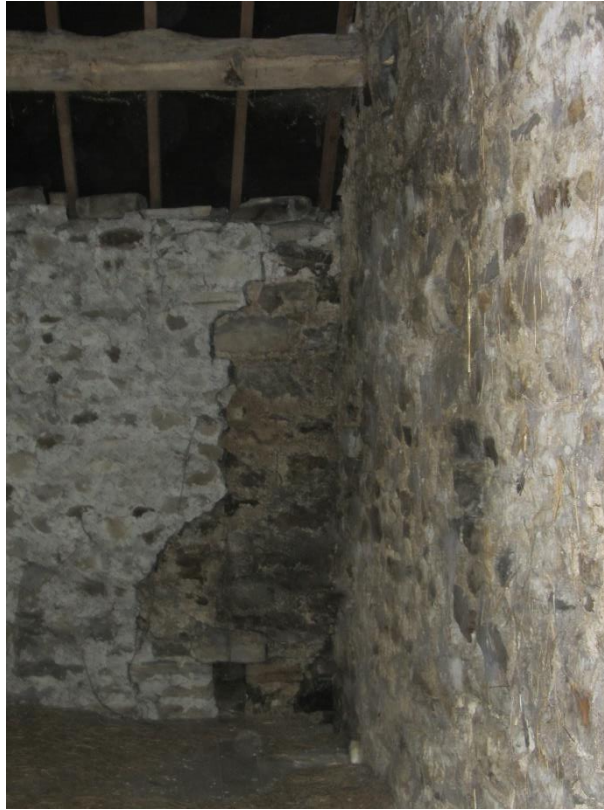
Photo 15 –Vertical cracking – south east corner

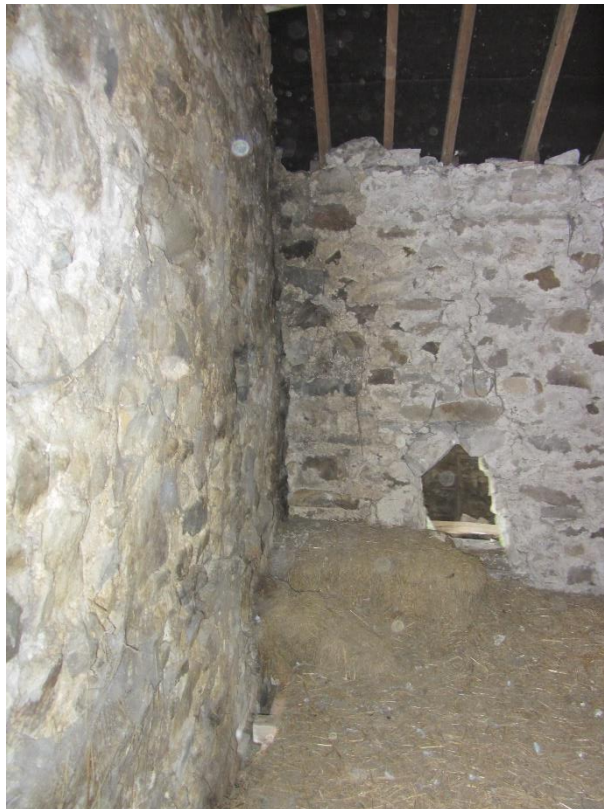
Photo 16 – Vertical cracking and separation

- Internal walls that are unbonded to external walls should be tied with stainless steel bars, drilled from the outside and epoxy grouted to the stone.
- The damaged masonry at the south corner should be taken down and re-built.
- Decayed timber lintels and bonding timbers should be removed and replaced with new pre-cast concrete items.
- Loose and partially collapsed areas of masonry should be consolidated by local re-building.

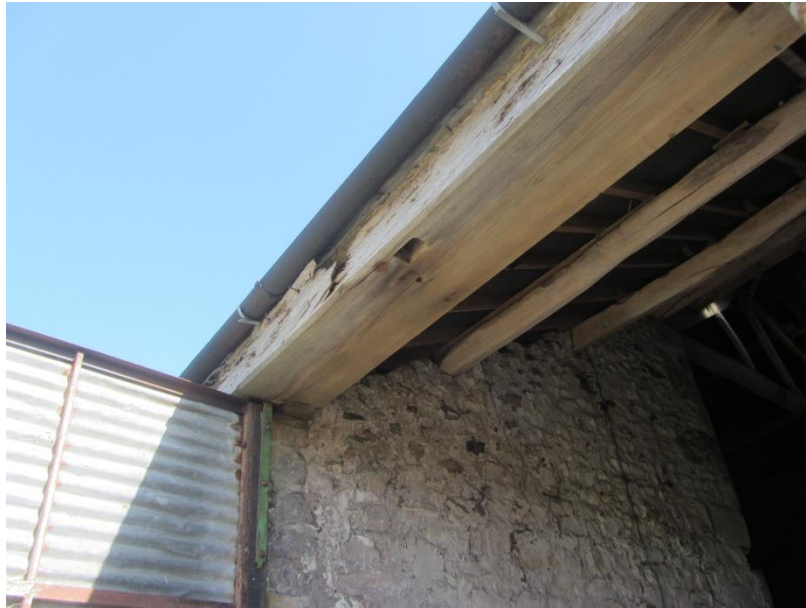
- The front wall is generally straight and vertical. The timber lintel above the wagon entrance is decayed (photo 17). An area of stone to the left of the entrance has collapsed, revealing decayed embedded timbers (photo 18).

Photo 17 – Front wall – decayed lintel

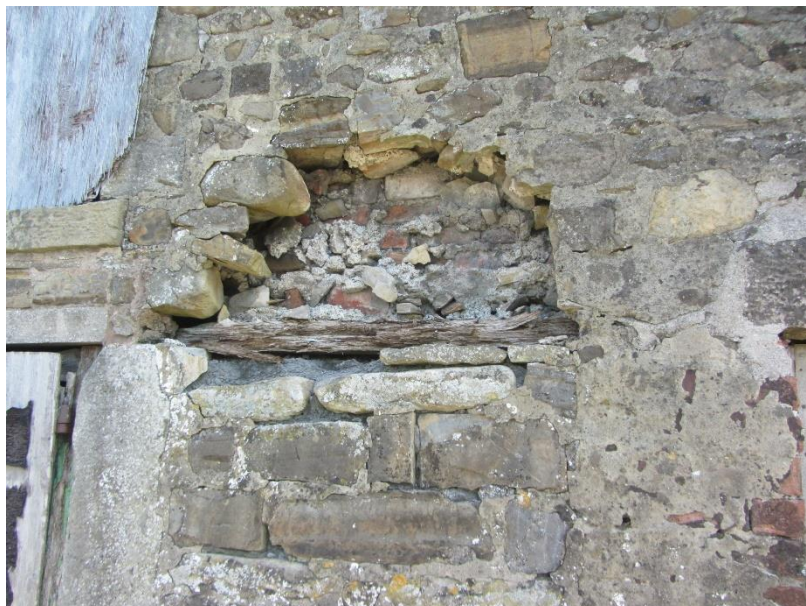
Photo 18 – Front wall missing stones

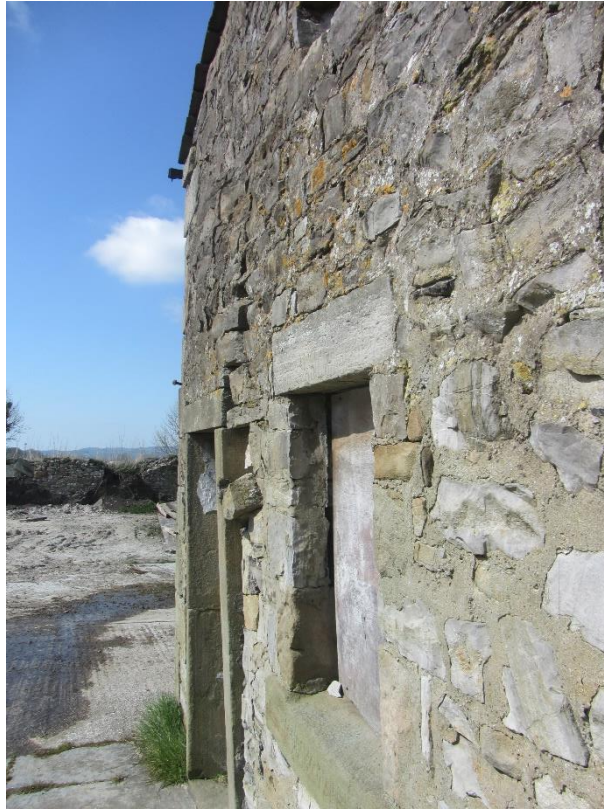
- The south east gable wall is generally straight and vertical, but an area of stone masonry at the south corner shows severe bulging and cracking (photo 19).

Photo 19 – South corner – cracked and bulging stone

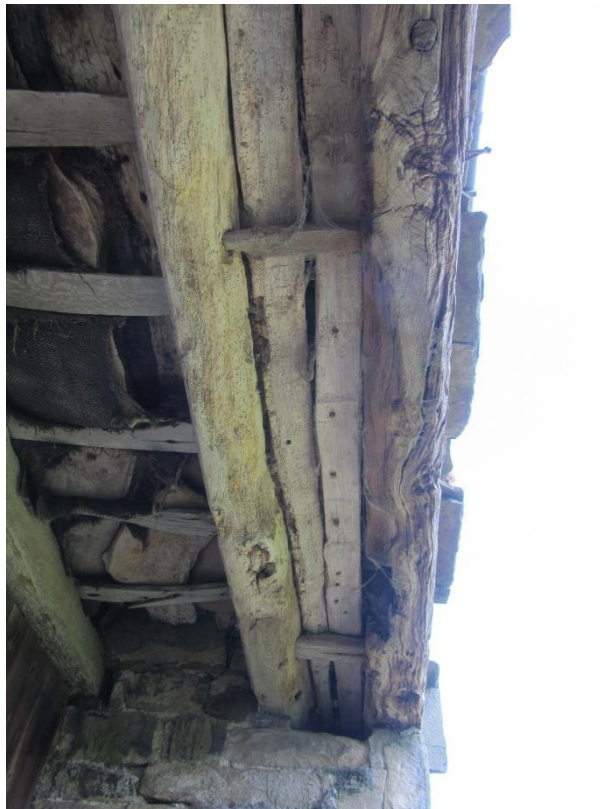
- The rear walls to both barn and shippon are generally straight and vertical. The timber lintels above the rear wagon entrance show signs of severe decay due to insect infestation (photo 20).

Photo 20 – Rear wall – decayed lintel

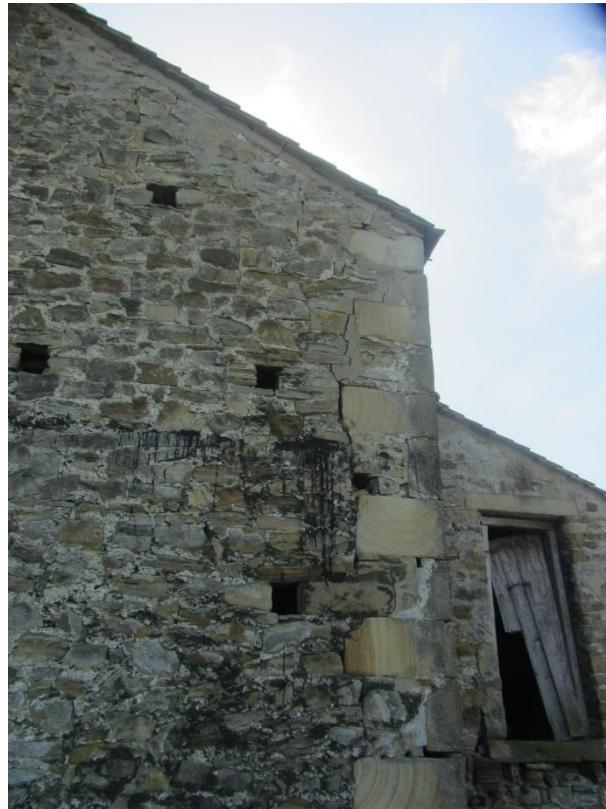
- The north west gable wall is generally straight and vertical. There is a vertical crack at the north corner, at the inner edge of the quoin stones (photo 21).

Photo 21 –North west corner – vertical cracking

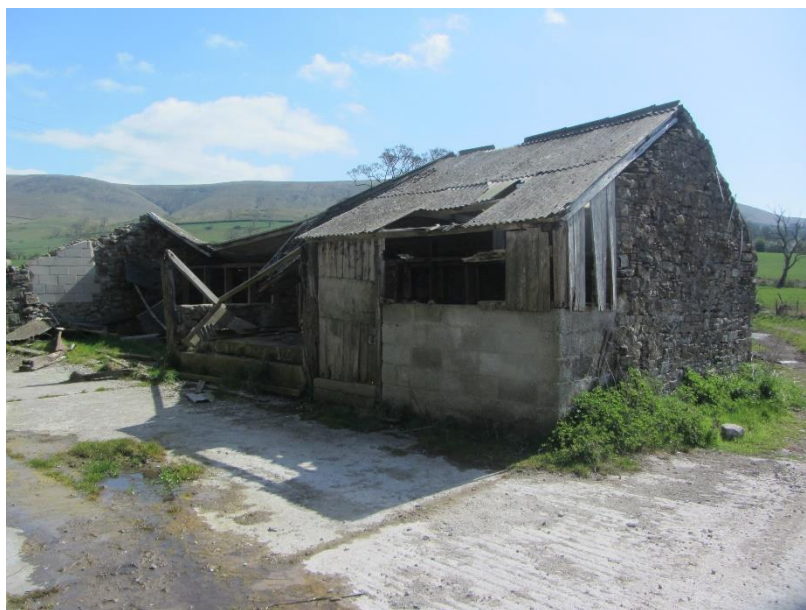
- Both outbuildings are in a state of extreme disrepair, with missing or partially collapsed roofs and leaning stone walls (photos 22 & 23).

Photo 22 – Outbuilding to south east

The outbuildings could be re-constructed. Damaged or badly leaning walls would need to be taken down and rebuilt.

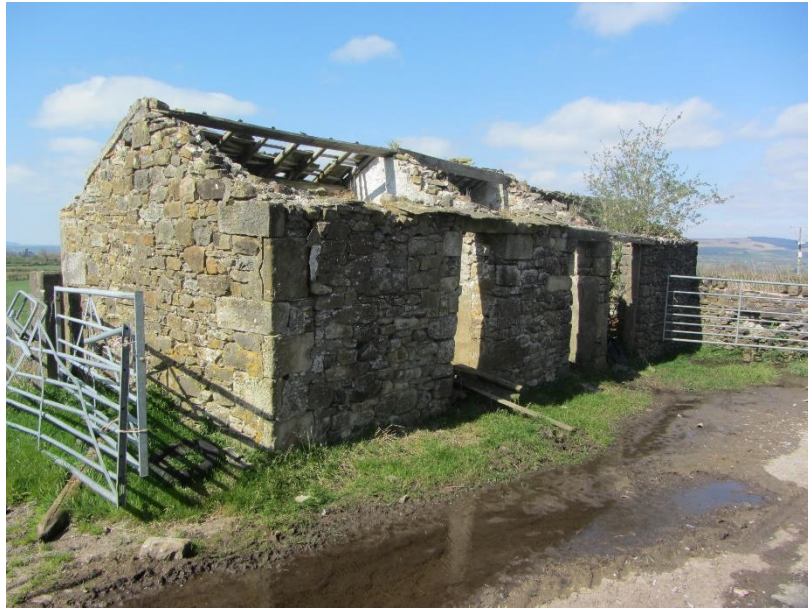
Photo 23 – Outbuilding to south west
