Preliminary Roost Assessment

18 Harewood Avenue
Simonstone
Lancashire
BB12 7JB

For
PJH Architectural Services

Gritstone Ecology

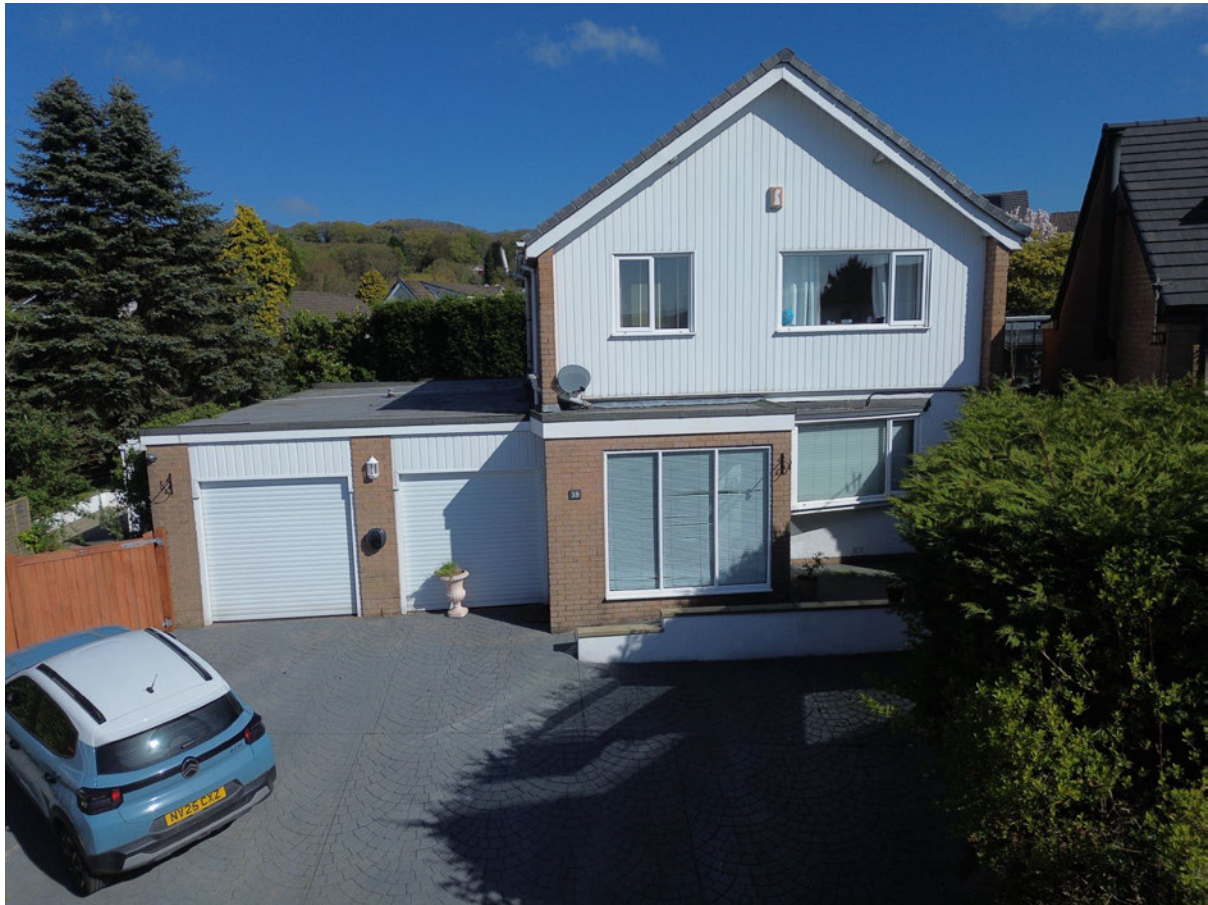
3.1a – The front of the house.

Nº18 Harewood Avenue, Simonstone, is a 1970's built detached house, which is currently occupied. It has a pitched roof, covered with concrete roof and ridge tiles. An attached double garage to the side has a flat felt-covered roof.

The building is relatively modern, well maintained, and in good condition. Ridge tiles are fixed tightly, there are no damaged or missing ridge tiles. There are no damaged, slipped, or missing roof tiles. Roof tiles are tightly fitted, with no gaps between tiles. Fascia boards, boxed soffits, and cladding are fitted tightly against the walls gaps are filled with sealant. Walls are in good condition, with no missing mortar or cracks.

There are no features externally which are likely be used by roosting bats, and no indications of use by bats were present during the inspection.

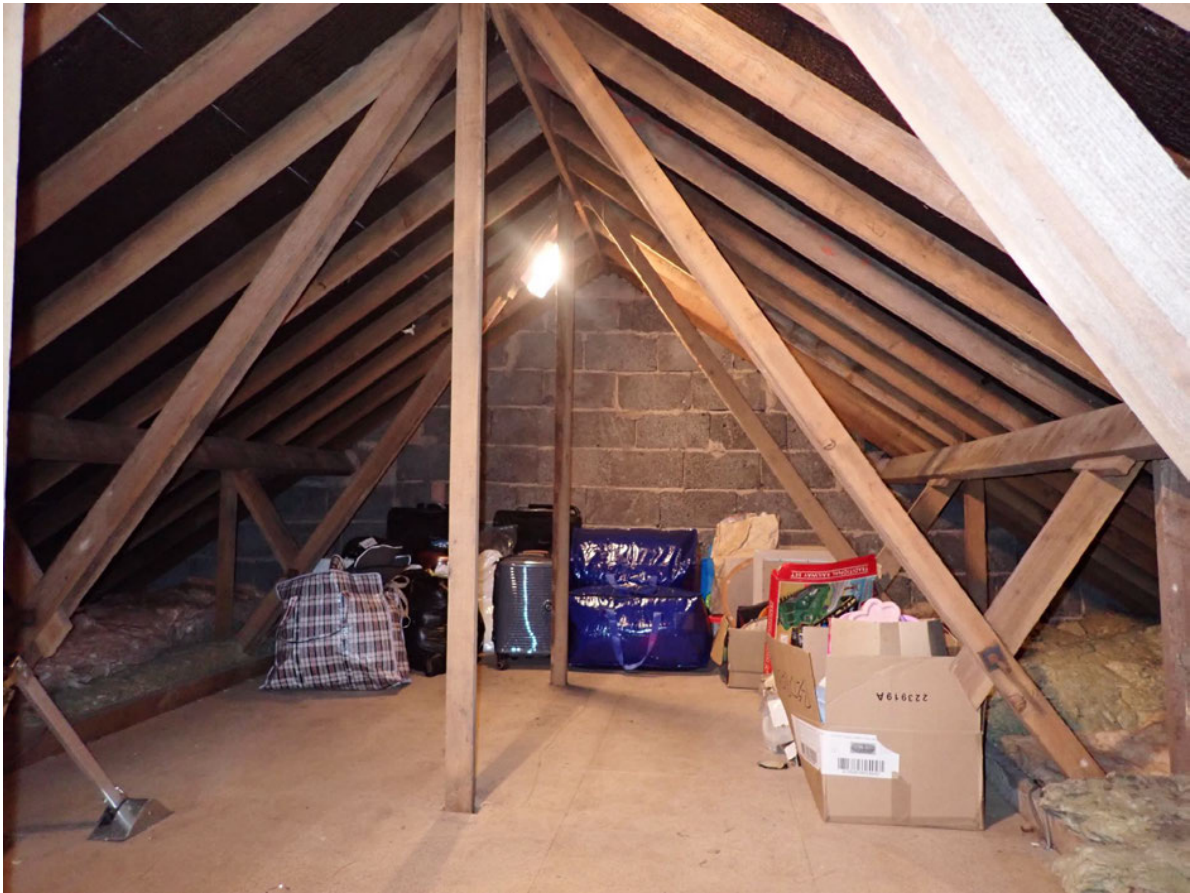
3.2a – The roof void.

The house has a single roof void, which is used for storage, and accessed infrequently for essential maintenance work.

The roof has a timber rafter and purlin structure, lined with bitumen felt, and insulated with mineral wool between the ceiling joists. The roof lining is in good condition with no tears, or gaps.

The wall cavity was inspected at the wall plate using a torch and endoscope, and has been filled with an expanding foam type insulation. There are no gaps at the eaves or gables; and there are no gaps which give direct access to the roof void from the outside. Boxed soffits open into the roof void and were inspected from above.

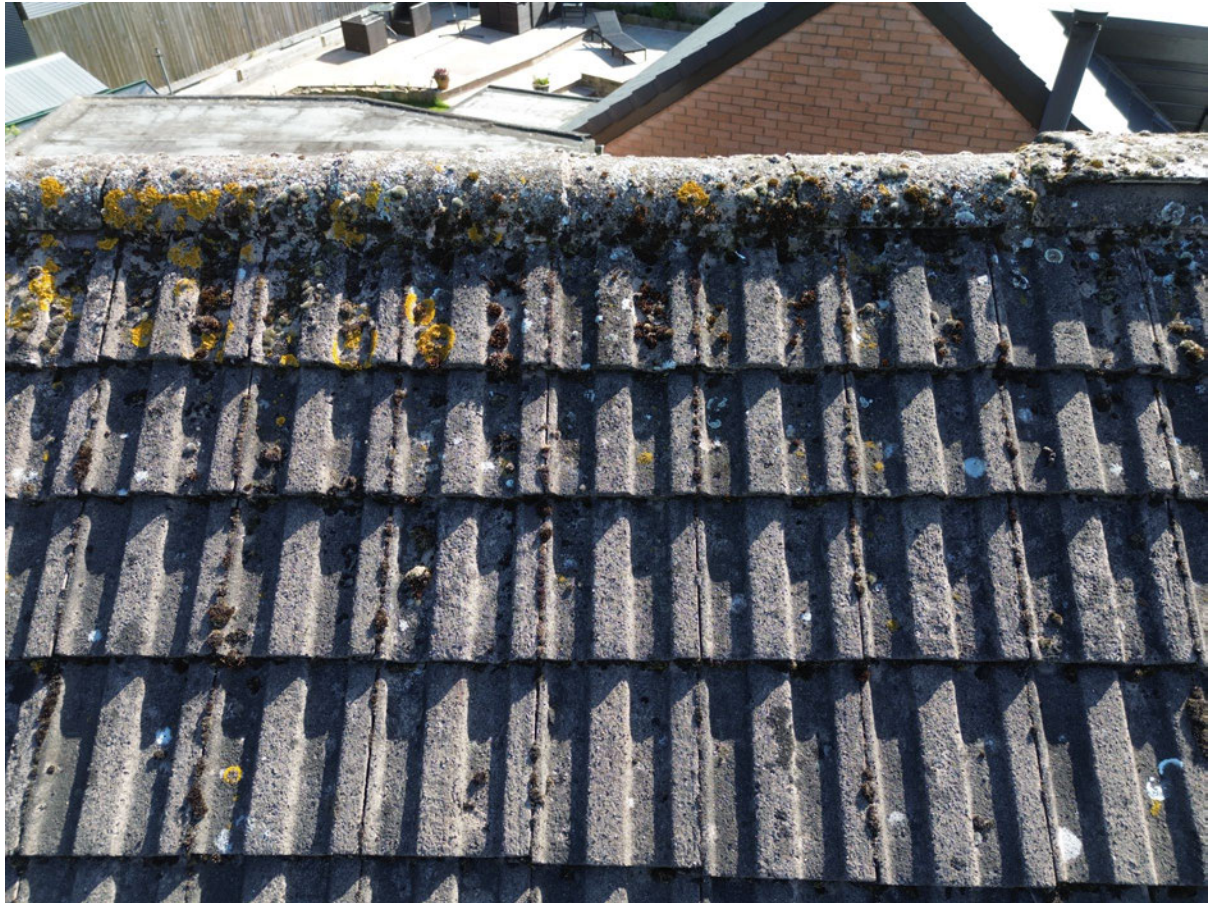
Roof and ridge tiles are in good condition; ridge tiles are sealed with cement. There are no gaps between roofing materials which could be used by roosting bats.

3 – Roof and ridge tiles are in good condition with no suitable gaps.

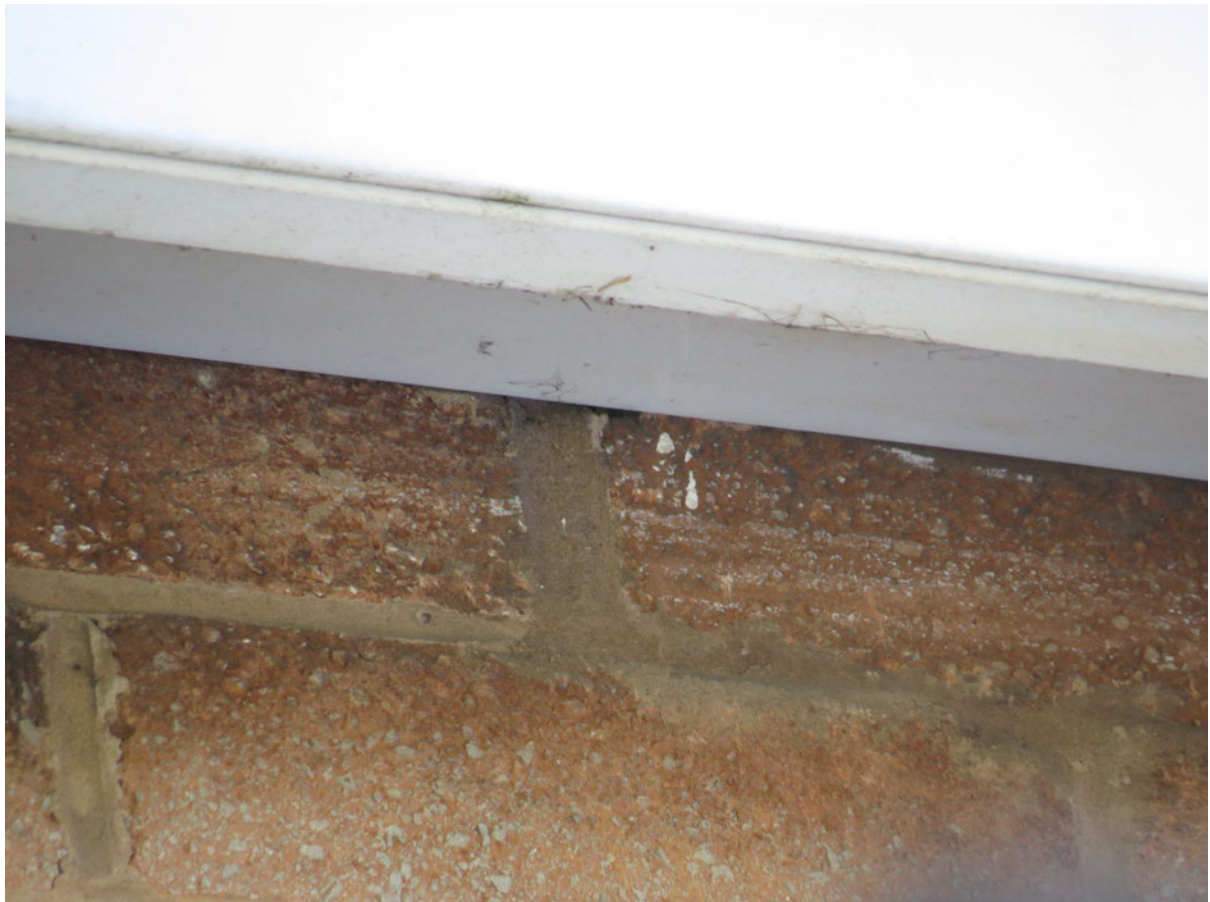
Fascia boards and boxed soffits at the eaves are fixed tightly against brickwork, with no suitable gaps; wall cavities and boxed soffits open into the roof void, and were inspected from above.

4 – Fascia boards and soffits at the eaves are fixed tightly against brickwork.

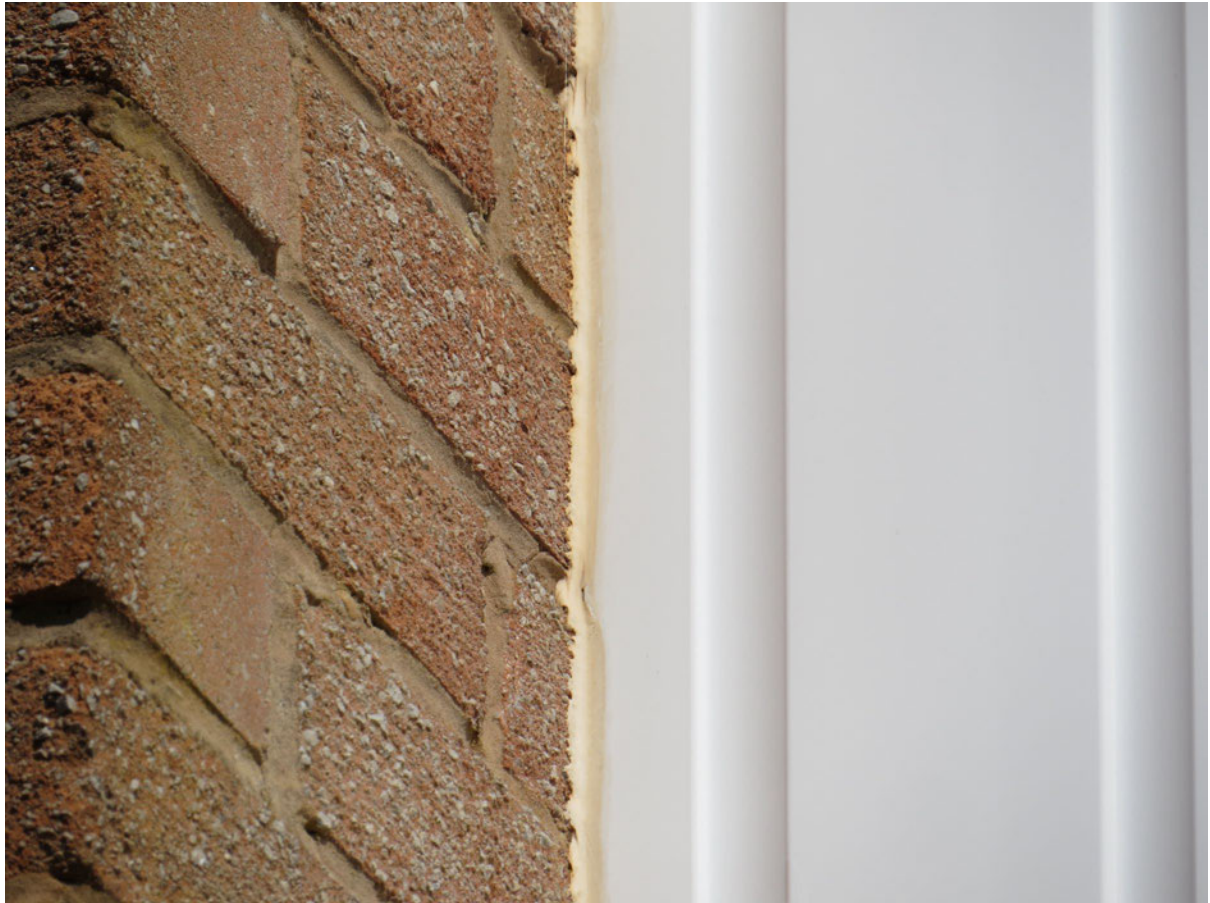
5 – UPVC cladding is fitted tightly with no suitable gaps.

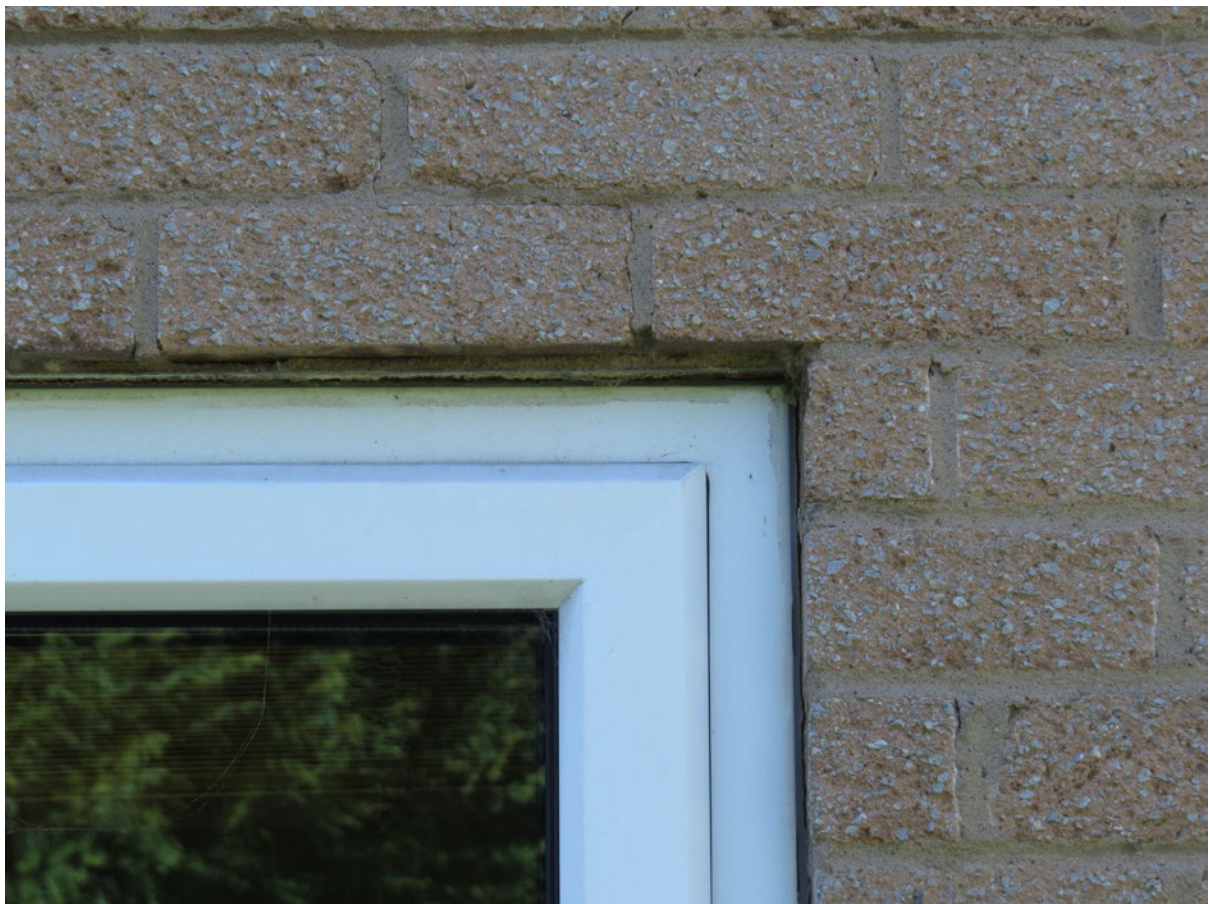
Walls are brick with an insulating cavity. The cavity has been filled with an expanding foam insulation. Walls are in good condition, with no cracks, or missing mortar which could be used by crevice dwelling bats.

Window and door frames are fixed into the brickwork, gaps are filled with sealant, and offer no suitable roosting opportunities.

6 – Brickwork is in good condition windows are tightly fitted with no suitable gaps.

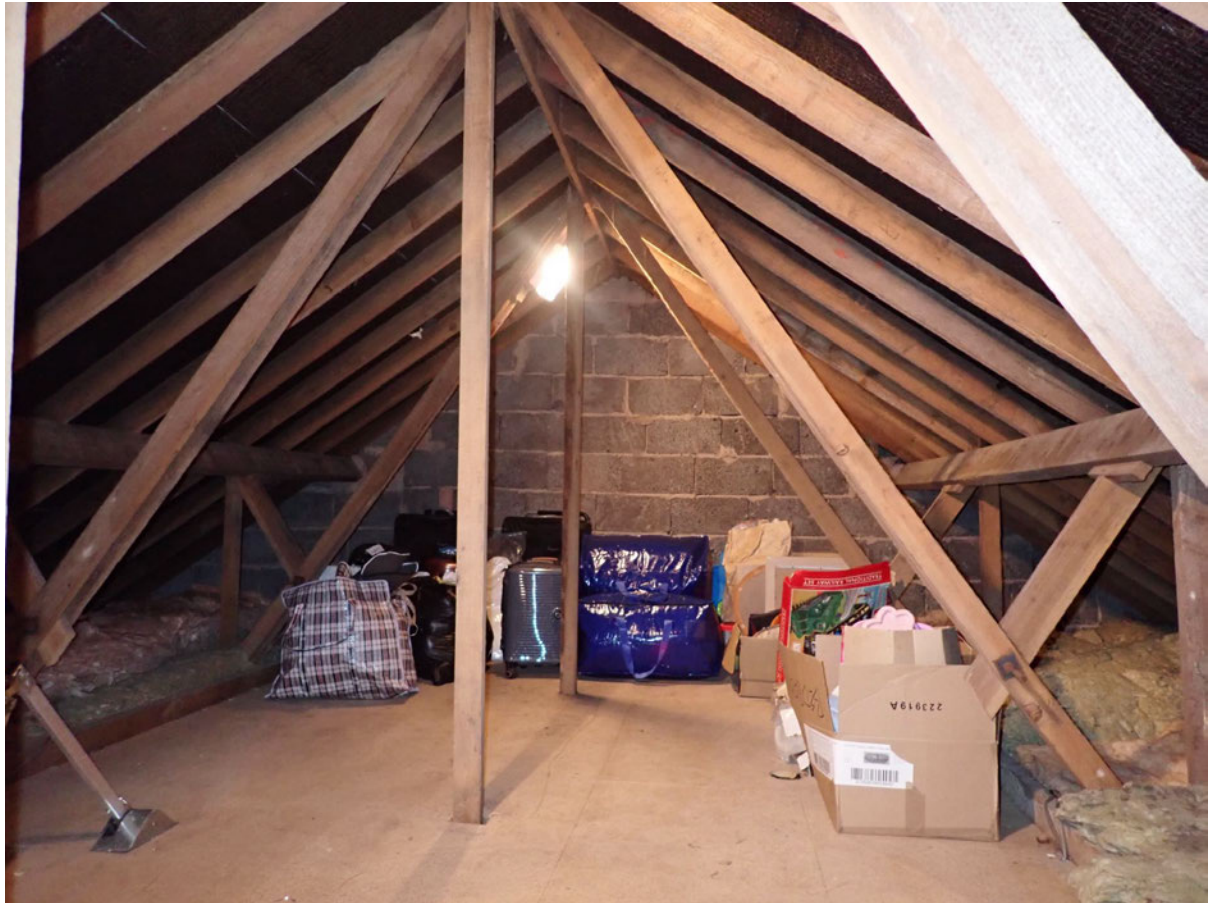
The small gaps between brickwork, roof timbers, and roofing materials, in the roof void were inspected in detail using an endoscope. No droppings were found, and no suitable gaps were present which could give access, or shelter to roosting bats.

7 – The house has a single roof void.

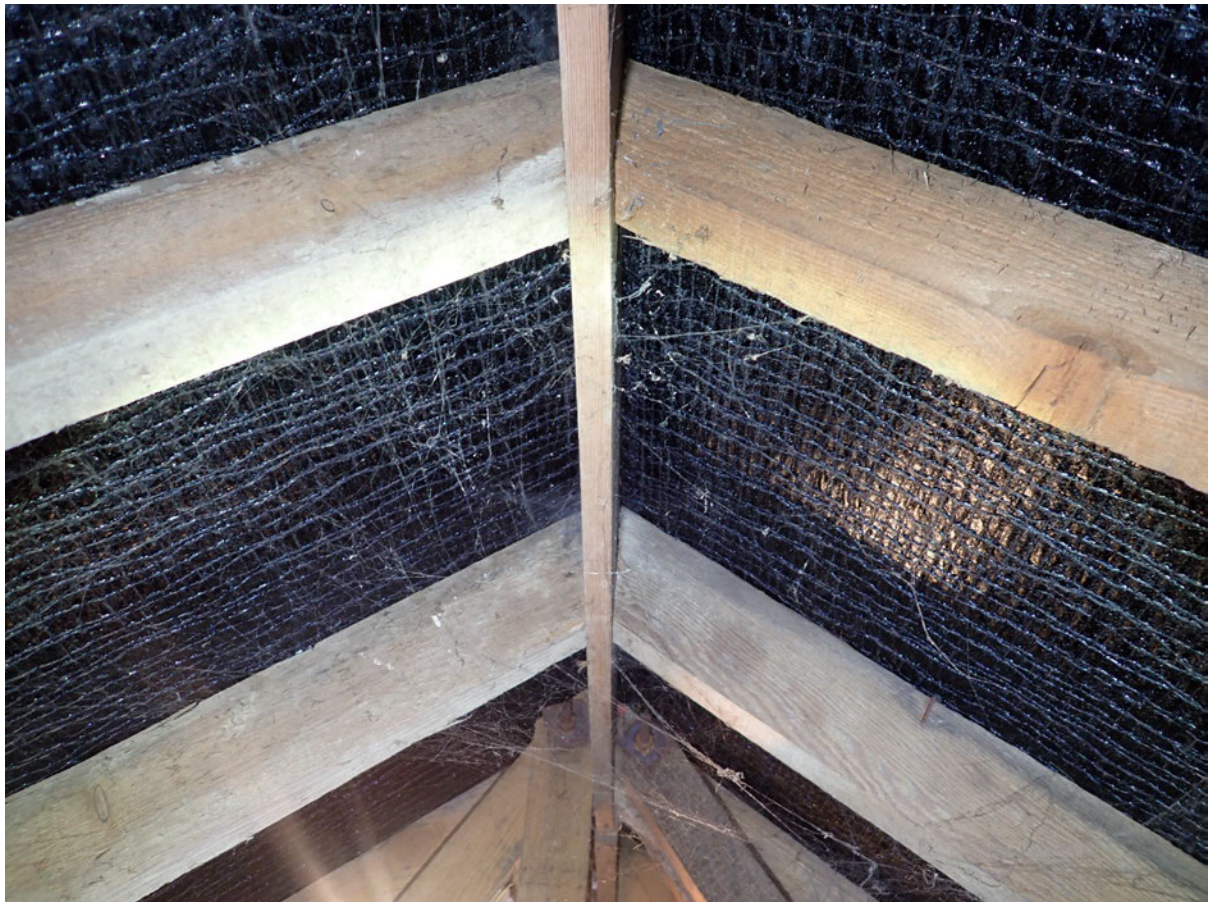
8 – Roof lining is in good condition with no gaps or tears.
