Ground Investigation Report

Proposed LED Floodlit Artificial Grass Pitch (AGP)

Brian Holden Memorial Playing Field, Longridge

January 2026

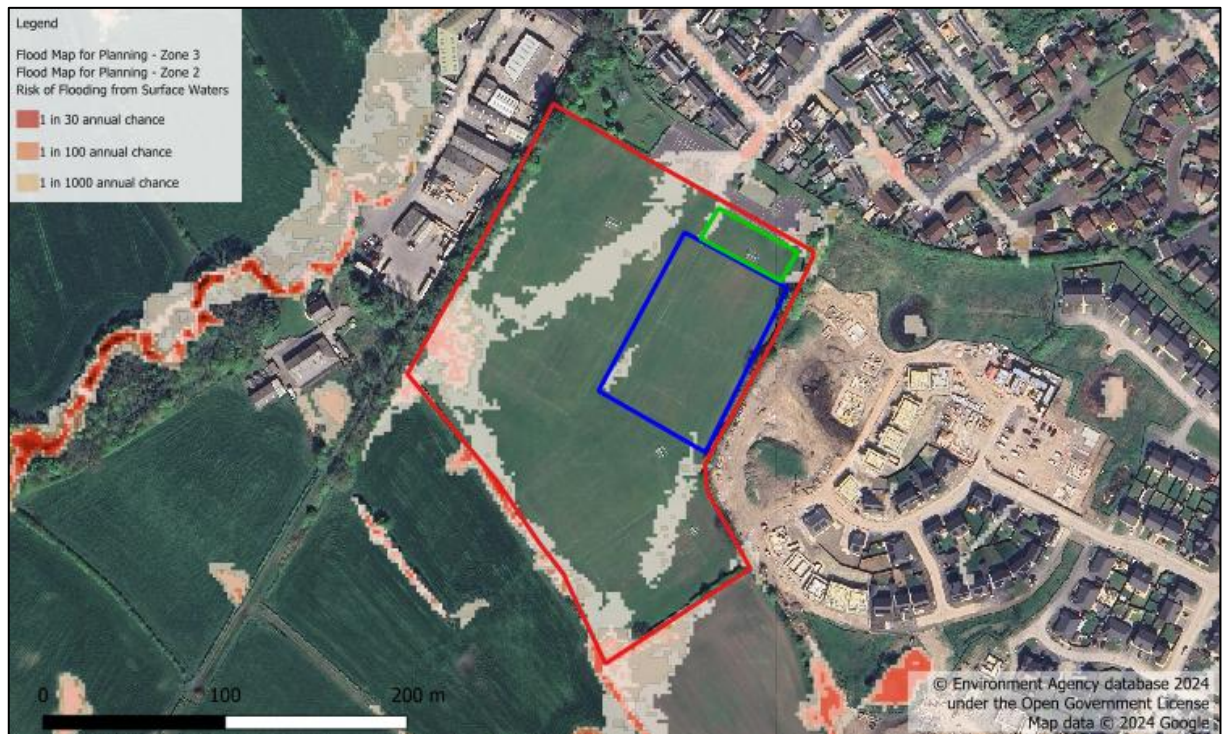
2.5.1 The site falls within a Flood Zone 1 area. This designation indicates there is less than a 0.1% chance of flooding from rivers or the sea in any year (refer to Figure 2-I below).

2.5.2 The south-western corner of the proposed AGP, the western corner of the proposed parking extension, and parts of the wider site are recorded in areas with the potential for surface water flooding during a 1 in 1000-year flood event. The western and south-western corner of the wider site are also recorded with the potential for surface water flooding during a 1 in 100-year flood event (refer to Figure 2-I below).

Figure 2-1: Extract of EA flood risk mapping for the site

2.5.3 It should be noted that this information does not constitute a site-specific Flood Risk Assessment, and one may be required for the scheme.

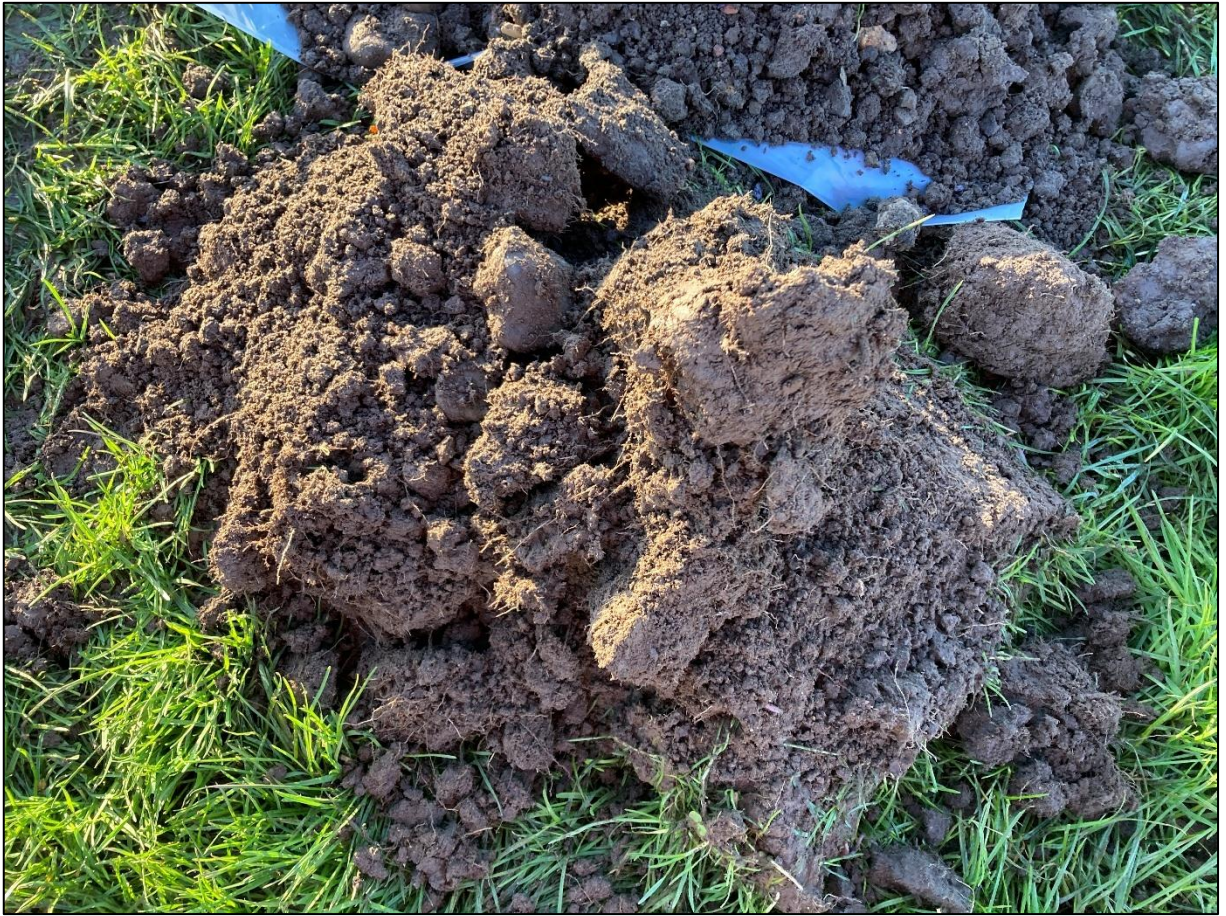
5.2.1 Topsoil was encountered from ground level in all exploratory positions, ranging from 0.10 m to 0.25 m in thickness. Topsoil was observed as grass onto a brown, slightly sandy clay with rootlets.

Figure 5-A: Topsoil deposits extracted from HP01

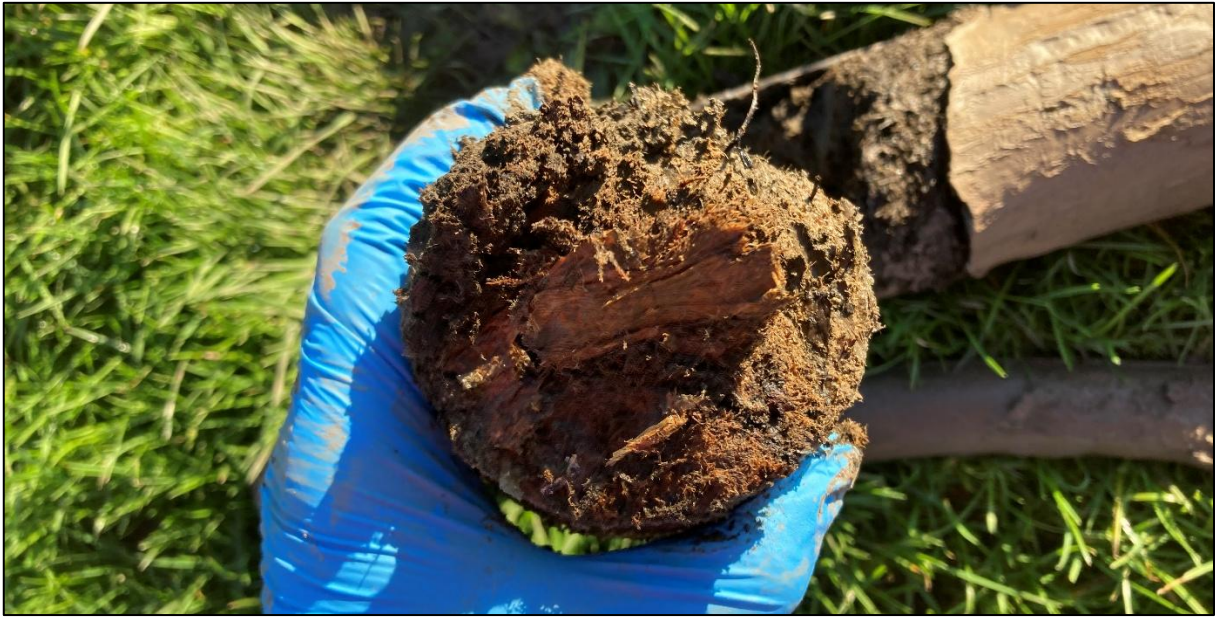
- 5.3.3 In the southern corner of the proposed AGP (WLS01), Made Ground was locally deeper extending to a depth of 3.00 m bgl, comprising soft to firm clay from depths of 0.70 m to 1.90 m overlying a very soft, dark brown, clay, with frequent fragments of wood and a strong organic odour throughout. A faint hydrocarbon odour was also noted between depths of 1.4-1.6 m bgl.

- 5.3.4 This deeper area of Made Ground in WLS01 corresponds to the historical location of a backfilled pond. As a result the deep Made Ground is only expected to be present within the footprint of the old pond, and is not anticipated to be widespread across the southern area of the site.

Figure 5-B: *Made Ground extracted from WLS01, encountered between depths of 1.90 m to 3.00 m bgl*

- 7.3.2 Such deposits are not considered suitable for supporting concentrated foundation loads due to their compressible nature. Accordingly, floodlight foundations should extend, as a minimum, through such deposits. Should the deposits extend into the south-eastern corner of the AGP, formation of a traditional pad type foundation for the floodlight here could be difficult to successfully achieve at such depths. In reality, given the recorded location of the pond, and allowing for some inaccuracy in mapping, the deepest part is likely to be local to WLS01, and the pond is likely to be shallow towards the southeast corner of the AGP.

7.6.1 Due to the depth of Made Ground present within the southern part of the proposed AGP to depths of 3 m bgl, as discussed in Section 7.3 above, formation of a traditional pad type foundation for the south-western most floodlight could be difficult to successfully achieve at such depths. However, the following assessment is based on the assumption that the infilled pond is unlikely to extend significantly into the area of the proposed floodlight (probable based on mapping), and excavations for pad type foundations could be extended through any Made Ground and into the underlying Devensian Till.

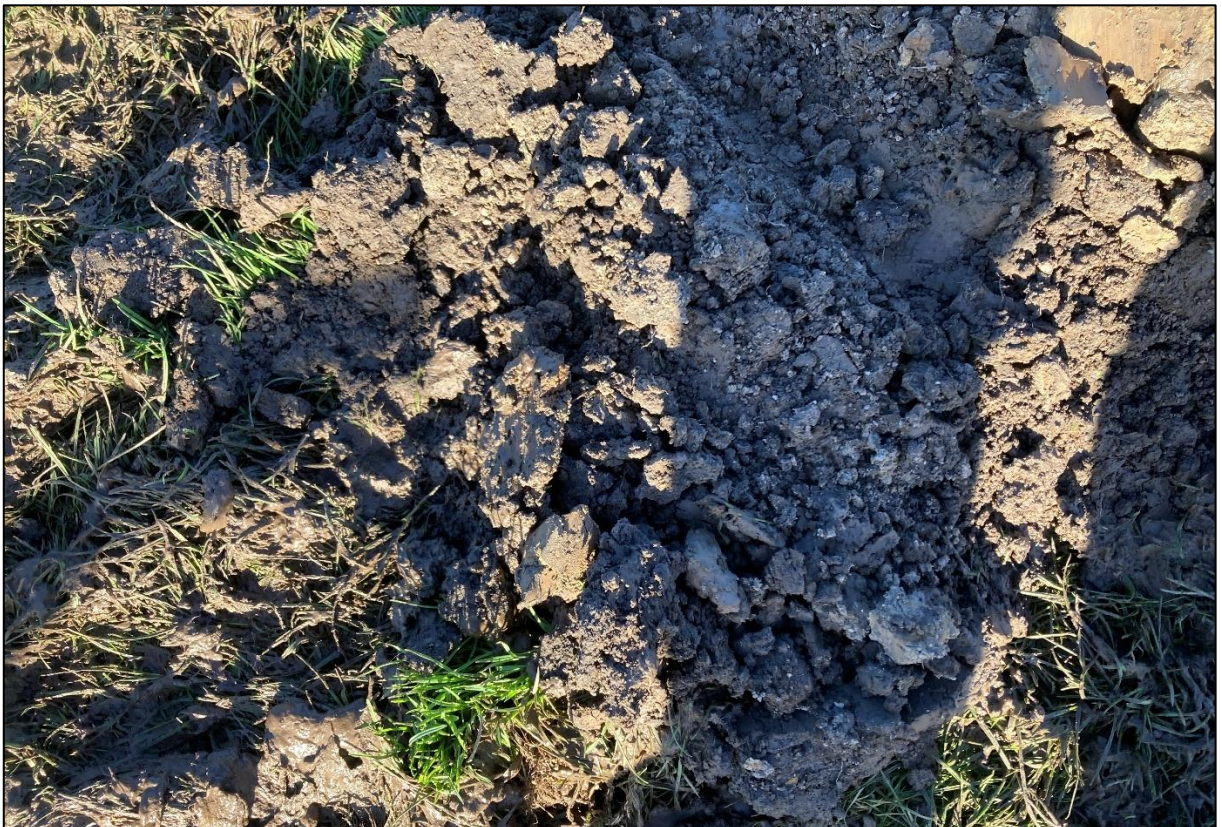
Figure 5-C: *Made Ground extracted from WLS02.*

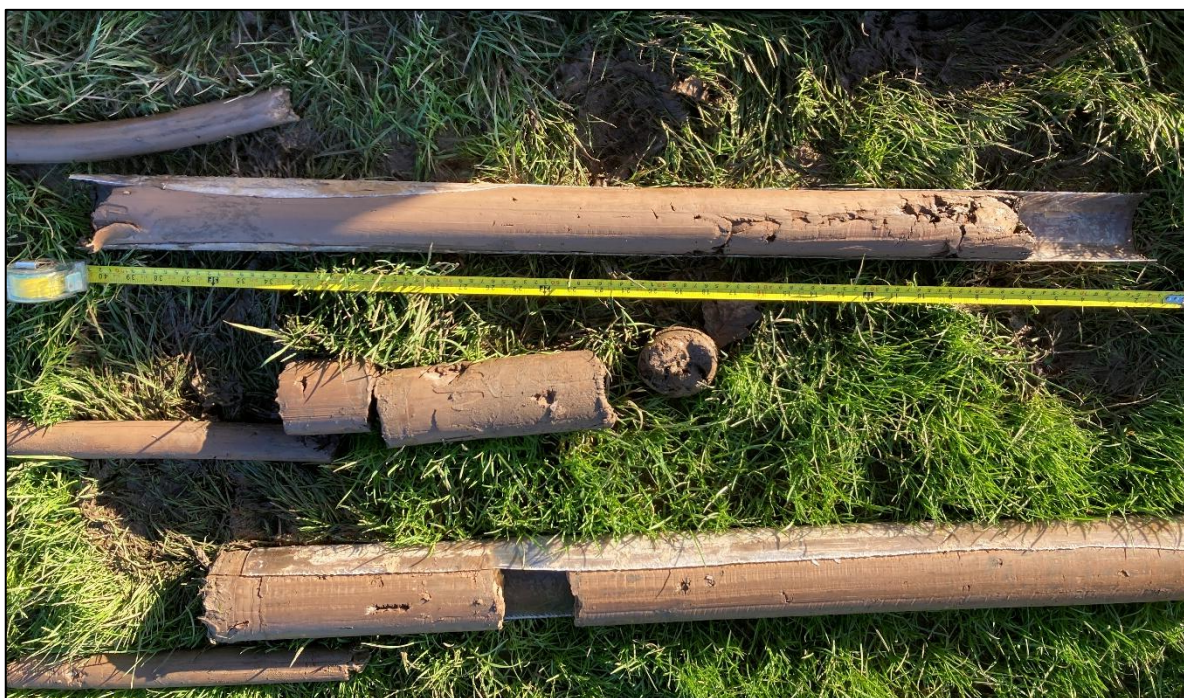
- 5.4.1 Devensian Till was encountered in every exploratory position underlying Made Ground and extended to depths of at least 5.45 m bgl, the maximum depth investigated. The Devensian Till typically comprised firm to stiff brown mottled grey gravelly clay.
- 5.4.2 Photographs of the Devensian Till generally encountered on site are presented below.

Figure 5-D: Devensian Till extracted from WLS02
