TREE RISK AND CONDITION ASSESSMENT OF TREES **AT CLITHEROE ST PAUL'S CHURCH, LOW MOOR, CLITHEROE** **Review April 2026**

Client: The Vicar and PCC of St Pauls Church, Edisford Rd, Clitheroe

Date of Tree Inspection: 7.4.2026

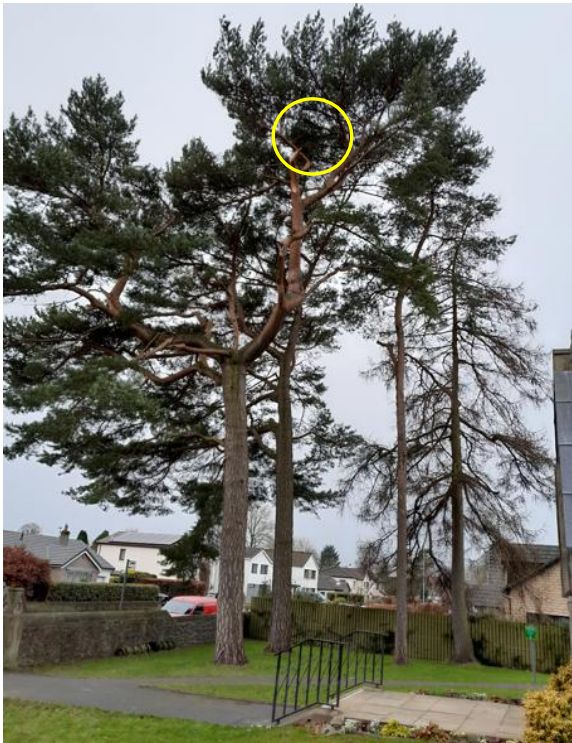
The trees and wind damage (looking west)

Visible targets are the pavement and entrance area to church, the parking locations on the road and the Bus stop

1. The greatest concern is with the late mature Pine (Tag 632/629) where the trees have suffered further limb damage on two occasions since November 2024 and alerted the PCC to the apparent connection between climate change and higher wind speeds leading to tree failure.

4. The remaining pine and larch have on one hand a high Height/Diameter ratio and an overhang towards the neighbouring private property. When the larger trees are removed the wind stress will be taken by the lesser trees. The solution is to fell all four trees and in autumn 2026 replacing with lower and more colourful broadleaves such as Maple which will lose their leaves in the winter when wind stress will be greater.

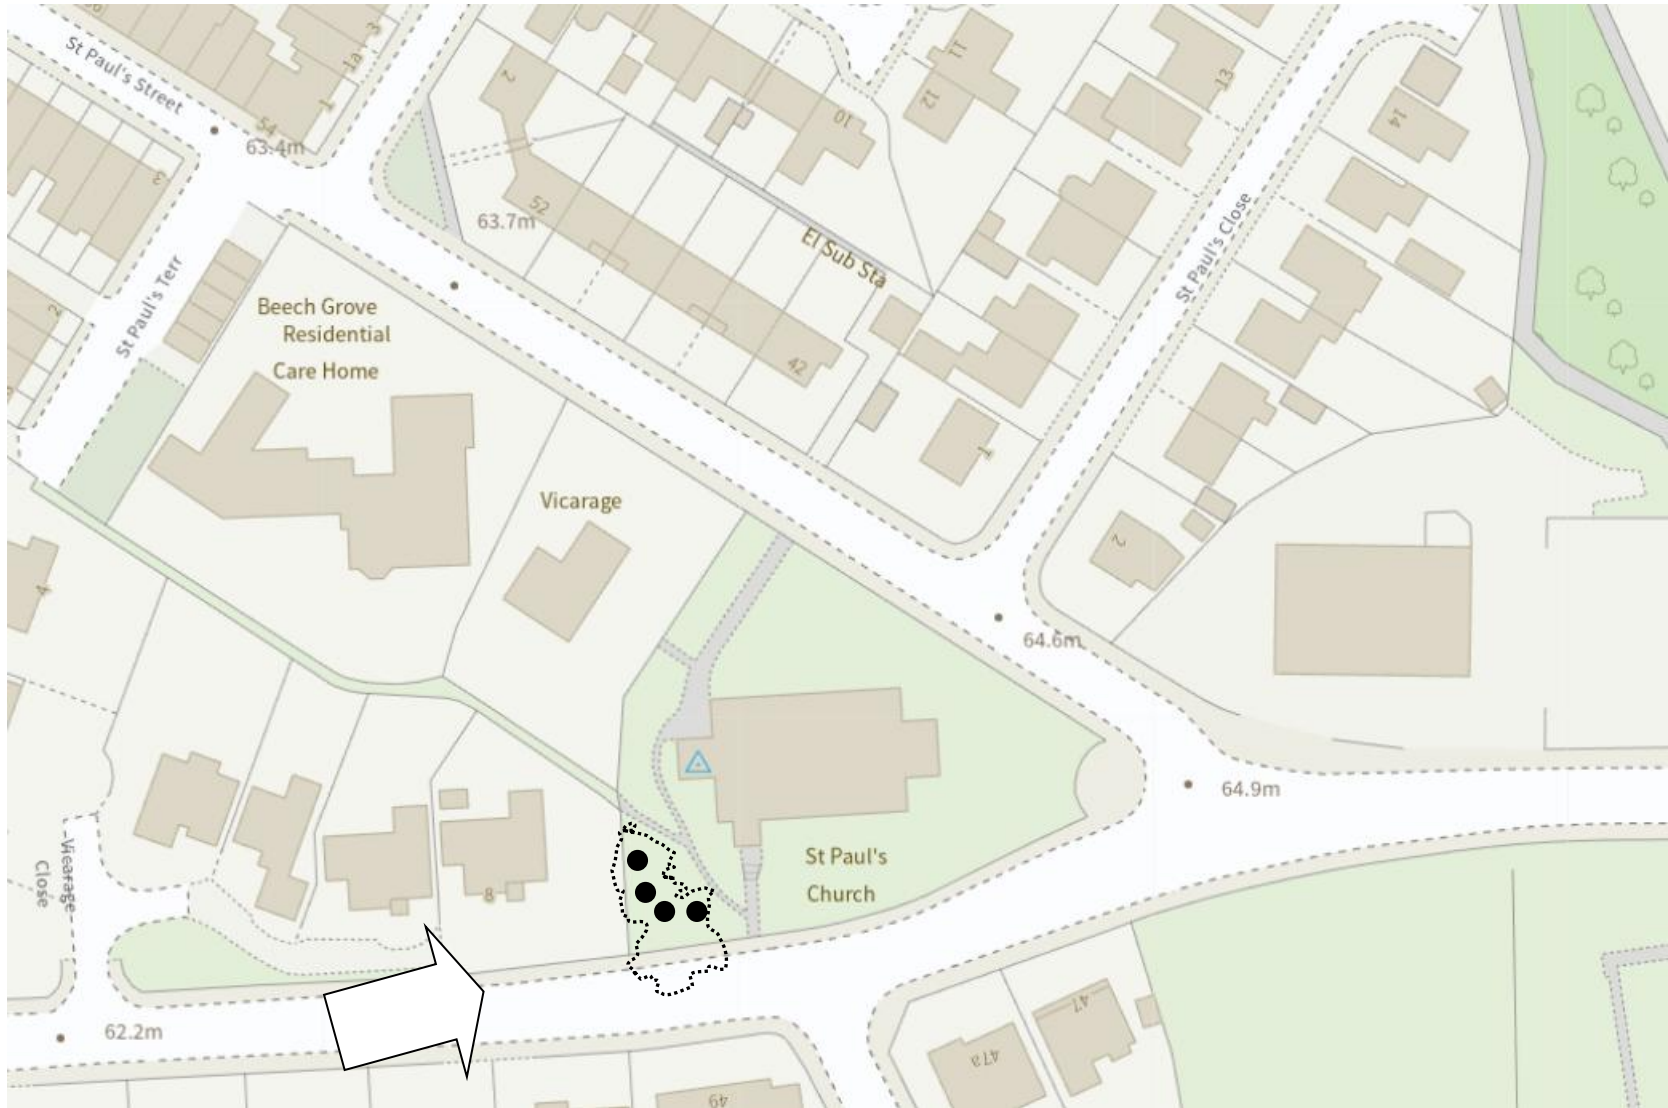
Tree Location Plan Trees number tagged 632,629,630,631

Prevailing wind shown by Arrow
