TREE CONDITION ASSESSMENT OF SEVEN LIME TREES LOCATED ON THE EASTERN BOUNDARY OF 86 WHALLEY RD WILPSHIRE

Client: Mrs E Fisher. Resident Occupant.

Date of Tree Inspection: 16.4.26

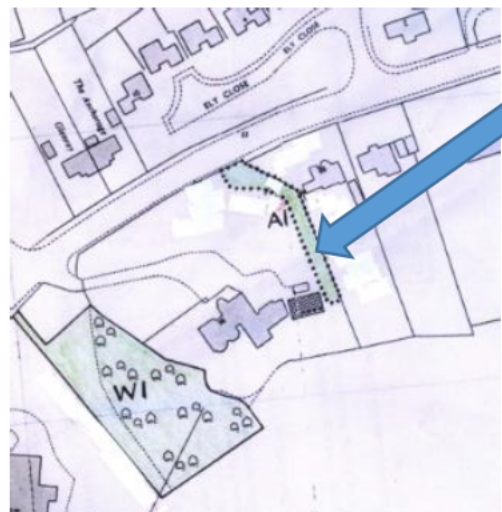
1. The trees are all mature with a DBH of 500-600mm, a height of 21m and a canopy spread radius of 5m. It is our view that the trees were planted as a line of screening prior to the building of 88 Whalley Road. Originally a greater number of trees were planted. One of the trees within the TPO is now within the property of No. 88 and there is evidence of the stump of a lime felled or failed many years ago on the client's side of the fence line.
2. The limes were in early *Bud break* and are shown in the distance in the photo above and arrowed.
3. For identification purposes the trees have been tag numbered 001-007 starting at the north end of the boundary as shown on the plan and within the dotted area of A1.
