# Bat Survey Report Stephen Park, Gisburn Forest, Lancashire

Prepared for: Forestry England  
Date: August 2026  
Reference: J710-D01

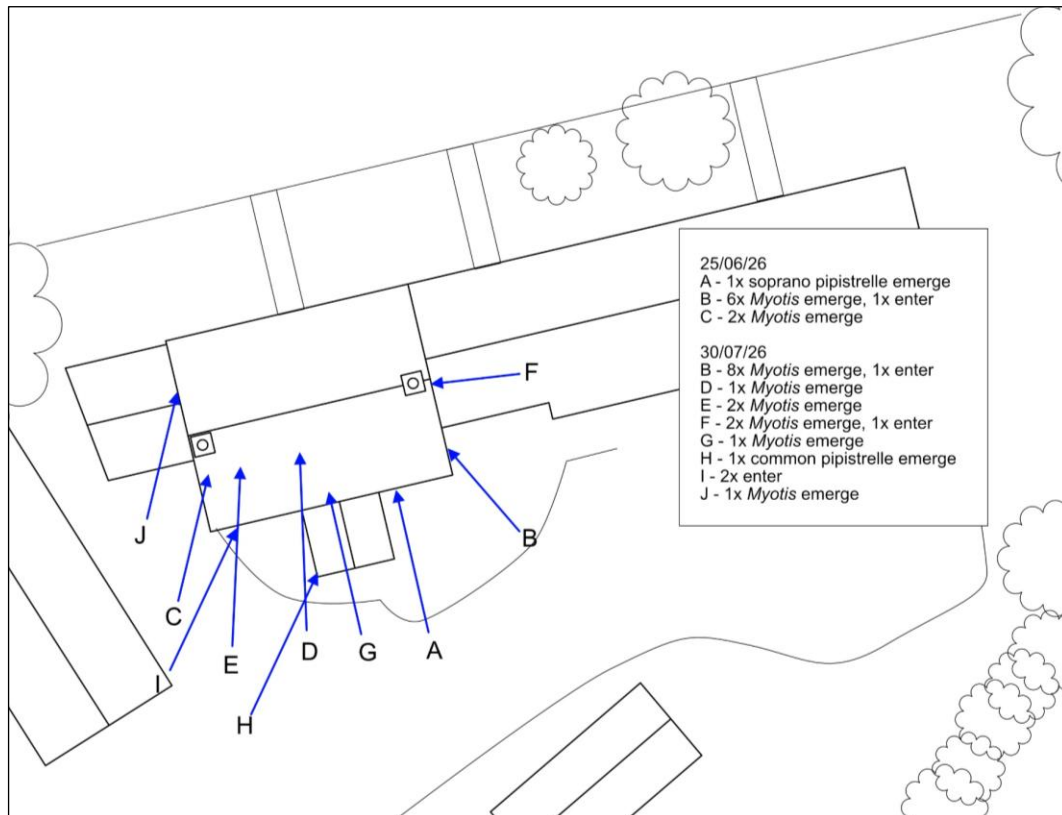
Figure 3: Plan of roost locations

- Roost A – 1x Soprano pipistrelle bat emerged from the eaves of the building, above the right-hand window;
  - Roost B – 6x *Myotis* bats emerged from the southern side of the east-facing gable end, and one bat re-entered;

- Roost C – 2x *Myotis* bats emerged from a loose slate on the southern roof pitch, beneath the western chimney.
- 3.10 *Myotis* bats were recorded regularly flying around inside the roof void of the house. A camera was trained on the chimney area and no bats were observed using this area, either to roost near or to exit the property via. Due to the limit in the amount of area that the internal cameras were able to cover, emerging bats were unfortunately not recorded in frame.

- 3.13 Again, numerous *Myotis* bats emerged from the building. On this occasion 16 bats emerged, and three returned again;
- Roost B - 8x *Myotis* bats emerged from the southern side of the east-facing gable end, and 1x *Myotis* bat entered;

- Roost D - 1x *Myotis* bat emerged from a loose slate on the southern roof pitch;
  - Roost E - 2x *Myotis* bats emerged from a loose slate on the southern roof pitch;

- Roost F - 2x *Myotis* bats emerged from the damage flashing of the eastern chimney, and 1x entered;
  - Roost G - 1x *Myotis* bats emerged from a loose slate on the southern roof pitch;

- Roost H - 1x Common pipistrelle bat emerged from the south-western corner of the porch roof
  - Roost I - 2x *Myotis* bats entered the western end of the southern eaves;

- Roost J - 1x *Myotis* bats emerged from the western gable;

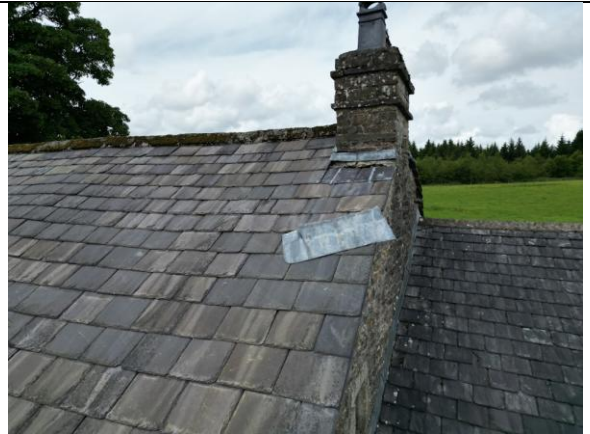
- 3.4 The building is constructed from rough-hewn limestone blocks, which are generally well pointed throughout. There were no obvious gaps or crevices in the walls that could be seen. The roof is slate-covered and again appears to be intact and does not feature any apparent damage, gaps or openings where bats could enter. This is with the obvious exception of the damaged chimney, where the lead flashing has come away from the base, revealing the stone-work beneath and a clear gap into the underlying wall and roof void.

Photograph 10: Damaged chimney flashing

- Replaced lead flashing on the eastern chimney should include an access vent to retain access for roosting bats;
  - Works should be restricted to the chimney flashing and no slate replacement or re-roofing should be carried out. If further works are required then a license may be required, as the impacts to the maternity or day roosts may be too great;

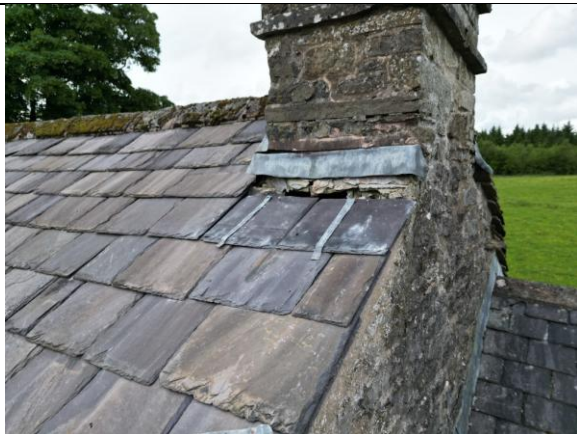
Photograph 11: Damaged chimney flashing

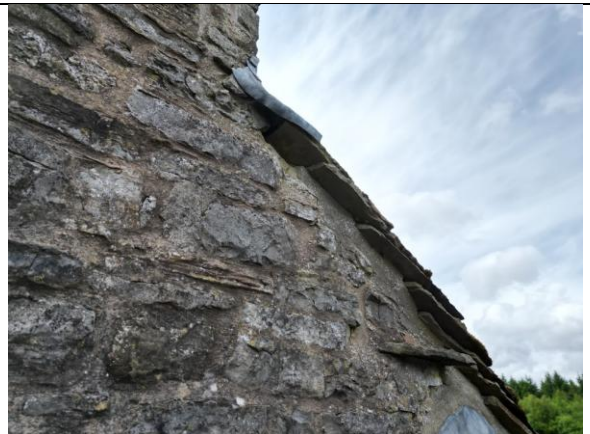
- 3.5 Aside from this clear opening, the roof also has other occasional potential access points, including a gap to the side of the western chimney, possible small crevices between the gable slates on the southern end, and occasional risen slates.

Photograph 12: Gap in western gable

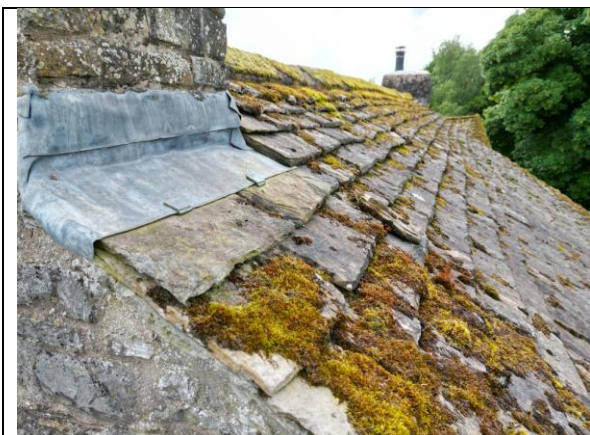
Photograph 13: Western chimney flashing

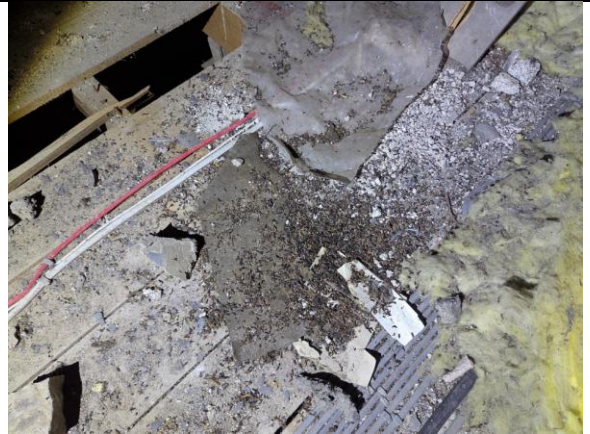
- 3.7 Although no bats were found roosting within the roof void, large piles of droppings were found within the area, mostly in the eastern portion of the void, although there were droppings scattered throughout the loft. The droppings were medium-sized and resembled either those of a brown long-eared bat or a *Myotis* bat, such as a Natterer's or Daubenton's bat. Further droppings were found on the gable walls, including close to the chimney area, where the works are planned for.

Photograph 20: Pile of droppings in eastern end

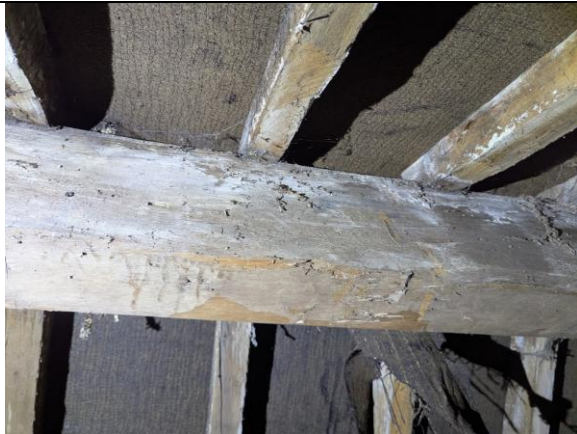
Photograph 21: Clean and clear beams above dropping pile

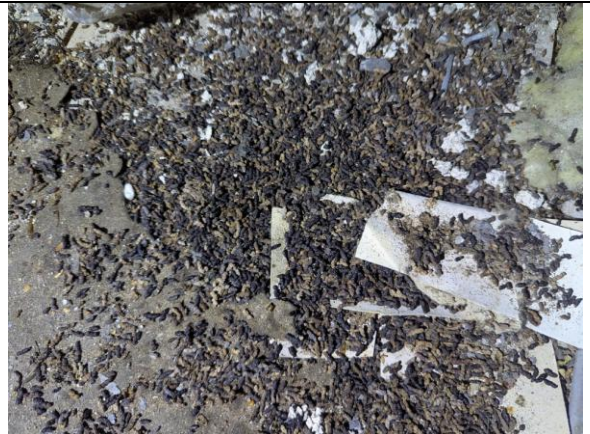
Photograph 22: Detail of droppings

- If a license is needed at any point, then droppings from the roof void should be sent for DNA analysis, to determine with certainty what species of *Myotis* bats the colony are;
