**STRUCTURAL CONDITION SURVEY**

FOR THE EXTENSION OF  
LIVING ACCOMODATION INTO THE  
ATTACHED BARN AT MOOR CLOSE FARM  
WHYTHA LANE  
RIMINGTON  
BB7 4EQ

FOR MR AND MRS HOOPER

Date: 28<sup>th</sup> April 2026  
Author: Louise Read MRICS  
Job No: - 180

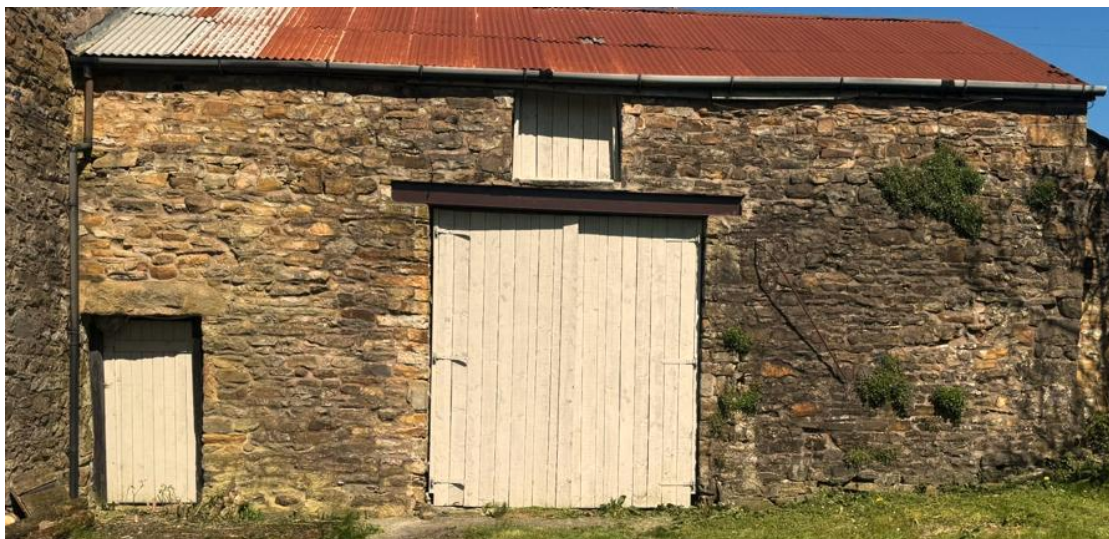
The pointing to the South elevation of the barn is in average condition, there are a couple of areas where pointing is missing and hairline cracks visible in the mortar joints. To the Eastern gable wall the pointing is in good condition. To the South elevation there is a step back at about barn door head height within the wall thickness (the barn has been built with this step), there is also vegetation growing out of the walls in some areas. During the conversion works the vegetation growing within the walls will need to be removed and some areas will require re-pointing.

Photograph (1) – South elevation wall

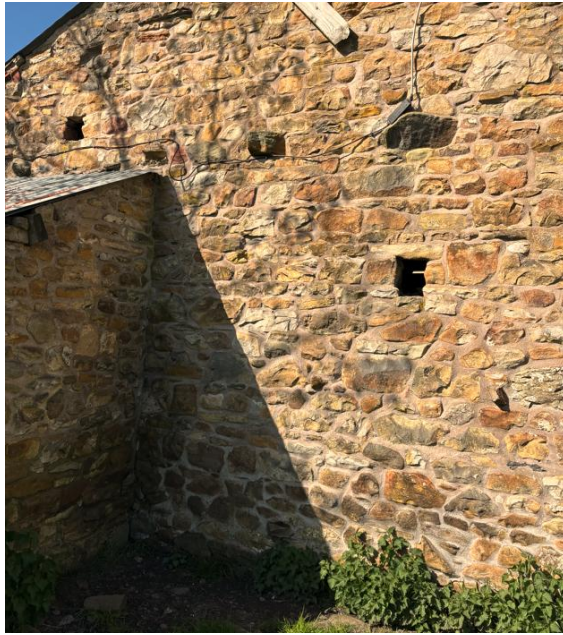
Photograph (2) – East elevation wall

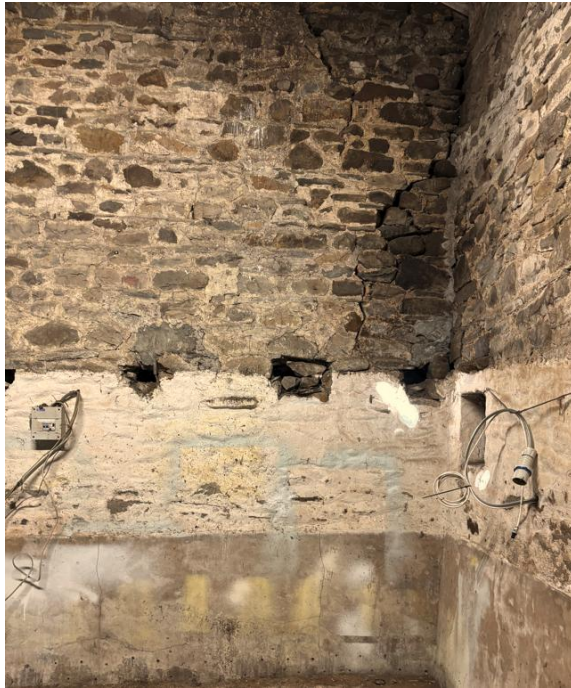
A couple of cracks were noted internally within the barn, one to the right hand side of the cart opening and the other to the back corner of the barn where the barn meets the house and garage walls. The crack at the barn/ house/ garage wall intersection extends from where the hay loft would have been located (sockets for the timber floor joists are visible in the wall) upto the underside of the purlin. In this location the crack will need to be stitched with helical bars to tie the structure together.

Photograph (3) – Showing crack that requires crack stitching

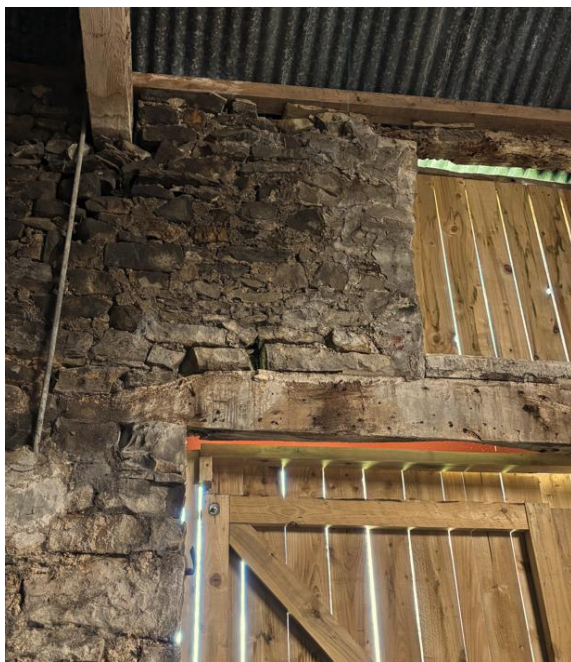
The existing large barn door opening has a timber head above the opening internally; this is decaying and needs replacing. The timber head over the window above it is also decaying and will need replacing.

Photograph (4) – Showing decaying head to cart opening and window above

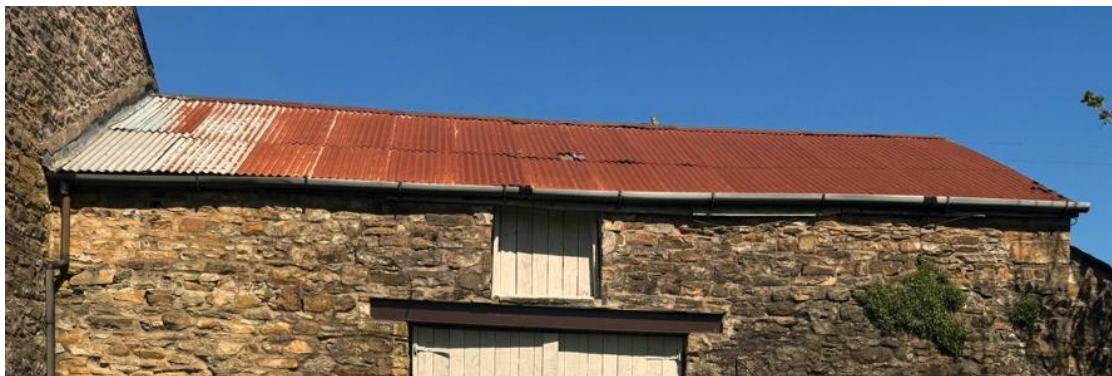
The corrugated tin sheets are in average condition; daylight is visible through in some areas and some of the sheets appear to move/ become displaced in the wind. However, as part of the works it is proposed to replace the corrugated tin sheets with slate which will be more in keeping for a barn of this age. The roof trusses and purlins over the main barn are in good condition.

Rainwater goods are present to the South elevation but they are old and in poor condition, the downspout is not connected. To the North elevation the rainwater goods are missing or broken. The rainwater goods will need replacing during the works. To the East elevation the timber fascia boards are in poor condition/ missing.

Photograph (5) – South elevation roof condition

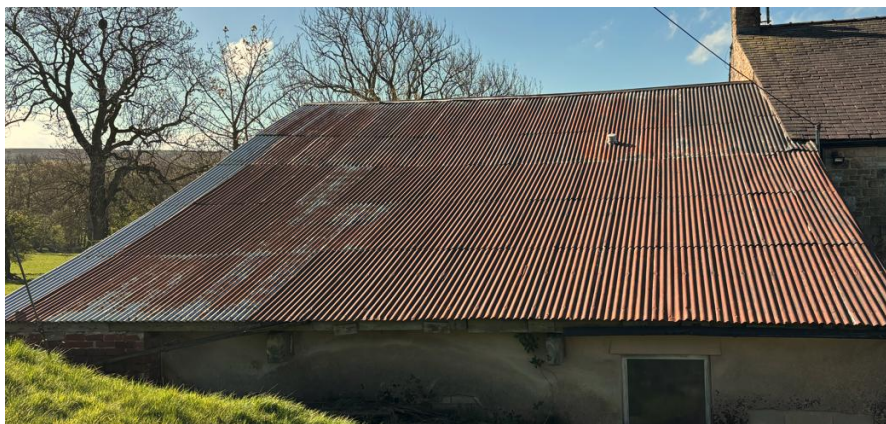
Photograph (6) – North elevation roof condition

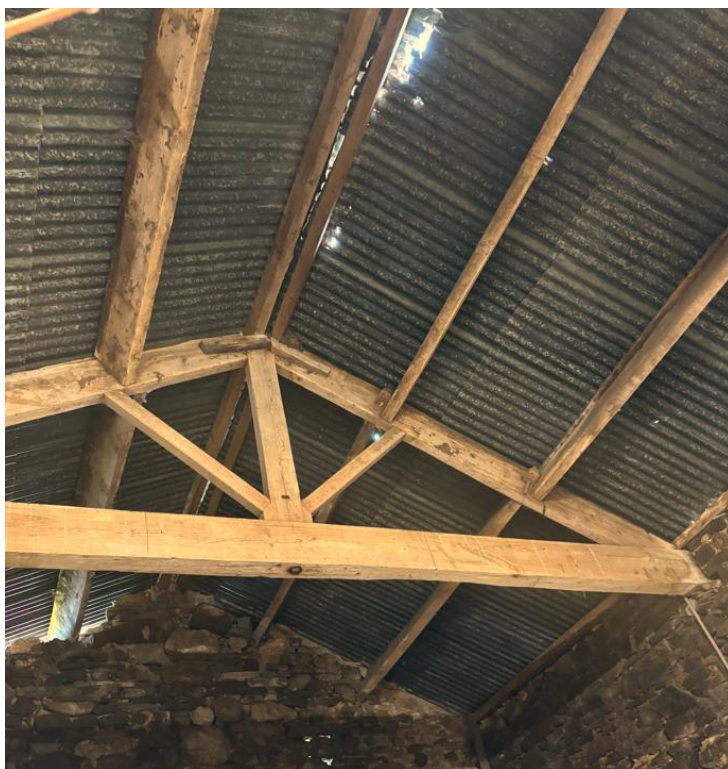
The roof is covered with corrugated tin sheets. The barn has a traditional timber roof construction, comprising of trusses and purlins which the roof sheets are fixed too. Above the garage the roof construction is made up of trusses, purlins and rafters with the roof sheets fixed over the rafters.

Photograph (7) – Showing the condition of the roof structure
