# Preliminary Roost Assessment

13 Brookside  
Old Langho  
Blackburn  
BB6 8AP

## Gritstone Ecology

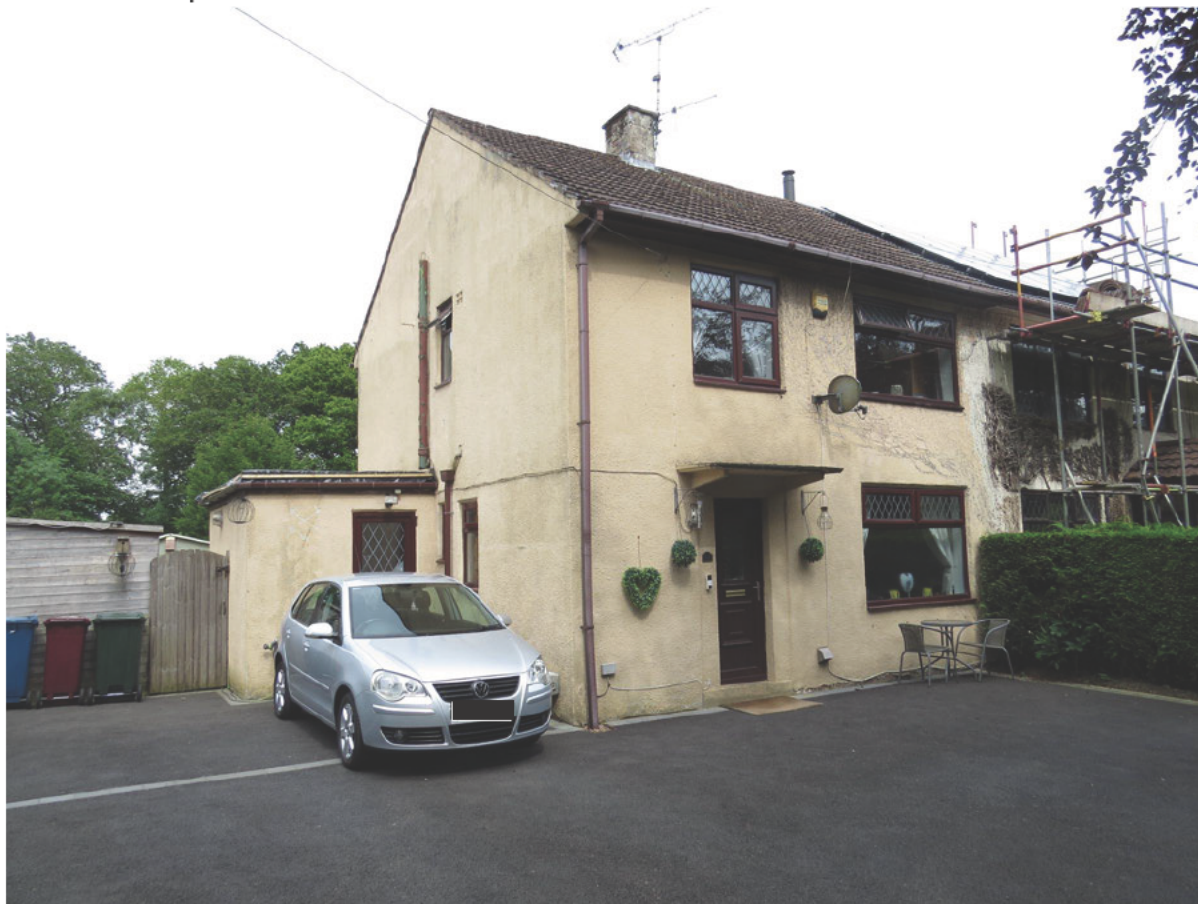
3.1a – The front of the house.

The building is well maintained, and in good condition. Ridge tiles are fixed tightly, there are no damaged or missing ridge tiles. There are no damaged, slipped, or missing roof tiles. Roof tiles are tightly fitted, with no gaps between tiles. End tiles at the verges are sealed with cement. Fascia boards and boxed soffits are fitted tightly against the walls with no viable gaps. Walls and render are in good condition, with no missing mortar or cracks.

There are no features externally which are suitable or likely be used by roosting bats, and no indications of use by bats were present during the inspection.

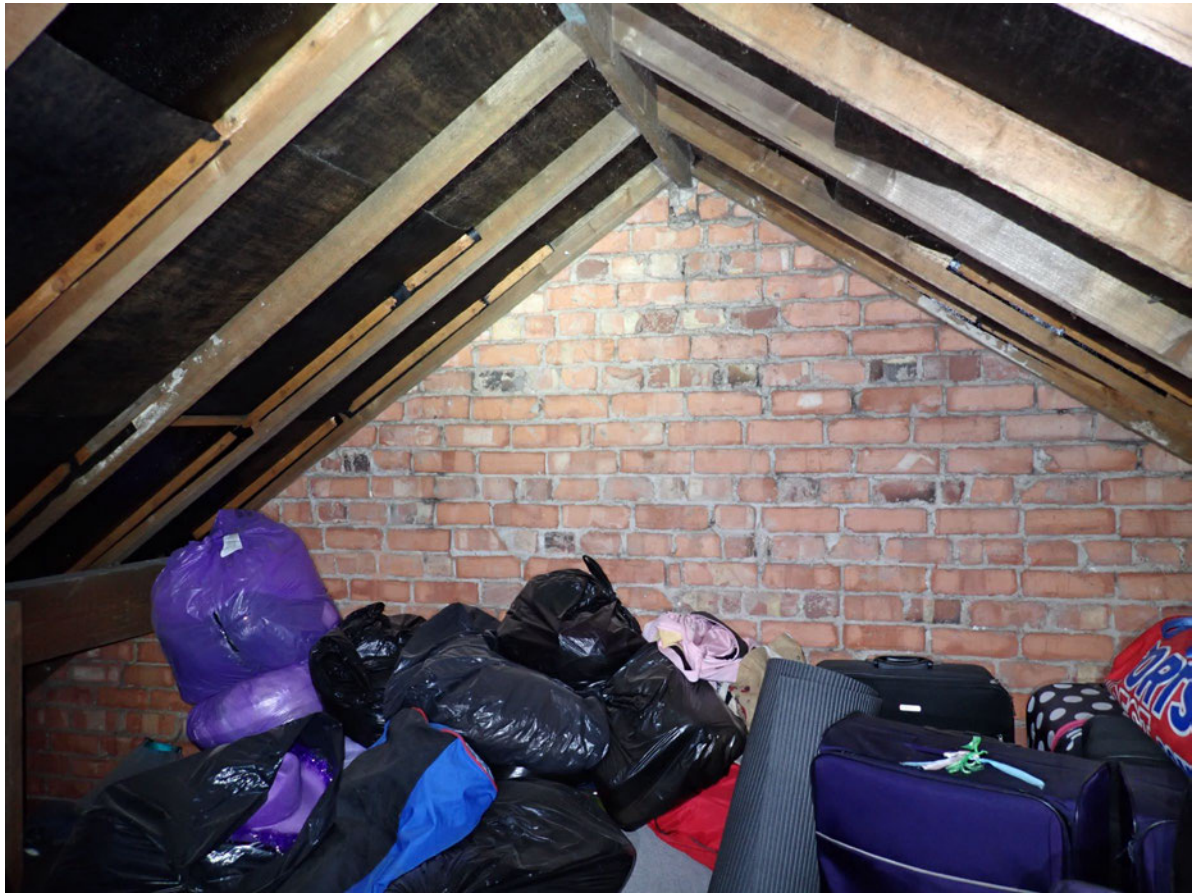
3.2a – The roof void.

The house has a single roof void, which is used for storage, and accessed infrequently for essential maintenance.

The roof has a timber rafter and purlin structure, lined with bitumen felt, and insulated with mineral wool between the ceiling joists. The roof lining is in generally good condition with no tears, or gaps.

The wall cavity was inspected at the eaves and gable end using a torch and endoscope. There are no gaps at the eaves or gable end, and there are no gaps which give direct access to the roof void from the outside. Boxed soffits open into the roof void and were inspected from above.

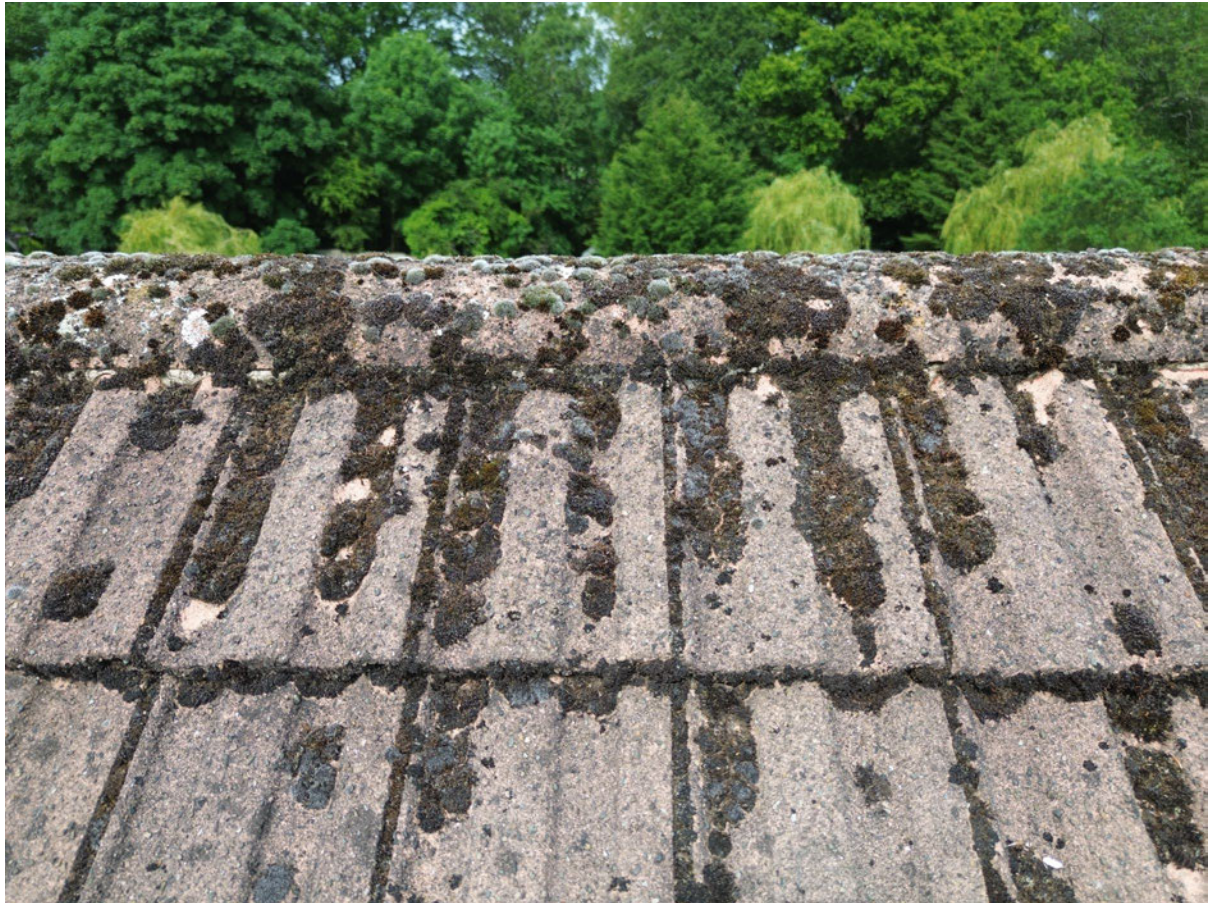
Roof and ridge tiles are in good condition; ridge tiles are sealed with cement, end tiles at the verges are sealed with cement. There are no gaps between roofing materials which could be used by roosting bats.

3 – Roof and ridge tiles are in good condition with no suitable gaps.

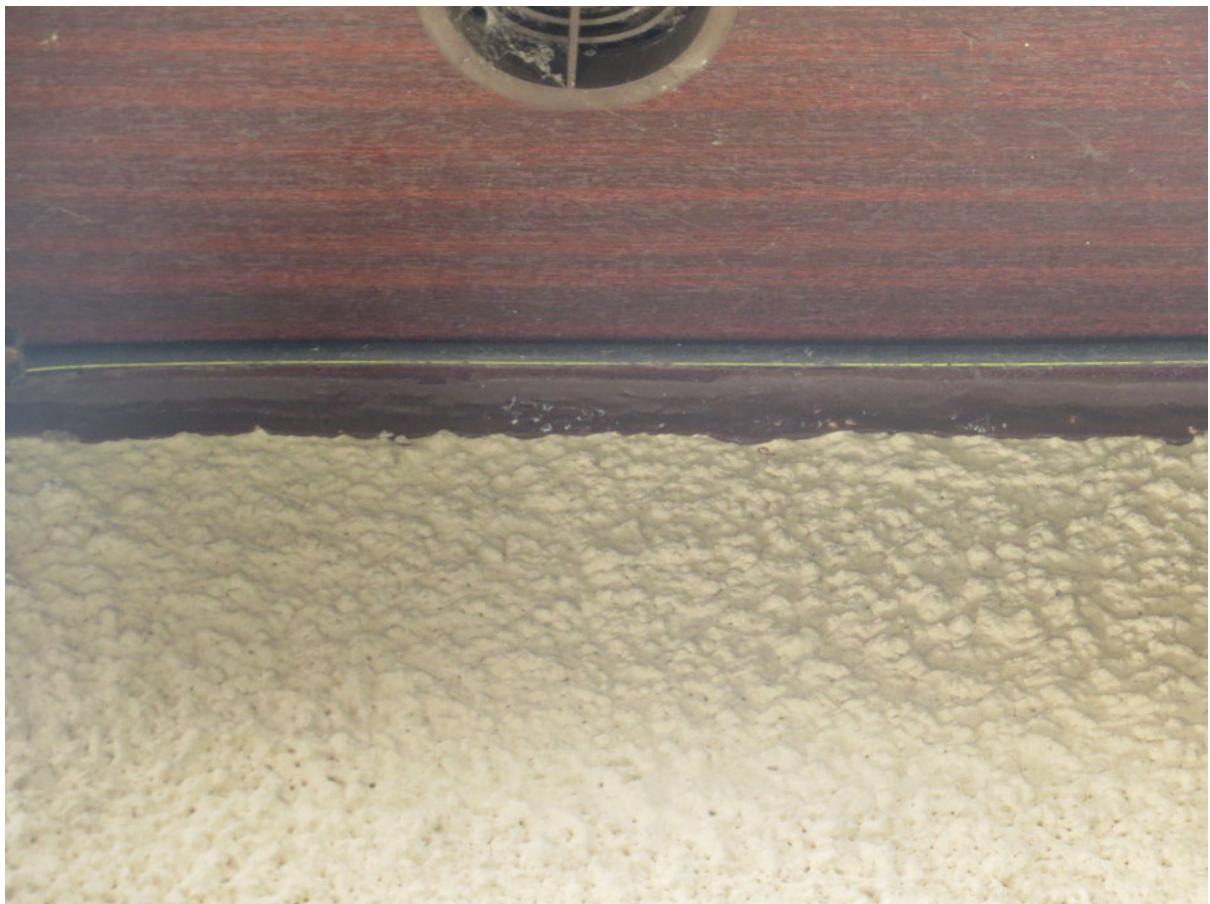
Fascia boards and boxed soffits at the eaves are fixed tightly against brickwork, with no suitable gaps; wall cavities and boxed soffits open into the roof void, and were inspected from above.

4 – Fascia boards and soffits at the eaves are fixed tightly against brickwork.

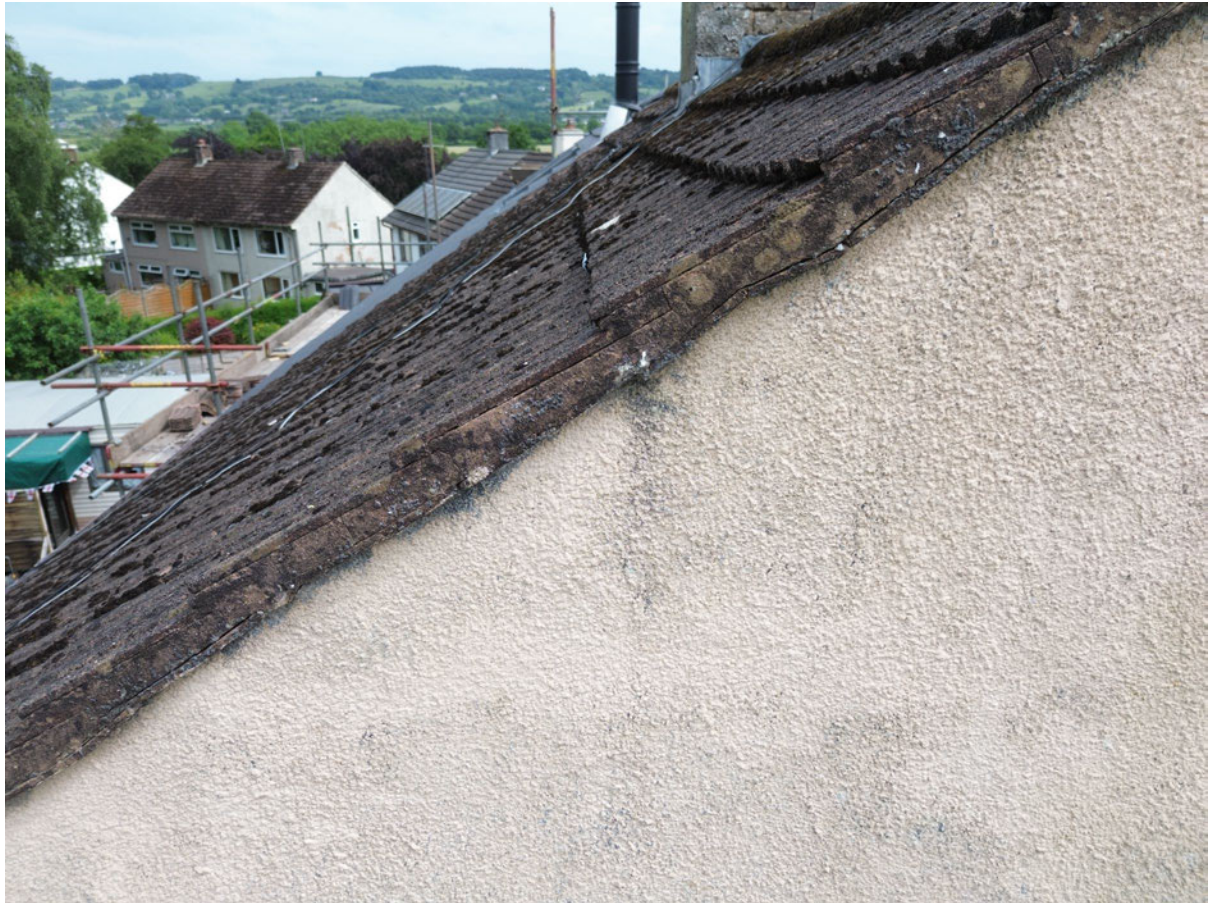
5 – End tiles at the verges are sealed with cement.

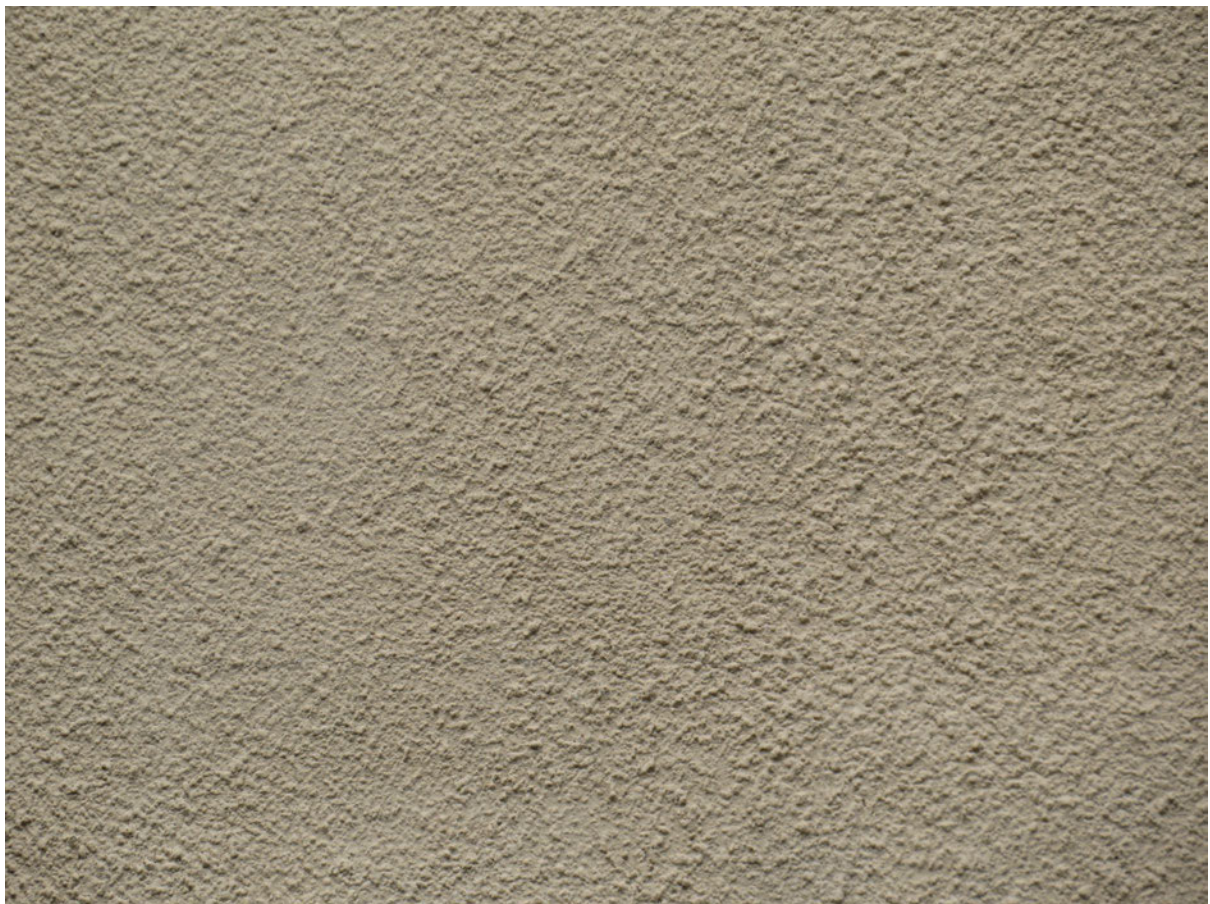
Walls are brick with an insulating cavity, covered with a painted cement render. Walls and render are in good condition, with no cracks, or missing mortar which could be used by crevice dwelling bats.

6 – Brickwork and render are in good condition with no suitable gaps.

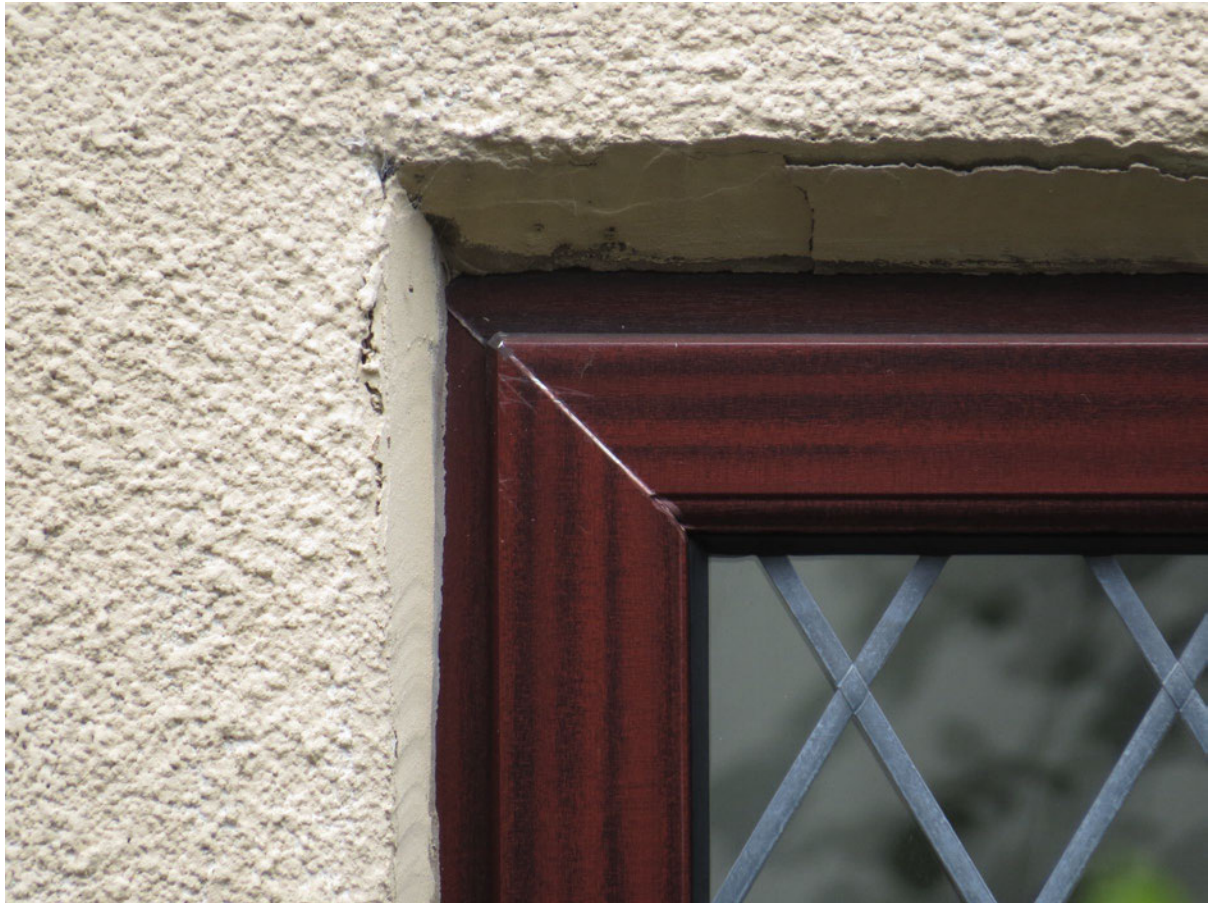
Window and door frames are fixed into the brickwork, gaps are filled with sealant, and offer no suitable roosting opportunities.

7 – Window and door frames are tightly sealed into brickwork with no suitable gaps.

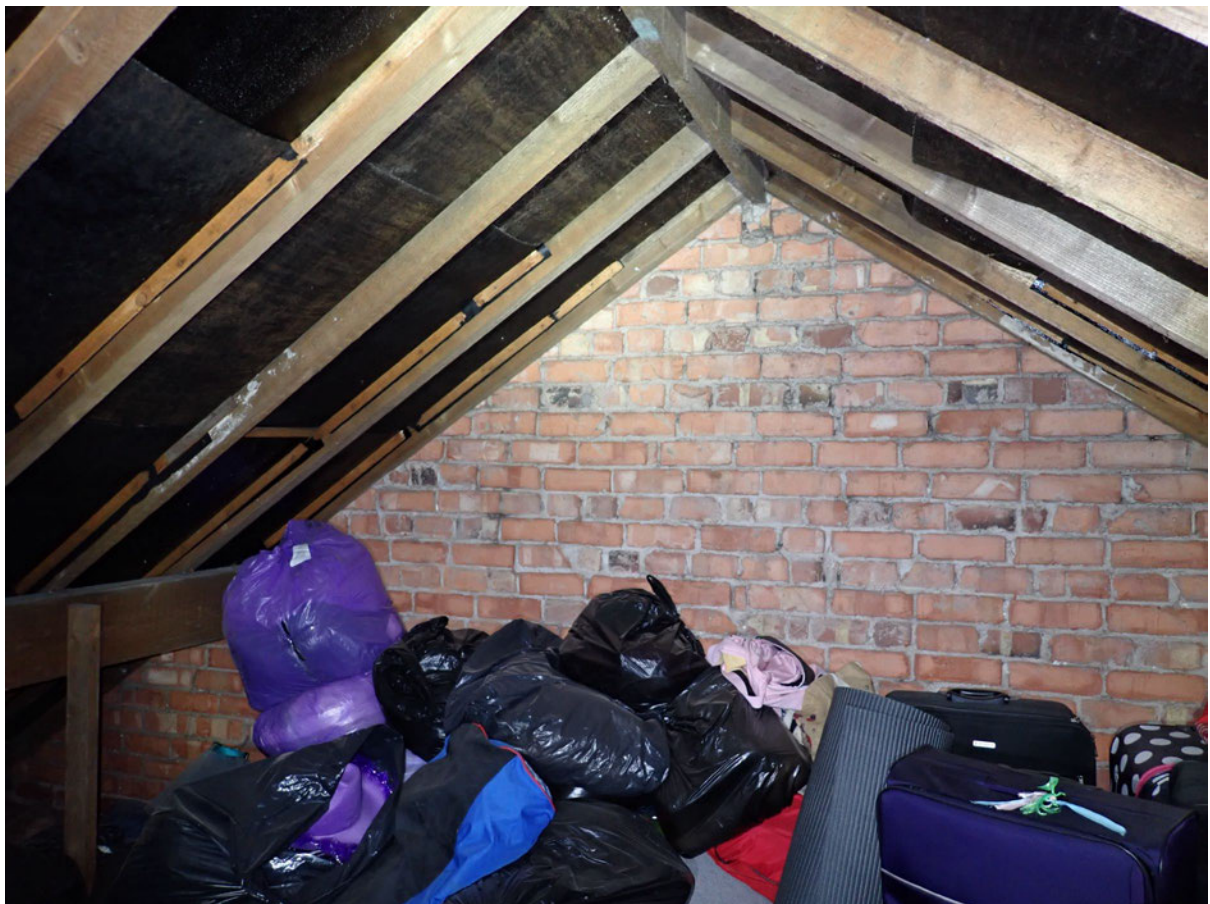
8 – The house has a single roof void which is lined with bitumen felt.

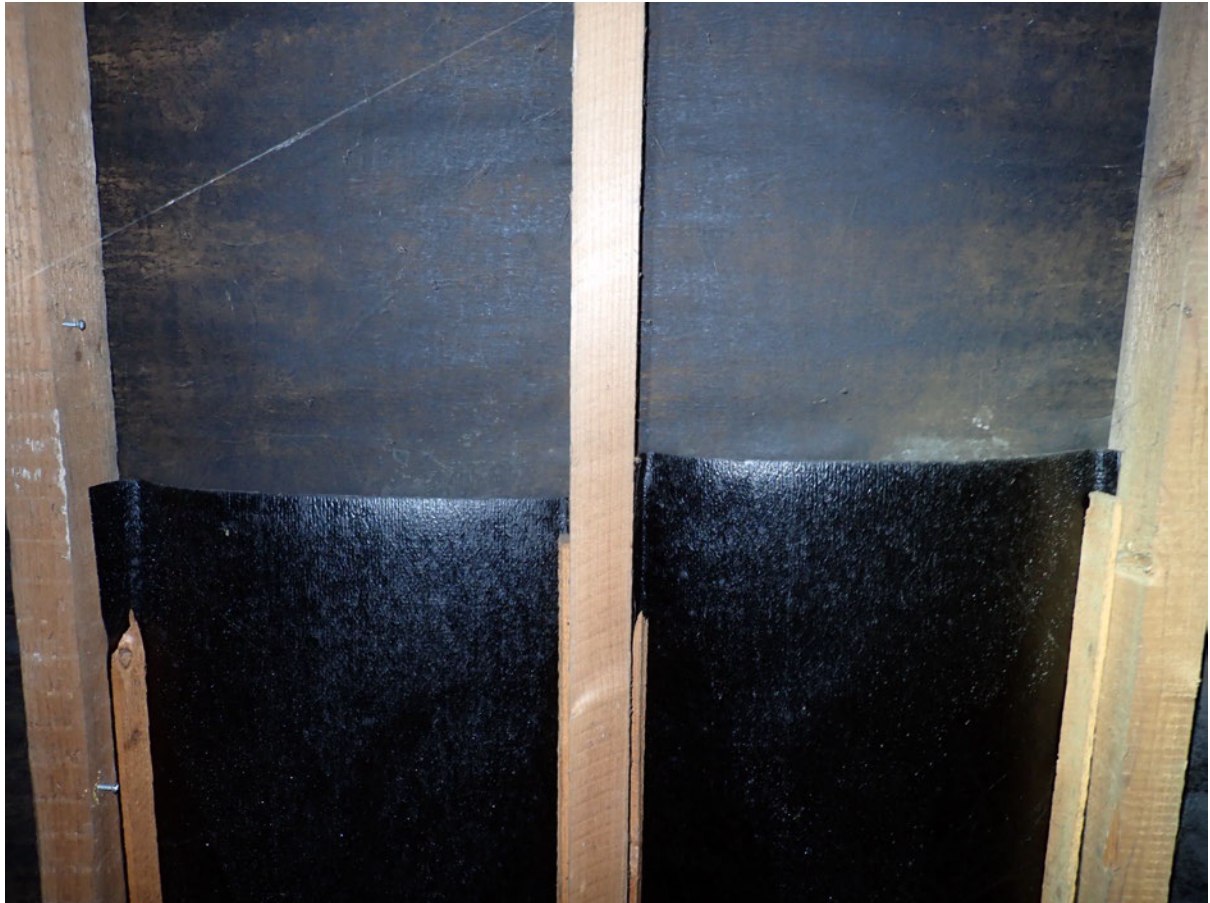
9 – The roof lining is. In reasonable condition with no gaps or tears.

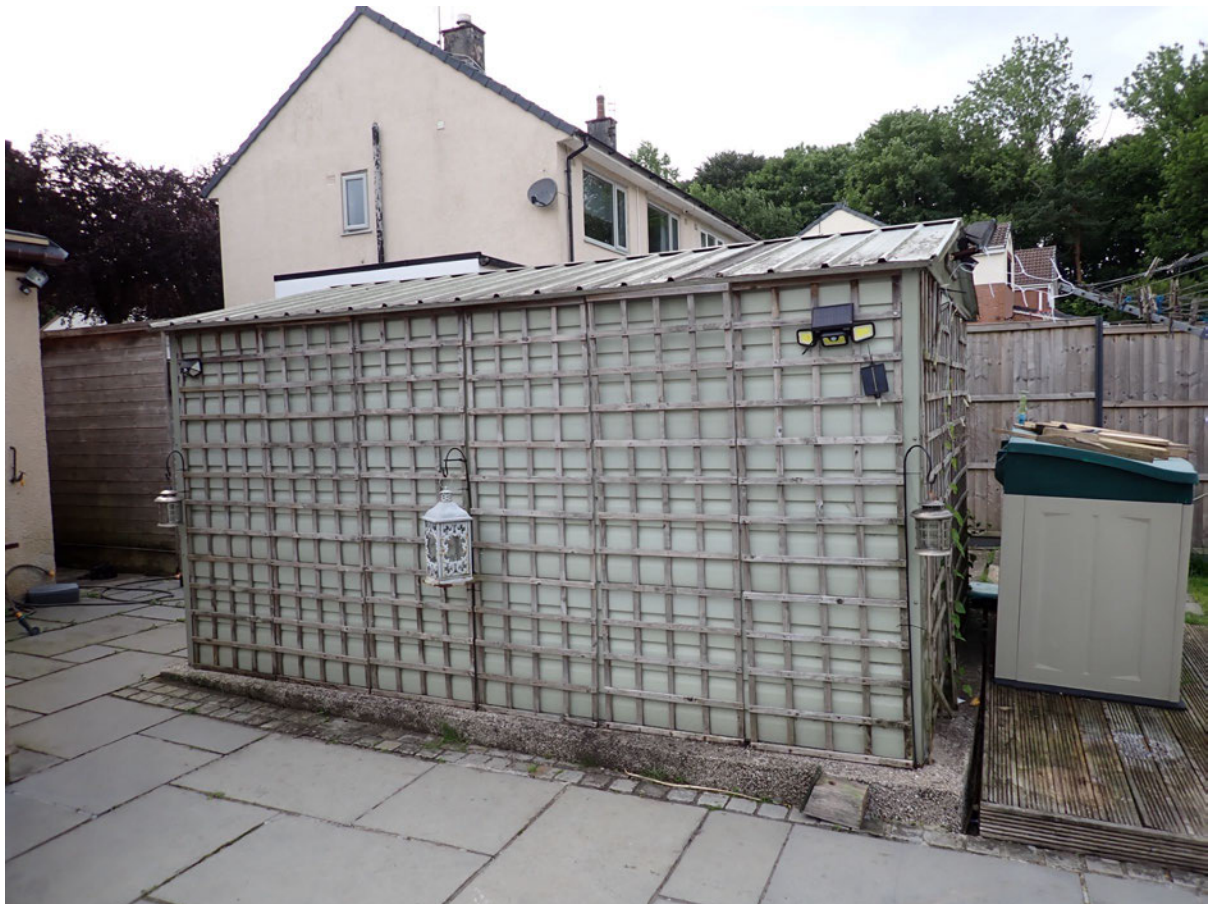
Outbuildings, which will be moved to facilitate the extension, have no features suitable for use by roosting bats.

10 – Outbuildings have no features suitable for use by roosting bats.
