Refurbishment of Ivy Cottage, Slaidburn for The Slaidburn Estate

Historic Building Impact Assessment

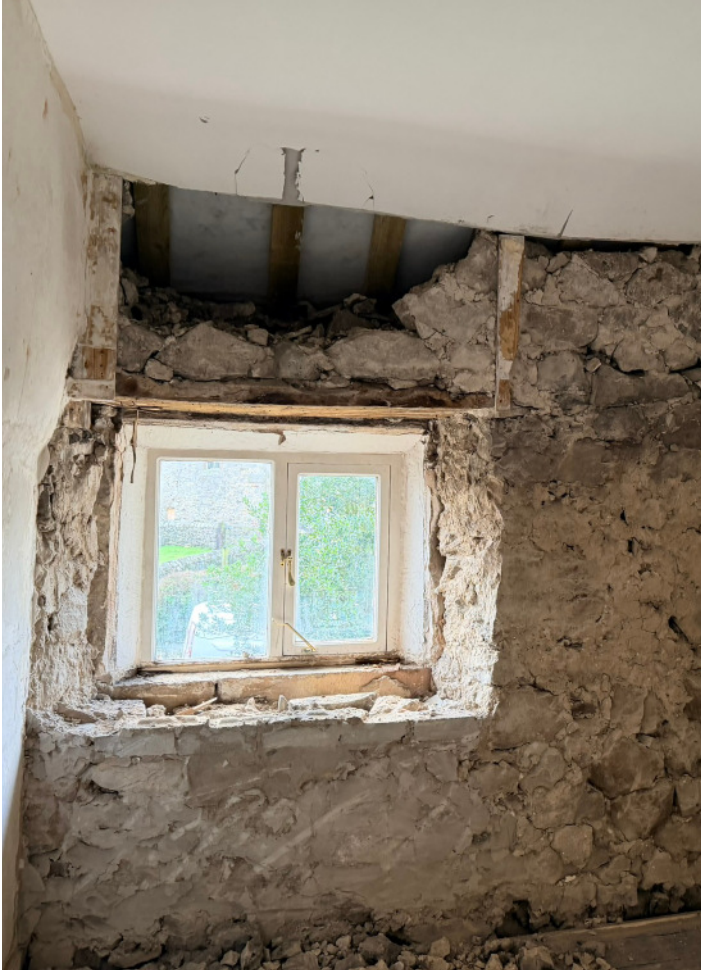
Image 3
Existing windows / stonework

Window openings on the front elevation have stone heads and surrounds externally but timber lintels of variable size internally and minor plaster removal has shown rot and past replacement with inferior timber to be present, and in some locations particularly the western most first floor bedroom window, the stonework above the windows has become loose and collapsed.

It is proposed to obtain oak timbers of similar or rather larger dimensions from those existing, from materials available on the estate and replace the internal lintols of the three first floor front windows and rebuild stonework above the lintols using existing stone set in lime mortar.

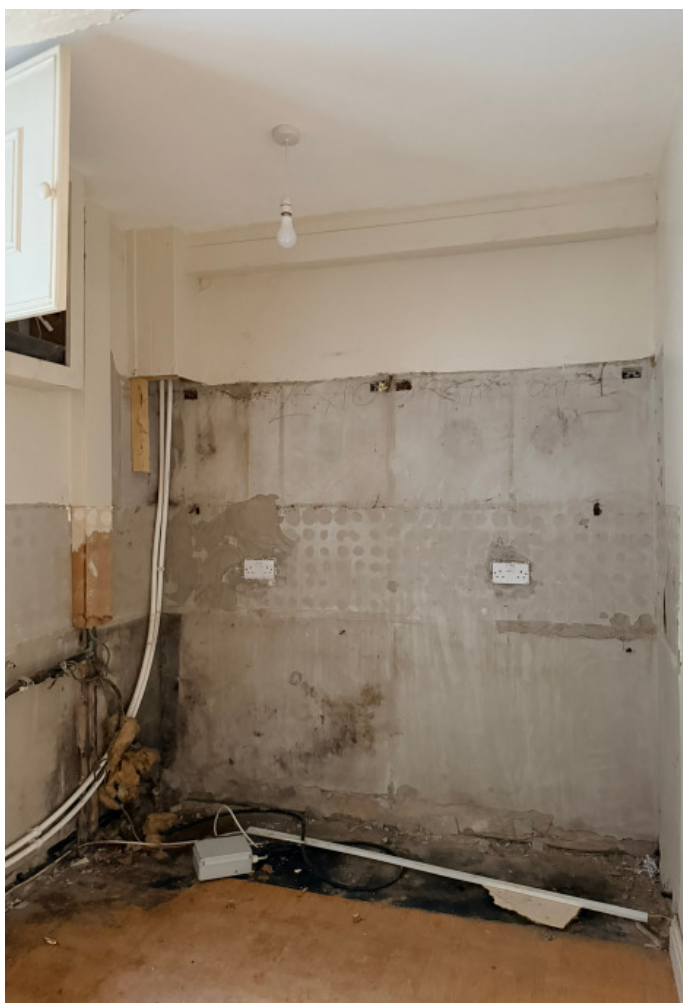
Image 8
Existing utility

The rear part of the 'out shot' has a floor level below external ground level and there is evidence of damp penetration.

The existing (very tidy) kitchen units will be carefully removed and all plaster on external walls, much of which is sand/cement is to be knocked off carefully throughout.

Stone walls are there to be raked out and brushed down and pointed up flush using lime mortar (1 part lime to 5 parts coarse river sand) and 'bagged off'.

The external walls of the out shot are then to be tanked to a height of 1200mm above floor level using Sika 1 system tanking slurry – three coats of Sika 1 tanking slurry and a Sika 1 material fillet at joints with floors, internal walls etc.

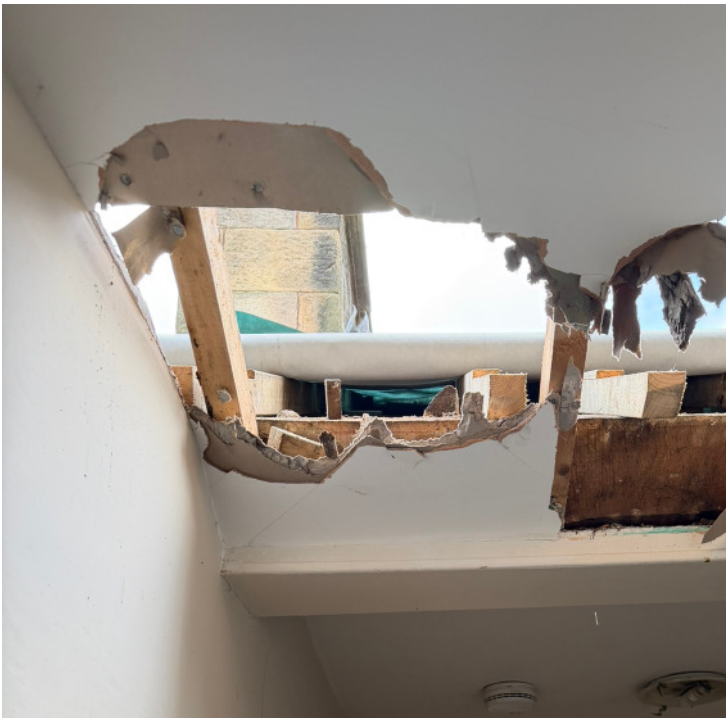
Image 8
Valley Gutter (internal damage)

Existing first floor ceilings will be insulated with one layer of Crown or equal insulation laid in one direction between joists and a second layer 150mm thick running at right angles. Some modern plasterboard ceilings under the junction between the front range and out shot have come down due to leaks from the valley gutter. These will be replaced like for like.
