Structural Appraisal

Listed Barn & Outbuildings

Home Farm, Chatburn Road, Downham

Blackett-Ord Conservation Engineering

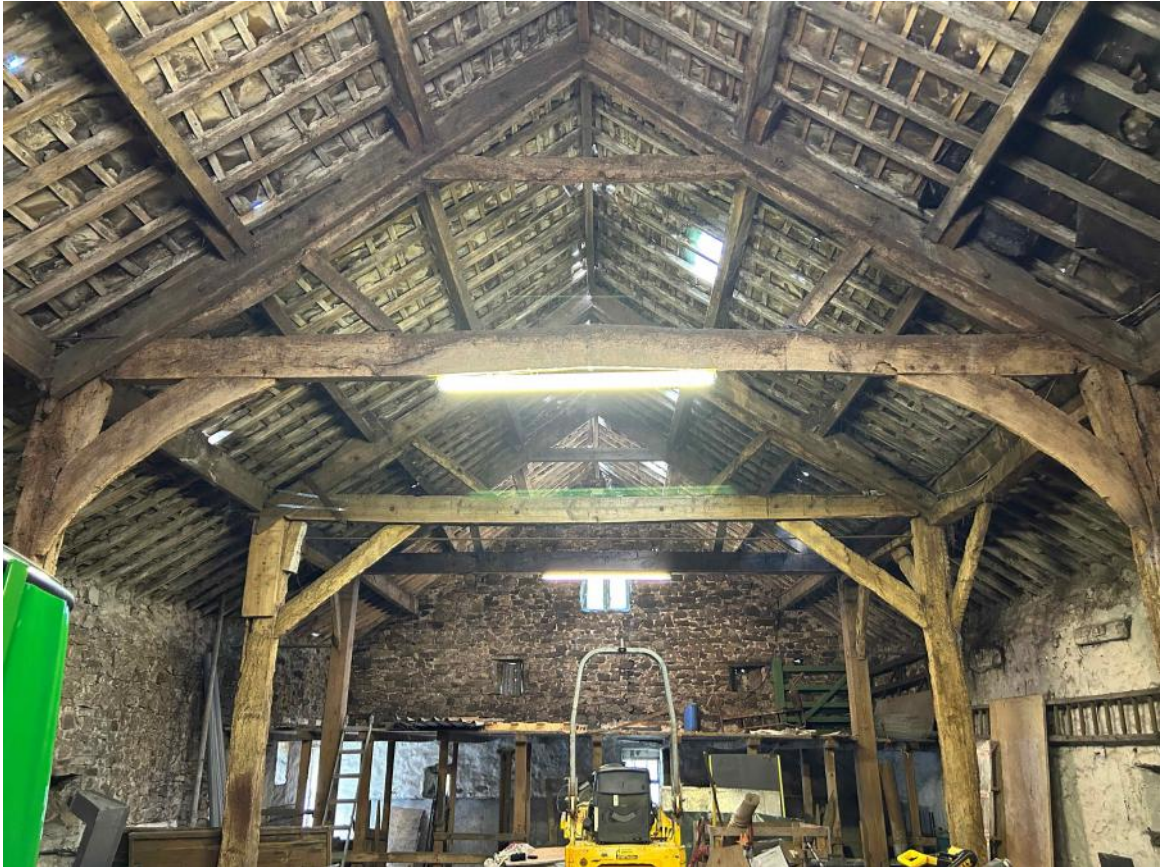
Photo 5: Frame No.3

On truss no.3 the upper collar on the original truss is too slender. A tie rod has been inserted between frame posts on truss no.2. Their purpose is unclear. A small outward lean was noted on the south elevation masonry but this does not appear to be ongoing nor a structural concern.

The northern timber post of frame 3 has a large vertical shake. The post has also split at the top where the truss and lower purlin connect. All frame posts suffer from decay due to woodworm. The largest loss of section recorded was approximately 25mm.

A new collar should be provided on truss no.3 to make the existing slender collar redundant. This could be achieved by fixing a new collar between the softwood rafters that are bolt fixed to the existing truss.

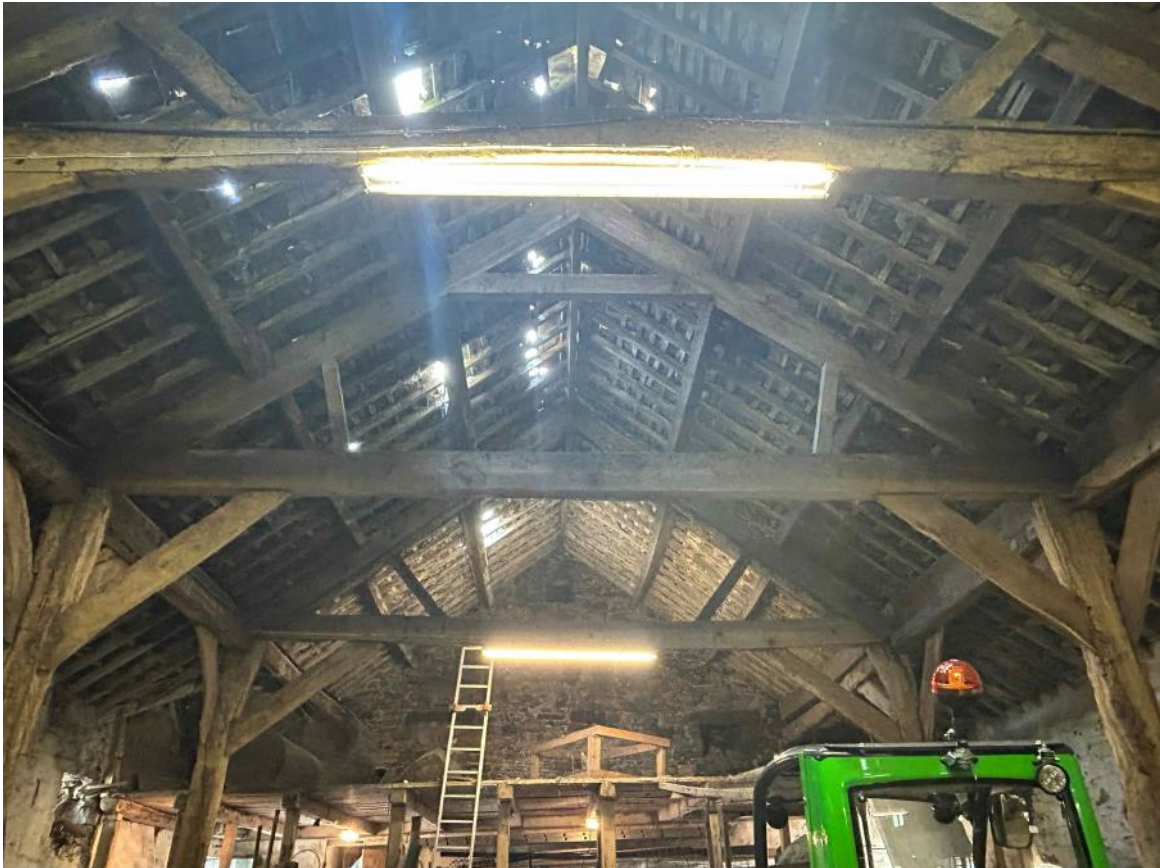
Photo 6: Frame No.5 & No.6

There are a number of diagonal braces that are missing. On the south side of frame no. 5 & no.6, the longitudinal braces have been previously replaced with softwood, they are poorly detailed and inadequately fixed.

The missing diagonal braces should be replaced. The 2No braces that are pulling out at their connection to the frame post should be refixed. The softwood braces on frames no.5 and no.6 should be replaced, profiled to match the original, and adequately fixed to the frame posts. Repairs may be required to the frame posts to ensure an adequate connection is possible following removal.

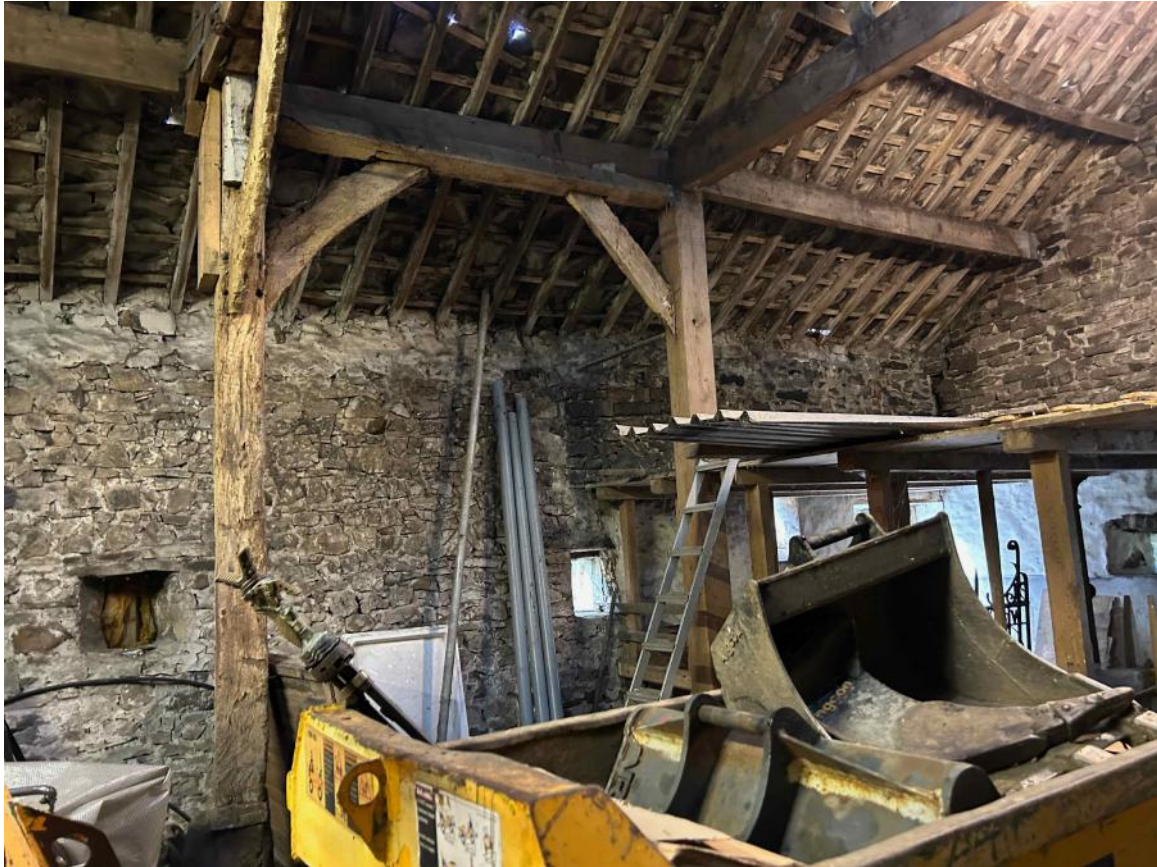
All of the purlins have been previously replaced in softwood. In most bays, the older lower purlins have been retained in situ with new softwood supported above. Some of the older purlins are not adequately fixed where they are spliced. In bay 3 the purlin has dropped at the splice and is sagging. In bay 2 the southern lower purlin has become twisted and is also splitting at the notch for the diagonal brace. The diagonal braces are pulling out of their fixing to the post in this location.

Photo 7: Bay 2 (South)
Upper Purlin Not Connected, Lower Twisted & Braces Pulling Out

The lower purlins that are inadequately spliced should be mechanically fixed together using steel plates, allowing the original timbers to be retained. The one purlin that has dropped may be able to be jacked back into place, otherwise timber packers provided between the upper and lower purlin. The purlin that has become twisted and is splitting should be replaced.

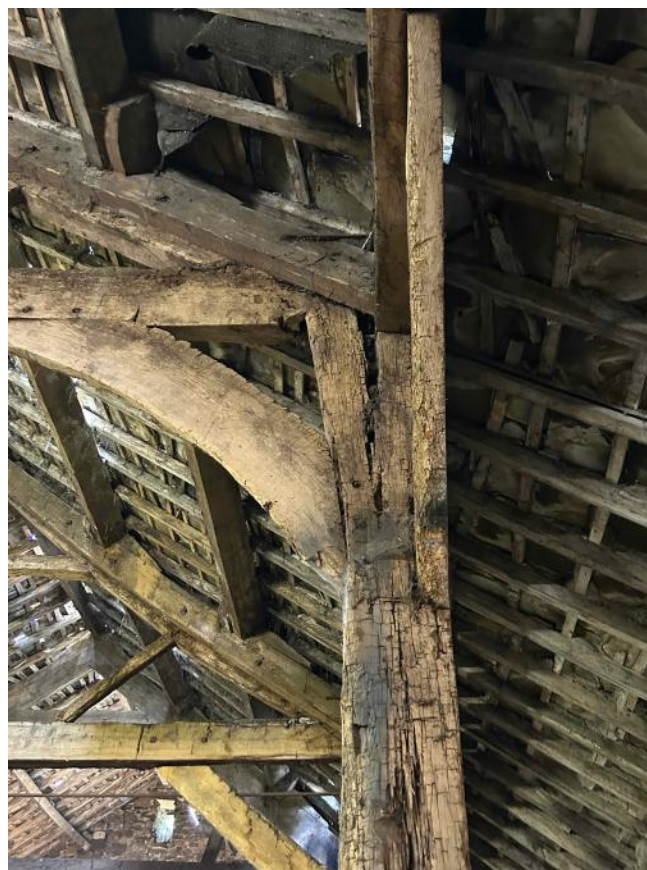
Photo 8: Frame No.3 - Split in Post

The connections at the top of the frame posts should be reviewed once the additional timbers have been removed and high level access made available. Where new truss members have been fixed to the existing, the detail should be revised to ensure connection of the new rafters or truss to the frame posts. The post that has split should be replaced.

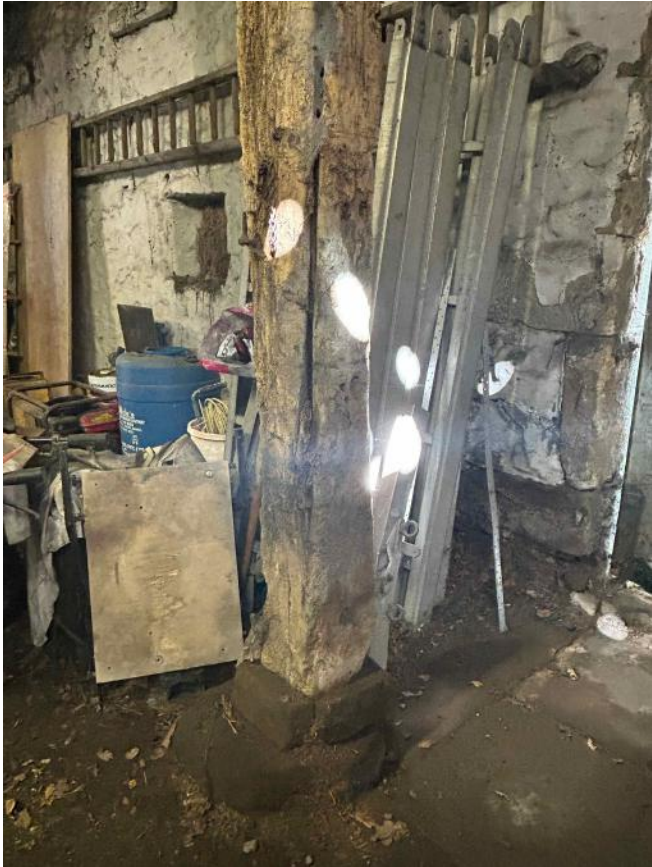
Photo 9: Frame No.3 - Vertical Shake in Post

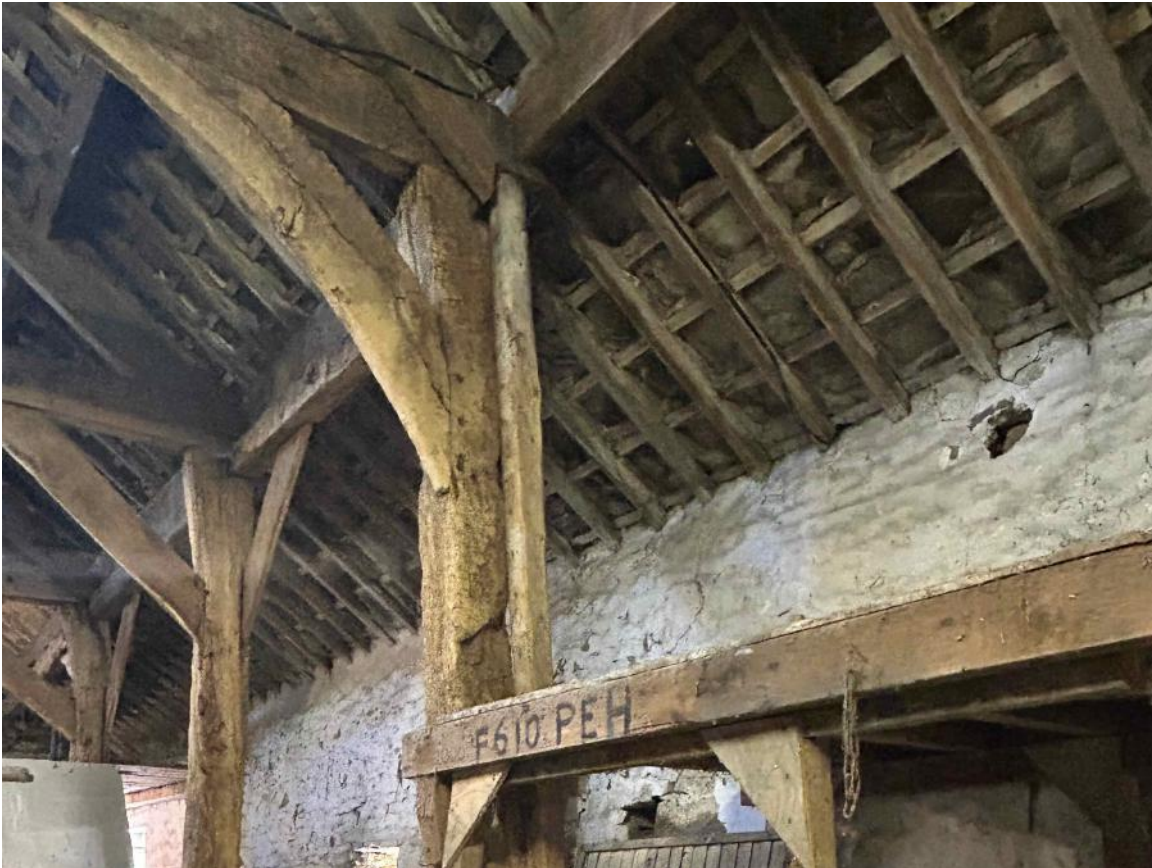
The main defects noted are a result of previous repairs and poor workmanship. New softwood trusses (T.2 & T.5) or principal rafters (T.3 & T.4) have been provided to strengthen the existing frames but these have been mechanically fixed to the existing with no adequate connection to the frame post. In some cases the principal rafter is supported on the purlin using a birds mouth joint. On Frame No.2, inadequate lightweight steel restraint straps have been used as a fixing in this location. Trusses No.1 and No.5 have been previously replaced in softwood.

Photo 10: New Rafters Not Adequately Supported

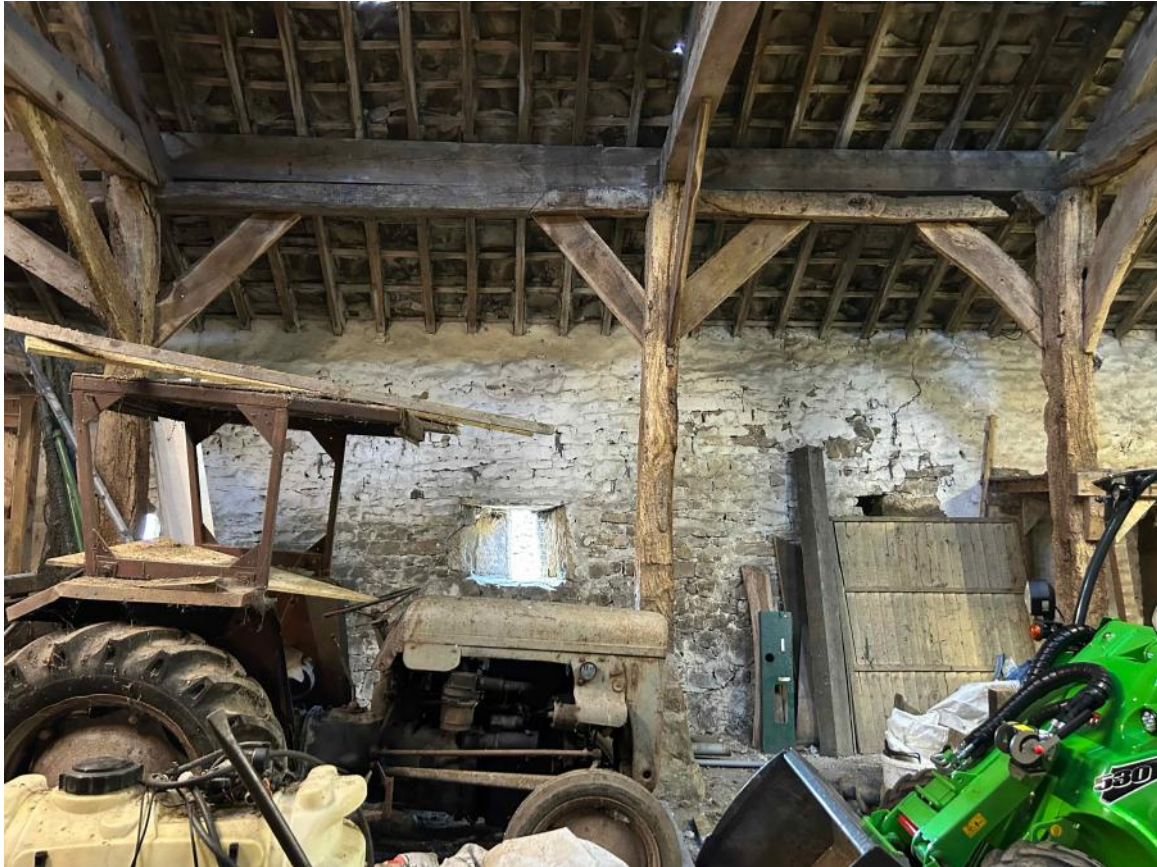
Photo 11: Bays 5 & 6 (South) - Lower Purlin Not Connected

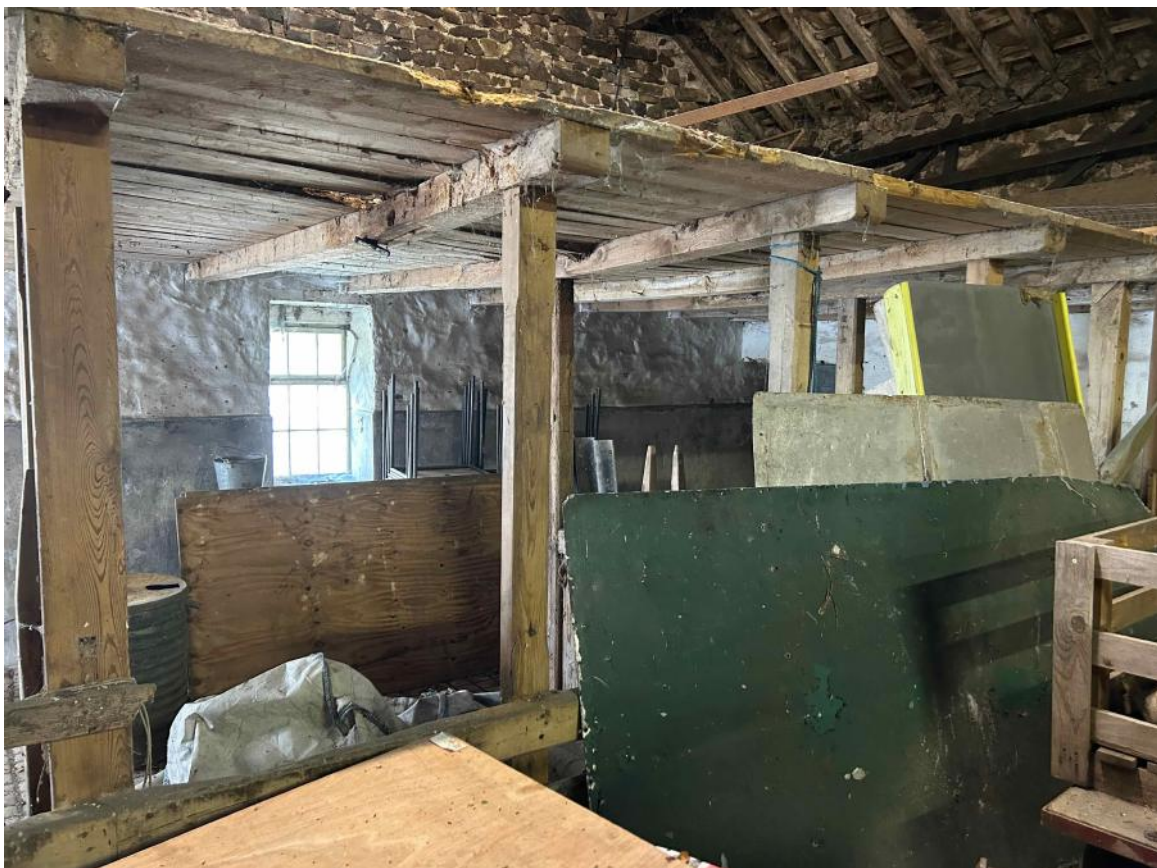
The current mezzanines are not adequate for use as a floor. The joists are too widely spaced for the boarding and are supported on the stable stall posts.

Photo 12: Existing Mezzanine Structure Inadequate for Access

The current mezzanine structures are inadequate for reuse as a floor. New structures would be required consisting of structural posts on a concrete foundation with an edge beam. The joists that are in good condition may be reusable but new joists would be required to ensure adequate joist spacing.

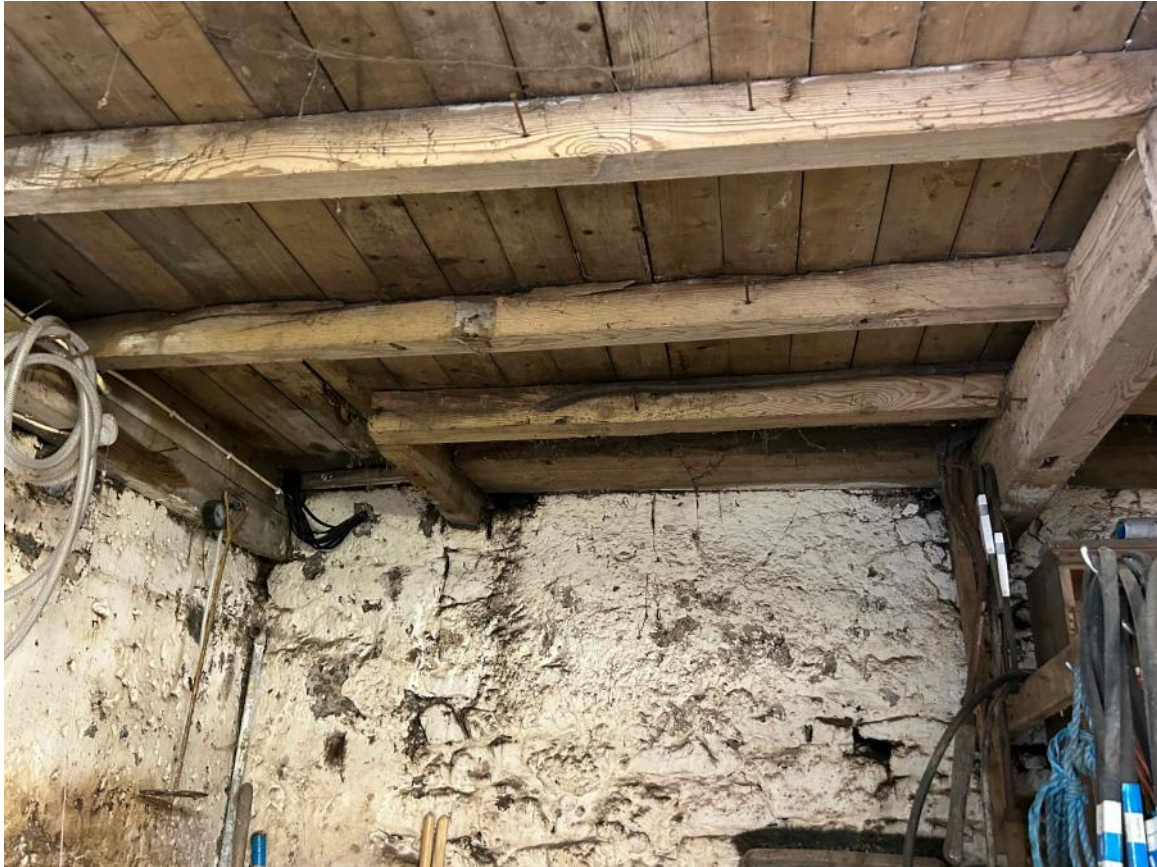
In the workshop there is 1No joist that has split. It also does not span full length into the wall and is inadequately supported by a cantilevered timber trimmer.

Photo 13: Workshop Joist Split & Inadequately Supported

In the workshop to the east, the split joist should be replaced to span into the external masonry to ensure adequate support.

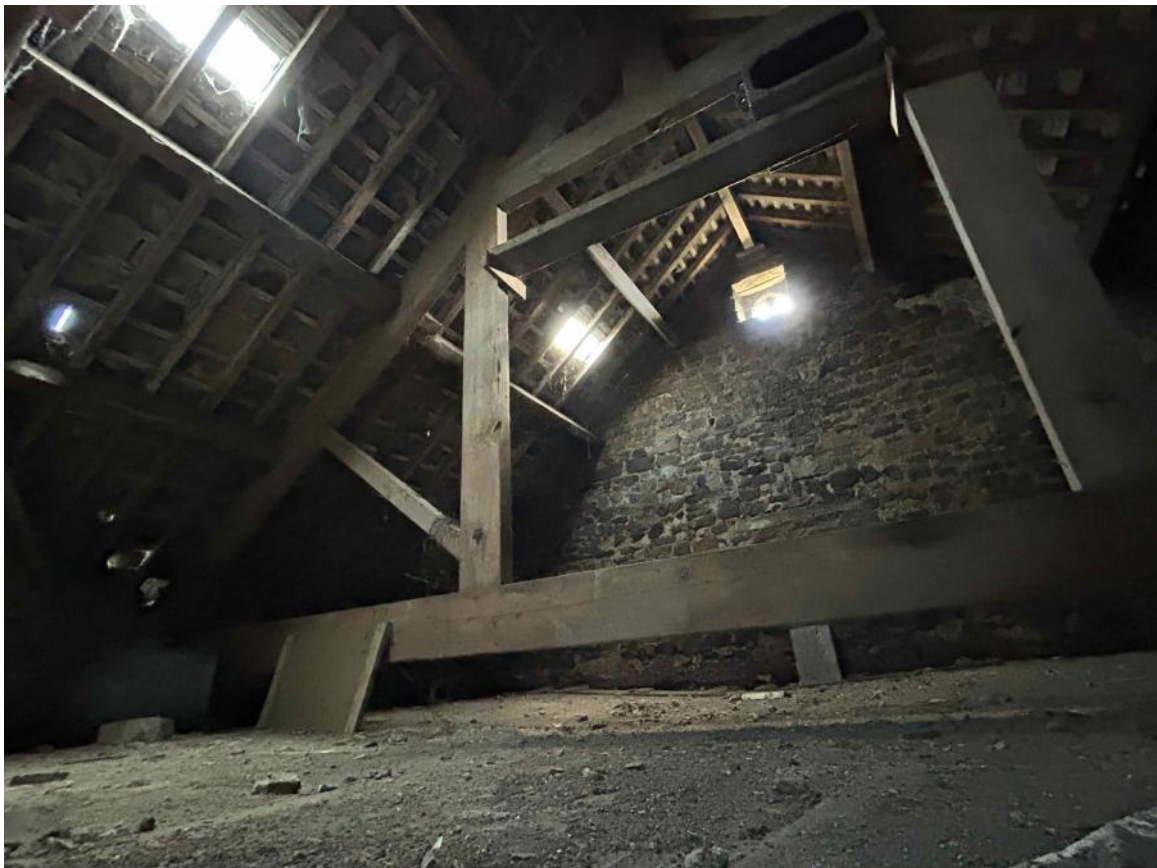
Photo 14: Queen Post Truss Over Workshop
(Note: Only 300mm Between Tie Beam & Floor Level)

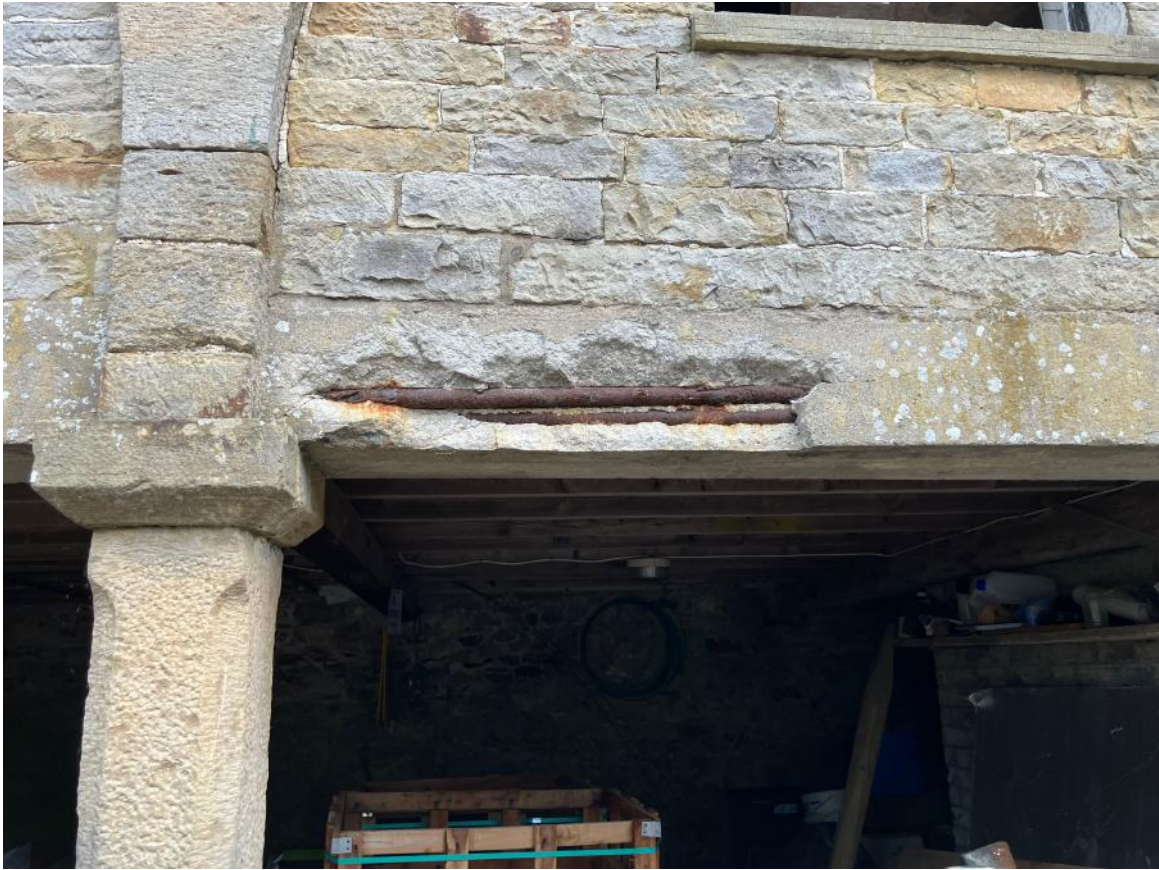
The Cart Shed is in reasonable condition and the only significant defect noted was the exposed corroding reinforcement in the concrete lintel over the central of the three openings. Cracking was also noted in the southernmost concrete lintel which suggests the corroding reinforcement may not be a localised issue.

Photo 16: Spalled Concrete Lintel - Reinforcement Exposed & Corroding

The concrete lintel should be locally repaired where the concrete has spalled and reinforcement is exposed and corroding. The reinforcement should be wire brushed and coated with an anticorrosion paint system. The beam should be checked for other areas of cracking or spalling and treated appropriately using proprietary methods.

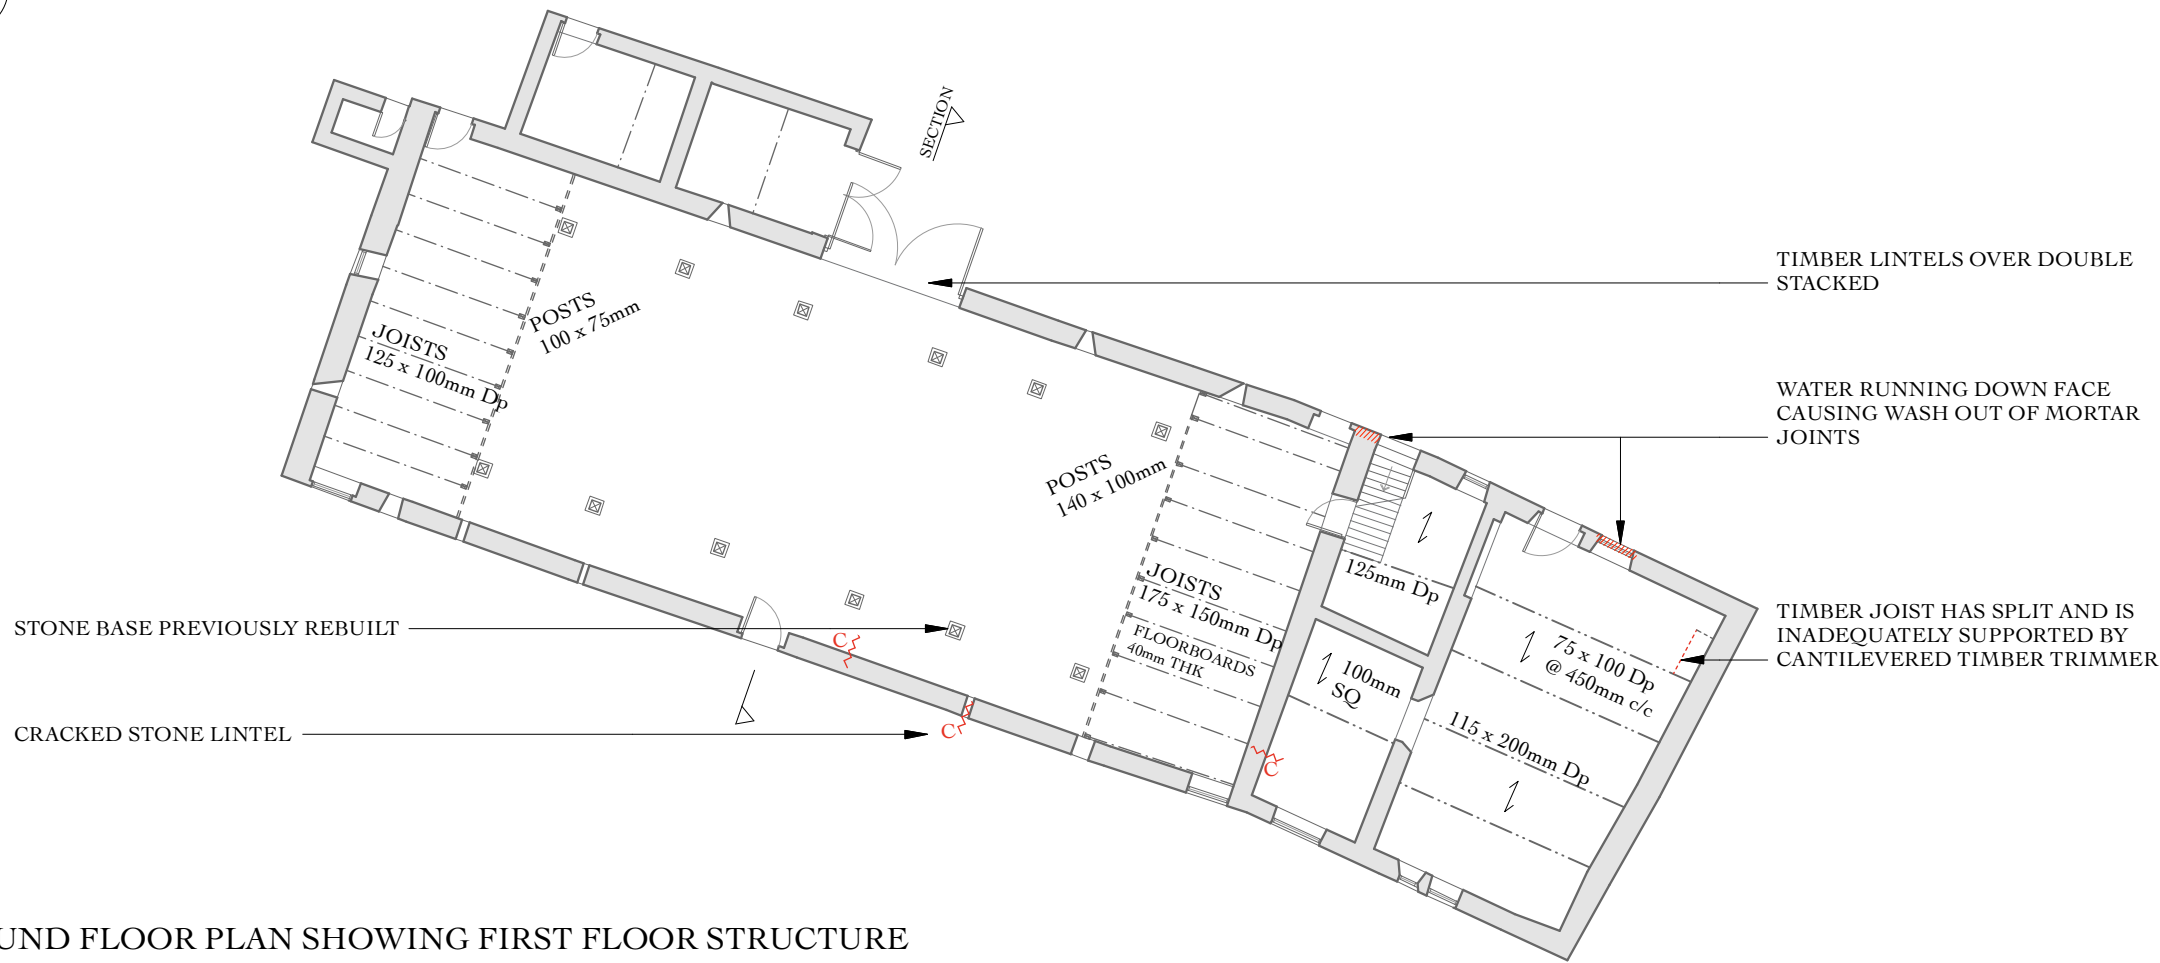
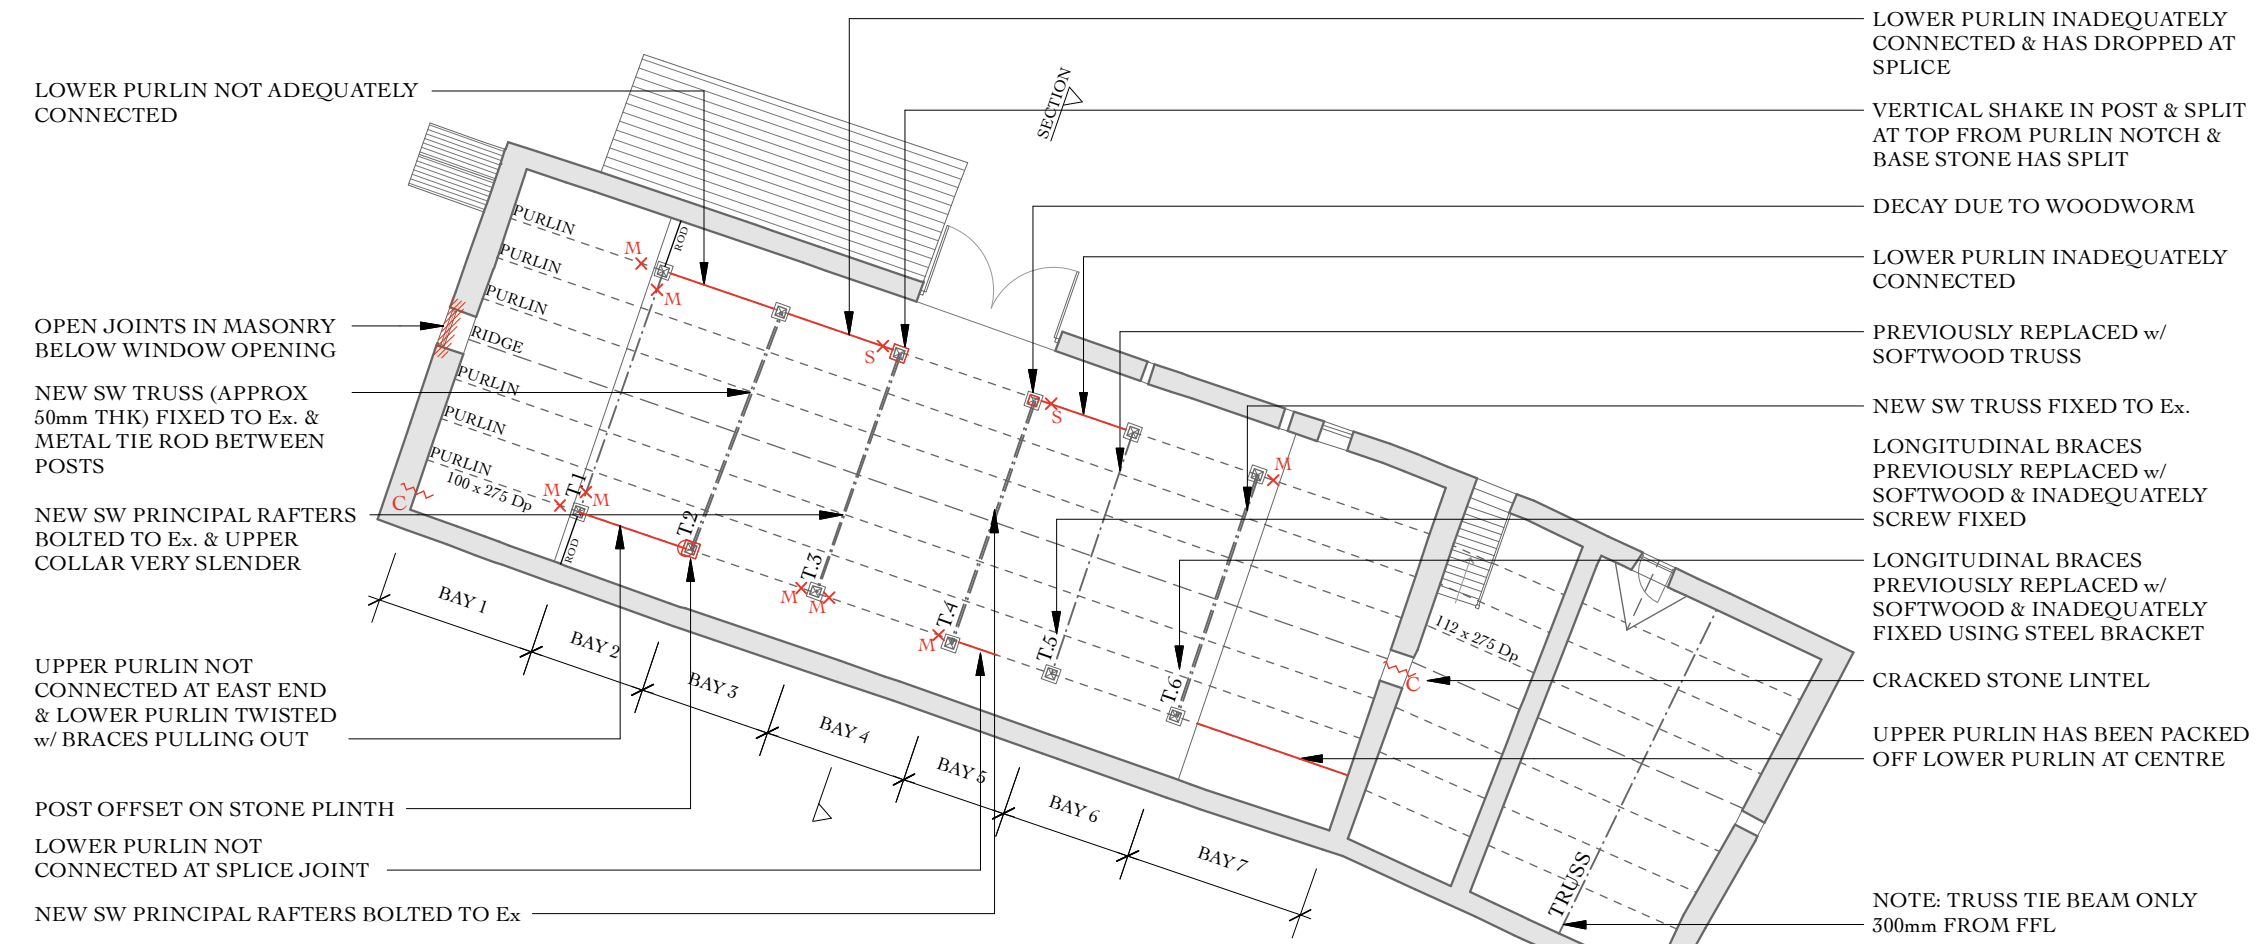
Aisled Barn: Plans

1. Additional pieces of timber fixed at top of the frame posts. Condition underneath unknown.
2. Original purlins have previously been replaced with softwood. Lower purlins are double stacked - single purlins only in bays 1, 3 & 4 south side, and bays 1 & 7 north side.
3. Evidence of historic woodworm decay in timber posts, approximate 25mm loss of section.
4. Water ingress on upper purlins under roof lights
5. Majority of rainwater goods are missing.
6. No below ground drainage provision.

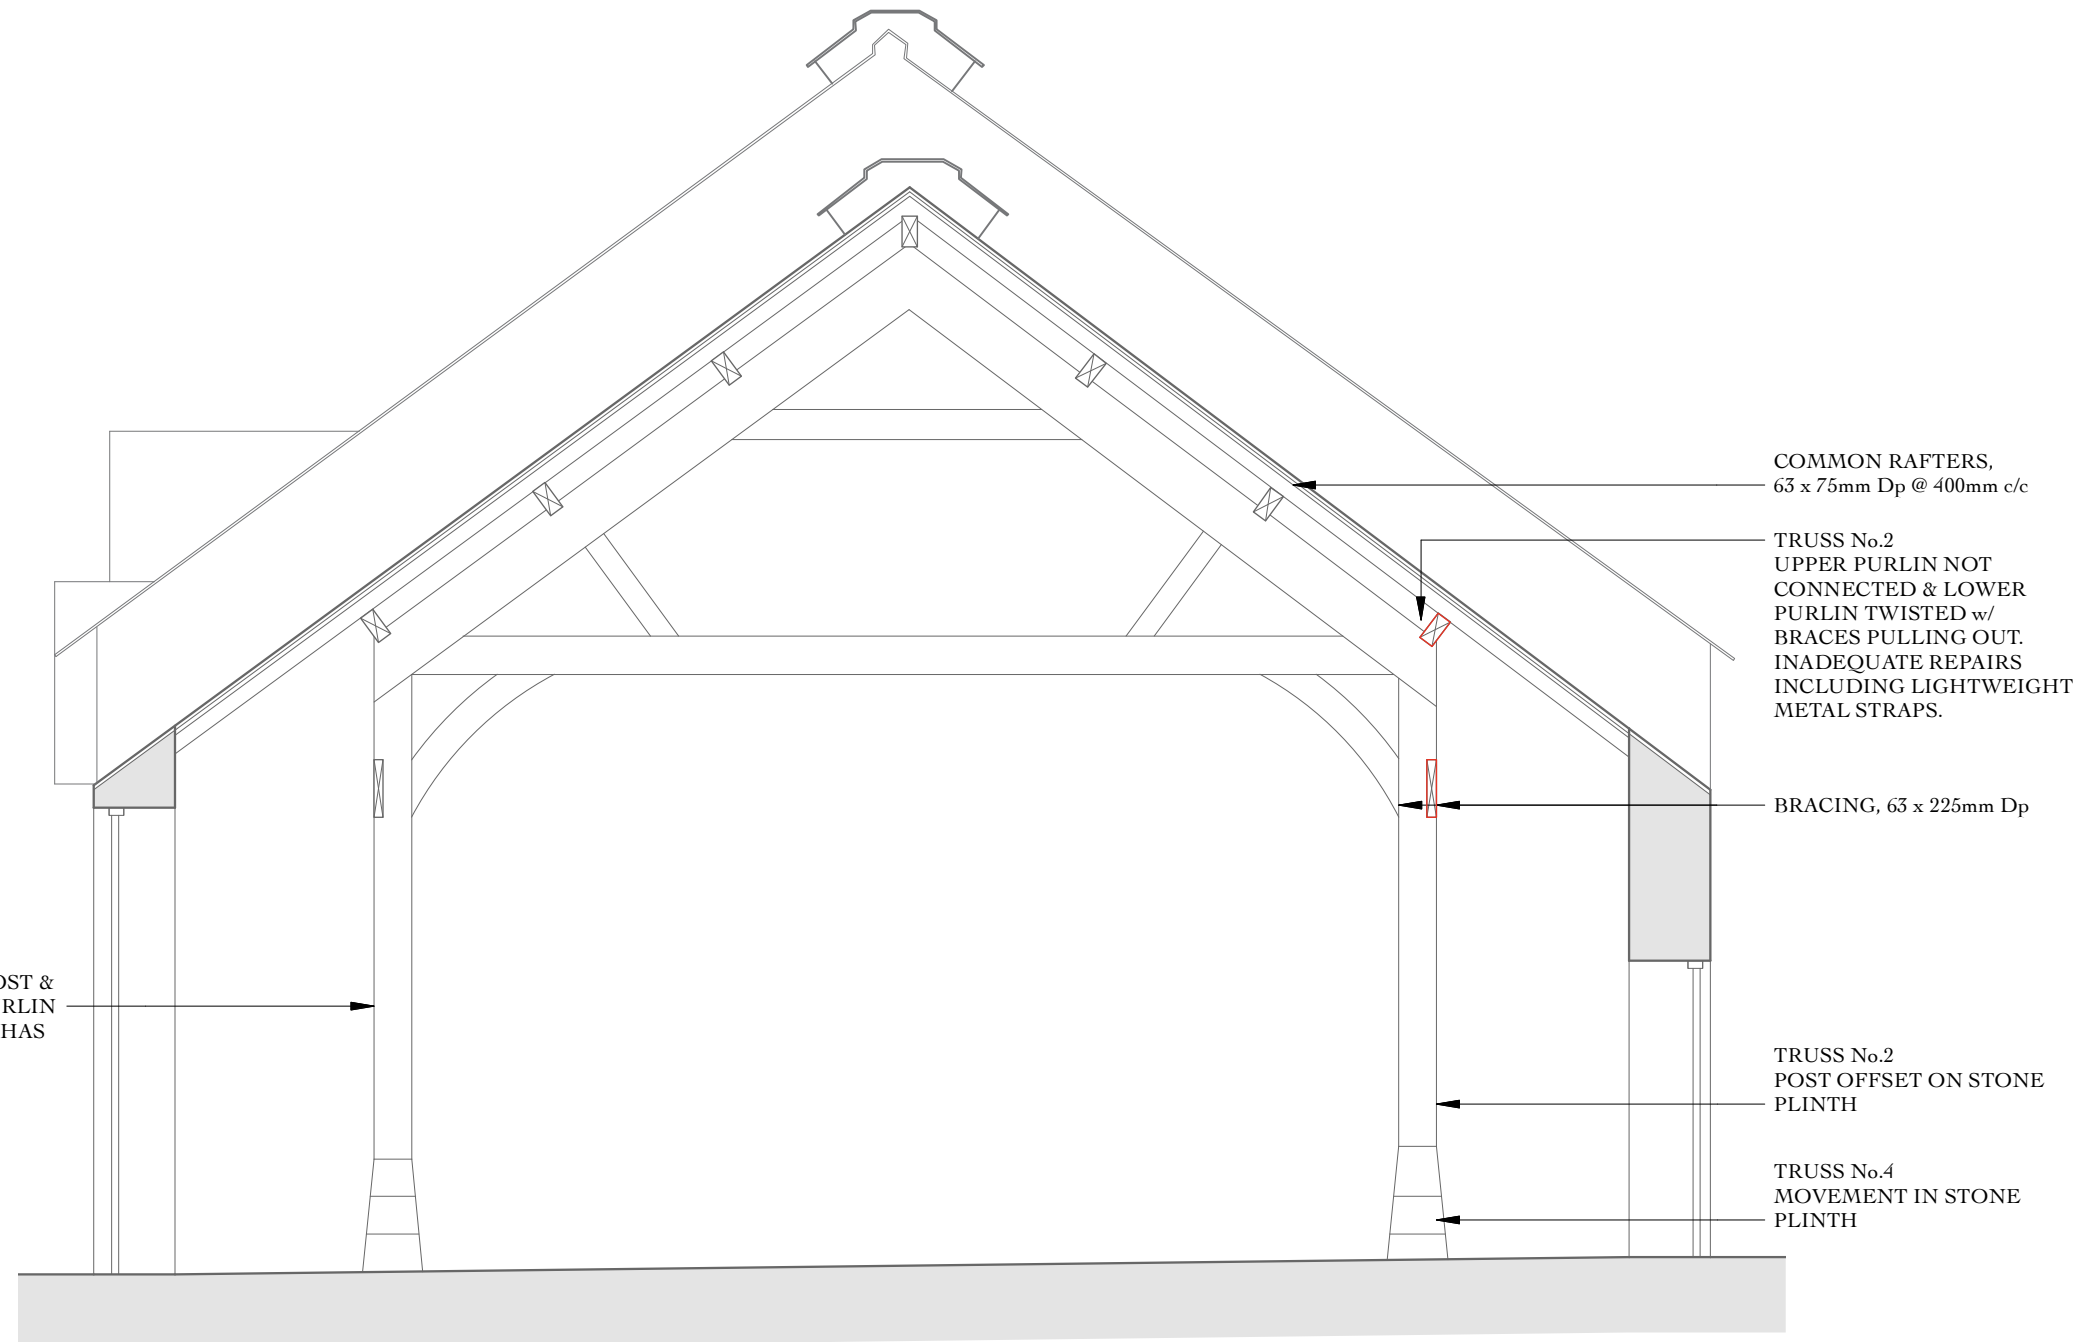
Aisled Barn: Section

1. Additional pieces of timber fixed at top of the frame posts. Condition underneath unknown.
2. Original purlins have previously been replaced with softwood. Lower purlins are double stacked - single purlins only in bays 1, 3 & 4 south side, and bays 1 & 7 north side.
3. Evidence of historic woodworm decay in timber posts, approximate 25mm loss of section.
4. Water ingress on upper purlins under roof lights
5. Majority of rainwater goods are missing.
6. No below ground drainage provision.
