**The Barn, Springwood,  
Hurst Green**

**Level 2-3 Historic  
Building Recording**

AB Heritage Project No: 63086

Date: 27/02/2026

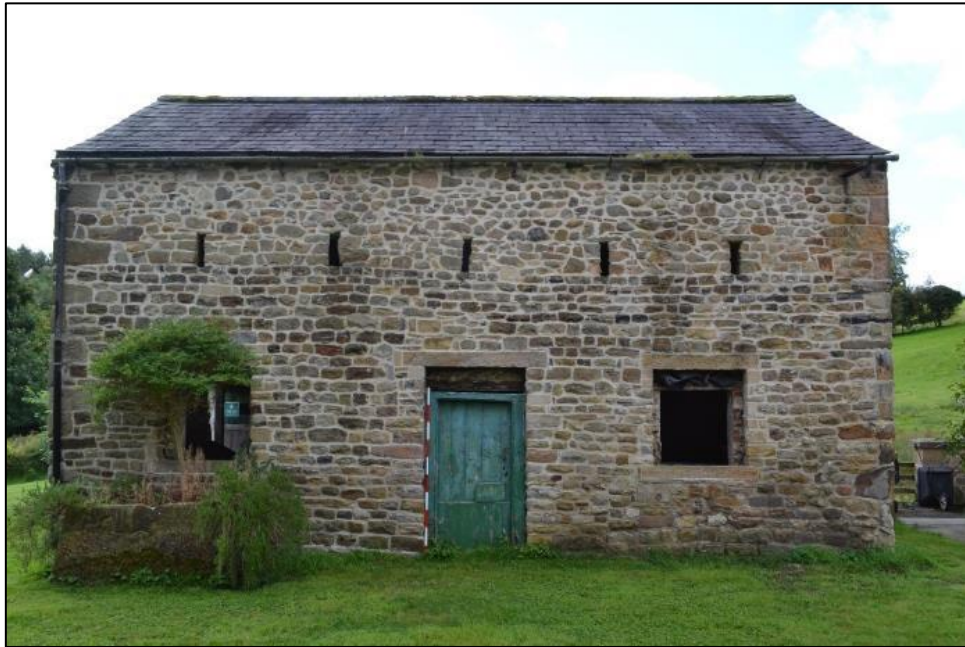
**Plate 8. The north elevation (scale 2m)**

- 4.2.5 The stonework appears to have been recently repointed with lime mortar. The timber batten door is not original and does not fully fit the portal, which has a stone lintel. The window on the west has stone cill and lintel, while the east window has only a stone cill and no lintel. There is small iron tethering ring under the west window, and a stone trough in front of the east window.

- 4.2.6 This elevation does show subtle evidence of alterations. The door has clearly been changed, and it is apparent on Plate 8 that the windows on the ground floor have been reduced in size, note the bricks and render inside the window openings that would have housed smaller frames and glazing. The quoins on the east and west returns of the north elevation also show where the height of the building has been raised, note the size and type of quoins from the level of the base of the ventilation slits. These correspond with changes on the gables which more clearly show a change in build that evidences the historic work to the roof. A building break on the north elevation is discernible from the base of the ventilation slits which indicates the original eaves height of the building.

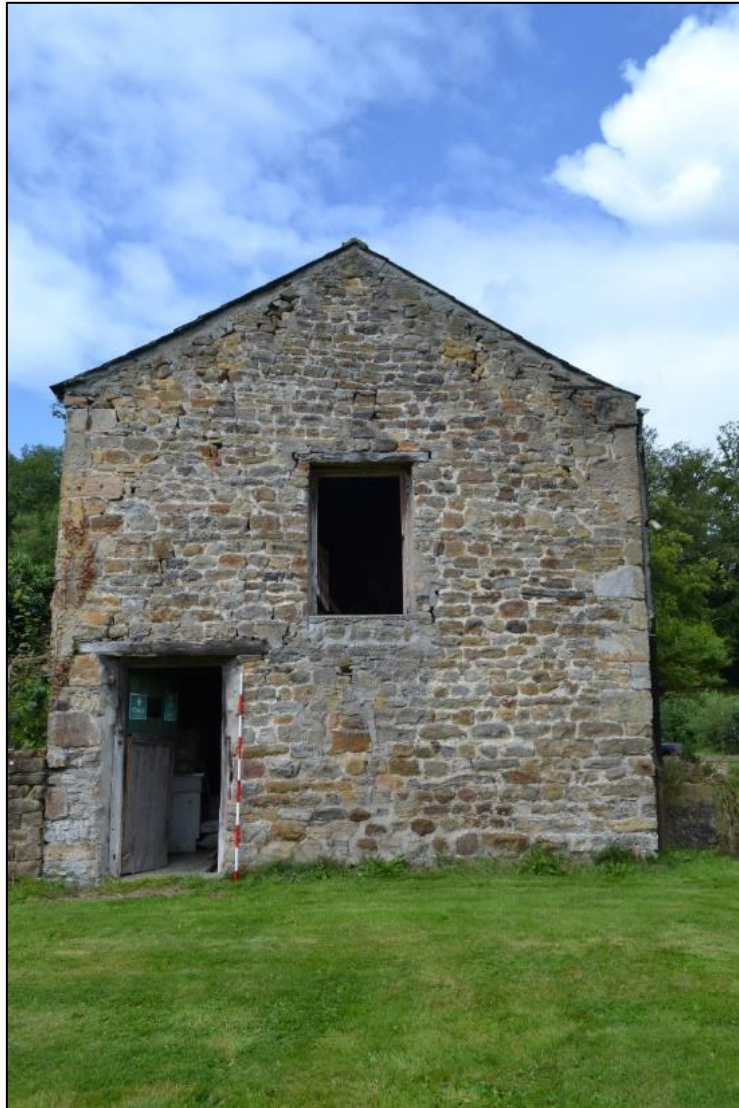
**Plate 9. The east elevation (scale 2m)**

- 4.2.9 The east elevation features a ground floor door under a worn timber lintel. The door itself is of a timber board, stable type. The portal looks to have been adapted to fit the later door, evidenced by the jamb being 'rendered' with cement.

- 4.2.10 At first floor and located just off centre is a loading bay door, again with a worn timber lintel, but with a thin concrete cill, and a timber architrave. This portal does not look like part of the original field Barn, perhaps evidenced by the cementitious pointing around it.

- 4.2.12 It is apparent on Plate 9 that the ruinous building on the south elevation and the trough on the north elevation are not integral to the build of the Barn.

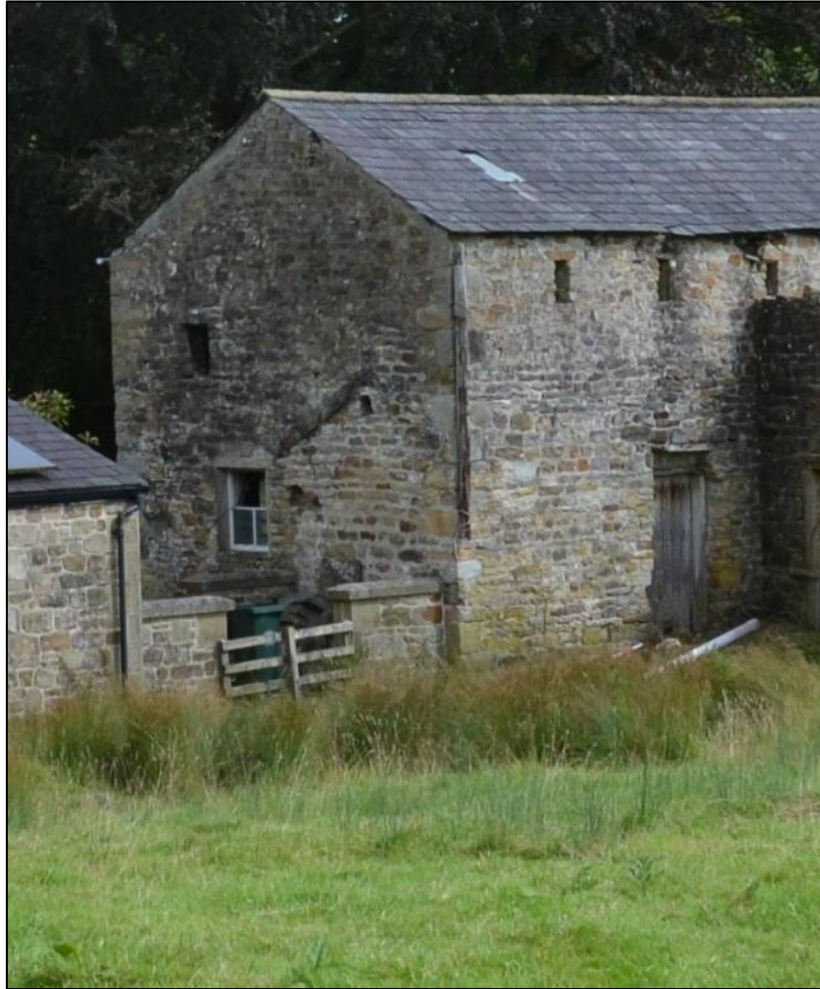
**Plate 10. The west elevation**

- 4.2.14 The west elevation shows evidence of several interventions to the original appearance and build. On the ground floor there is a small sash window, the location of which strongly suggests that it belongs to the dairy phase of the building. The window is broken with the upper sash missing. The inside edges of the portal are finished with concrete and there is a stone lintel.
- 4.2.15 South of the window, also on the ground floor is a building scar and a possibly a putlog hole that evidences the former small building that is shown on Plate 4 from 1888. The scar indicates that the building was a porch or similar, and there is evidence on the interior face of the west elevation for a blocked door (see Plate 16, below). This smaller building clearly had a pitch roof (Plate 11, below). The two protruding dwarf walls are modern, this area now being in use as a refuse store.

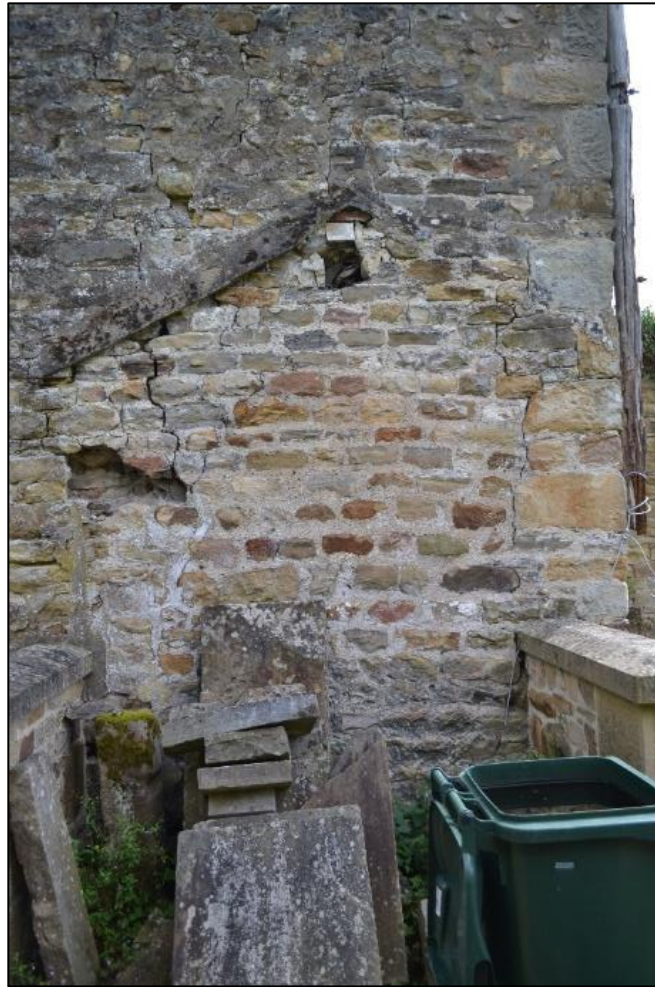
**Plate 11. Detail of former porch**

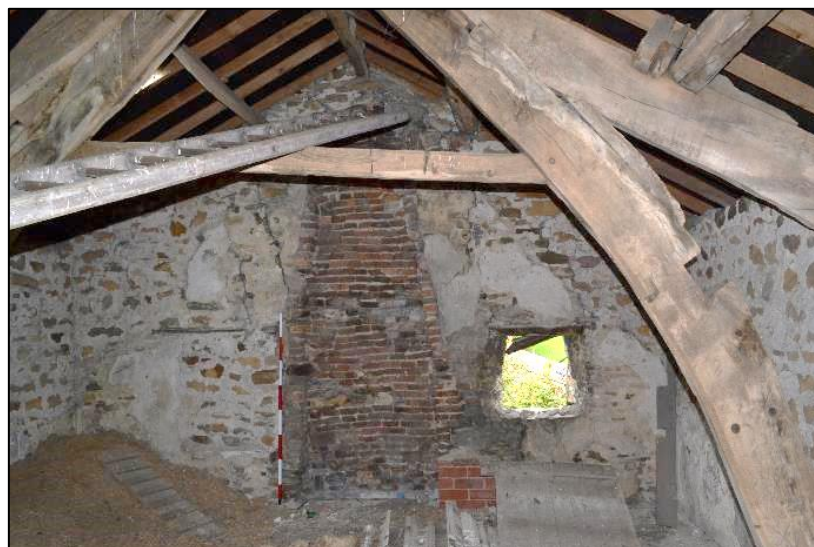
4.2.16 The window at first floor is unglazed and has no window architecture, indeed Plate 12 below shows the window from the interior, and it is in a very poor state of repair.

**Plate 12. First floor. West elevation interior (scale 1.6m)**

- 4.2.17 The window is flared towards the interior, which suggests the primary function was the admittance of light rather than ventilation and this may suggest that the window is part of the original barn (though it is uncomfortably close to the roofline). Note, on Plate 12, adjacent to the photography scale, there is a similarly located, thin slate lintel. This may indicate the presence of a former window, but the exterior face of the west elevation shows nothing, and that feature may have been an internal niche.

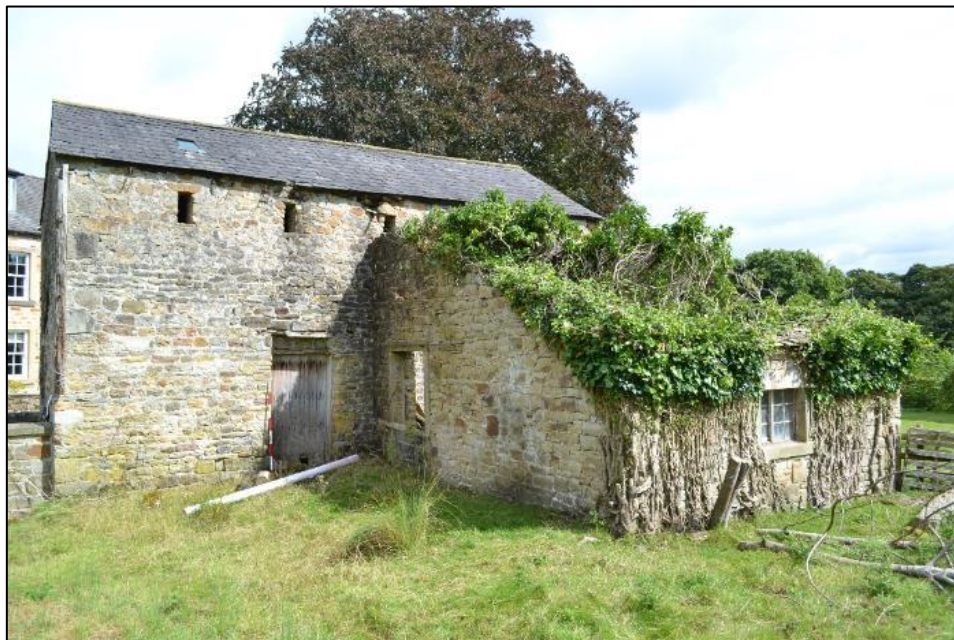
**Plate 13. The south elevation (scale 1.6m)**

- 4.2.19 The south elevation is simpler than the opposing north elevation. The south has only a single, off-centre door at ground floor. As with the portal on the north elevation, the door is timber batten in style and is smaller than the original opening, which has stone packing beneath the rotten timber lintel and above the door.
- 4.2.20 At first floor are five ventilation slits that correspond with those on the north elevation. Together these features represent the ventilation required for fodder storage on the first floor, most probably associated with the later dairy phase of the Barn.

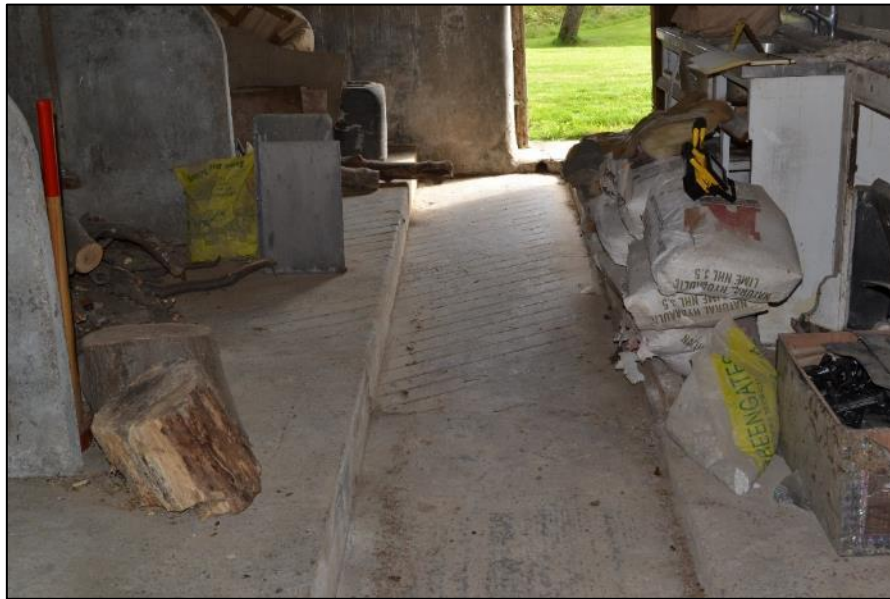
- 4.2.22 The floor is concrete and includes drainage / grip striations, and the waste channel which leads to an external drain via a small hole under the east door (Plate 14).

**Plate 14. Ground floor, concrete dairy floor**

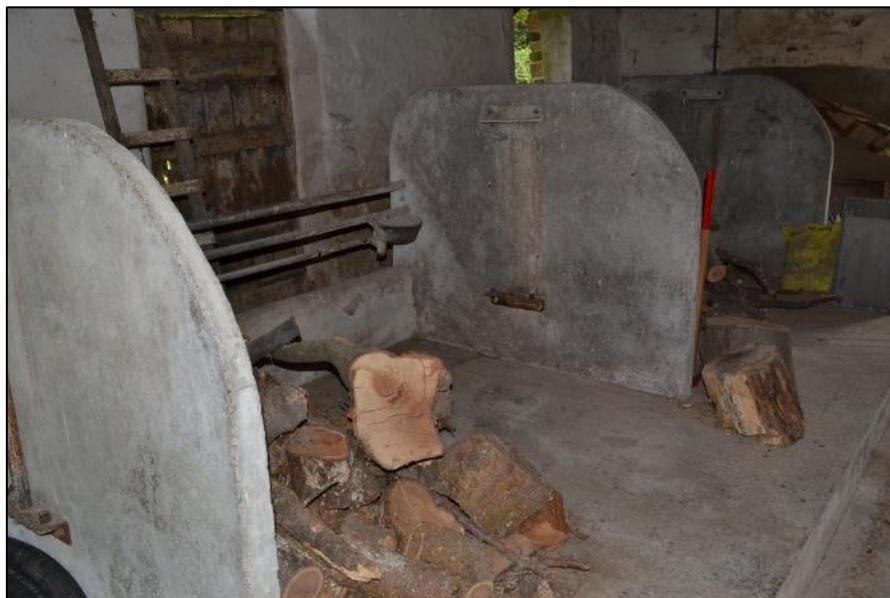
- 4.2.23 The most notable features on the ground floor are the concrete and iron milking stalls. These could accommodate up to four cows, separated from one another by the concrete screens and fitted with drinking water bowls and tethering apparatus (Plate 15).

**Plate 15. Cattle stalls**

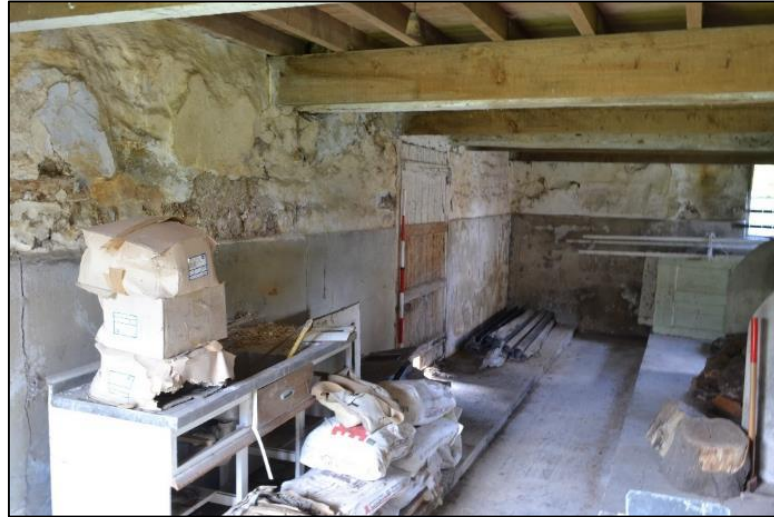
- 4.2.25 Throughout the ground floor, the space was adapted for cleanliness as would be expected in a dairy. The walls were half rendered to the height of a cow and whitewashed to aid cleaning (Plate 16).

**Plate 16. Ground floor general shot (scale 1.6m)**

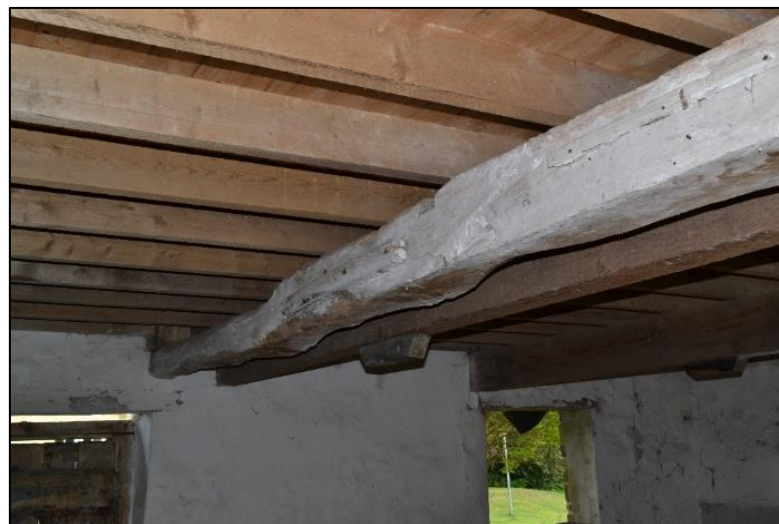
- 4.2.26 The ceiling of the ground floor supports the floor and supports the roof. Mostly the structure is of modern machine cut timbers (see Plate 16 above). There are however, two remaining transverse joists that appear to be original and one of these is shown on Plate 17 below. Both are simple cross members with little in the way of distinguishing joinery markings.

**Plate 17. Showing original simple transverse joists**

- 4.2.27 Both of the original timbers were paired with modern equivalents, and the originals were riddled with woodworm and appeared very rotten in places. All of the timbers, regardless of the age, were fixed into mortice holes in the fabric of the Barn. These cross members supported the crucks and the floor joists supporting the floor above.

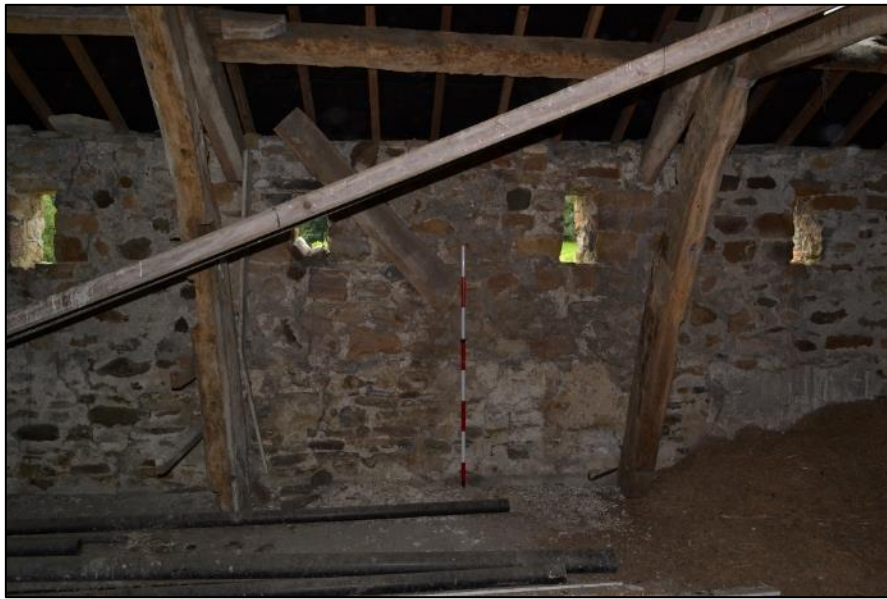
**Plate 20. First floor south elevation and original crucks (scale 16m)**

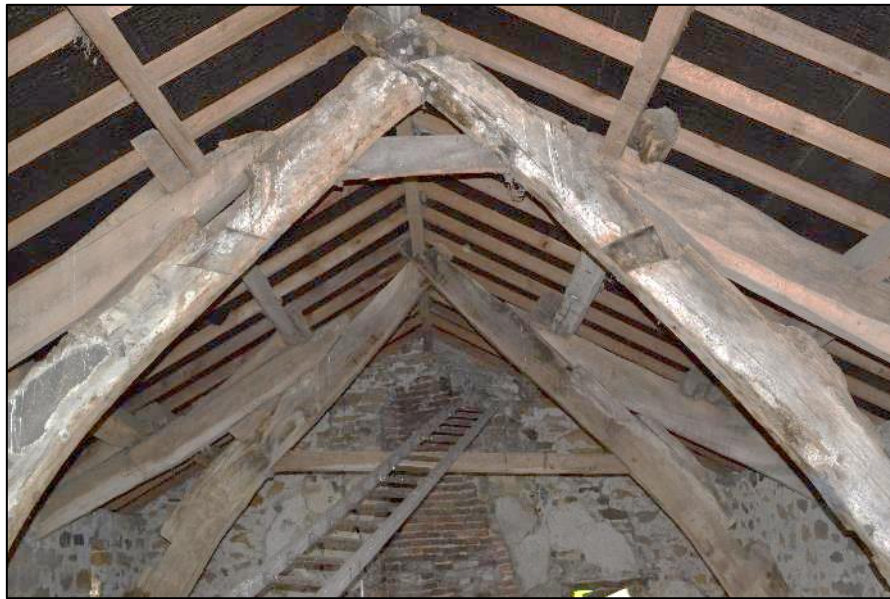
- 4.2.33 Plates 21 & 22 below show in some detail the original crucks, including how they are pegged at the apex and how the purlins run along the backs of the crucks. Scale drawings of the crucks are provided as Figures 5 & 6; the crucks were drawn in 2025, after they had been removed from the Barn. The crucks would each have originally included two stabilising collar beams, and each has a notch on the outer face that would have held a purlin.

**Plate 21. Detail of crucks and other roof timbers**

- 4.2.35 It was clear that the original crucks included evidence that the roof may have been repaired several times, for example the notches on the 'inside' of the crucks on Plate 21 show a downward inclination, which would accommodate a structural use in the roof as it is presently (note the horizontal tie beam above and on the cruck behind). Furthermore, the raised roof has required the later timbers to be integrated into the masonry and it is these that take the weight of the roof, with some merely piggy backing on the original crucks (Plates 21 & 22).
- 4.2.36 Close examination of the original timbers revealed no personalised joiner's marks beyond the rather unexplained notches already described. What was abundantly apparent, however, was that the original timbers were, or had been, heavily infested with woodworm and a good degree of deterioration from rot.

- 4.2.37 In summary, the roof is very interesting but in a poor and potentially deteriorating condition. It is entirely possible that the original crucks are not actually *in-situ* and that the curiously located notches were perhaps from an earlier phase of the structure, after which they were moved when the roof was raised.

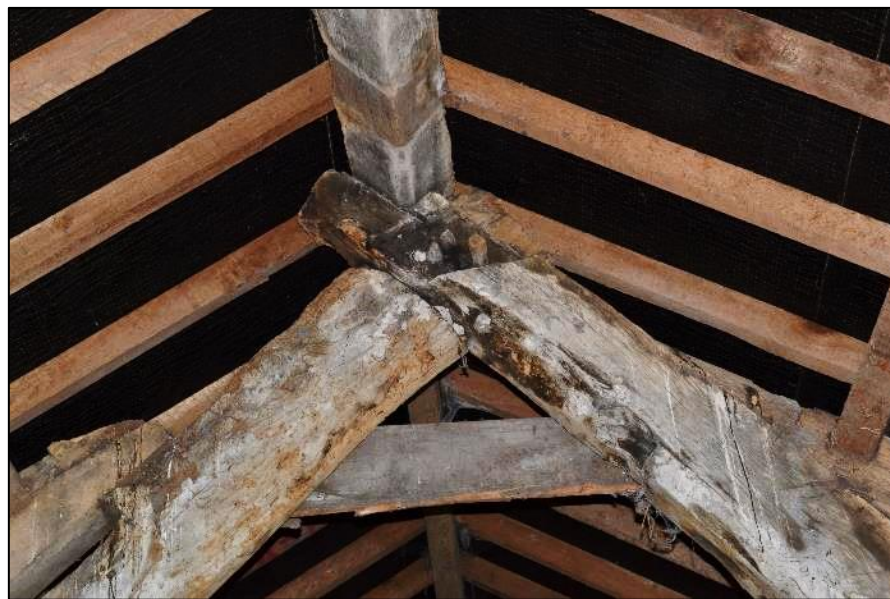
- 4.2.34 The crucks were originally constructed with dowels, but there are several holes on each that still have the remnants of wooden pegs, and some, presumably later, that have metal pins or pegs. It is assumed that these various holes were not constructional in nature, but rather for hanging purposes.

**Plate 22. Showing pegs in cruck and ridge purlin**

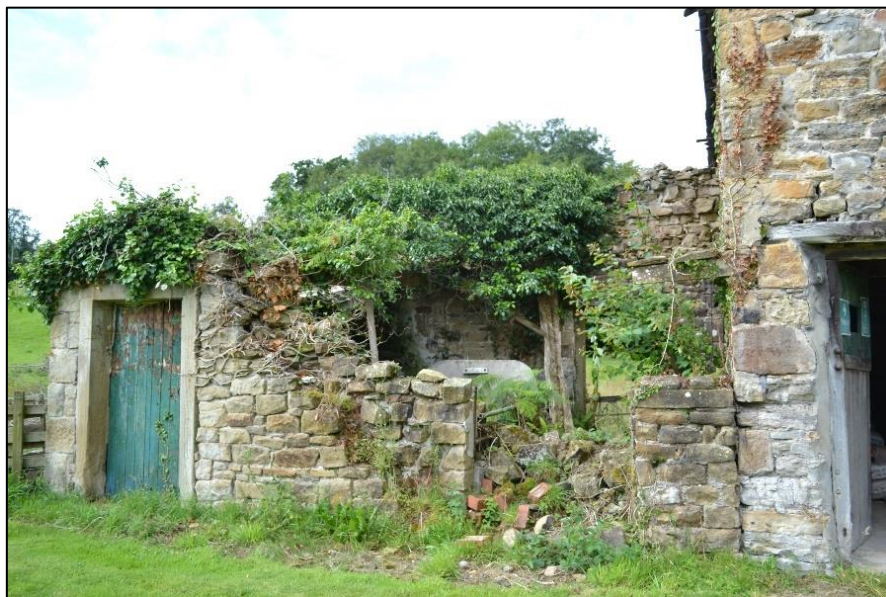
- 4.3.1 Abutting the Barn on the east side of the south elevation, is the ruined building shown on the 25 Inch OS map of 1932 (Plate 6) so we can assume that the building very much post-dates the original construction of the Barn. The building is almost square in plan, and is a single storey, built of sandstone blocks. The roof was slate and mono-pitched, sloping down from the adjoining Barn (Plate 23).

**Plate 23. The ruin from the east**

- 4.3.2 Plate 23 shows the state and condition of the building in 2024. However, it is possible to identify certain key features and to identify the function of building in the past. Plates 13 & 23 show the east and west elevation of the ruin, and they show that the building had opposing doors close to the back of the Barn.

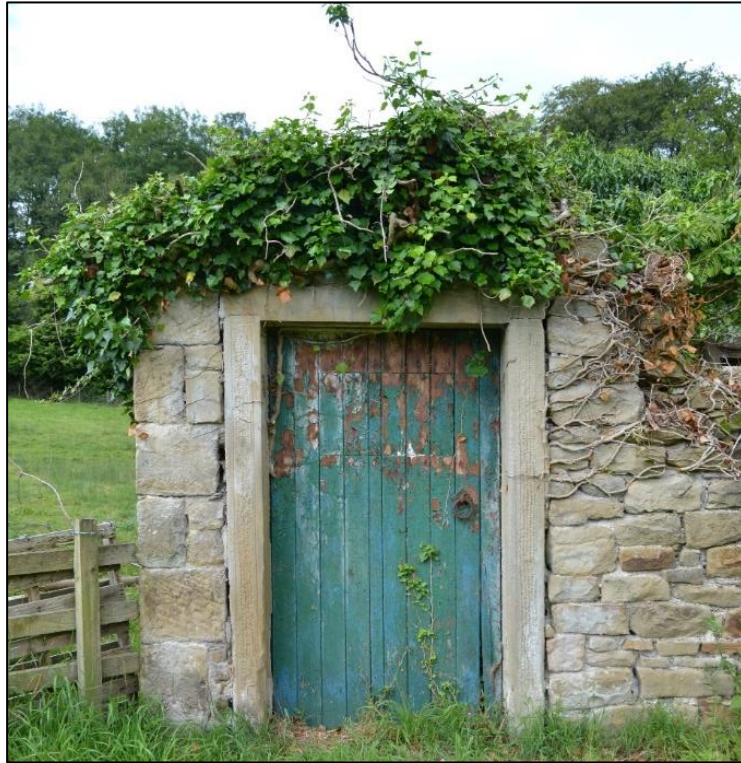
- 4.3.3 There is another door on the south east part of the east elevation (Plate 24). These doors and the single surviving window on the south elevation (there are the remains of a window next to the wide green door on the east elevation) suggest a smaller version of the dairy in the later phase of the Barn. The green door shown on Plates 23 & 24 would most likely have been access for cows, while the opposing doors would have served as access for the dairy workers. Despite the very overgrown and ruinous state, it is possible to make out a concrete stall, like those in the Barn amongst the rubble.

**Plate 24. Intact east access door on east elevation**
