# STRUCTURAL SURVEY INSPECTION REPORT

**MOORCOT  
NICKEY LANE  
MELLOR  
LANCS  
BB2 7HF**

**JULY 2026**

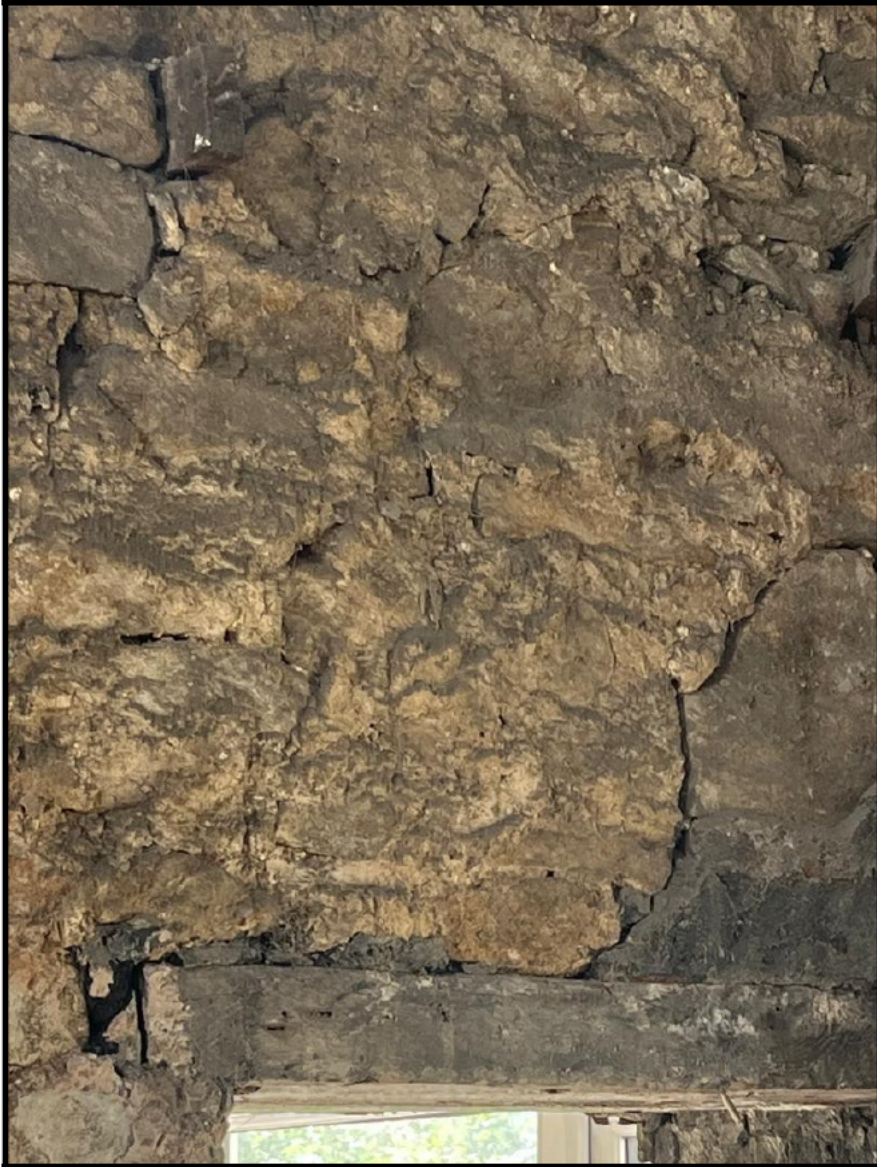
The doorway between the living room and sun room has timber lintels in a poor condition.

*Doorway between living room and sun room*

The recommendation is to take down the walls and rebuild on new concrete foundations. The original wall is in very poor condition and is still susceptible to movement. All decayed timbers are to be removed and replaced.

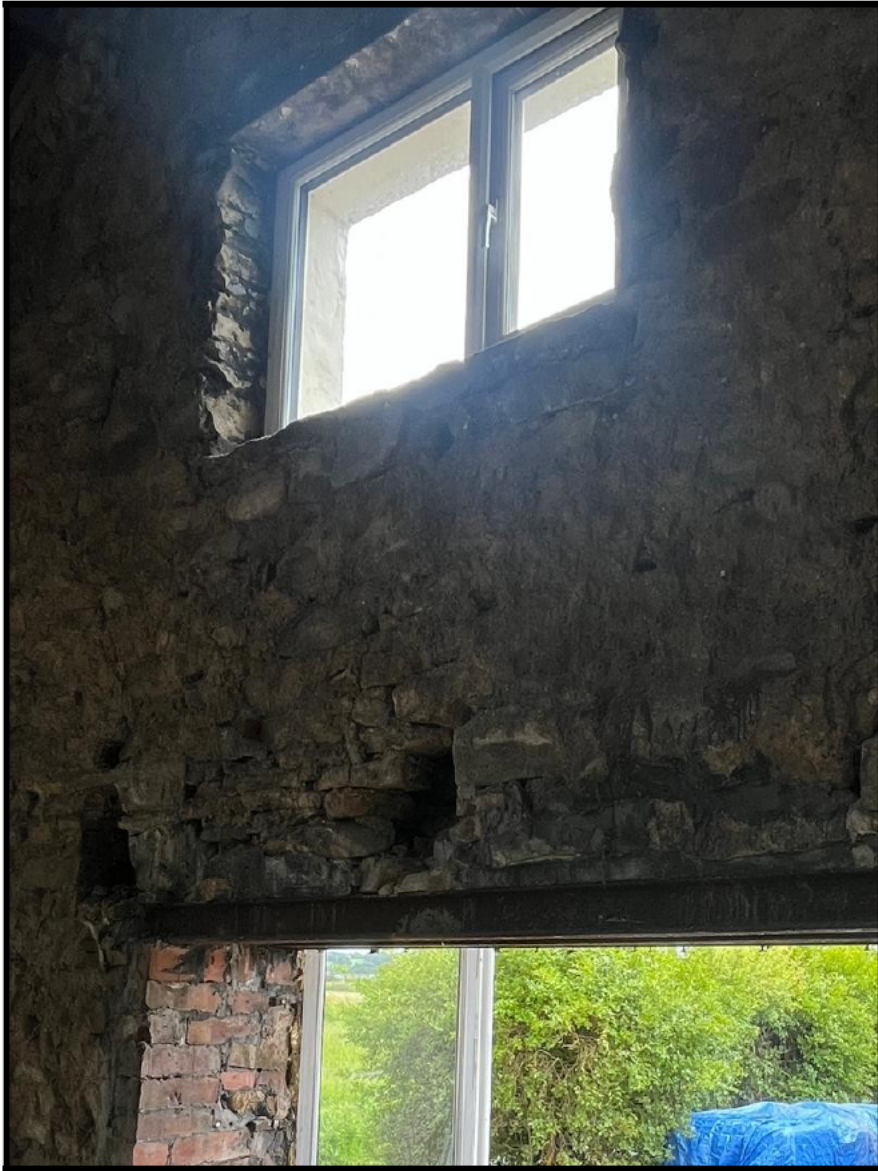
The bay window to the living room is a later addition, which is evident by the steel lintels and made up brickwork jambs. The jambs are poorly constructed in weak mortar.

*South gable wall showing bay window.*

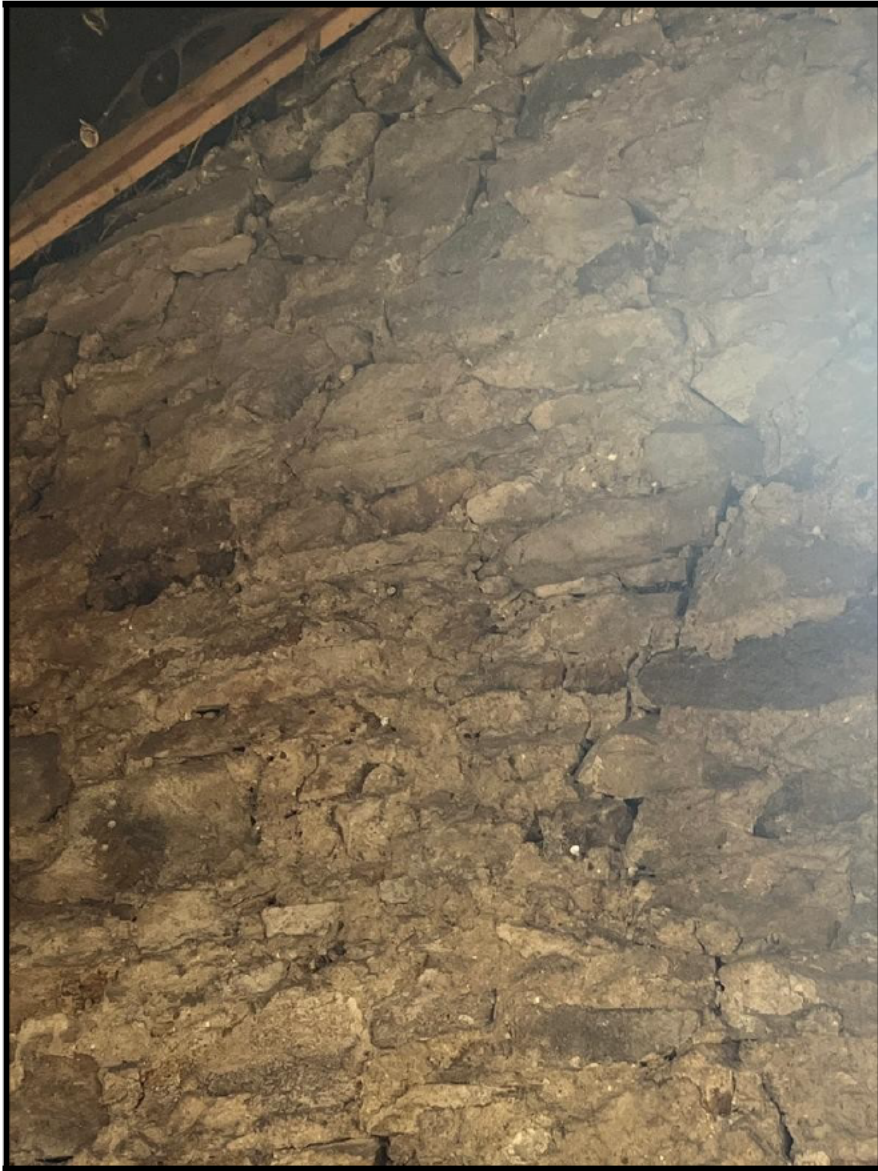
The gable wall is in a similar condition to the internal wall with extensive movement cracking throughout the height and length of the wall.

The windows to the gable have timber lintels, which are in a very poor condition, and are the cause of the movement cracking in the wall.

The foundation to the gable wall is stone flag and only 500mm below ground level. This is a contributing factor to the movement in the walls and the undulating levels of the ground floor.

*South gable wall showing movement cracks.*

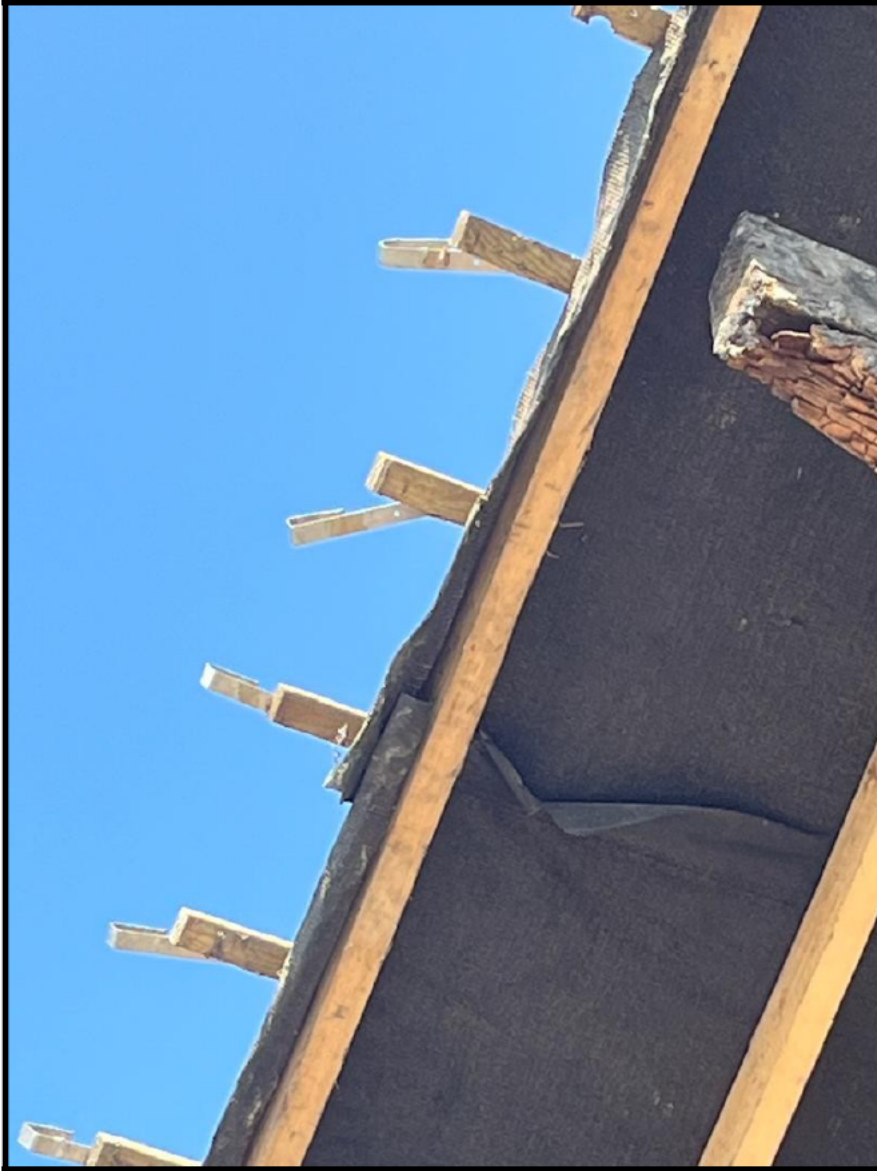
The purlin ends to the main roof are severely decayed, although they are not the original purlins. The rafters to the building appear relatively recent, regular and squared section timber, indicating that the original roof timbers have been replaced. The blue slate roof covering has also been replaced. The sarking felt and battens look relatively recent indicating that the roof covering has been renewed. Given the age of the property it is likely that the original roof covering was natural grey, stone slate. This was typical vernacular for the location.

*Exposed roof structure showing decayed purlin ends.*
