## SPECIFIC SURVEY

THIS IS A REPORT TO CONFIRM THE STABILITY OF STRUCTURES (WALLS)  
OF THE PROPERTY AT

PEWTER HOUSE FARM

CARR LANE

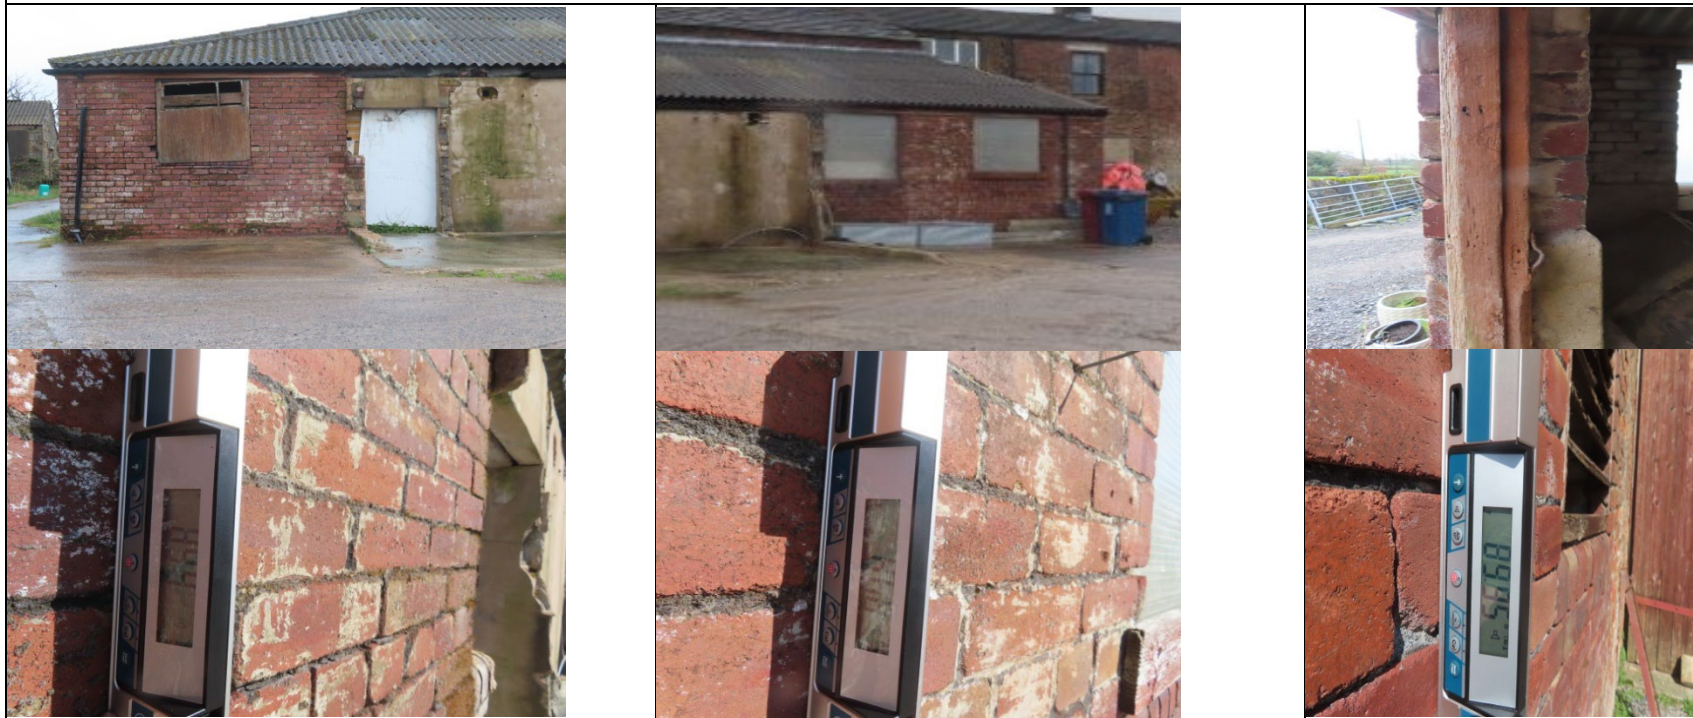
| DESCRIPTION OF ELEMENT INVOLVED | ASSESSMENT METHOD | FINDINGS | FURTHER INVESTIGATION REQUIRED |
|---|---|---|---|
| West and south facing external wall of single storey agricultural building built in solid brick configuration and assumed as shallow agricultural foundation. | Visual initially followed by related photography and laser inclinometer for vertical alignment. | None of the brick walls of the single storey shed under the cement sheet roof, appeared as more than 1.2 degrees from the vertical and this is considered fair to good for the age of the construction. These walls have continued to remain virtually vertical despite any vertical or horizontal mechanical pressures exerted from failing roof components or attached structures. | None at this time |

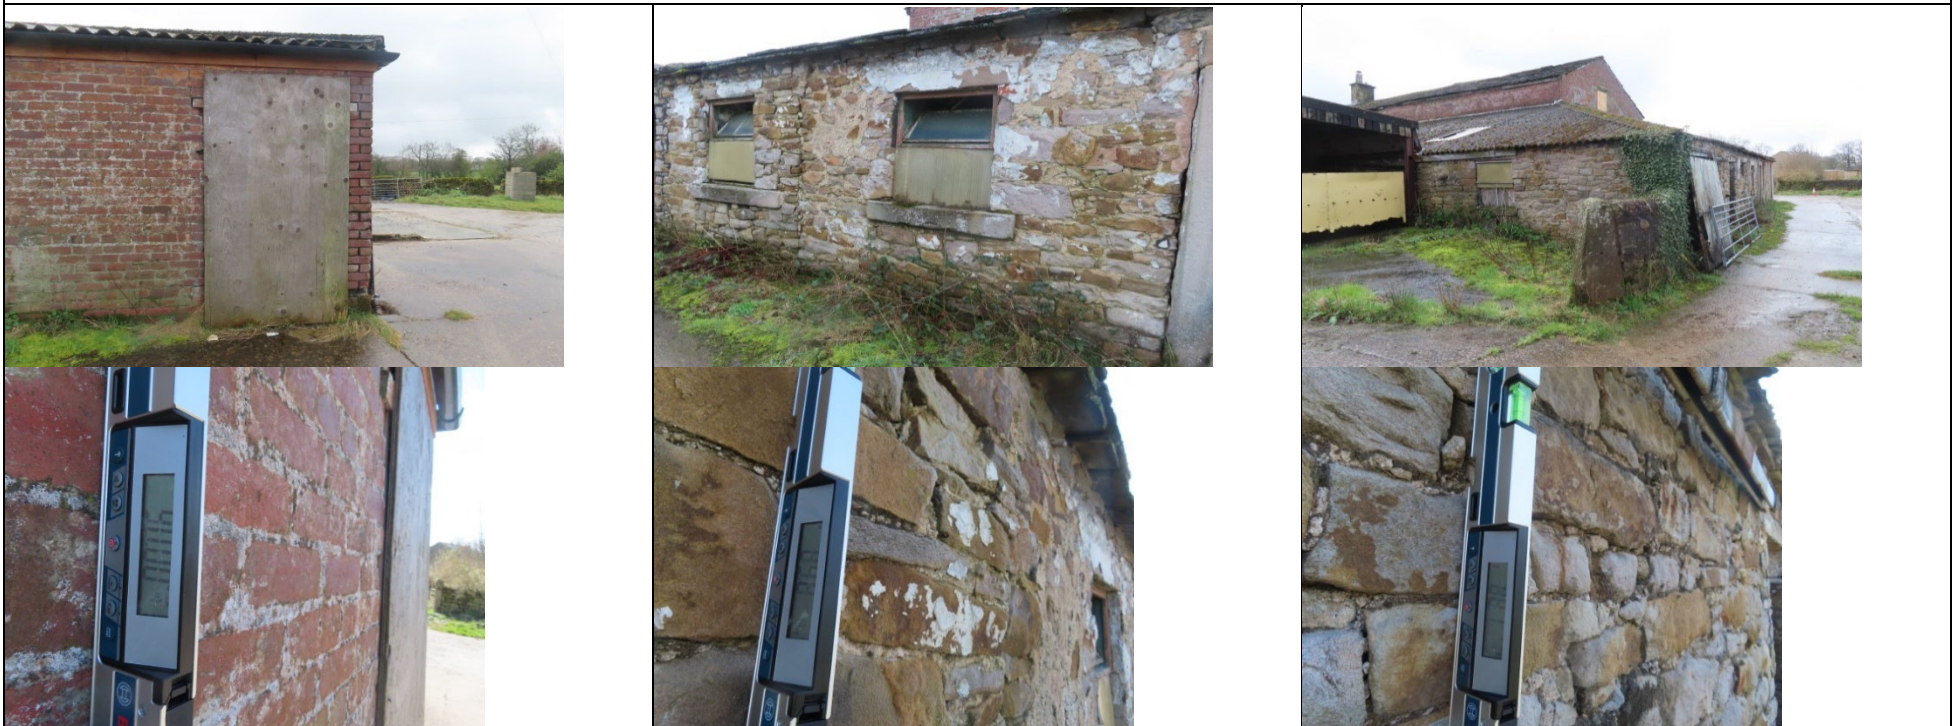
| ELEMENT INVOLVED | ASSESSMENT METHOD | FINDINGS | FURTHER INVESTIGATION REQUIRED |
|---|---|---|---|
| East walls of the single storey building under the cement sheet roof constructed in solid brick and original single storey shed constructed in rubble configuration sandstone. | Visual initially followed by related photography using handheld and drone footage | As for the west elevation, these walls appear close to vertical and with no significant or obvious movement. The brick walls will be of shallow foundation and the rubble walls to a similar depth but likely with padstones. | Not at this time |

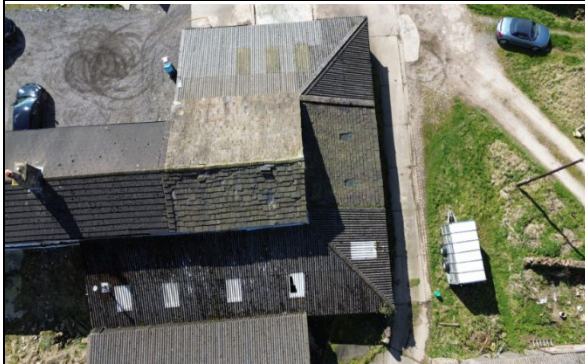
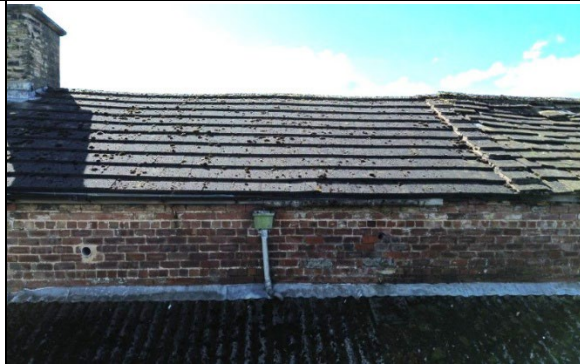
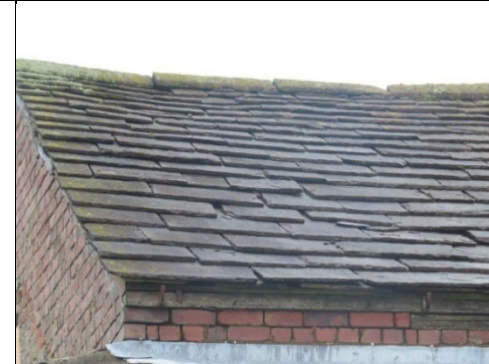
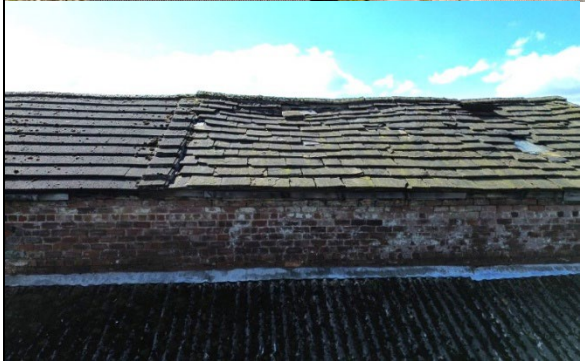
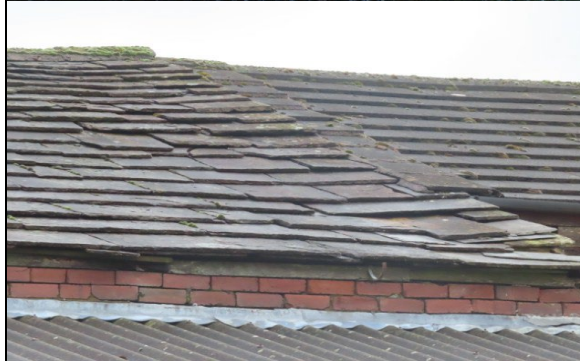
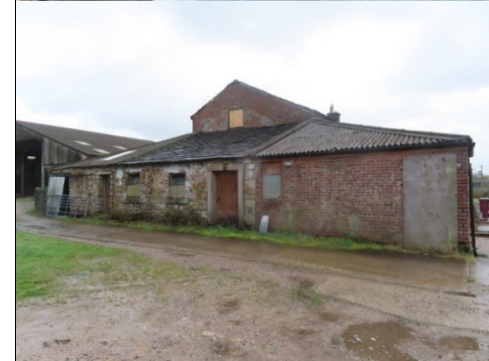
| ELEMENT INVOLVED | ASSESSMENT METHOD | FINDINGS | FURTHER INVESTIGATION REQUIRED |
|---|---|---|---|
| The roof coverings for the original pitches are in poor condition and we consider it likely that only 45% is recoverable. The cement sheet coverings are likely to require removal due to possible asbestos content. | Visual initially followed by related photography using handheld and drone footage. | The single storey coverings do not appear with particular defect other than the nature of the component (possible asbestos). That there is no particular defect is a reflection of the integrity of the component rather than the roof frame. The condition of the original covers (stone) is poor with clear evidence of dishing, deflection and decay. | Not at this time |

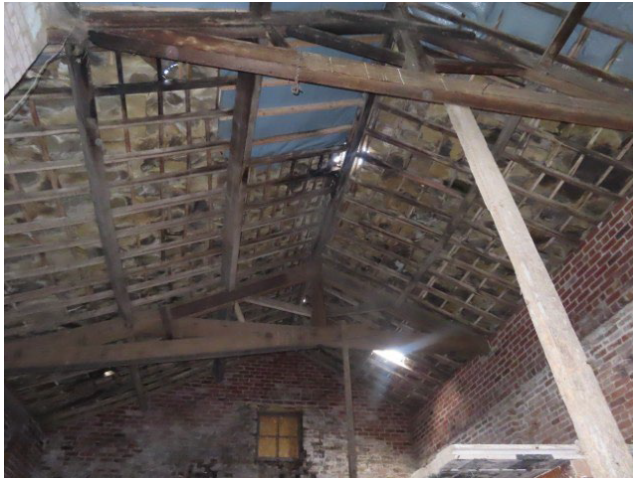
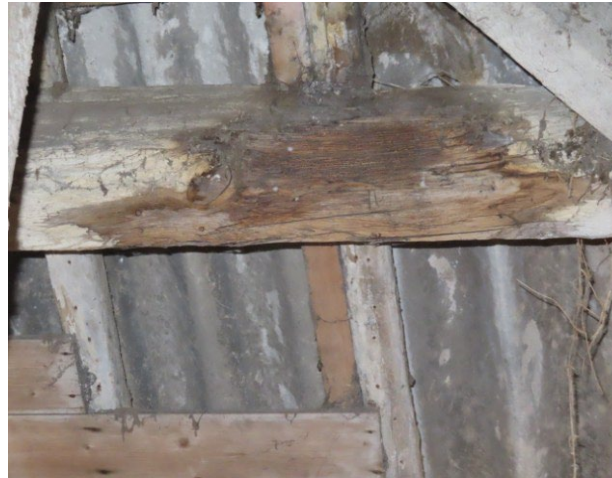
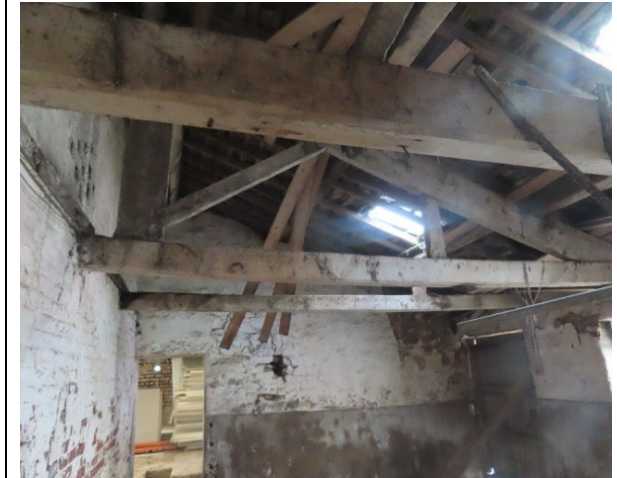
| ELEMENT INVOLVED | ASSESSMENT METHOD | FINDINGS | FURTHER INVESTIGATION REQUIRED |
|---|---|---|---|
| Cut timber roof frame in a King Post configuration with various extending collar beams supporting purlins and rafters | Visual and handheld photography | A considerable number of the timber components have failed and mostly due to the effects of moisture and insect investment. Although the nature of the specific assessment is to report on the condition of the main walls, the effects of the roof frame are a paramount consideration. The decay of these elements can have severe effect on the walls below which are subject to mechanical forces. | Not at this time |

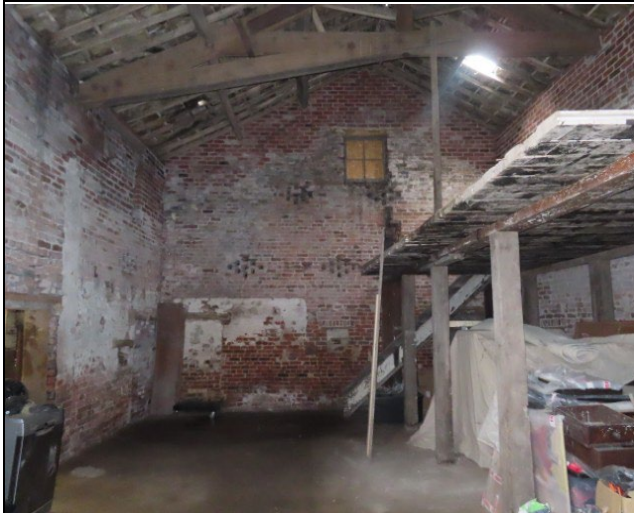
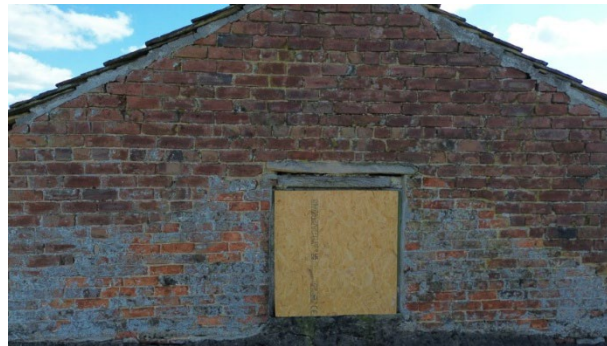
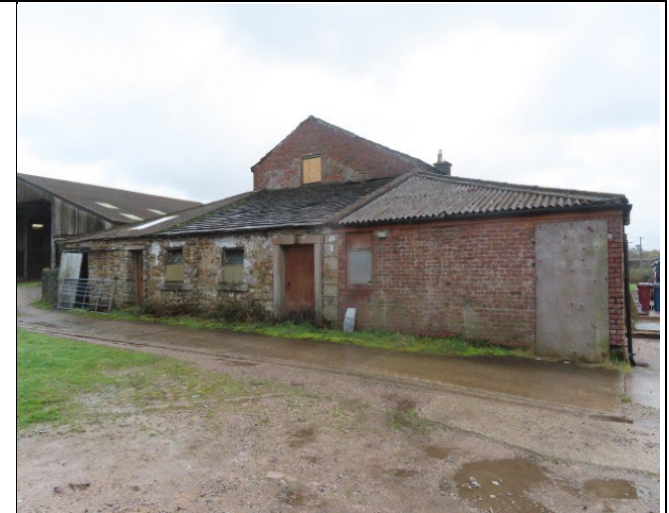
| ELEMENT INVOLVED | ASSESSMENT METHOD | FINDINGS | FURTHER INVESTIGATION REQUIRED |
|---|---|---|---|
| Internal supporting walls of the double height barn area constructed in solid brick garden bond configuration and which support the stone flag roof. | Visual with handheld photography | These walls have been constructed in an agricultural fashion with missing bricks. This is indicative of walls constructed up to the late 1800's and used to prevent damp in stored items such as bound straw. Such construction produces weak points around perforations and apertures such as the loop below, where bound straw would have been distributed. Step cracks to the verges can be observed. | Not at this time |

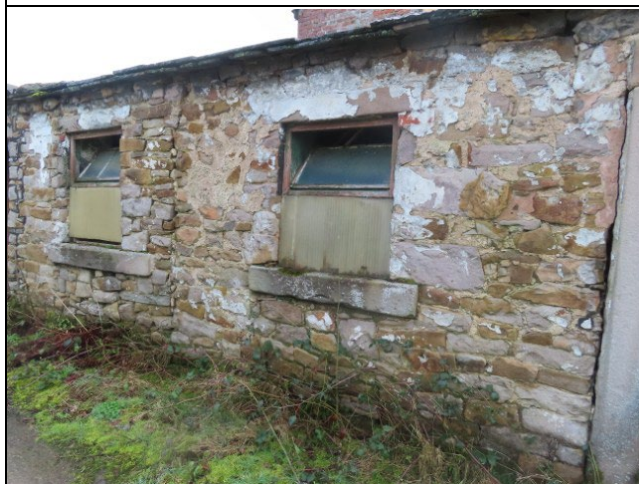
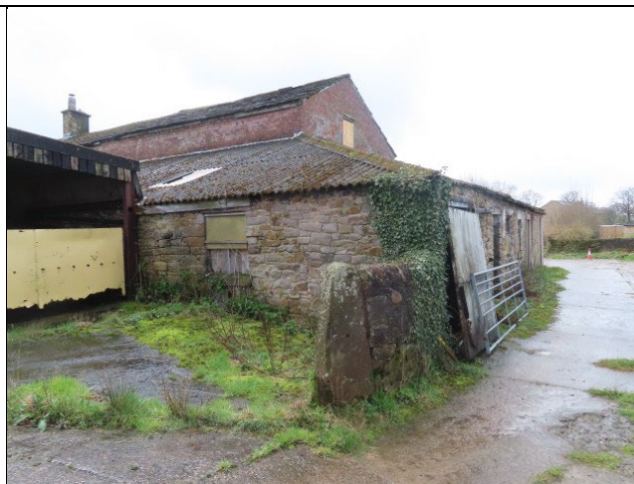
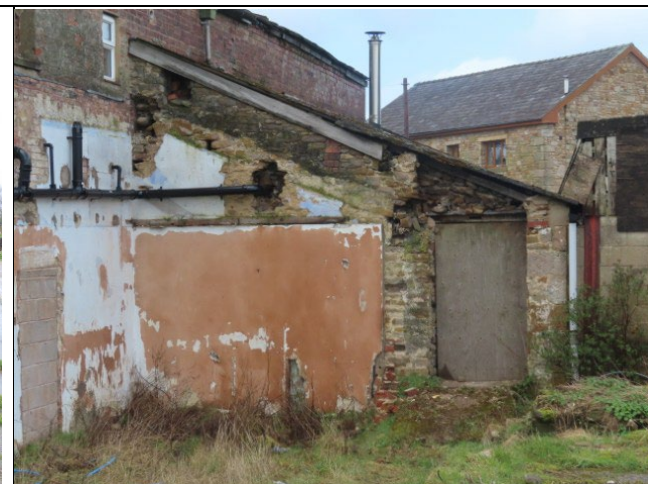
| ELEMENT INVOLVED | ASSESSMENT METHOD | FINDINGS | FURTHER INVESTIGATION REQUIRED |
|---|---|---|---|
| The east and south elevations of the single storey which wraps around the double height barn is mostly constructed in sandstone rubble configuration. | Visual with handheld photography | These walls have been constructed at various times and likely by non-professional constructors with poor sectional joints. As with the brick walls there are some step cracks and minor separation caused by rotting timber such as windows and roof frame. Otherwise, they appear as recorded and mostly vertically complete. | Not at this time |

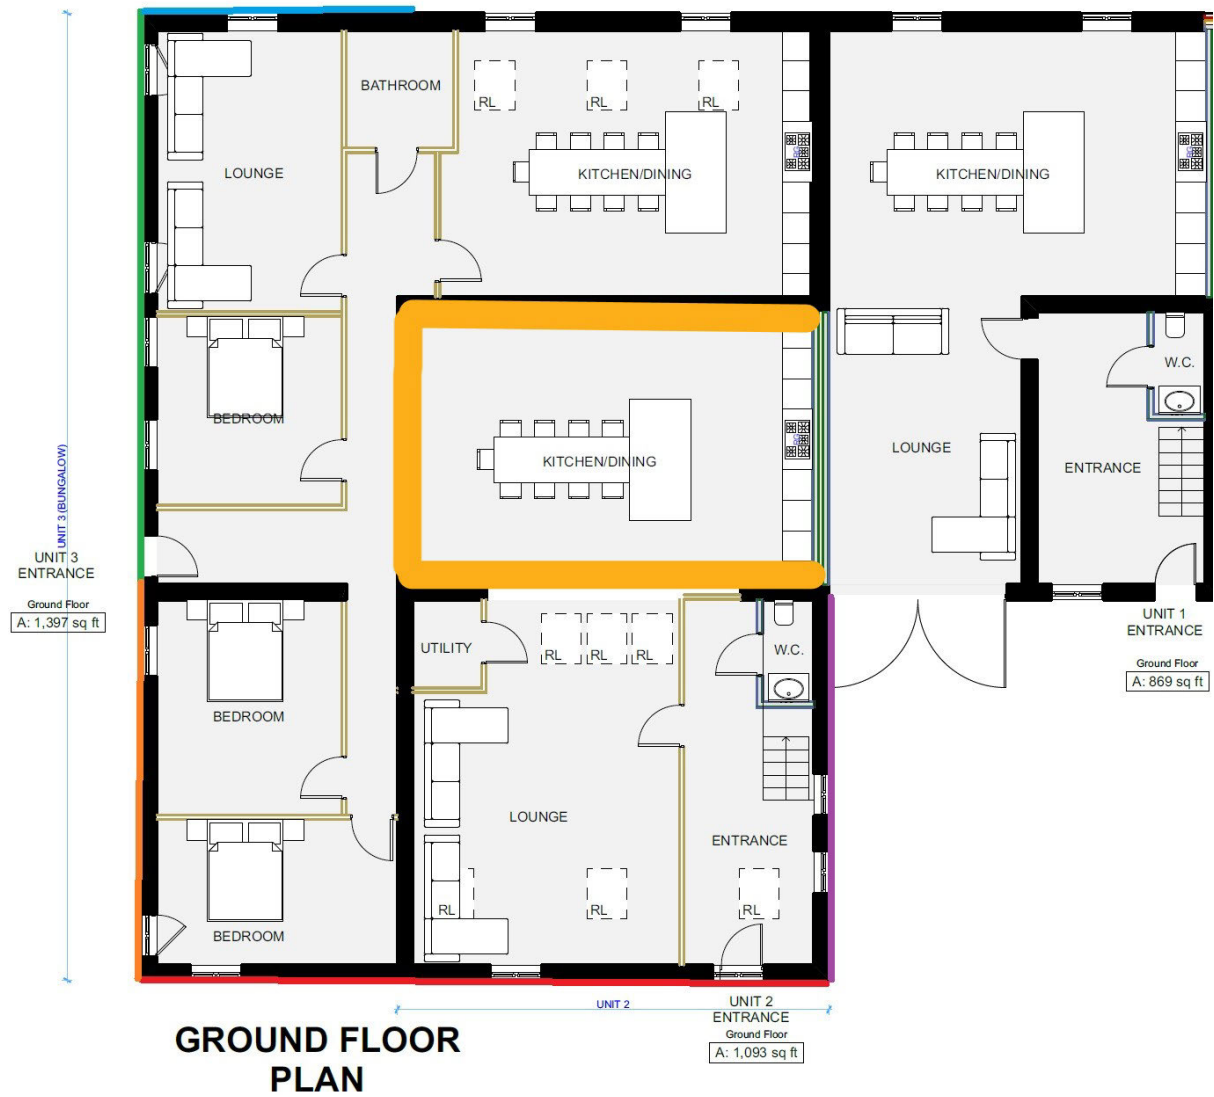
The solid brick internal walls which appear at upper level as second storey gable and flank walls, also appear in average expected condition and surprisingly stable considering the condition of the roof frame and the possible leverage from failing timber components. These walls require the same attention for remediation with joints being raked, grouted and pointed and would then be considered adequate as the outer leaf of the two-storey section for development. These walls have originally or over time been tied to other elements and it is considered that during and post refurbishment, they are insufficient to stand alone as the supporting walls of such a roof frame without additional support, and we specifically refer to the walls indicated on the plan in gold. We would therefore recommend a tied dense block inner leaf or structural piers for additional support. The other wall colors simply denote the type of wall which has been identified previously in the report.
