## Langho

### **Phase 1 Geo-Environmental Investigation Report**

For: Redwaters Developments Ltd

| <b>Report Reference:</b> | | <b>4548-01</b> |

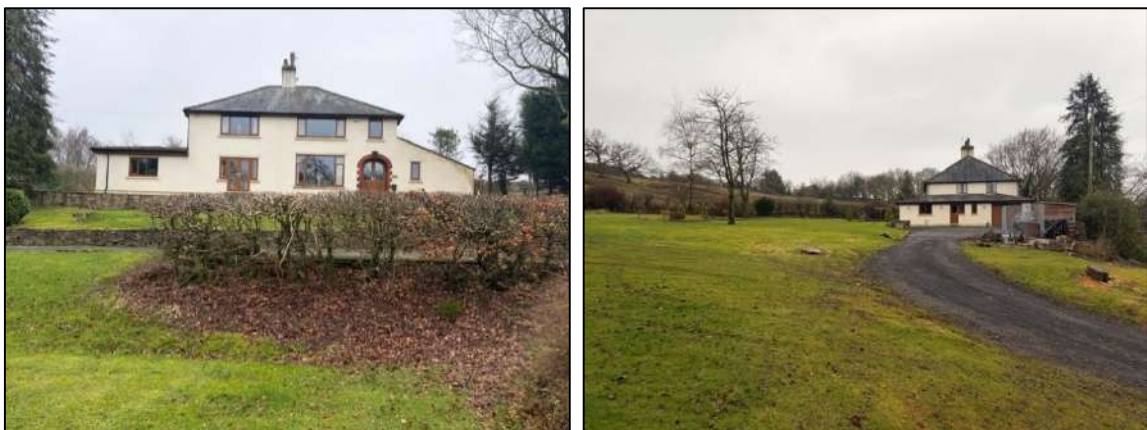
The site currently comprises a residential garden with associated landscaping with a driveway which runs from east to west in the northern site section. The garden area was also noted to be terraced due to the site topography, which generally falls to the north. The ground underfoot was noted to be grass across the majority of the site with the presence of gravel and asphalt along the driveway.

*Figure 3: Photographs of the northern (left) and central (right) site sections illustrating the presence of terracing.*

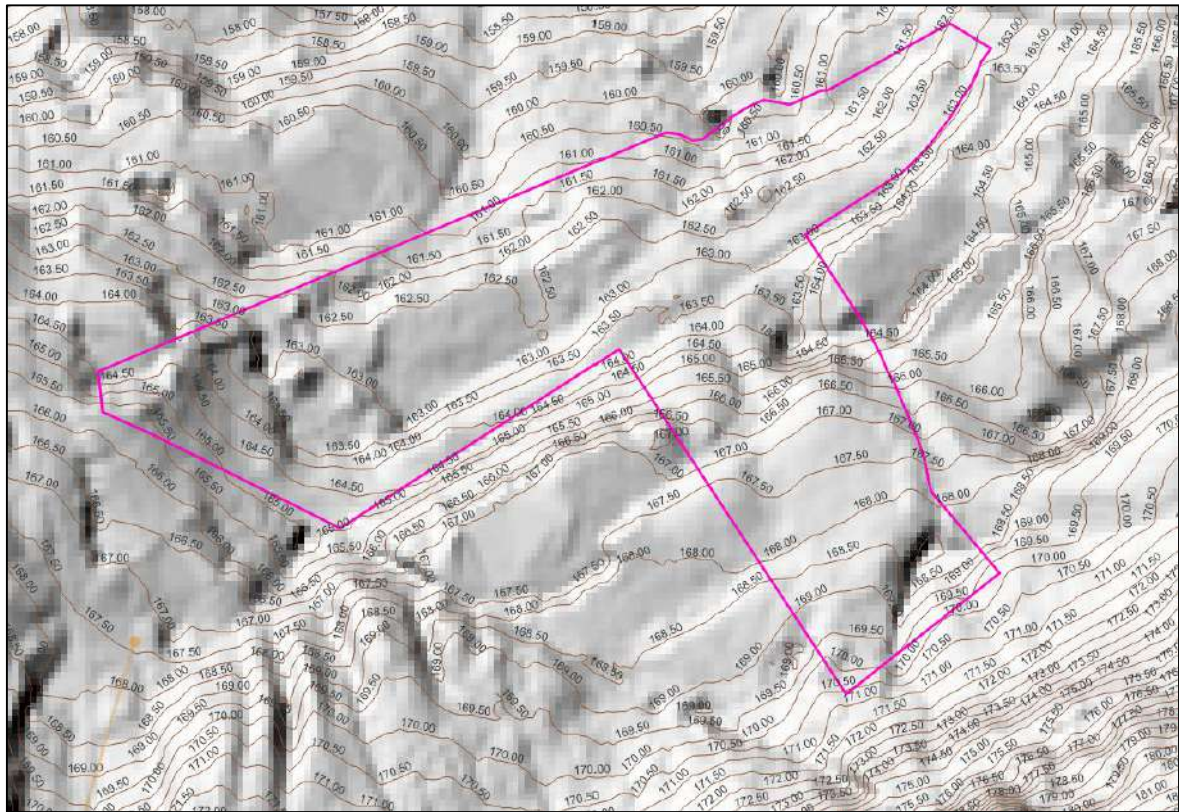
The topography of the site generally slopes from c. 170.00m AOD in the south to c. 161.00m AOD in the north, a rate of 1:10. However, steeper areas are present in the central site section where a gradient of 1:2 is present, as well as in areas that are terraced, falling at gradients of between 1:5 and 1:6. Beyond the southern site boundary a sheer rock face was identified, rising to a height of c. 174.00m AOD. A LiDAR contour plan is included below showing the topography of the site.

Figure 4: Extract of the LIDAR 0.50m contour plan.

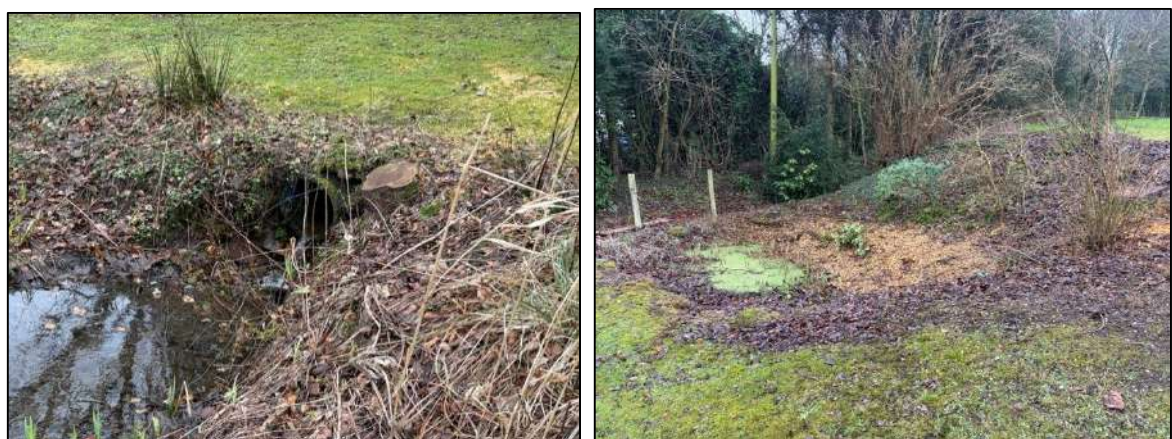
A pond feature was noted in the southern site section, with 2 No. culverted watercourses feeding into it from the south. An outlet was recorded to the north of the pond into an off-site culverted watercourse. A second pond feature was identified in the central site section.

Figure 5: Pond features identified in the northwestern site section (left) and in the central site section (right).

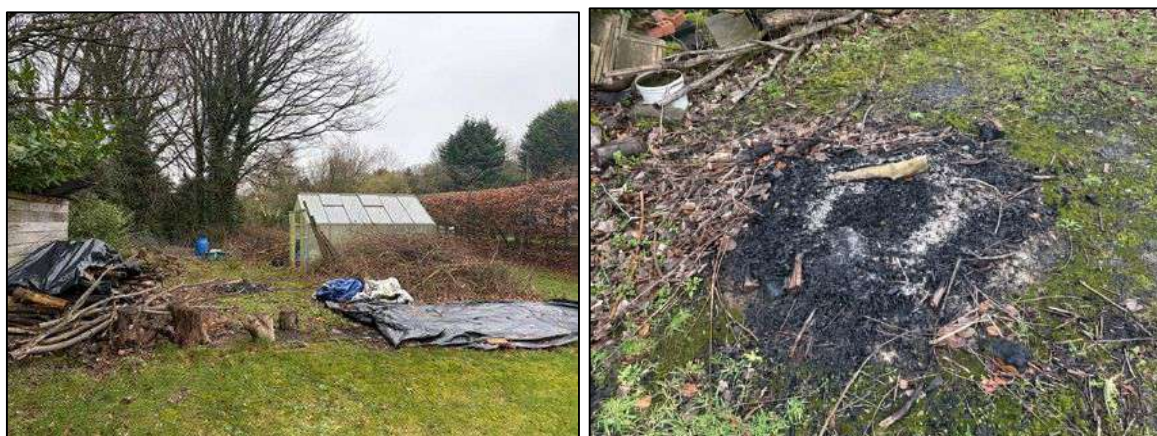
No evidence of significant contamination (i.e. spillages or leakages) or contaminative sources were identified. Evidence of fly tipping was noted in the northeastern site section, however, this is not considered a contaminative source as the material was primarily inert materials such as metal and timber. Some evidence of burning of unknown materials was identified in the northeastern site section with the presence of ash and charcoal, this may lead to a potential contaminative hotspot.

Figure 6: Evidence of fly tipping in the northeastern site section (left) and burning (right).
