# Tree Condition Report

6 Nethertown Gardens,  
Whalley,  
Clitheroe  
BB7 9GU

19/07/2026

Job Ref: 2351

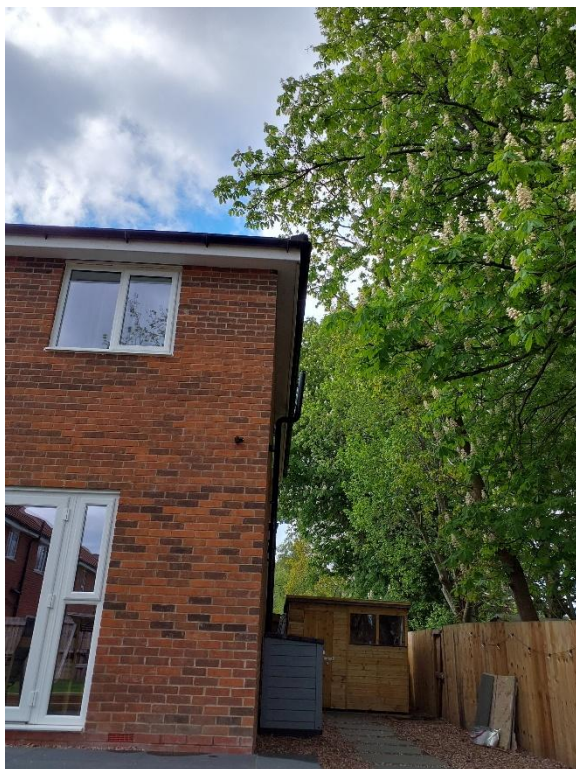
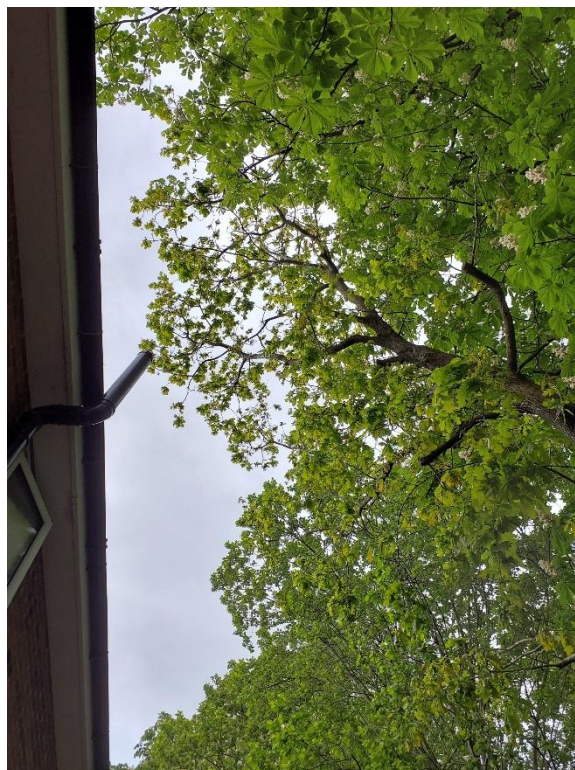
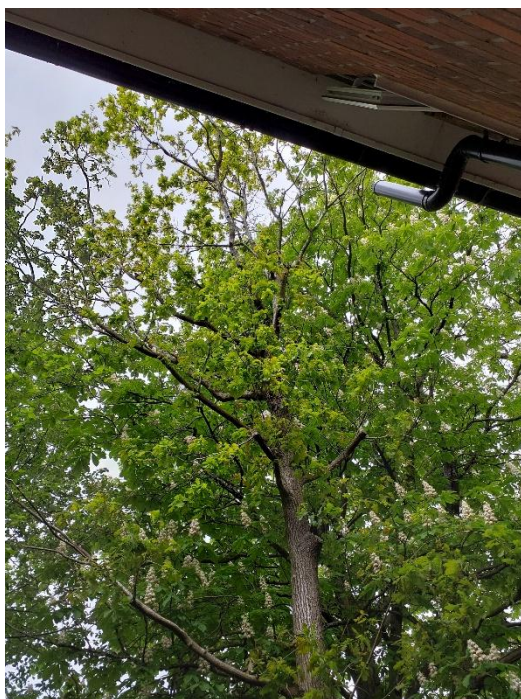
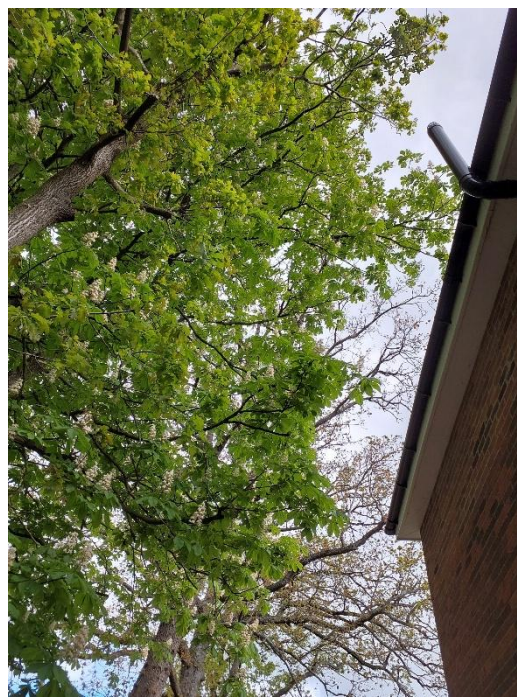
17.3. The neighbours' trees are encroaching the client's boundary lines and there is encroachment towards property, and as such boundary and property clearance pruning is recommended to clear the boundary line and to abate a nuisance.

Photos showing the encroachment over the boundary fence and over the roof of the property.

17.4. It is my recommendation that both trees are pruned back to suitable pruning points to give adequate clearance back to the property fence line, this will negate any future short-term requirements for a pruning.

17.6. This can be achieved from within the client's garden using a ladder leaned against the side of the property and a long reach pole chainsaw. Pruning points would be approximately 25 to 50 mm in diameter which would have minimal impact on the tree's health.

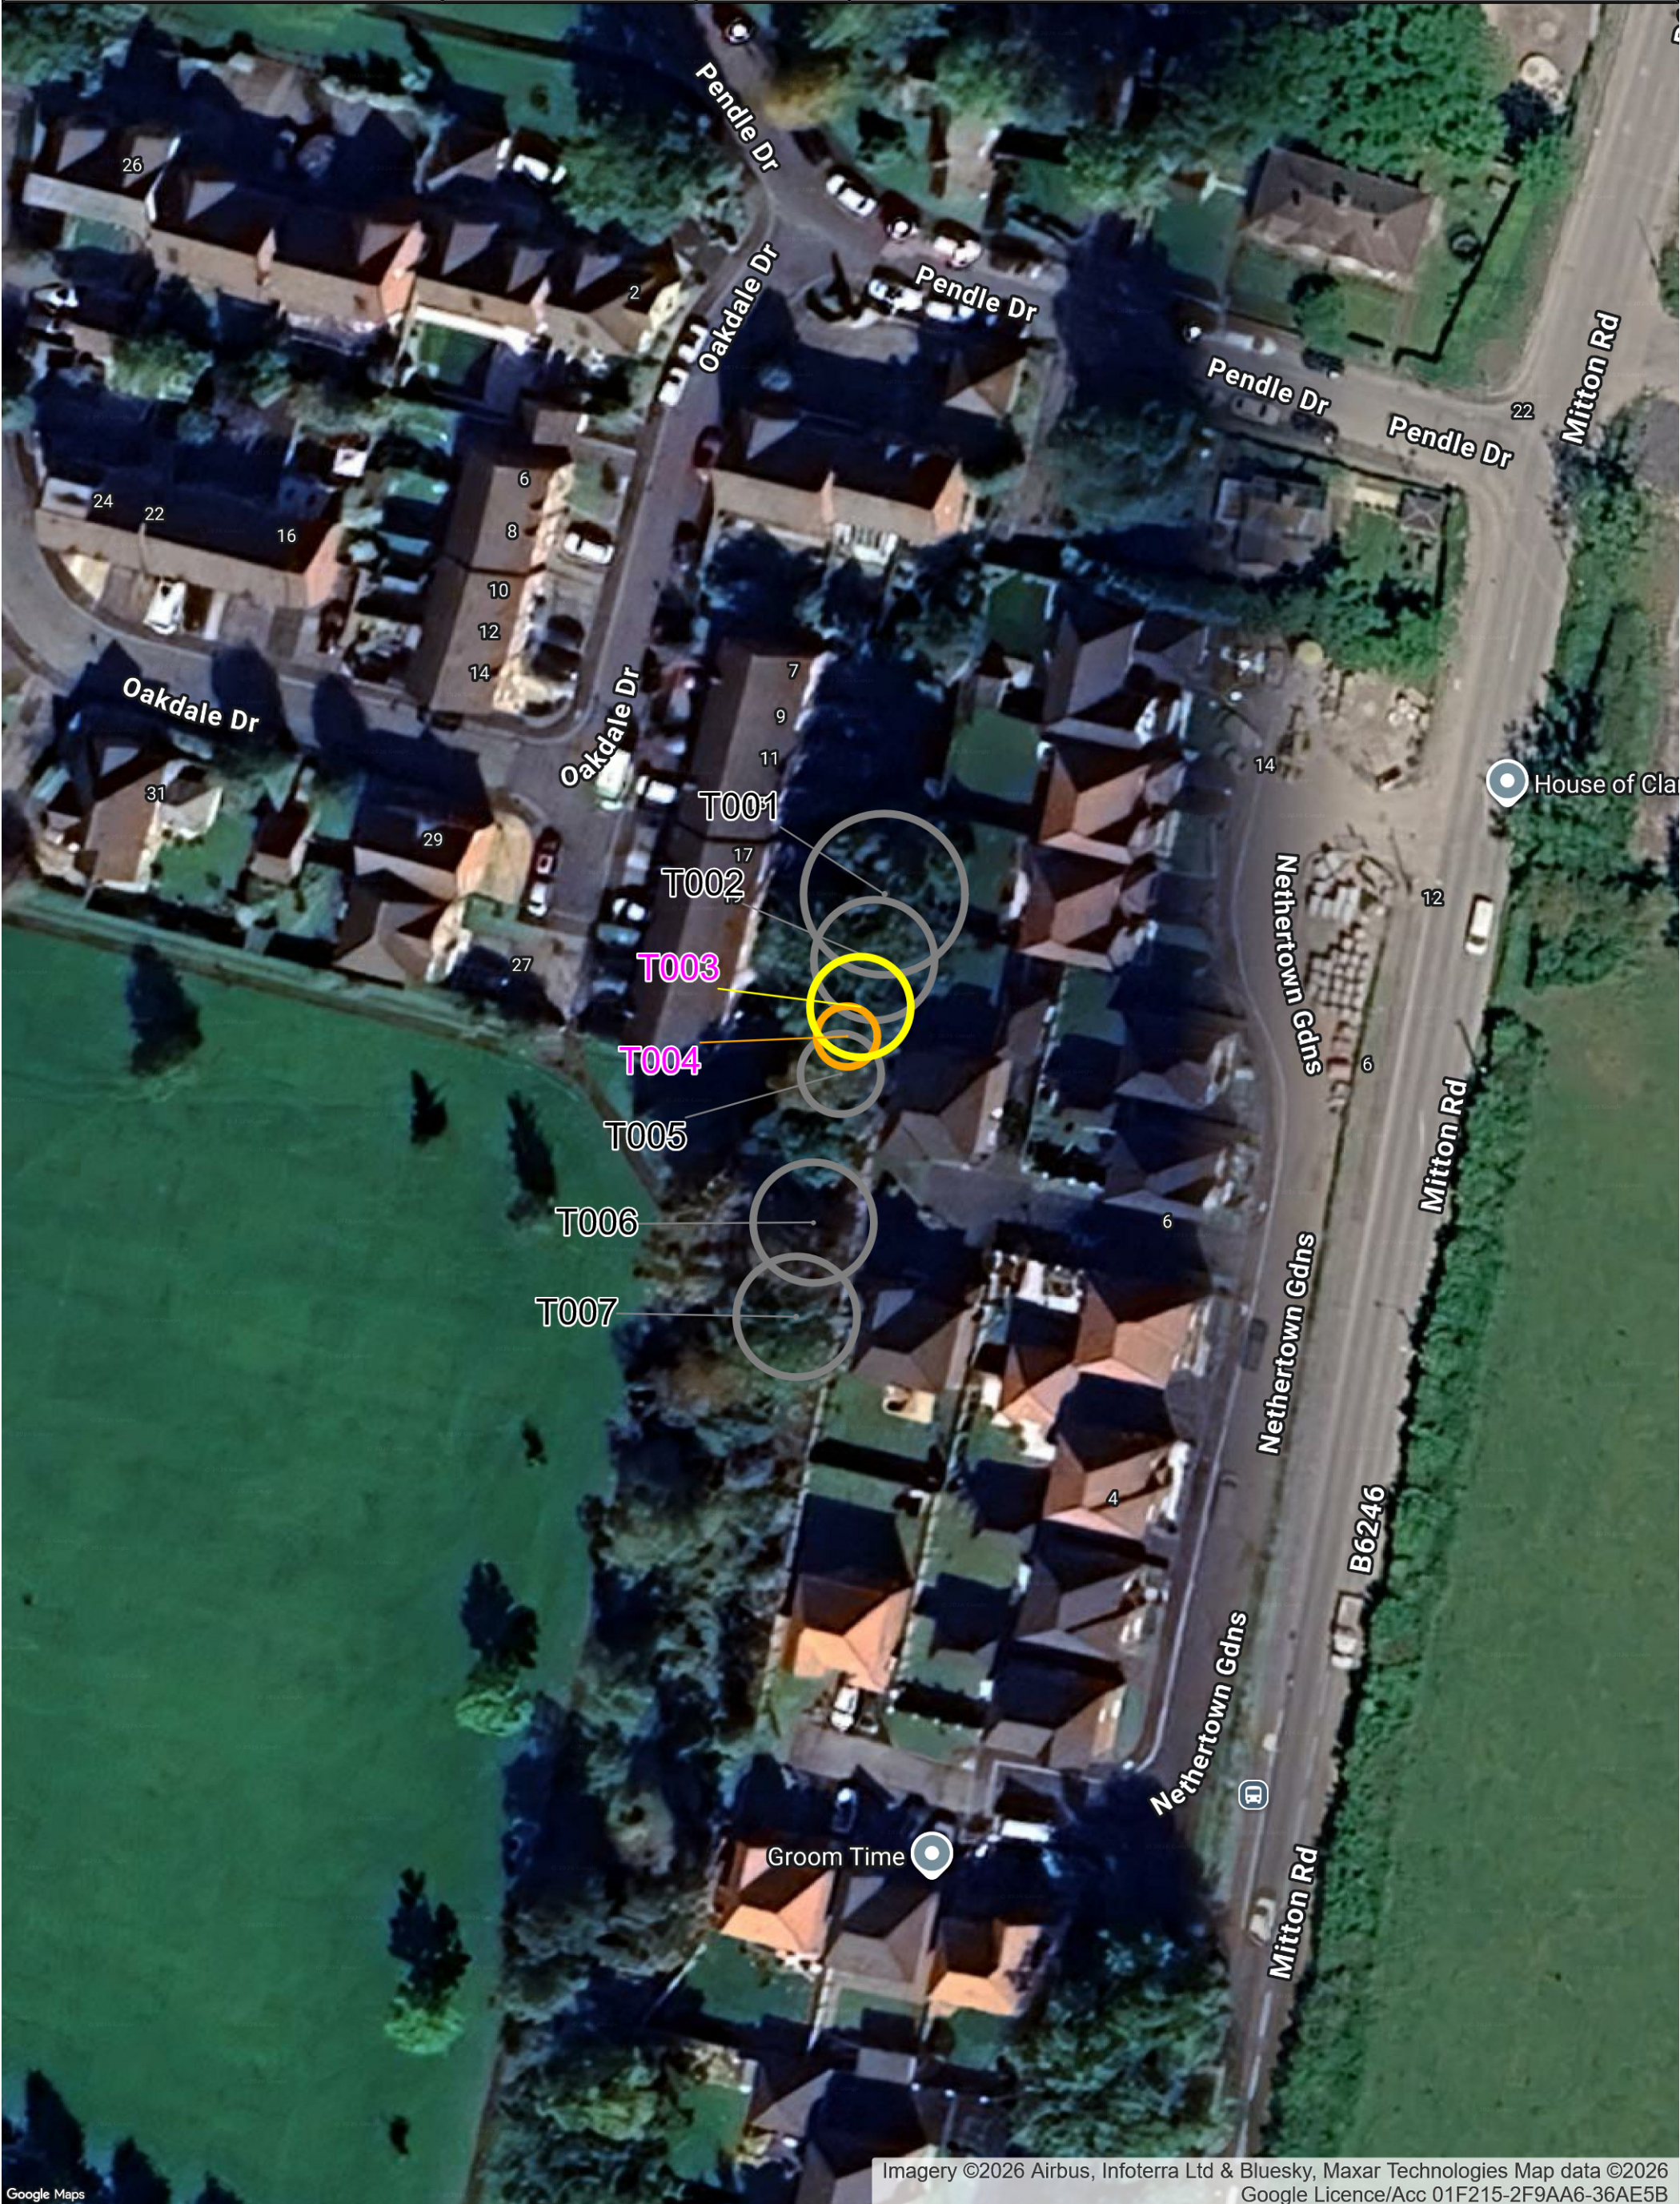
| Tree | T003 | Horse chestnut ( <i>Aesculus hippocastanum</i> ) | 1 | 10 | 16 | N:5<br>E:5<br>S:5<br>W:5 | Semi Mature | Good | Good | 40+ Years | <ul style="list-style-type: none"><li>_ Tree under 3rd party ownership.</li><li>_ No significant visual root defects.</li><li>_ No significant visual stem defects.</li><li>_ No significant visual branch defects.</li><li>_ Minor deadwood &lt;25 mm diameter.</li><li>_ Canopy encroaching boundary line.</li><li>_ Canopy encroaching building.</li><li>_ No significant visual foliage issues.</li></ul> | No significant visible fungus present at the time of inspection. | No significant visible Pests or Disease present at the time of inspection. | Owned by neighbour.<br>Target # - Dwelling<br>Target # - Garden<br>Target # - Conservatory<br>Target # - shed / greenhouse / outbuilding | YES | <ul style="list-style-type: none"><li>_ Prune to clear building by 2 m.</li><li>_ Prune to clear boundary line.</li></ul> | 11-May-2027 (1 Year) | 2 Years | | | | |
| Tree | T004 | Oak ( <i>Quercus sp.</i> ) | 1 | 30 | 10 | N:3<br>E:3<br>S:3<br>W:3 | Semi Mature | Good | Fair | 10+ Years | <ul style="list-style-type: none"><li>_ Tree under 3rd party ownership.</li><li>_ No significant visual root defects.</li><li>_ Leaning stem 15 degrees.</li><li>_ No significant visual branch defects.</li><li>_ Minor deadwood &lt;25 mm diameter.</li><li>_ Suppressed canopy.</li><li>_ Unbalanced canopy.</li><li>_ Grown as part of a group of trees.</li><li>_ Tree has poor form / shape.</li><li>_ Canopy encroaching boundary line.</li><li>_ Canopy encroaching building.</li><li>_ No significant visual foliage issues.</li></ul> | No significant visible fungus present at the time of inspection. | No significant visible Pests or Disease present at the time of inspection. | Owned by neighbour.<br>Target # - Dwelling<br>Target # - Garden<br>Target # - shed / greenhouse / outbuilding | NO | <ul style="list-style-type: none"><li>_ Prune to clear building by 2 m.</li><li>_ Prune to clear boundary line.</li></ul> | 11-Nov-2026 (6 Months) | Not Applicable | | | | |
