## **Barn at Cowley Brook Farm, Higher Road, Longridge, PR3 2YX**

### **Structural Condition Survey for Conversion to form Extension to Dwelling**

PSC-1073-CA

April 2026

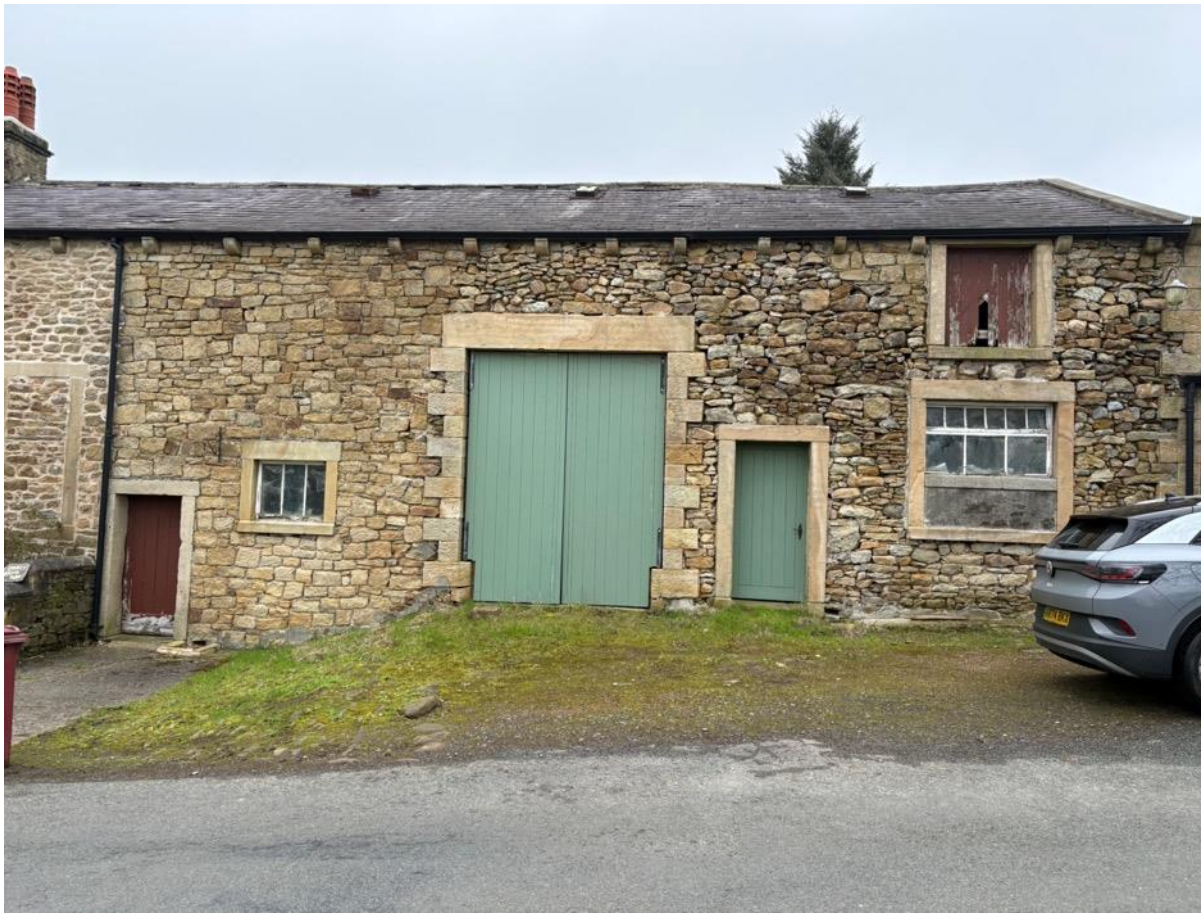
house. There are no signs of previous or ongoing movement but areas of the elevation are slightly out of plumb. The stone lintel over the main door is in good condition (photo 18). The main barn section has 3 window openings plus the main barn door and two further doorways (photo 1). The timber to the doorways is in a reasonable condition but the windows are in a poor condition. This section of the elevation has the benefit of guttering and downspouts which are in a reasonable condition.

Viewed externally, the main barn roof appears in reasonable condition with no sign of damage or slate loss, but some signs of deflection (photos 1 & 23).

Photo 1 - South West Elevation

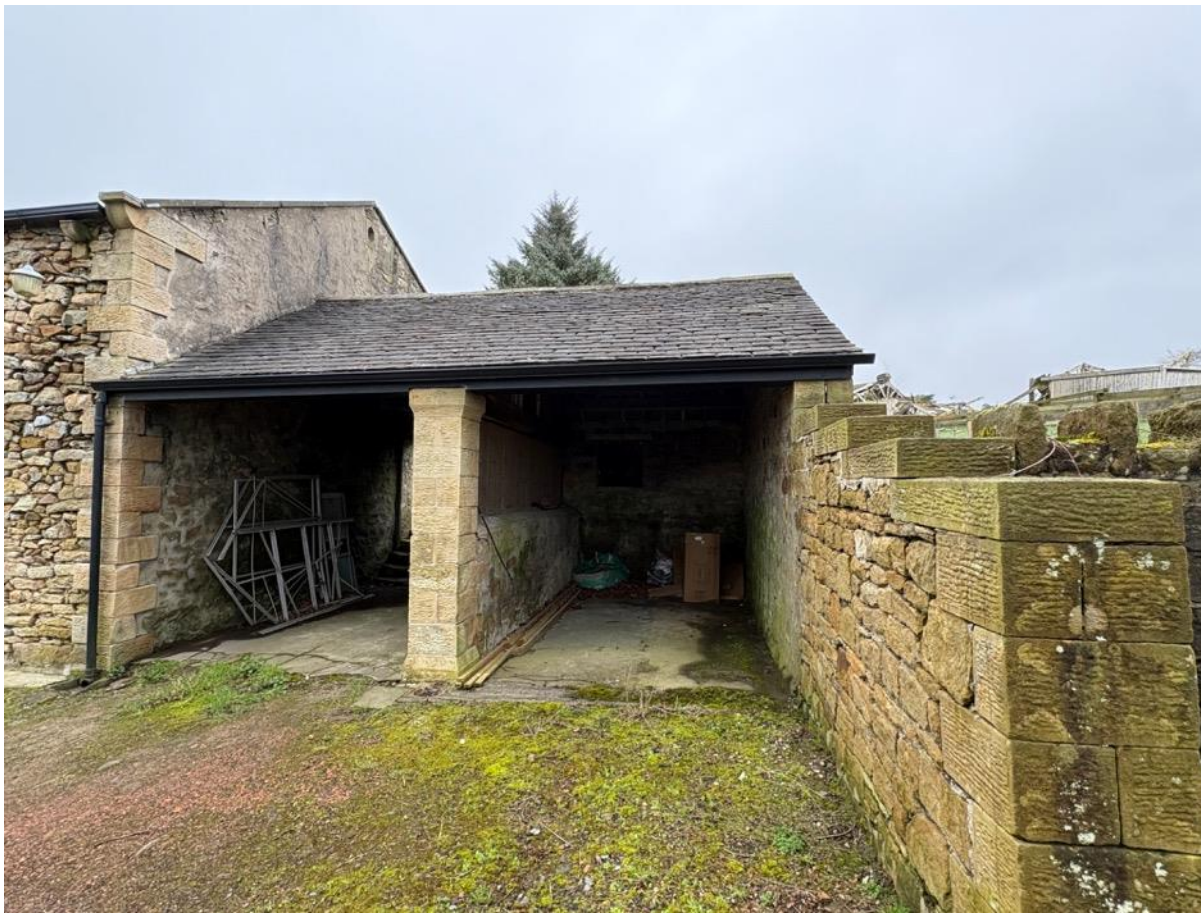
The twin garage is adjacent to the south-east gable (photos 5 to 10) and is likely a later addition. The stonework to this building is in a good condition and the garages have the benefit of guttering and downspouts which are in a reasonable condition. Internal inspection shows a concrete floor with some cracking evident but no sign of major movement or failure. The roof is slate sitting on under boarding supported by timber rafters and purlins (photo 10). There are signs of water ingress but the timber appears to be free from major signs of rot or infestation. The roof slates and ridge tiles are all in place and in a reasonable condition. Photo 19 shows the rear north-east elevation to the garage area. This is built in random stone and acts as a retaining wall to the higher ground behind. The elevation is plumb, well pointed and has no sign of movement. There is a single opening at the centre. The roof slates are in a reasonable condition and the elevation has functioning gutters and downspouts.

Photo 5 – South West Elevation – Open Garage/Storage at South East End

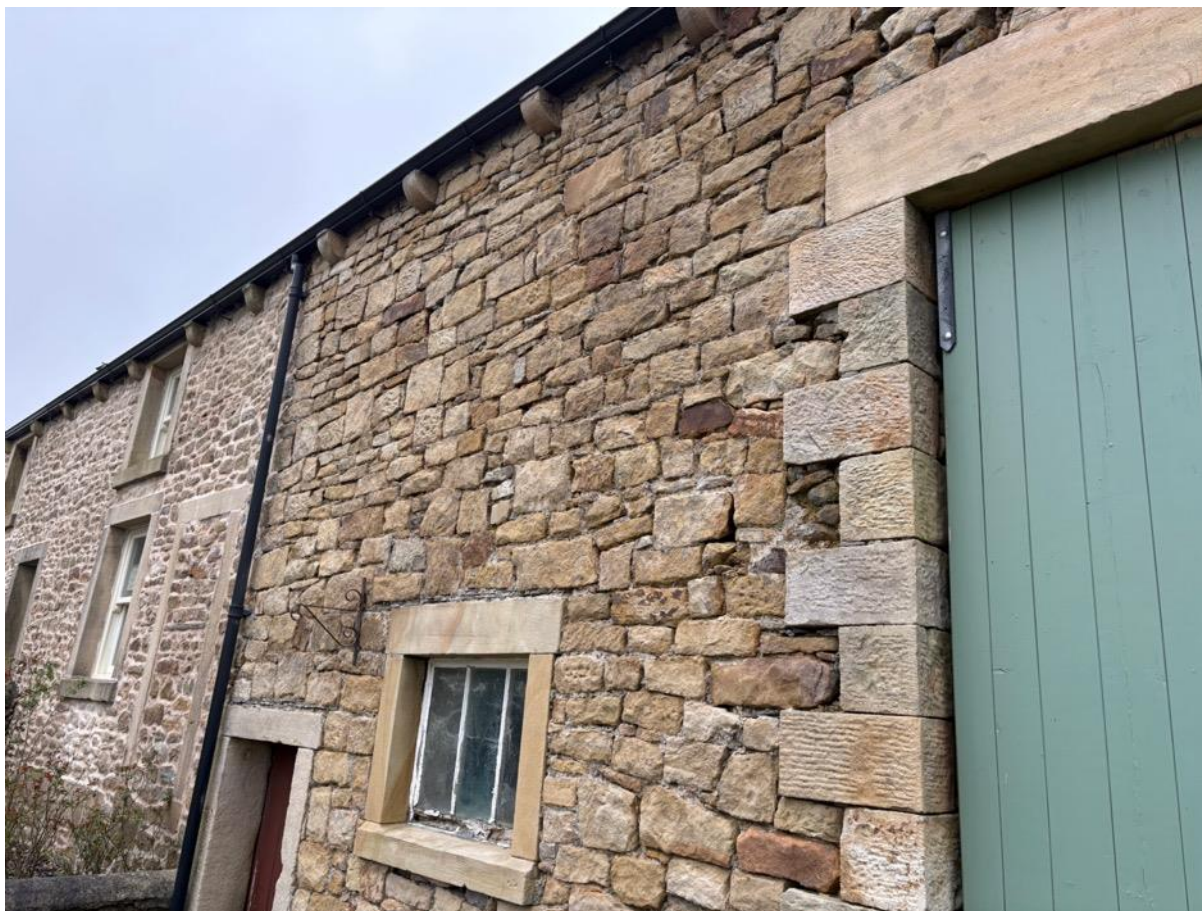
This elevation is in two sections covering the main barn and the twin garage on the gable. The walls are built in random sandstone and are 450mm thick. The walls appear to have been cleaned and had the pointing picked out. The section to the south-east above the main door and to the east of this appears to be of poorer quality stonework and the door jambs, sills and lintels sit proud of it (photos 11 to 16). This area may have been built later and possibly rendered. The stonework adjacent to the house is more regularly coursed and of much better quality (photos 16 and 17) and may have been built earlier as it sits at the same level as the

Photo 16 - Stonework to South West Elevation

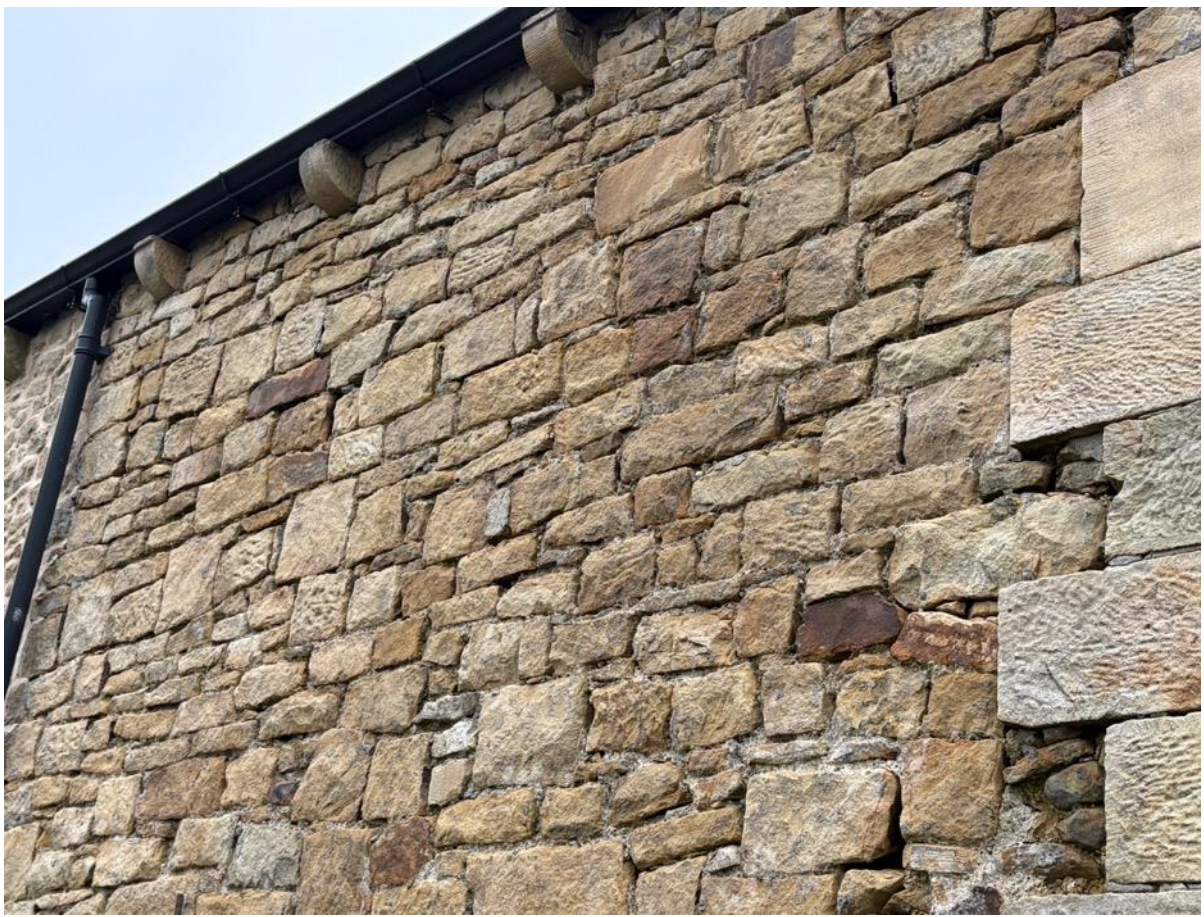
Photo 17 - Stonework to South West Elevation

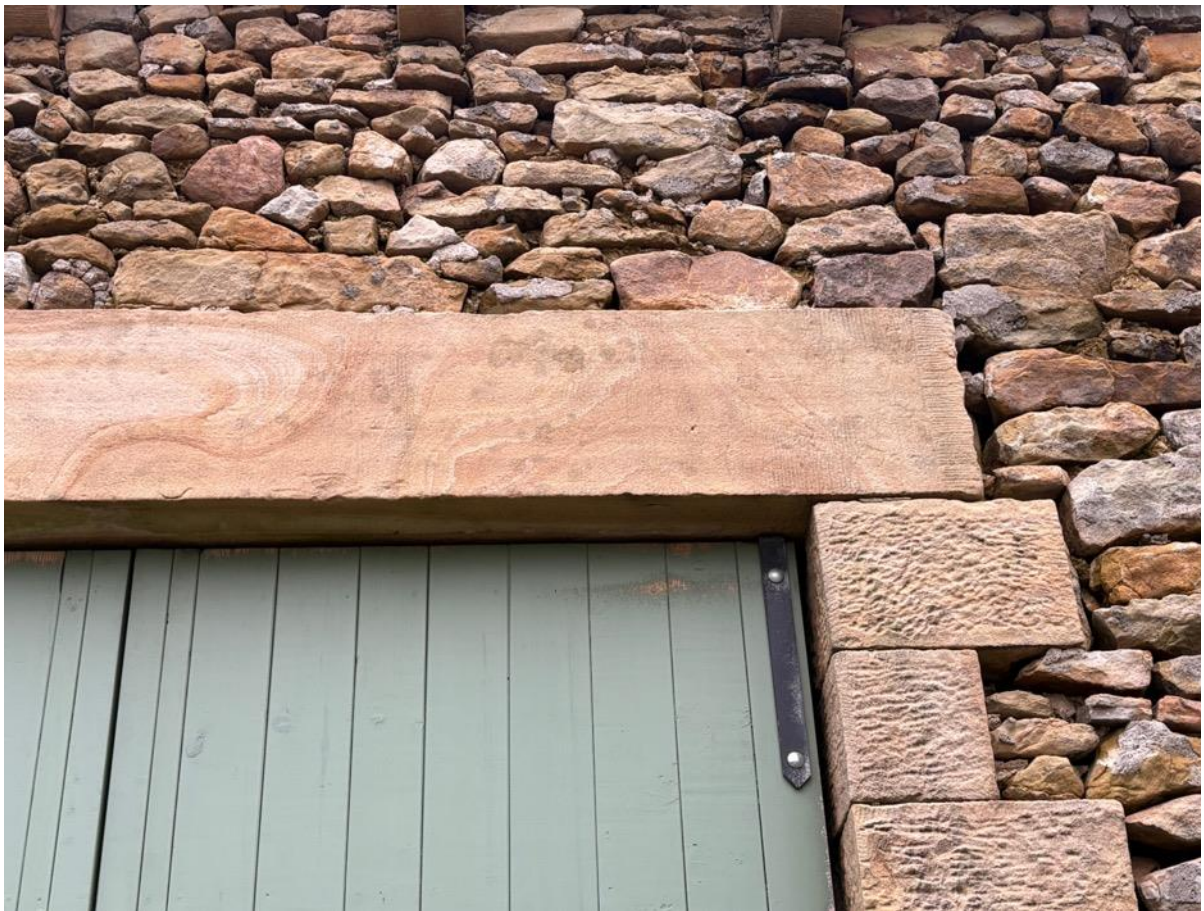
Photo 18 – Stone Lintel to main door to South West Elevation

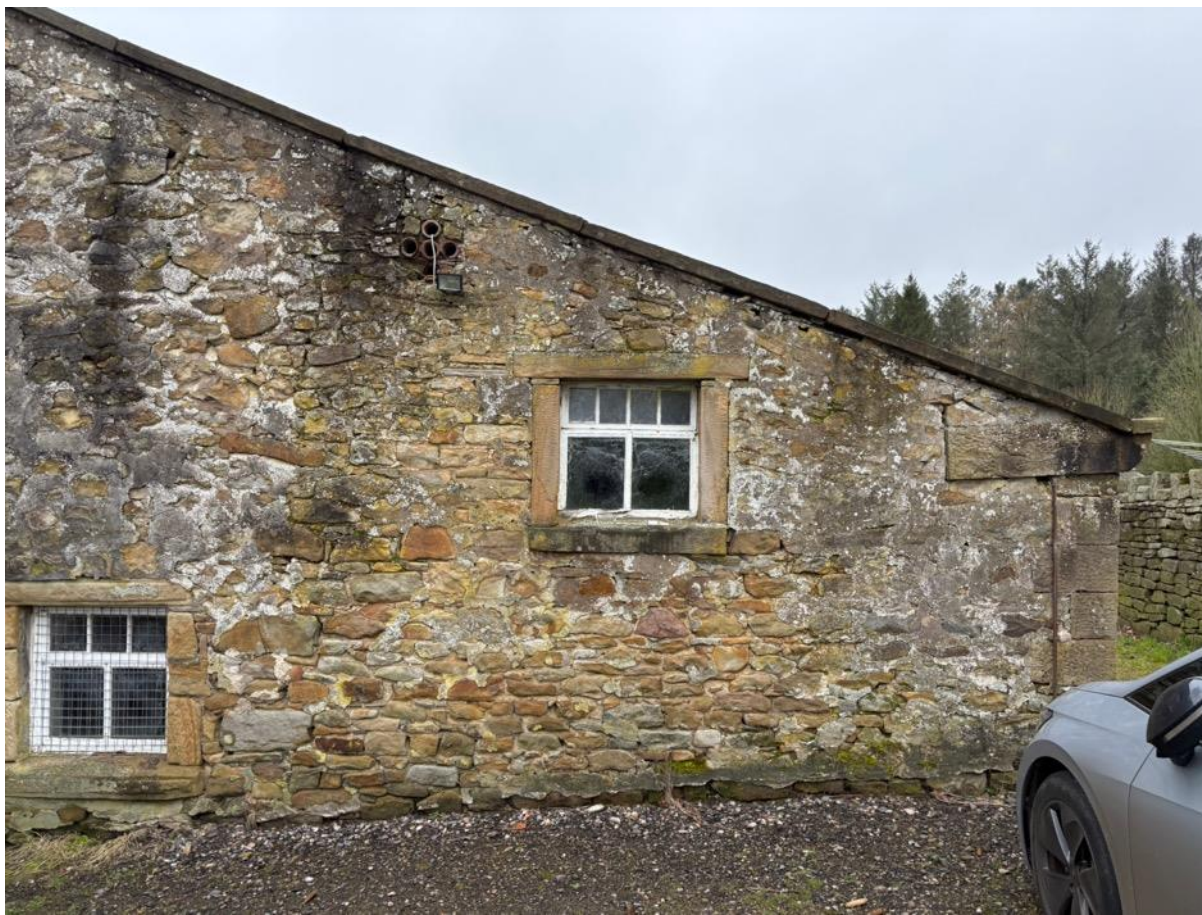
This elevation, 450mm thick, is plumb and free from any sign of movement. The wall is reasonably pointed with lime mortar and has not been picked out or cleaned as was the case to the front elevation. The gable extends to accommodate the rear lean-to section and there are two window openings, one to the loft of the main barn and one to the lean-to section (photo 21). The timber to these windows is in poor condition.

Photo 21 – South East Gable

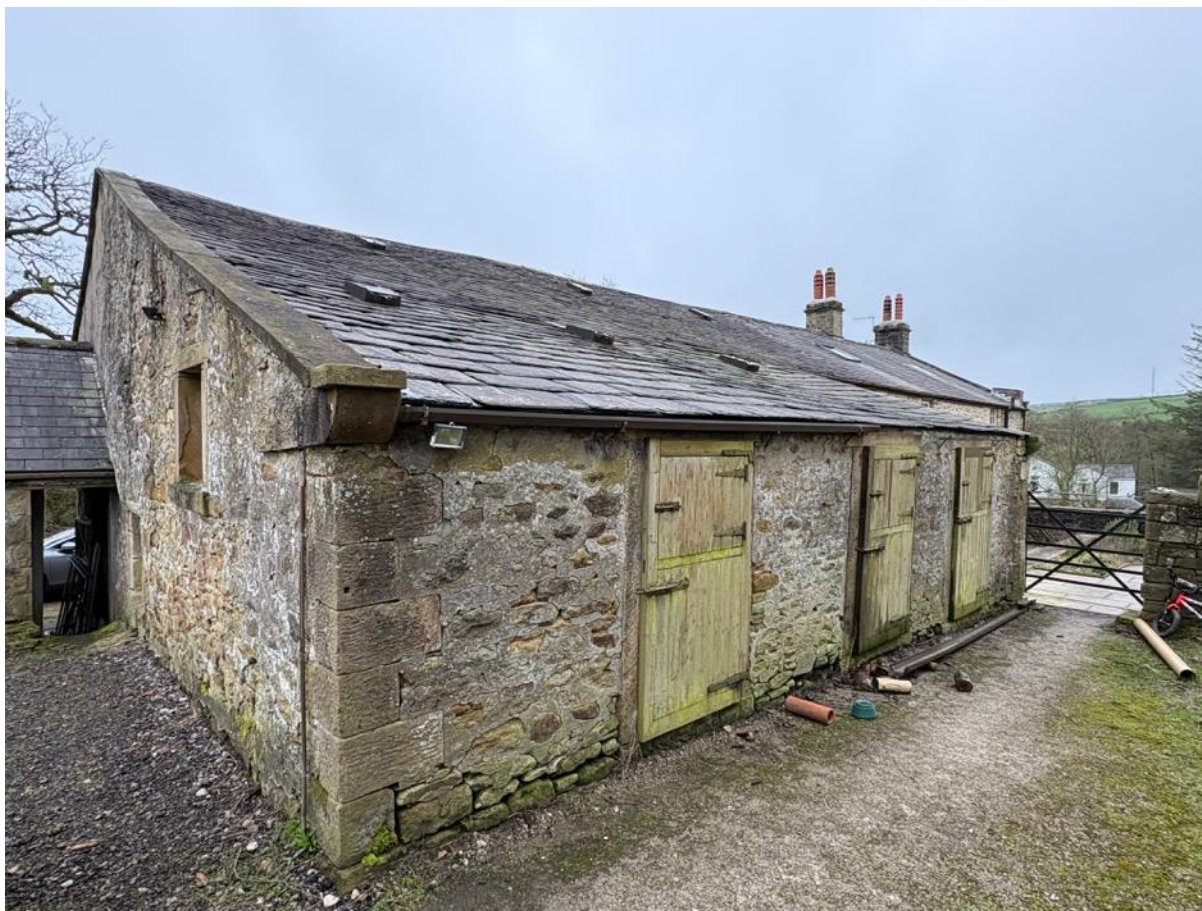
This elevation is a 300mm thick random stone and has been built as three separate stalls or stables, each with its own stable door. The wall is plumb, reasonably well pointed and free from signs of movement. There is some low-level damage to the stonework, probably from water flows/ingress due to poor drainage. The timber doors are weathered but in reasonable condition. The elevation has functioning gutters and downspouts.

Photo 22 – North East Elevation to single storey rear section

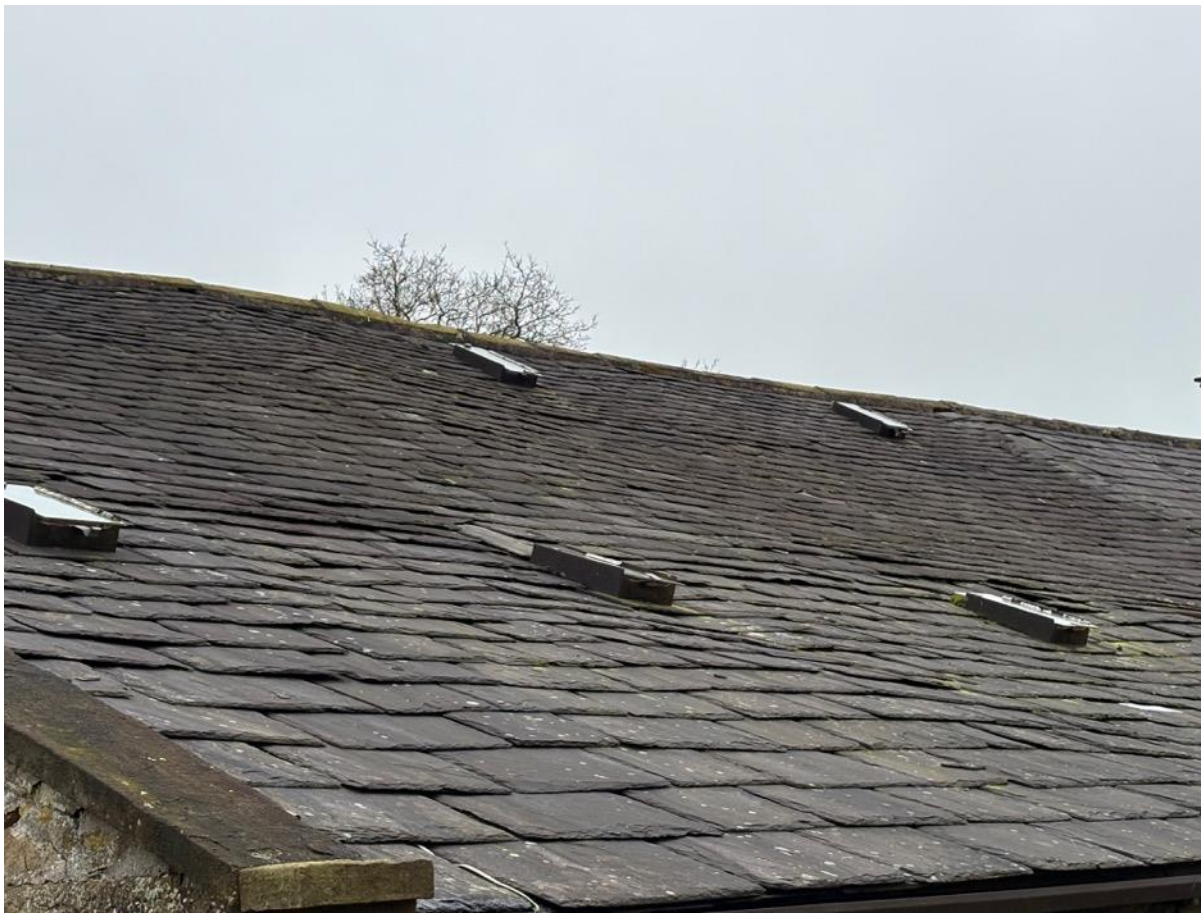
Photo 23 – Roof to North East Elevation

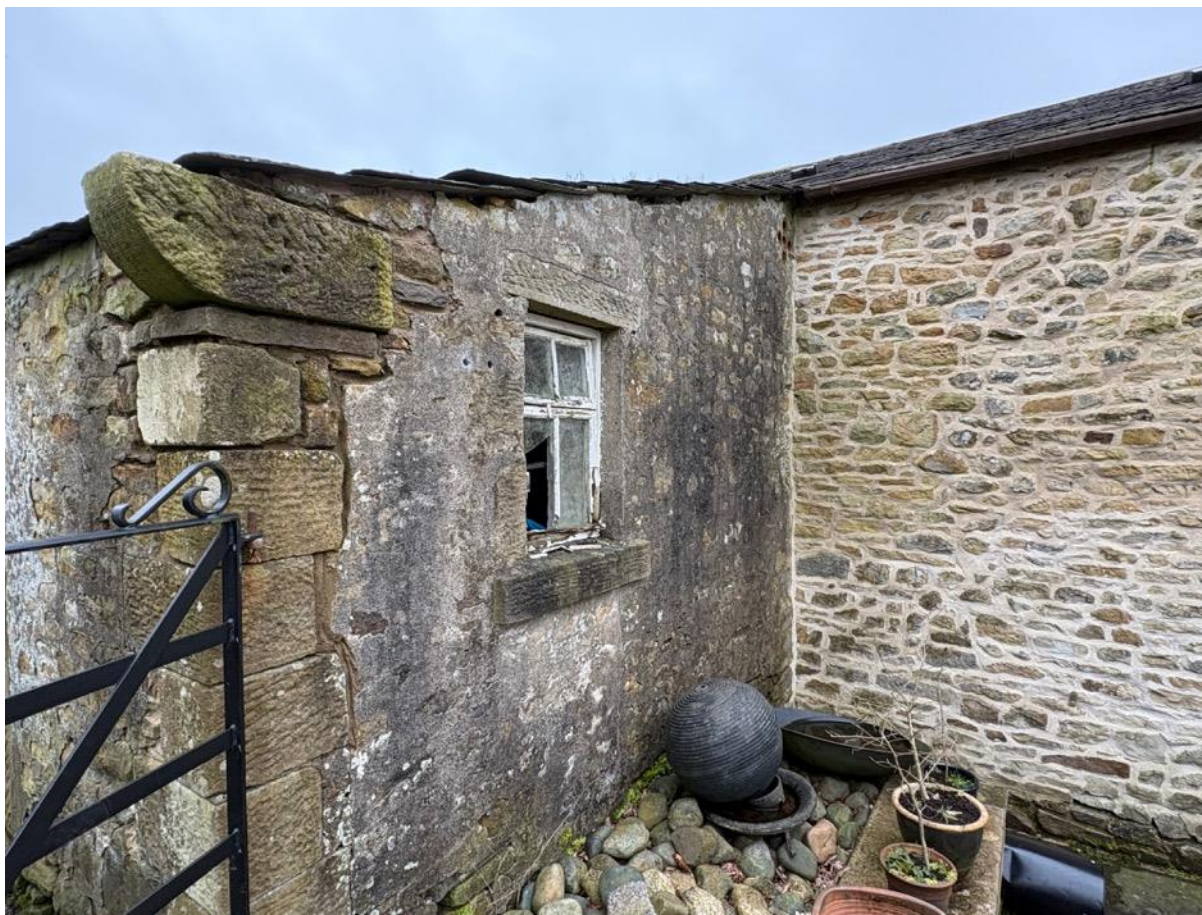
This elevation is a 300mm thick random stone wall with a single window opening. The wall is plumb, reasonably well pointed/rendered and free from signs of movement. The timber window is in a poor condition.

Photo 25 – North West Elevation or rear single storey section

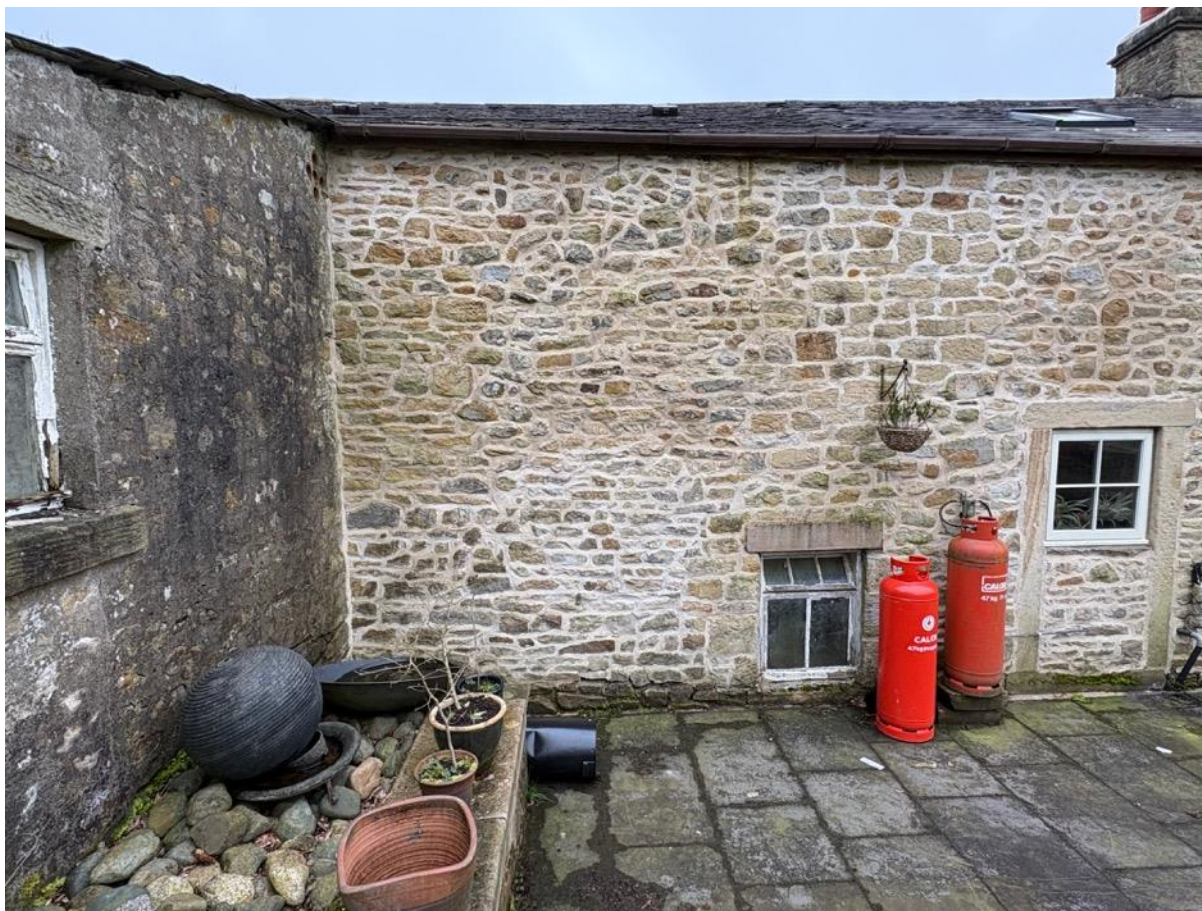
This wall is a 450mm thick random stone wall with a single window at a low level. This area of wall has been recently re-pointed to a good standard and is free from any sign of movement. The timber window is in poor condition. The photo indicates that the lower levels of the main barn rear wall act as retaining walls to the higher ground behind.

Photo 26 – North East Elevation adjacent to farmhouse

As noted above, the rear wall to the main barn acts as a retaining wall and this will need to be assessed for any required tanking detail during detailed design. In addition, the main barn has floors at differing levels and the new floor slab will need to be designed and detailed to take this into account.

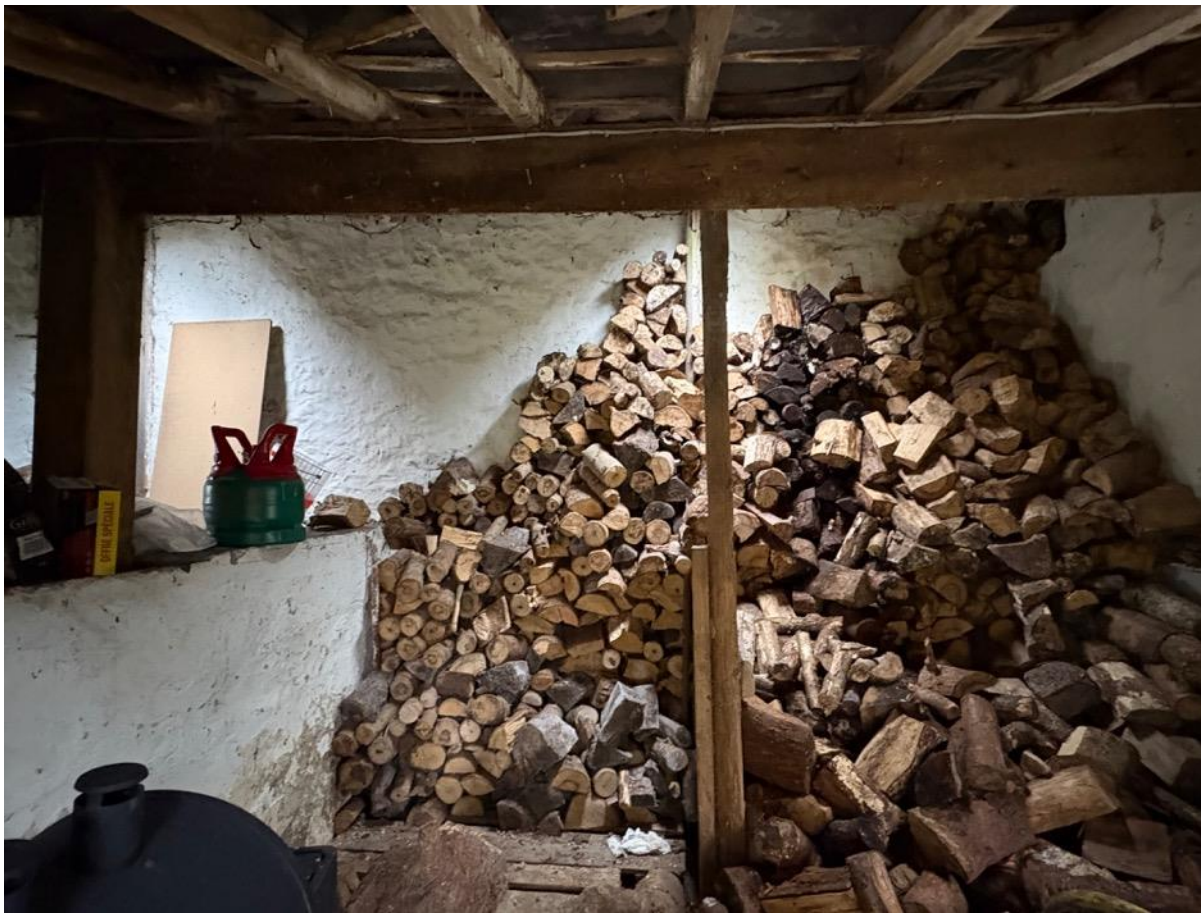
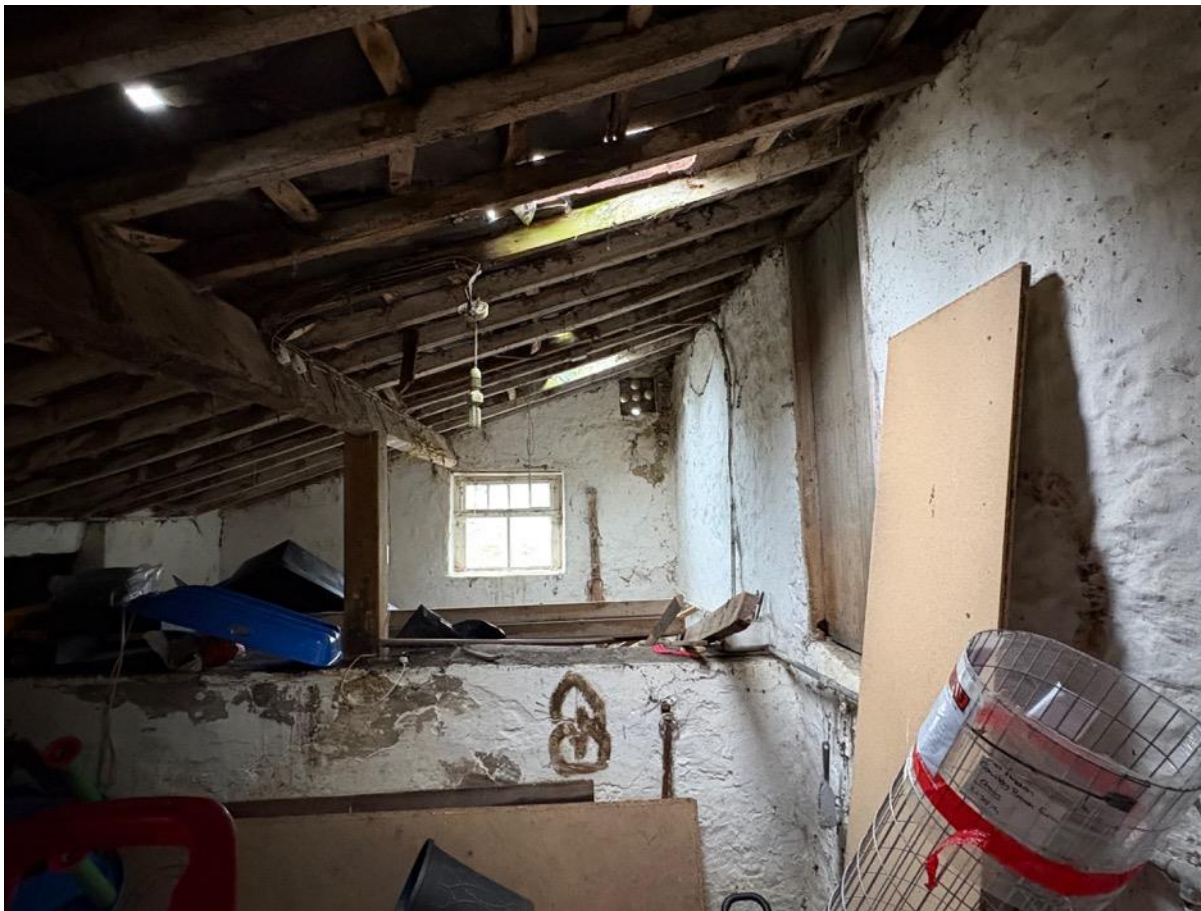
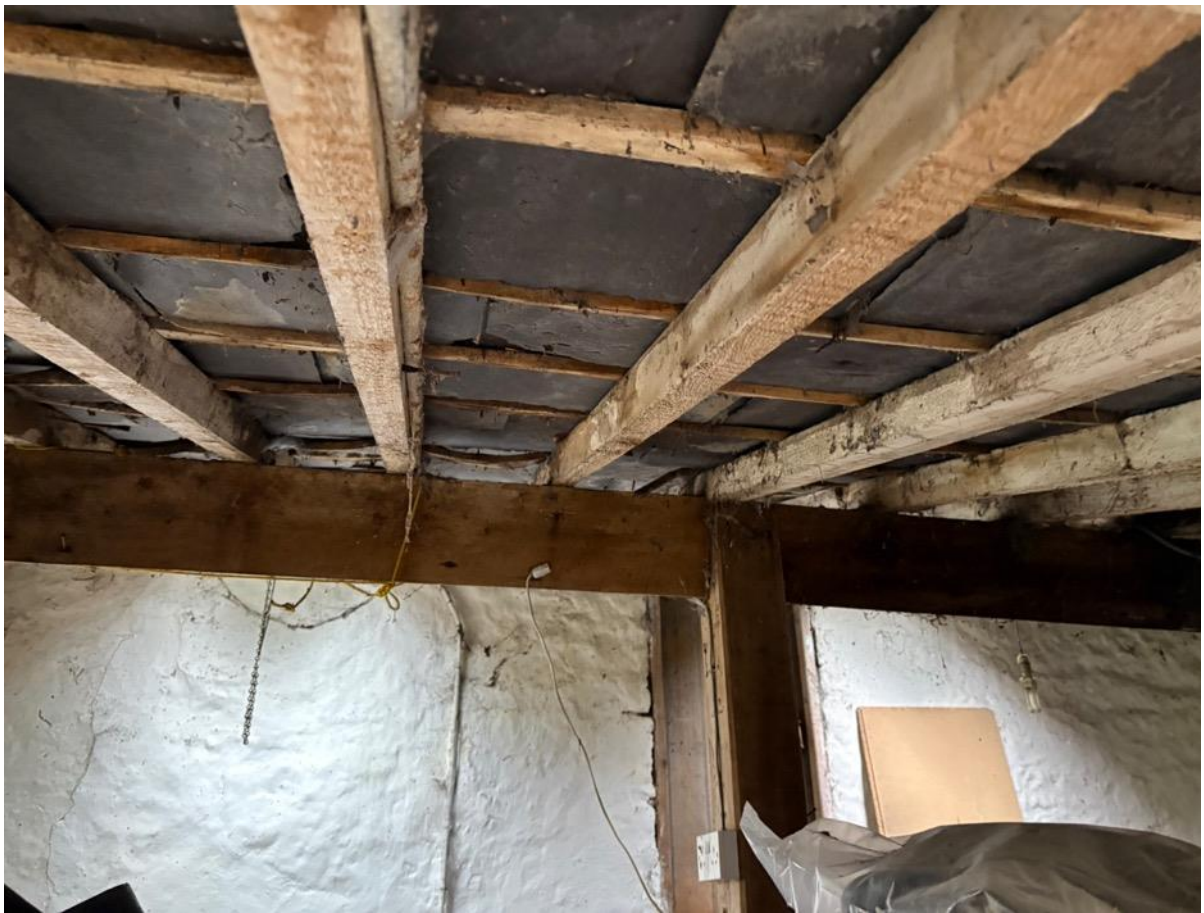
This section of the building consists of three stalls with dividing walls. All the walls are limewashed/whitewashed and are in good condition with no sign of significant movement. The timbers to the roof appear free from signs of rot or infestation. The solid concrete floor was in a reasonable condition where visible.

Photo 27 – Internal rear single storey

Photo 28 - Internal rear single storey

Photo 29 - Internal rear single storey

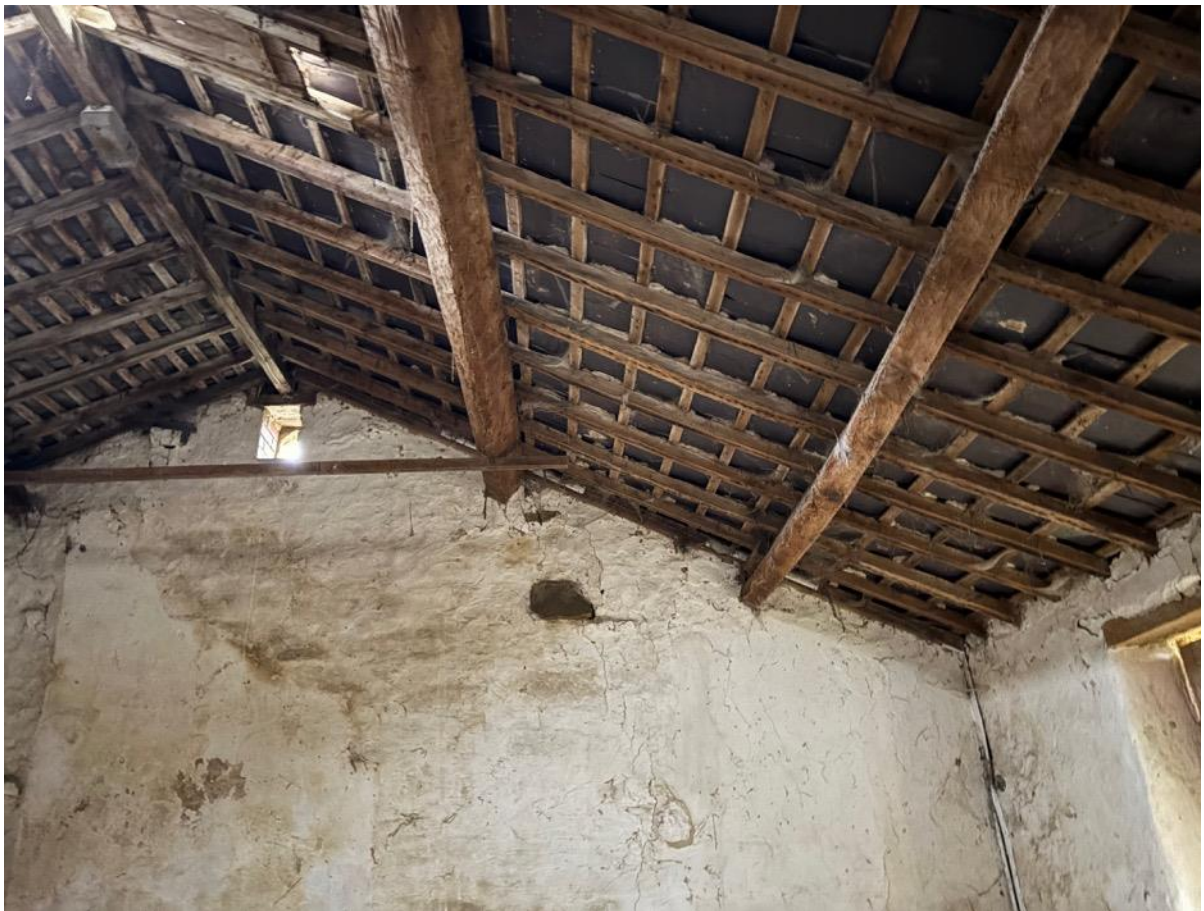
The timber to the roof truss, purlins and rafters all appeared in a reasonable condition with little or no sign of rot or infestation (photo 34). The solid flagged or paved floors, where visible appeared to be in a reasonable condition.

Photo 34 - Internal main barn roof

The existing trusses and purlins appear to be free from signs of rot or infestation but others have definitely suffered damage. Any timber retained should be assessed by a timber specialist, with regard to rot and infestation. All retained timber should be treated against rot/infestation and an indication of residual section given for structural purposes. All retained timber to be used structurally should be checked for structural adequacy.

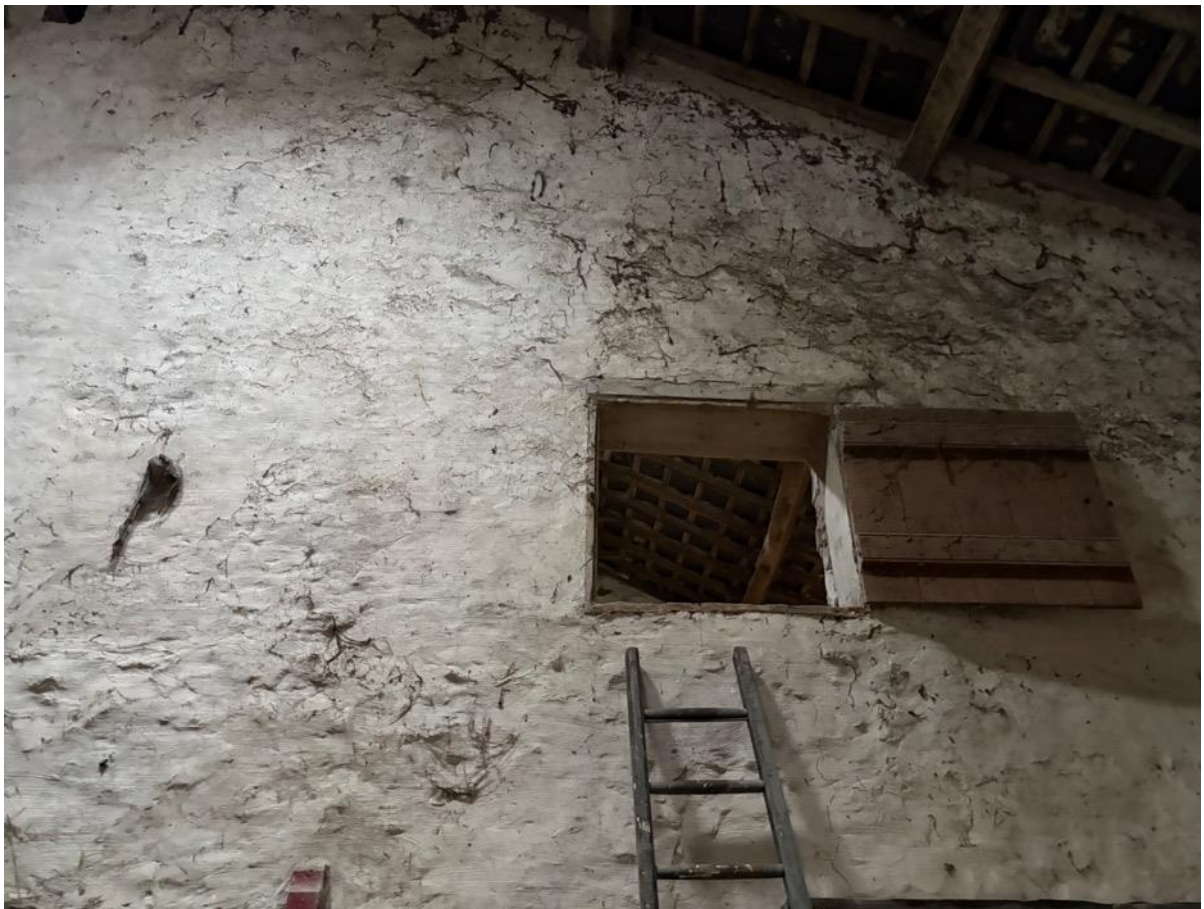
This larger area of the barn is full height in the central area at the main doors. To the north-west of this the ground floor is at a lower level and a mezzanine floor has been built on brick piers (photo 39). To the south-east of the main door there is full height masonry wall (photos 36 and 38) which is plumb and in reasonable condition with no sign of movement. The external walls are all reasonably plumb, well pointed and free from signs of movement. The rear wall where it retains higher ground is in good condition and there were no obvious signs of damp or water ingress. The main barn loft is south-east of the dividing wall (photos 32 to 35) and inspection of the walls at this higher level indicated they are in a reasonable condition.

Photo 36 - Internal main barn – Dividing wall main barn

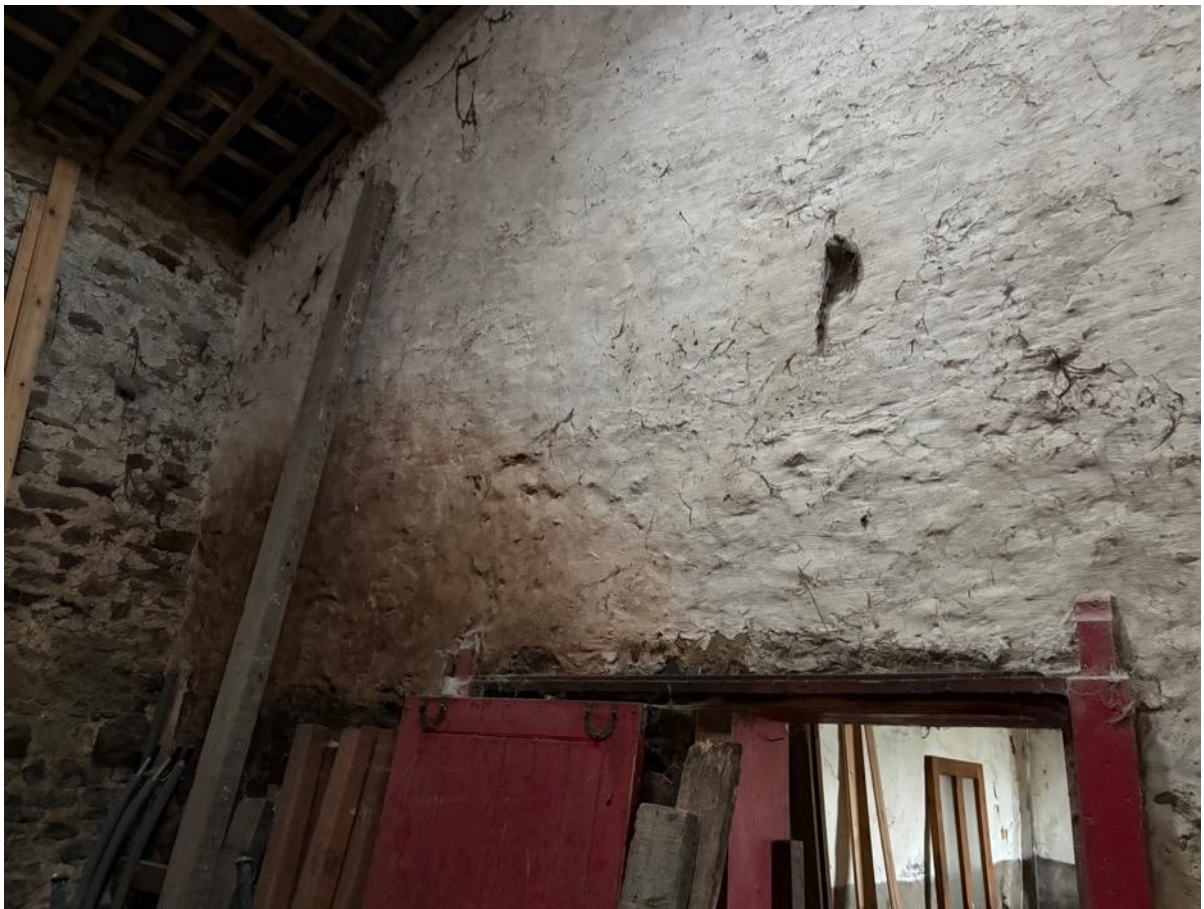
Photo 38 – Main barn dividing wall

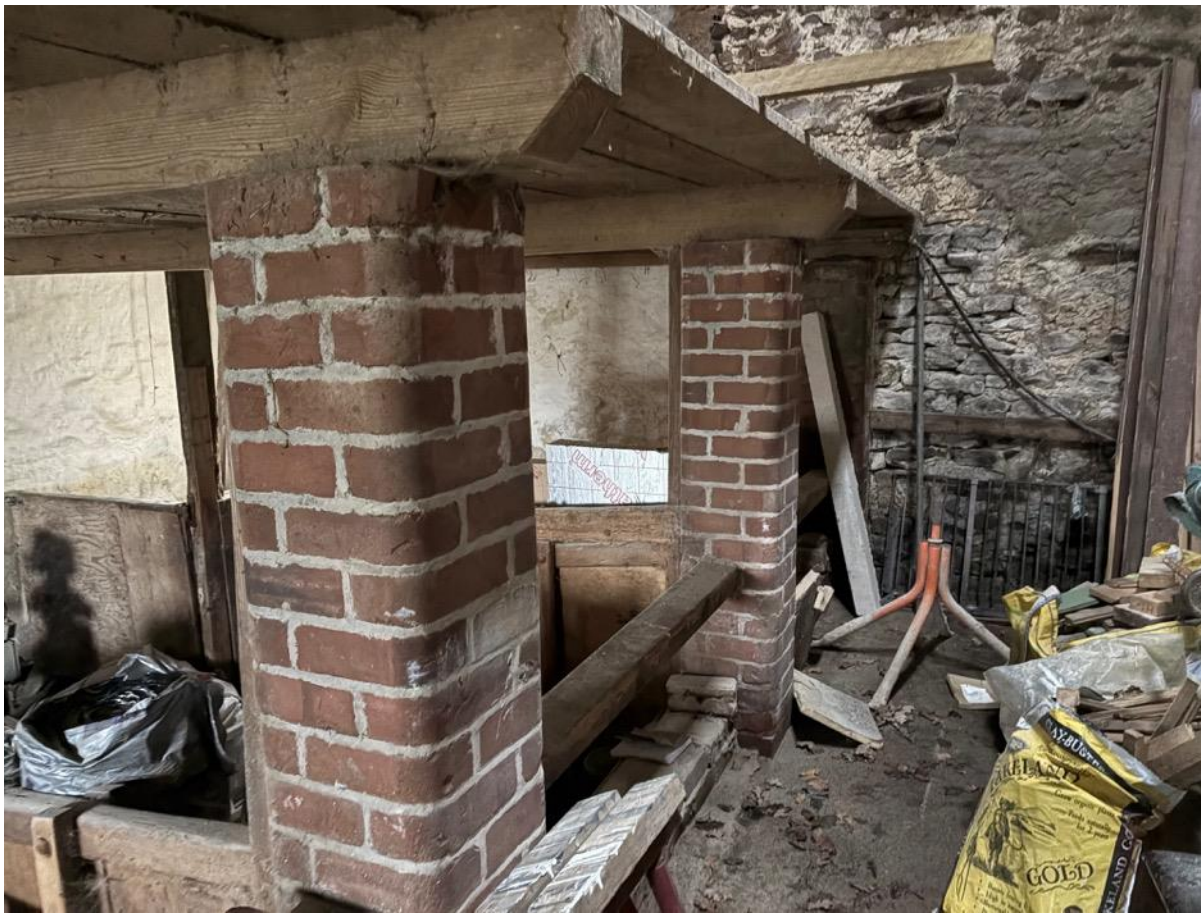
Photo 39 – Mezzanine with brick pillars in main barn
