# **CONDITION ASSESSMENT OF BEECH TREE LOCATED AT REAR OF 1 ST DENYS CROFT, CLITHEROE. BB72BY**

**Client:** Mr and Mrs A Mckenzie 1 St Denys Croft, Clitheroe (The resident property owners)

**Date of Tree Inspection:** 31.7.26

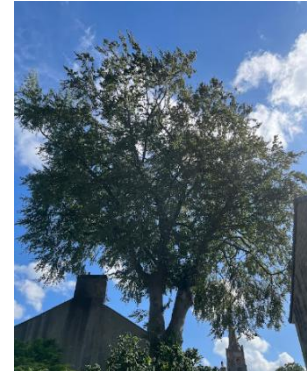
4. The canopy was in full growth at the time of the branch failure and the inspection and was **significantly different** to its condition when last inspected. There was an obvious lack of twig extension and a marked dieback shown by the canopy thinness as shown in the photo. The lower fork showed no signs of an included bark union but the ivy cover makes inspection obstructed as in the 2015 inspection.

5. The root plate was inspected and appeared free from any Ganoderma fungal fruiting bodies and there is no past evidence of Meripilus or the fruiting bodies of other pathogens. Hammer tests around the root plate and lower indicated structurally sound timber.
6. The situation indicates Summer Branch Drop (SBD) the cause and significance of which has been debated by the Professional Community for over 30 years.

The tree has no visible signs of structural defects or internal butt decay or root dysfunction. Ground and tree canopy desiccation is evident and beech have always been reported as surface rooters and therefore likely to summer in draught conditions. The failure of the limb raises significant doubts as to whether the tree should be retained in terms of the likelihood of a repeated limb or branch failure. The current and possibly future failure places responsibility to explain the problem to their near neighbours who will have views on the tree and its failure potential onto their roof or garden.

The tree should be felled flush to ground and the stump treated with Eco Plugs inserted according to the manufacturer's instructions.
