LIGHTWORKS  
STAINED GLASS

HORROCKSFORD OLD HALL FARM, CLITHEROE

HERITAGE LEADED LIGHT GLAZING: REPORT

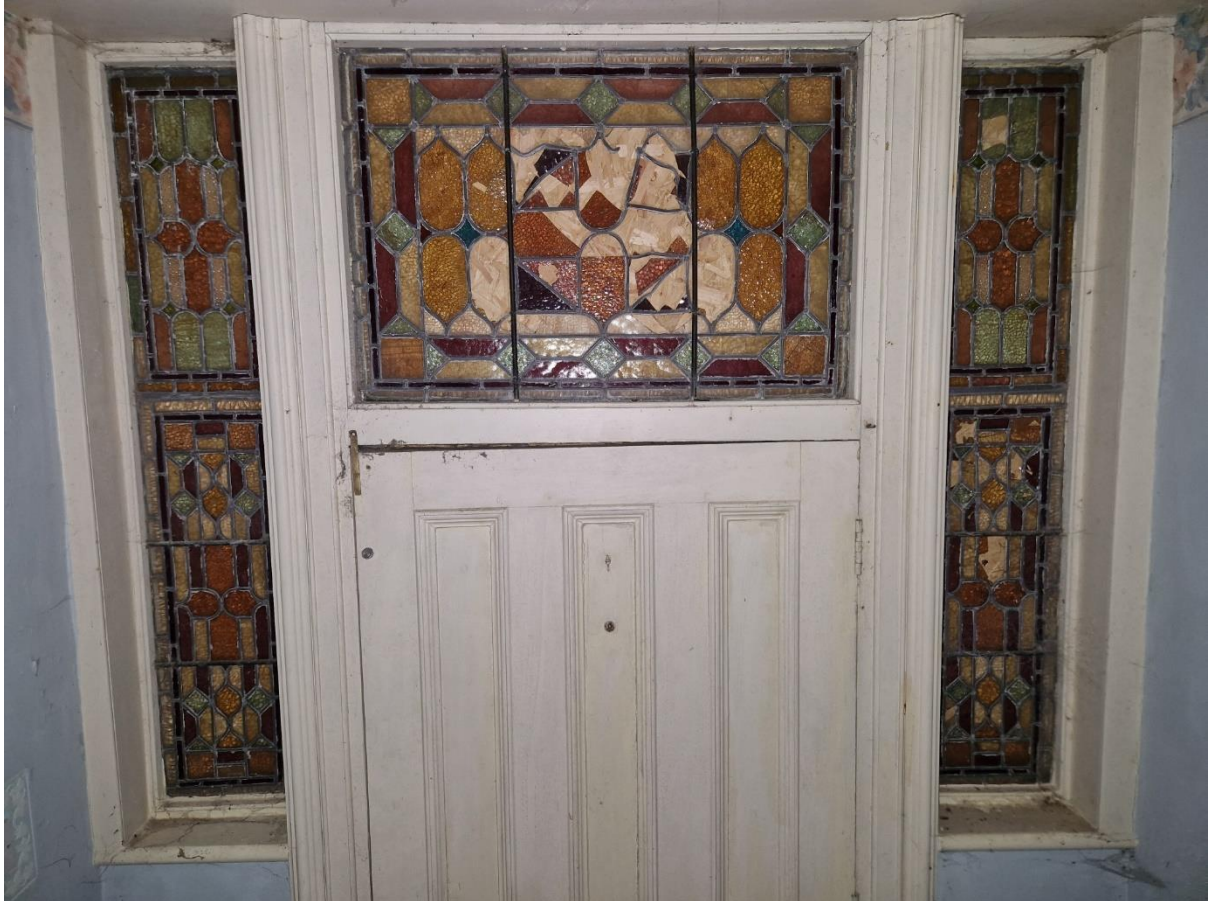
fig. 1: Full scheme (2 x Sidelights & 1 x Transom panel)

The glazing comprises a set of three panels of hand-crafted leaded glass: 2 x sidelights and 1 x transom panel (see fig.1).

Sidelights measure 270 x 1450mm and are supported internally on 2# 10mm diameter saddle bars positioned horizontally at approx. 300 & 600mm from the sill. Transom panel measures 935 x 630mm and is supported internally on 2# 10mm diameter vertical saddle bars.

Design: Traditional Victorian Geometric in style and executed in a mixture of pale tinted and textured "Cathedral" type glass (in predominantly amber, pink, green and clear). Glass is unpainted therefore would be technically described as leaded lights or leaded glass rather than stained glass.

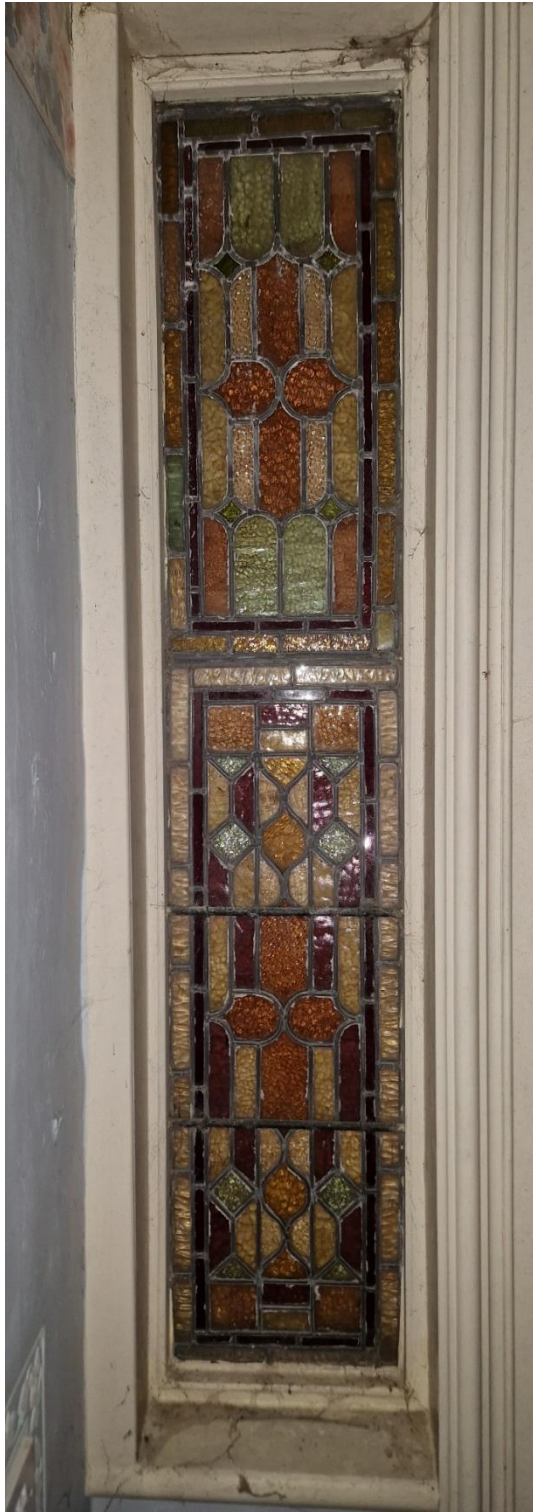
fig. 2: L/H Sidelight

This panel appears to be in good overall original (undamaged) condition with no visible glass or lead matrix damage (see fig. 2).

*NB: While not damaged, the L/H sidelight may potentially be removed for studio based restoration (re-leading) on the grounds of a) aesthetics (it will appear visibly different in its original condition when compared to the restored transom and R/H sidelight) and b) natural lifespan (at over 120 years old minimum, the natural waterproofing properties will be at or approaching the end of its natural lifespan potentially putting it at risk of water ingress and/or accelerated structural deterioration).*

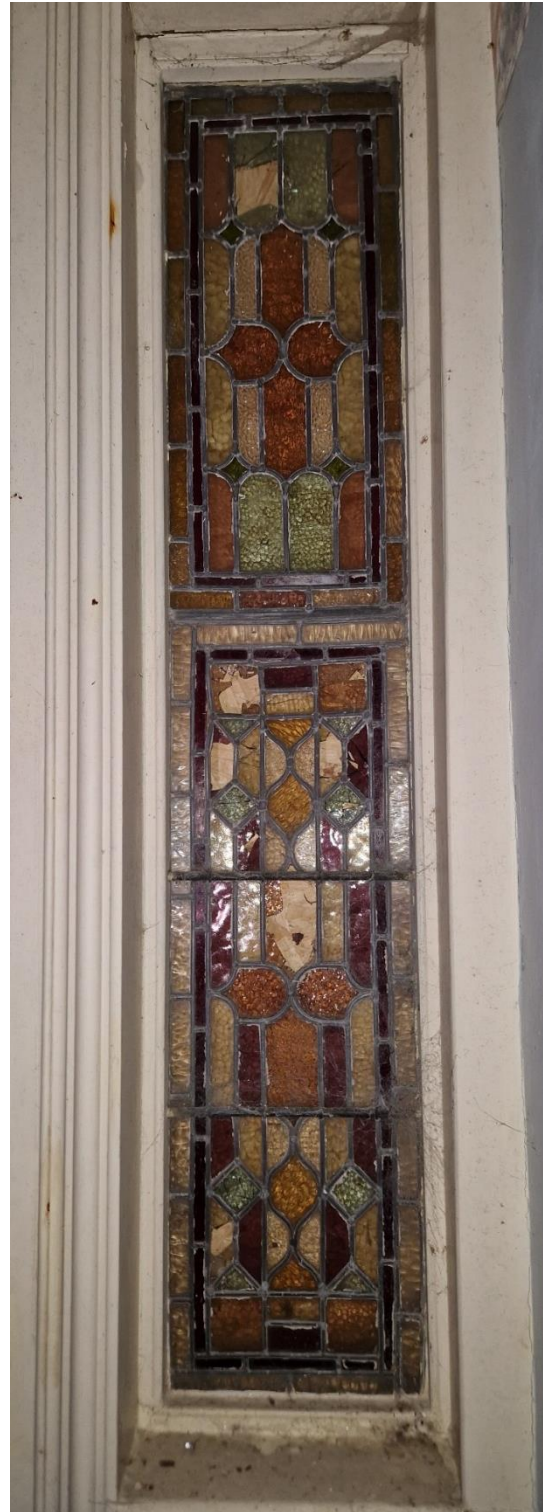
fig 3: R/H Sidelight

Considerable visible damage due to impact/strike concentrated across the lower half of the panel but with some additional localised damage at the head. This has resulted in damage to both the glass and lead matrix with approximately 25% of glass fractured/shattered and significant twisting/buckling/bowing of lead matrix (see fig. 3).

Lightworks propose that as a minimum, the internal R/H sidelight and transom panels will require removal from site to facilitate studio-based repair, restoration and conservation works before being re-installed back into their original settings.

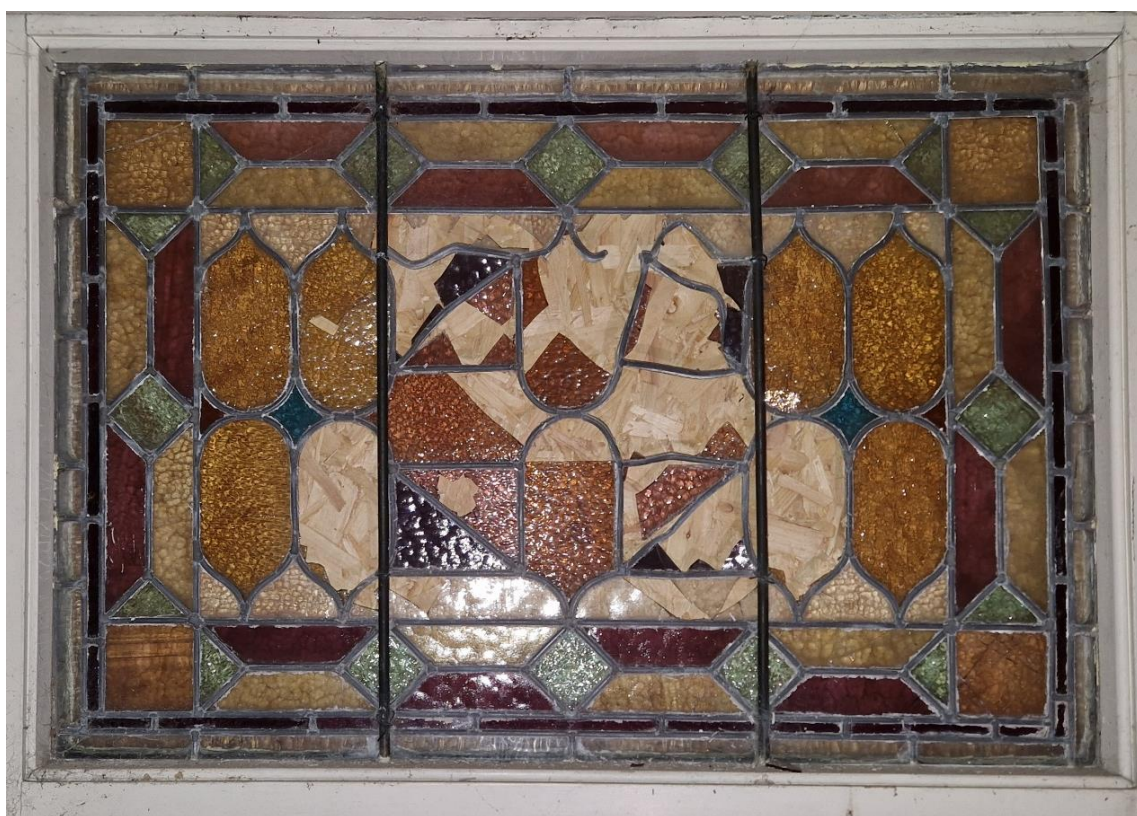
fig 4: Transom

Considerable visible damage due to impact/strike concentrated within the central area. This has resulted in damage to both glass and lead matrix with approximately 45 – 50% of glass fractured/shattered and significant twisting/buckling/breaking of lead matrix (see fig.4).
