# STRUCTURAL CONDITION SURVEY

EXISTING BOUNDARY WALL

THE OLD STABLES

LOWERGATE

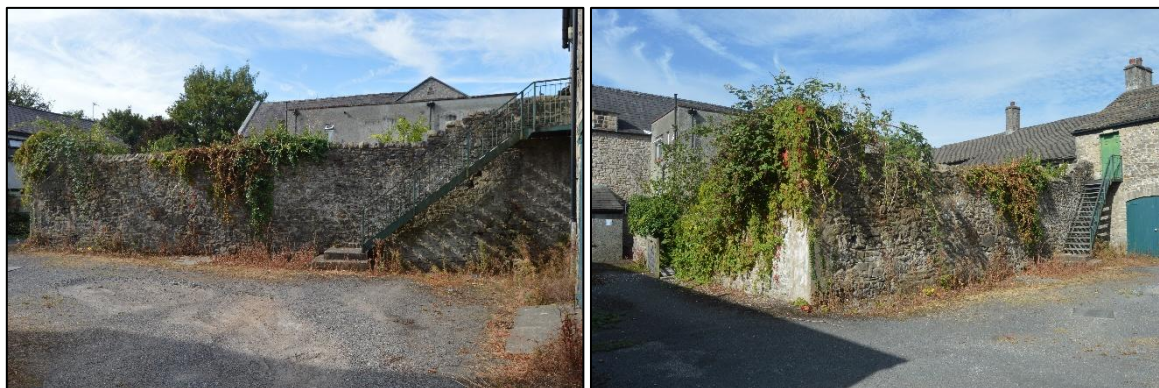
*PL01: Views of the wall from the north east yard area.*

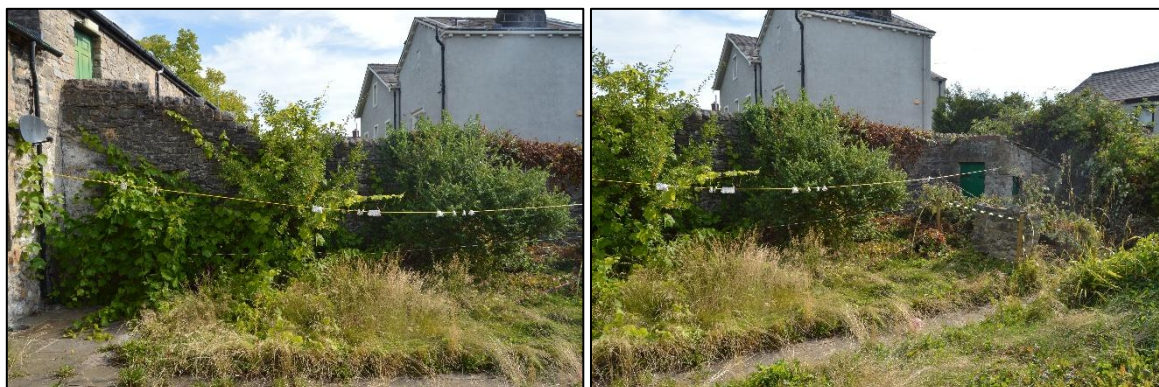
*PL02: Views of the wall from the south west within the garden to No 41 Lowergate.*

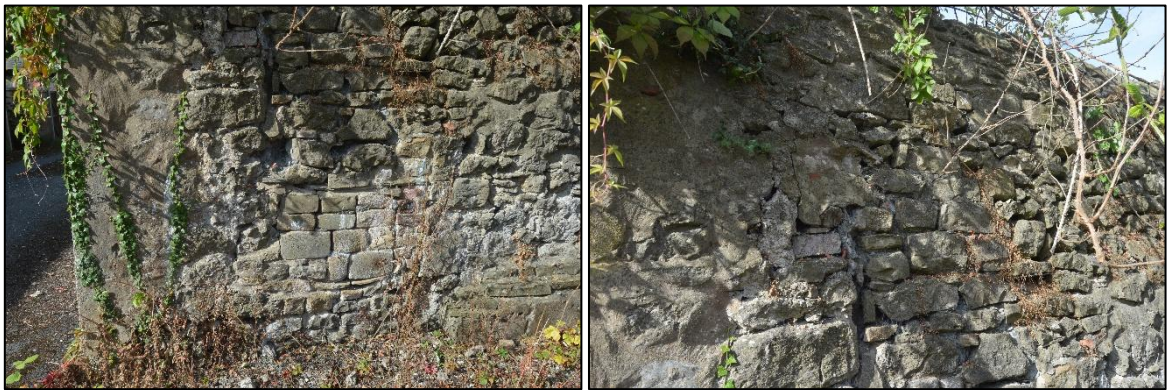
- a) The wall surface undulates along its length with bulges noted suggesting some possible separation of the stonework leading to isolated areas of movement to the stonework.
- b) Large areas of perished mortar were noted which leaves the stonework poorly consolidated and susceptible to dislodgement.

*PL03: View of areas of perished mortar pointing.*

The wall exhibits evidence of its continued decline in condition and if not addressed it will continue to deteriorate further. Given the poor condition of the wall, it is recommended that the wall is carefully dismantled and rebuilt. The wall should be reconstructed using modern methods and built off a new concrete foundation whilst incorporating the existing stonework as a cladding. This should be undertaken in accordance with Structural Engineer's details and specification. The wall should be capped with traditional stone copings in order to shed water away from the wall head.

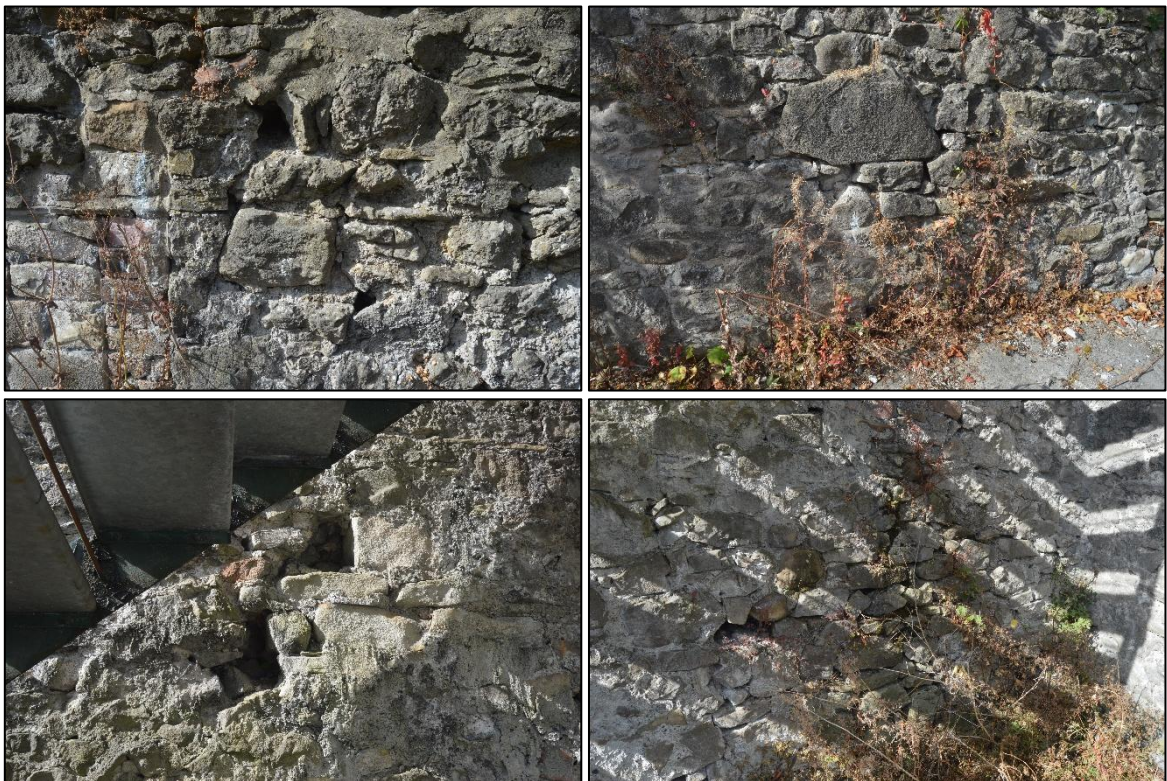
- c) Voids were noted to the wall caused by perished mortar and loose / missing stonework. This results in poorly consolidated masonry and an increased risk of penetrating dampness.

*PL04: View of voids / missing stonework noted to the wall.*

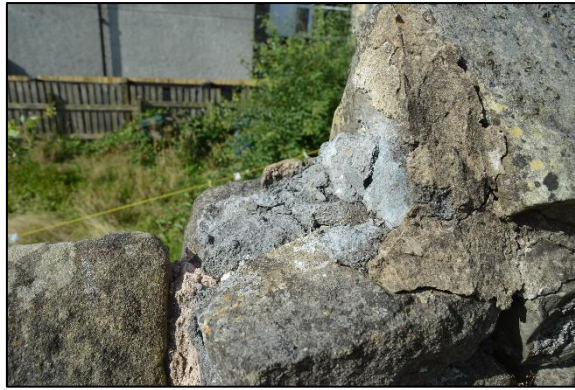
*PL05: View of missing coping to the wall head increasing the risk of penetrating dampness.*

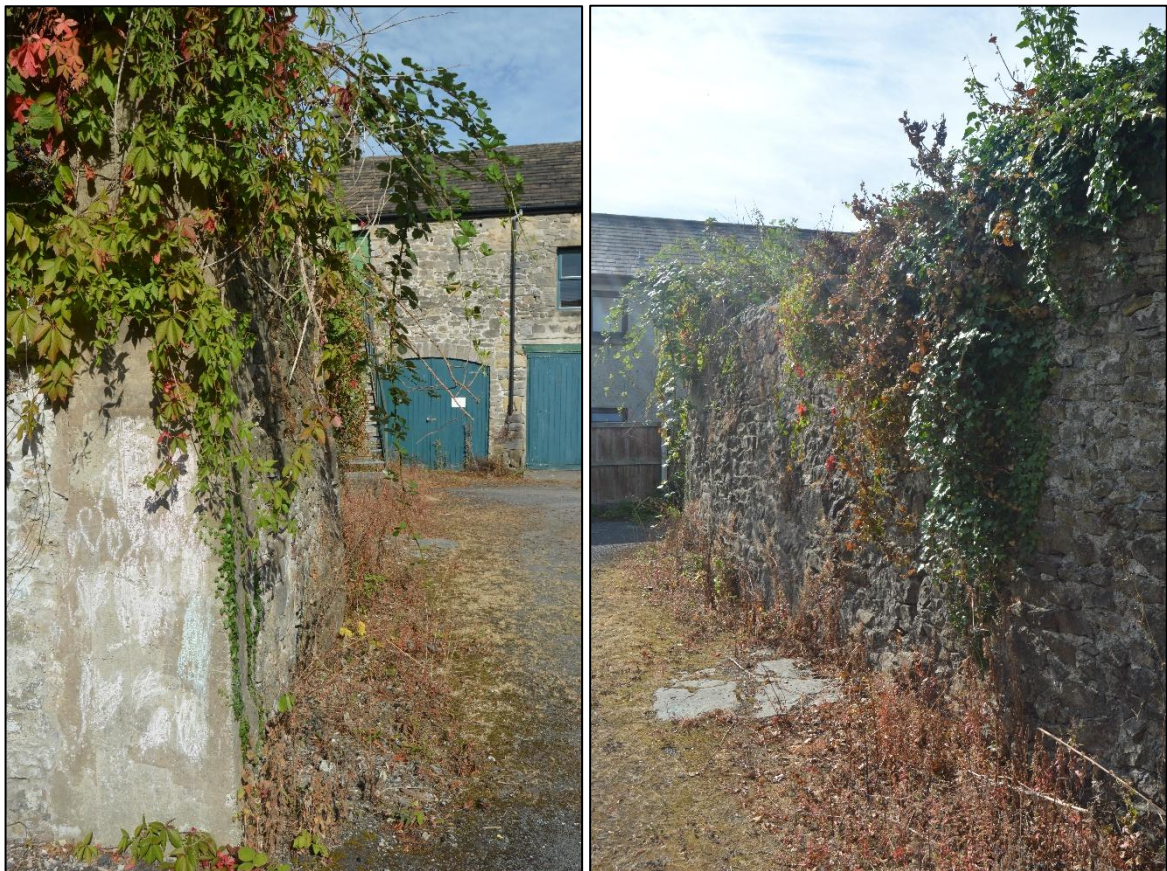
*PL06: View of undulations noted along the length of the wall.*
