Kirk Mill, Chipping, Lancashire

Archaeological Building Investigation

Oxford Archaeology North

August 2013

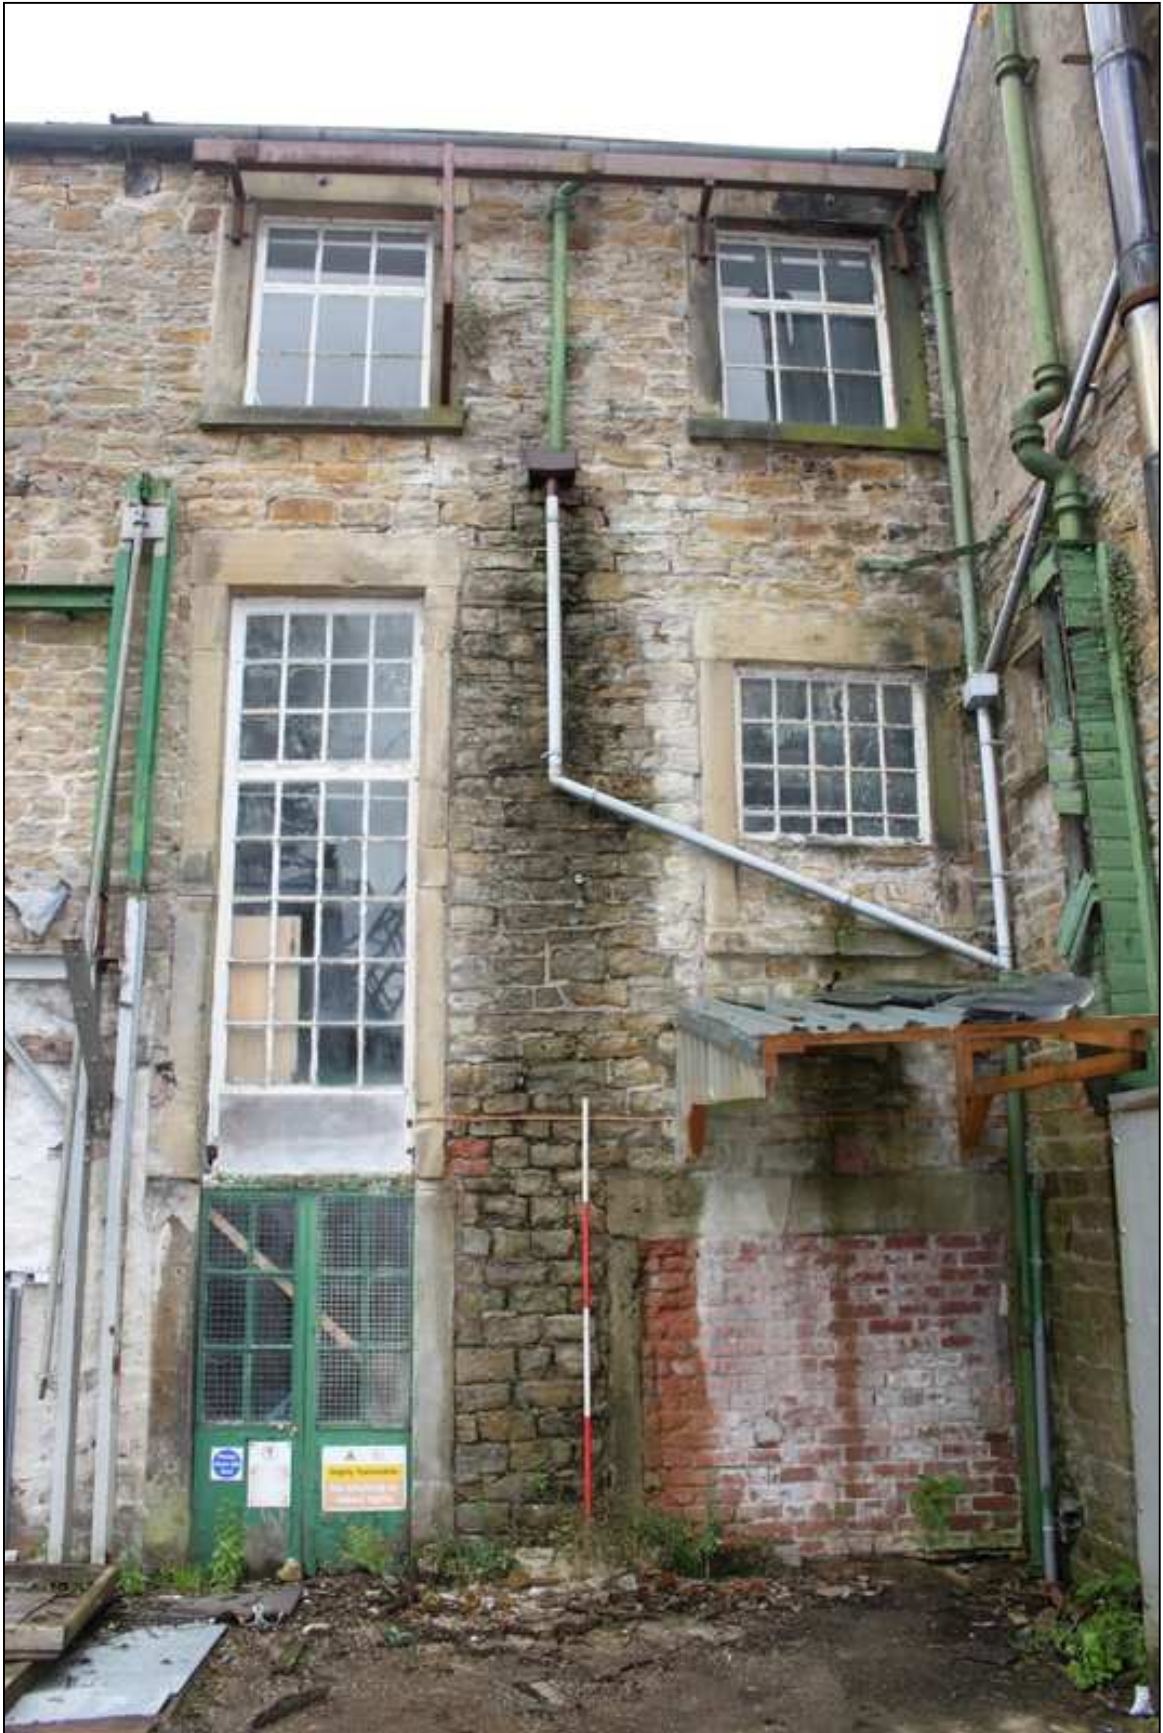
- 3.2.4 The eastern bay of the main façade houses the present waterwheel, and has similar windows to those elsewhere, at first- and second-floor level, that on the first floor having been reduced in height subsequently (Plate 8). It has a wider dressed doorway at ground-floor level, which afforded access directly to the waterwheel, presumably to allow maintenance of the buckets. This doorway was blocked with brick subsequently (Plate 8).

Plate 8: Façade of engine and wheel houses

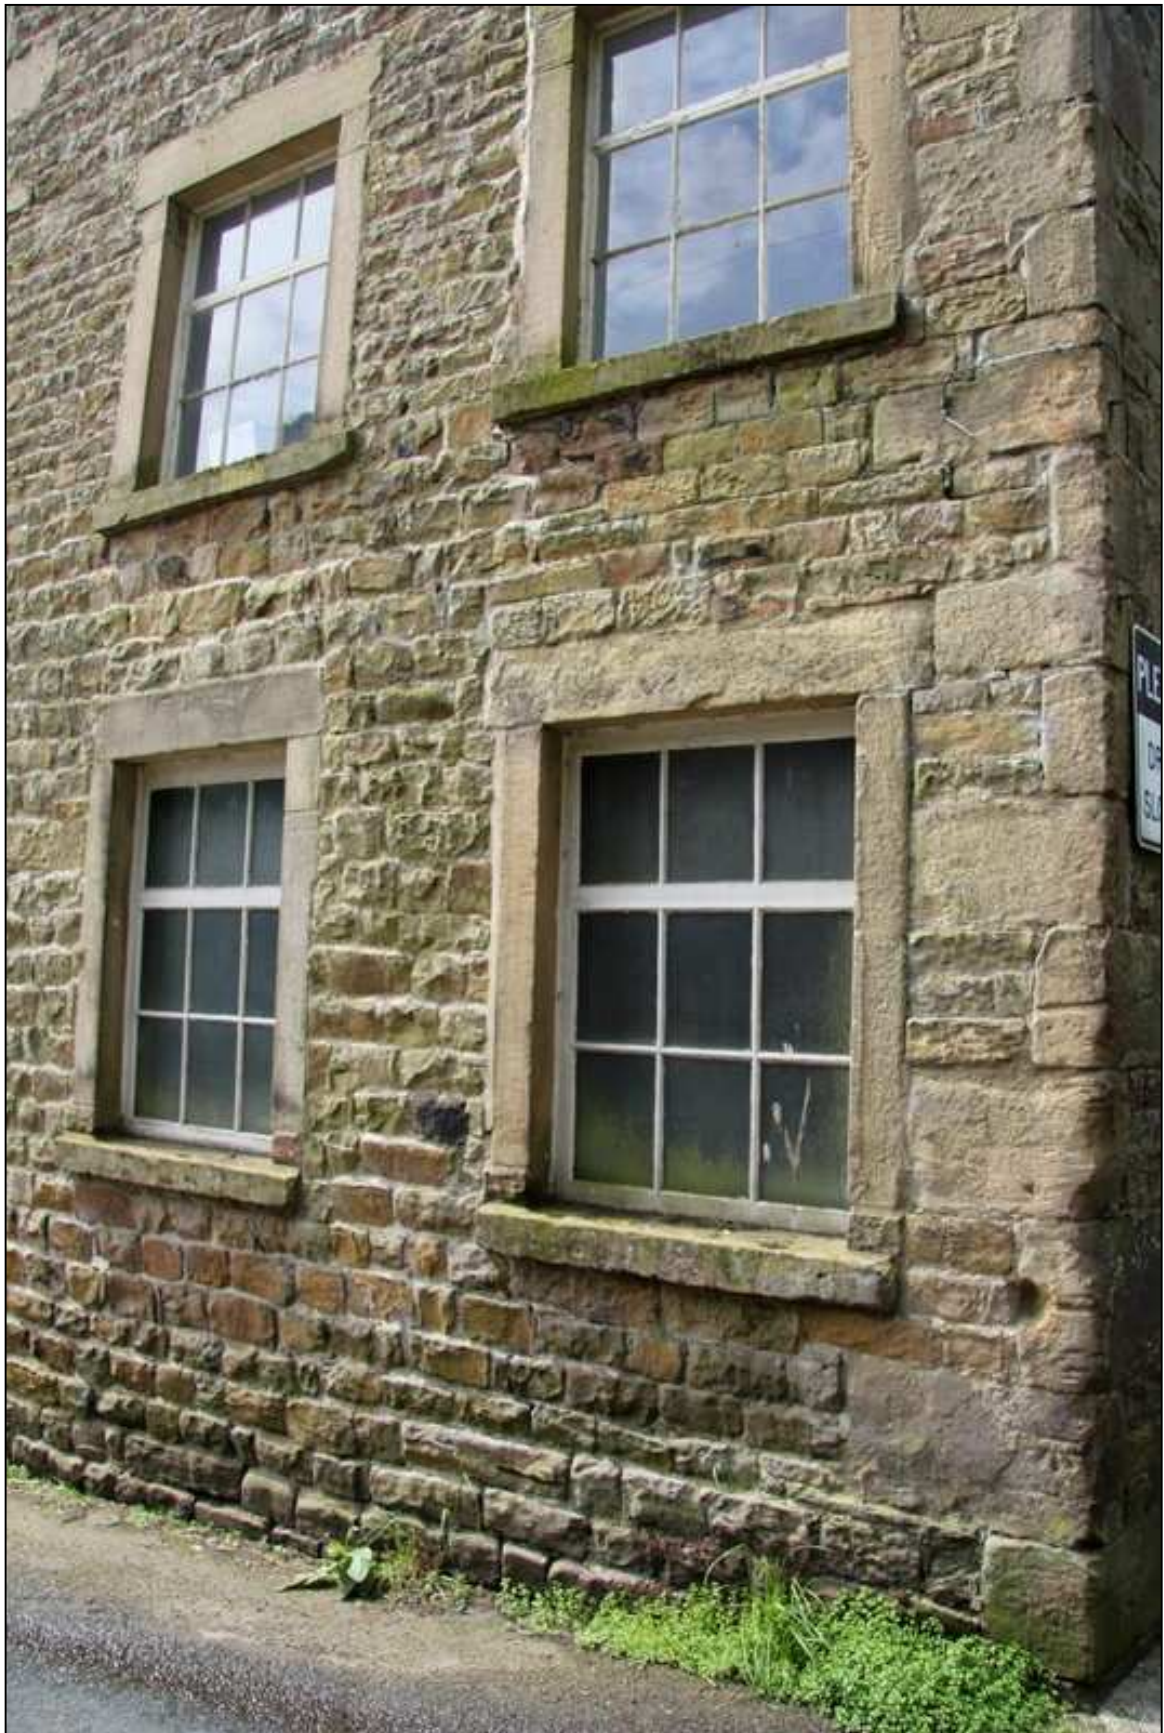
- 3.2.13 The northern wall was also repositioned subsequently, moving it flush to the wheel house, which had earlier been extended, as demonstrated by the quoins around its eastern return (Plate 11). This allowed for an extra window to be inserted at first- and second-floor level (Plates 19 and 20). The rebuilding of the wall can be seen within a subtle change in coursing and stone dressing at the northern end of the elevation, and a subtle change of gradient in the pitch of the roof (Plates 19 and 20).

Plate 20: North return of the east wing, showing rebuilt wall and inserted windows

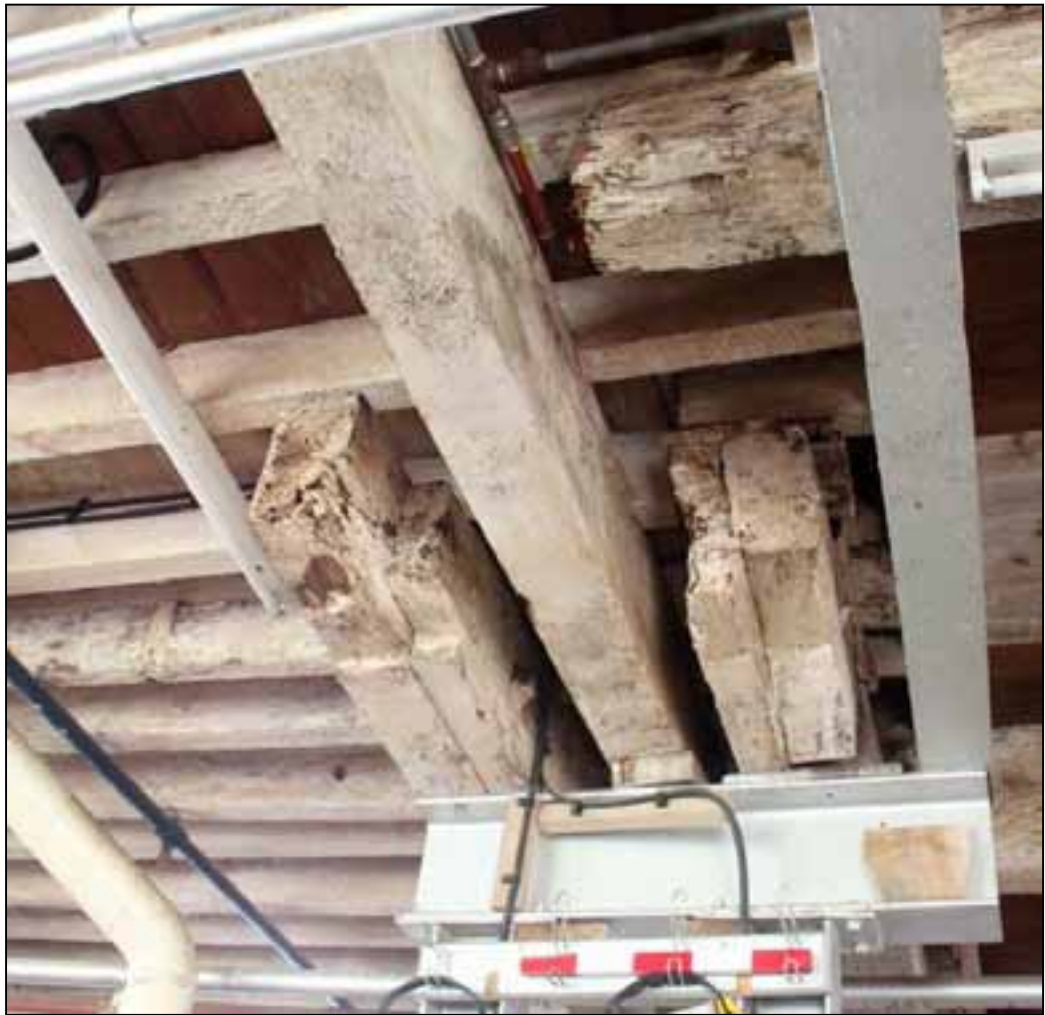
Plate 37: Close-set ceiling beams on late steel pad

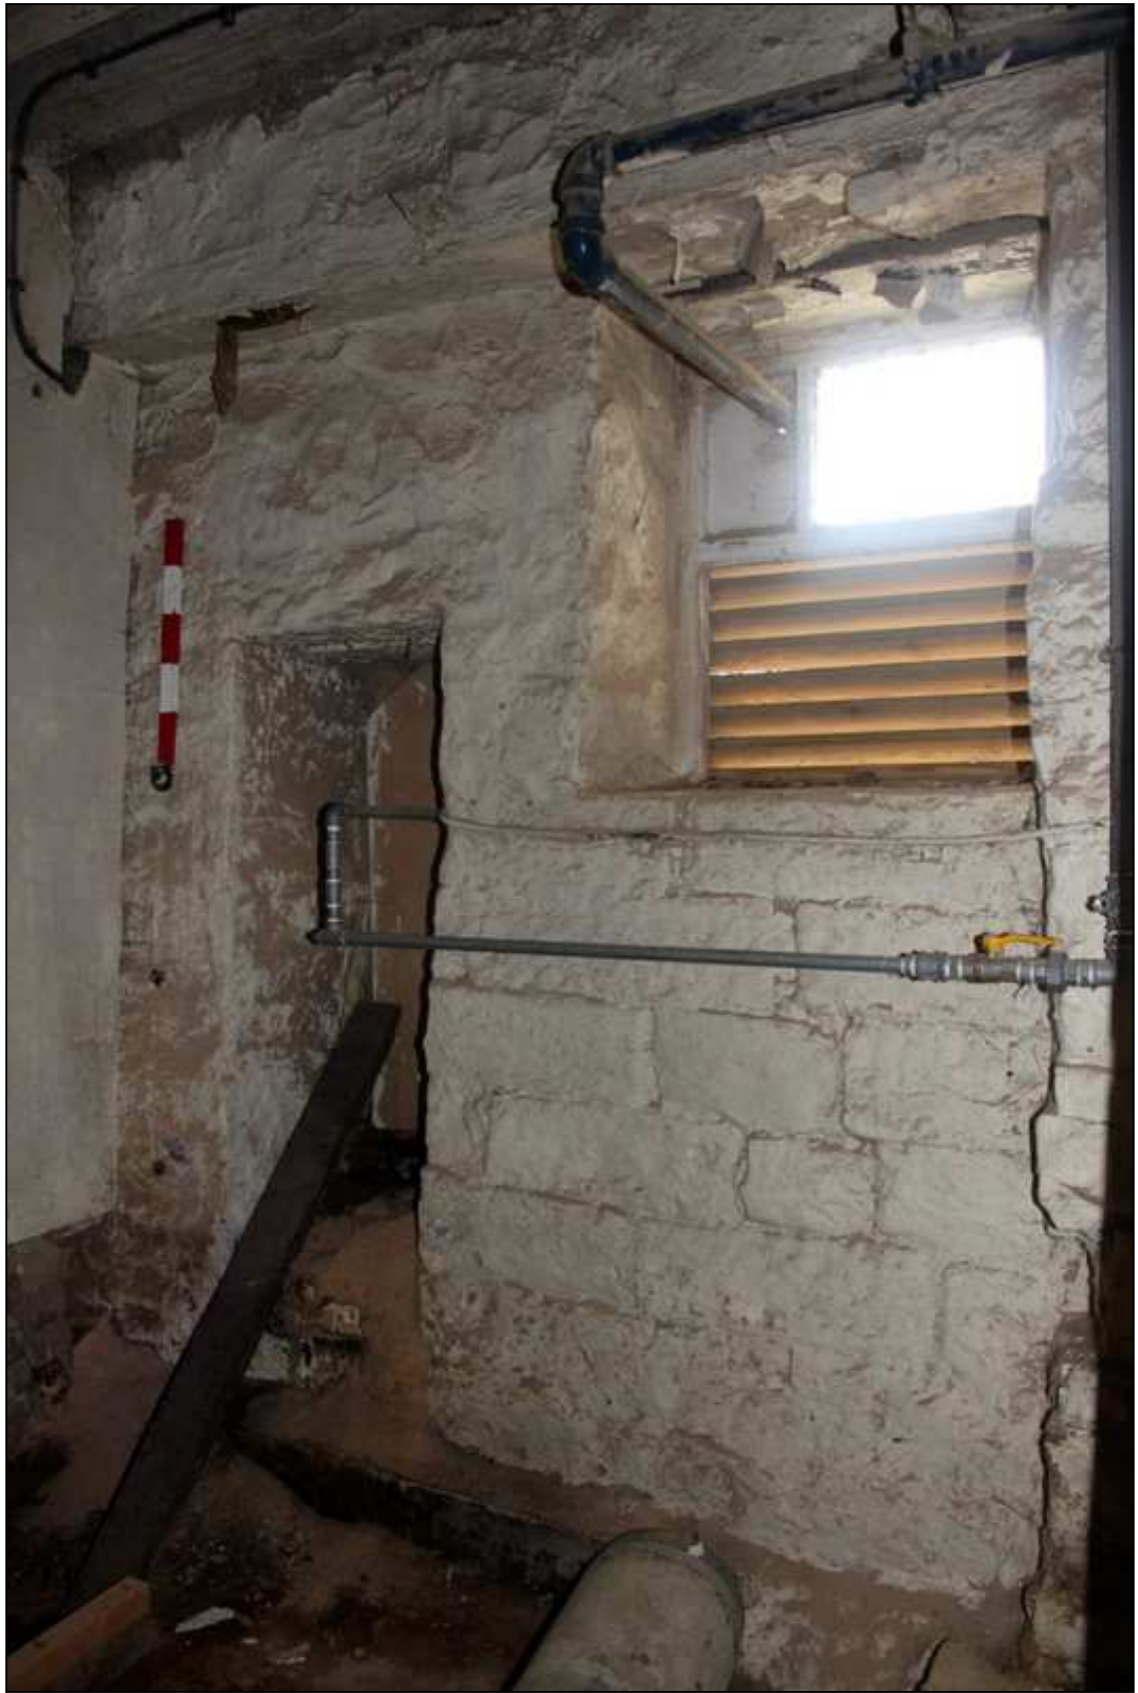
Plate 44: Blocked aperture in the south wall of the engine house, with possible bearing box on the left

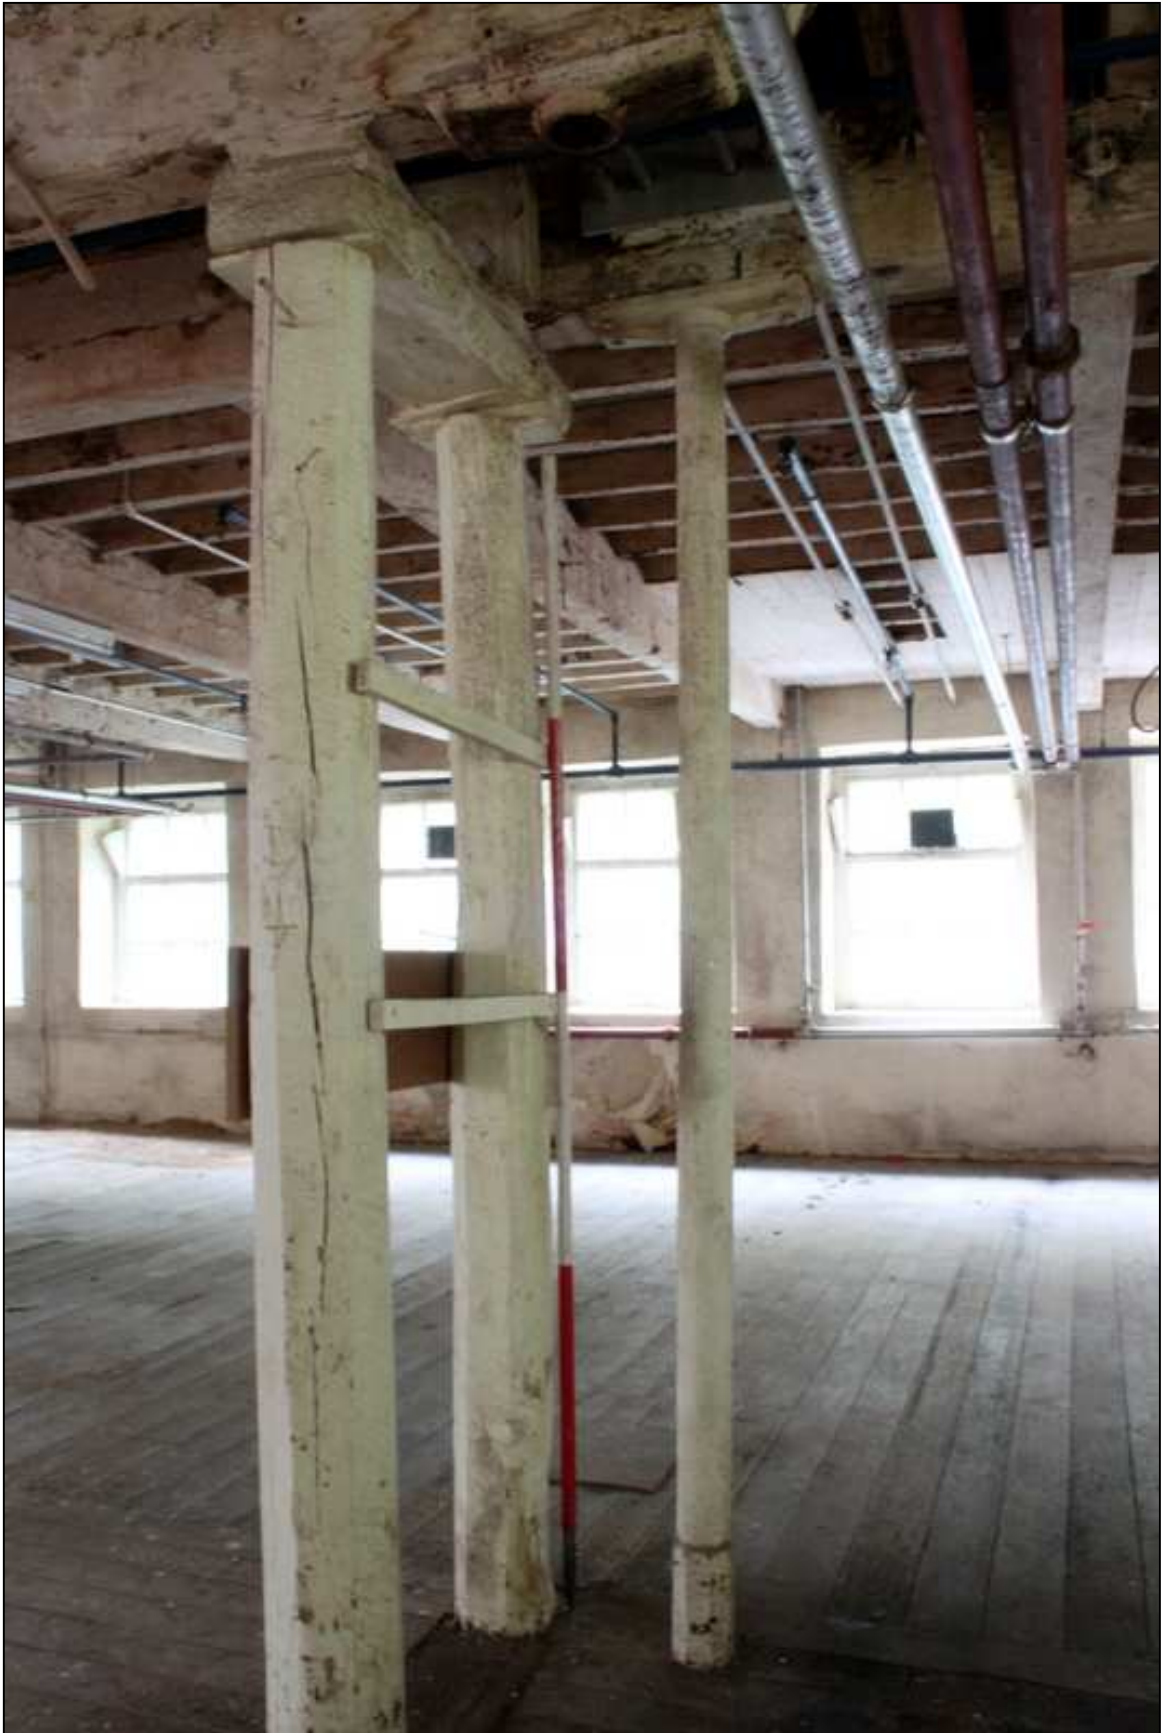
Plate 50: Timber props to ceiling beams adjacent to cast-iron column to scarf joint

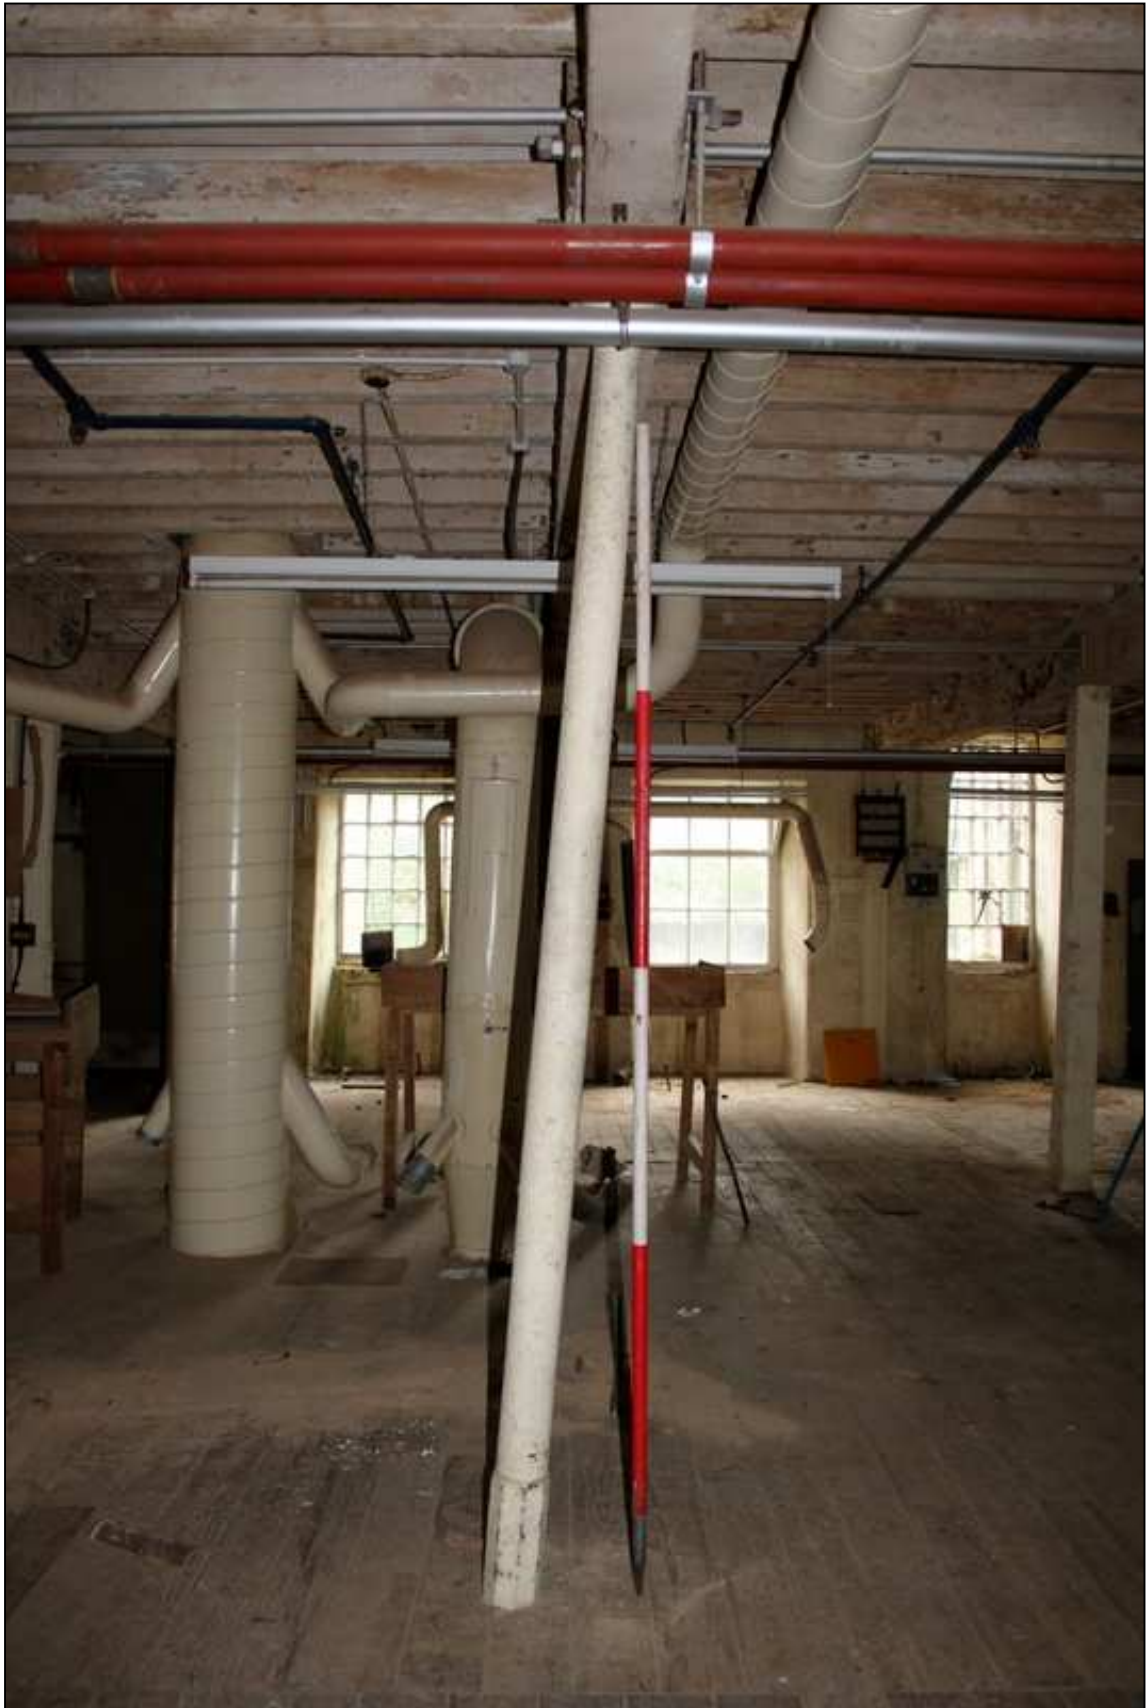
Plate 54: Deflection of first-floor column

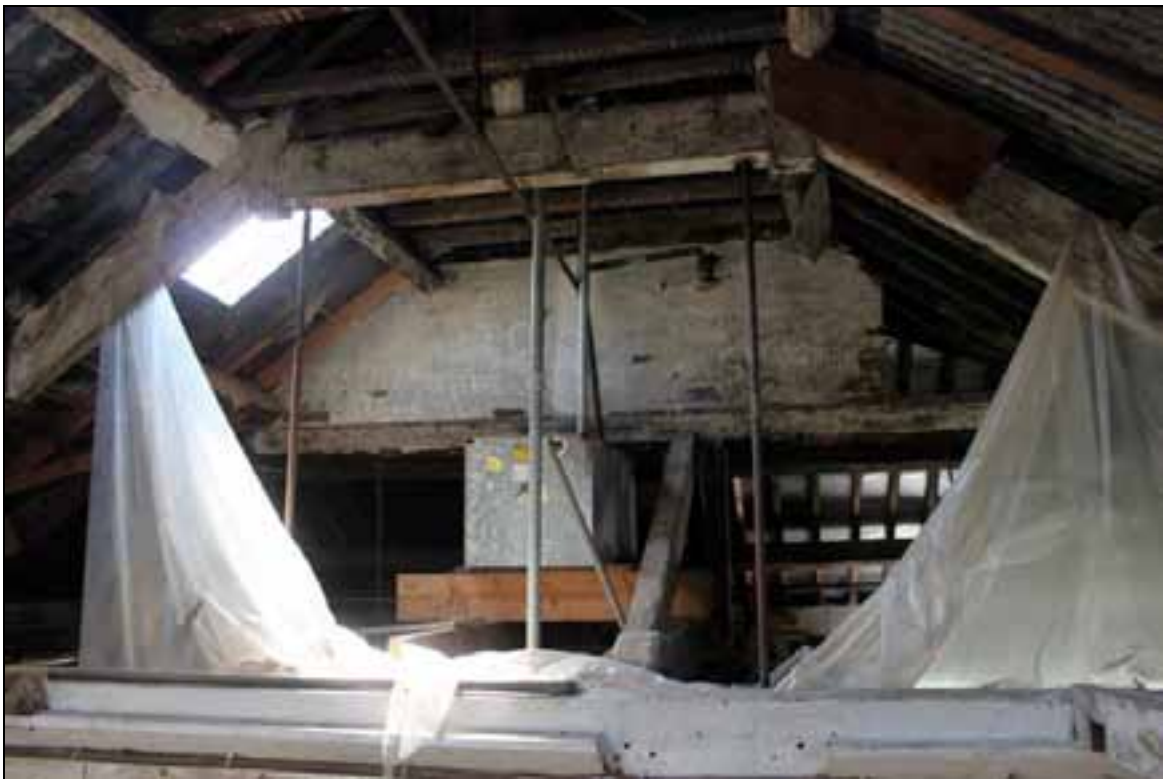
- 3.3.44 The western end of the roof was presumably originally hipped, and thus a new truss needed to be installed to carry the ridge from the original roof to that of the perpendicular extension, in order to avoid a valley between the two roofs. The truss installed was of queen post type, with two vertical members having a jowled head (Plate 87), carrying the shorter principal rafters, a straining beam placed between the two posts, and the weight of the upper purlin, which was housed in a notch within the head (Plate 88). These queen posts were also cut subsequently, and replaced with a pair of iron rods, placed immediately on their inside (Plate 87).

Plate 87: Lath and plaster partition between roofs of main mill and west wing, and queen post truss with replacement iron rods

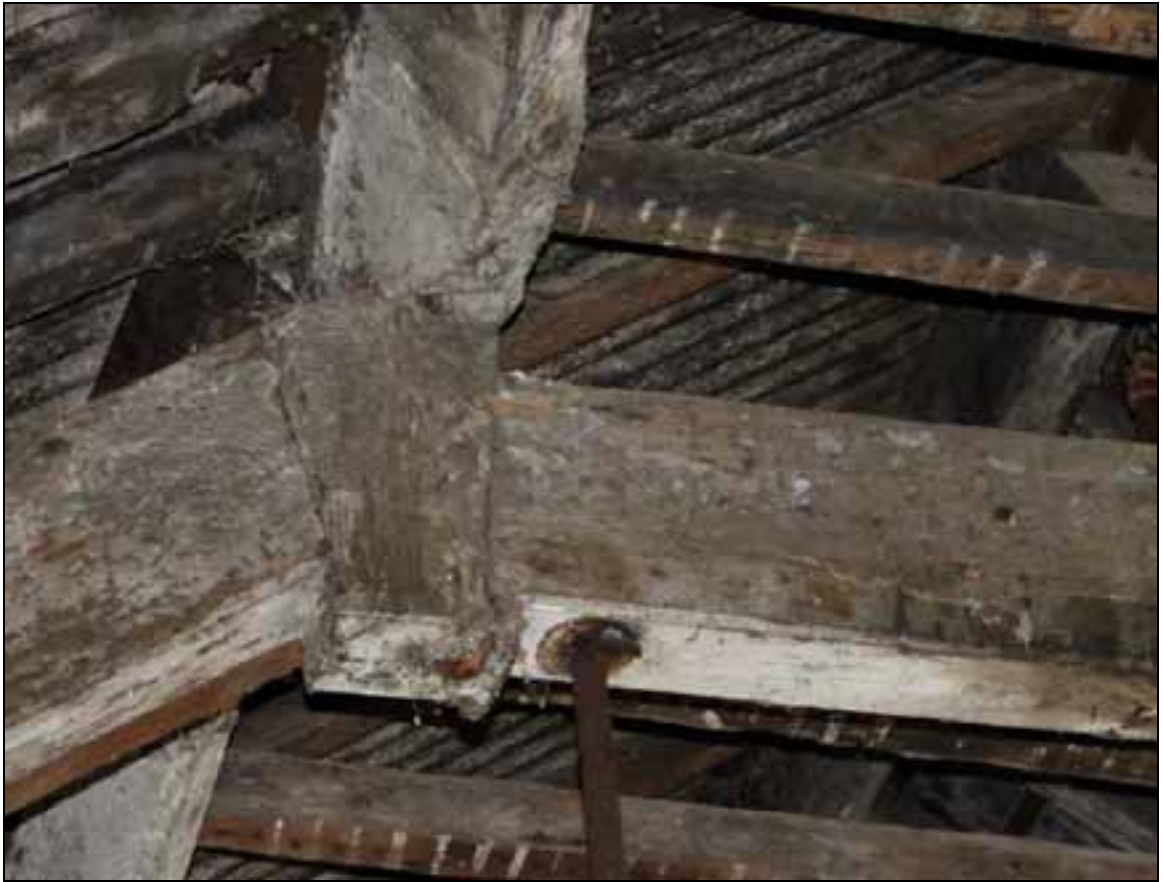
Plate 88: Jowled head of queen post, carrying side purlin, with adjacent replacement rod
