Haweswater Aqueduct Resilience Programme (HARP): Proposed Marl Hill and Newton-in-Bowland Compound Accesses

Marl Hill and Newton-in-Bowland Road Safety Audit Stage 1 - Addendum

B27070EP - Marl Hill and Newton-in-Bowland compound access-RSA1 | P01

07/02/23

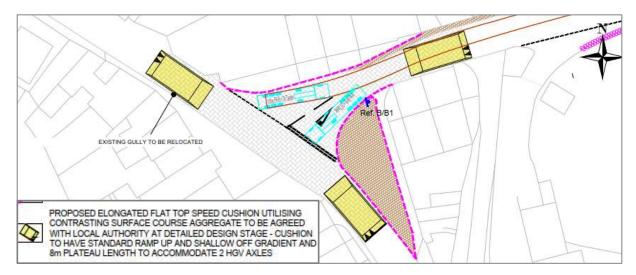
Figure 3 Proposed locations of speed cushion

Summary: Profile of traffic control measure (speed cushions) may not be suitable for HGV turning and could possibly up settle and loose the load into the carriageway and footway in direct conflict with other road users.

As per drawing no. B27070CQ-JAC-XX-DR-C-TR4_WV-1110 elongated flat top speed cushions are proposed on the approaches to the priority junction at the Higher Buck between West Bradford Road and the B6478. It is proposed that the cushions will have a standard ramp up and shallow off gradient and 8m plateau length to accommodate 2 HGV axles. Based on the traffic management plan (Document Reference: 80061155-01-UU-TR4-XX-RP-C-00024 Jan 23) provided to the RSA team, the following HGV types will be in operation within the scheme extent:

In addition to above, there will be abnormal load movements. As such the proposed speed cushions might not accommodate all sizes of vehicles within the scheme extents. Speed cushions that have inappropriate profiles may cause HGV instability resulting in the load shifting with the risk of the load or part of the load falling from the vehicle into the road or footway and injuring other road users.

Ensure that all speed cushions have an appropriate profile that can accommodate all sizes of vehicles.

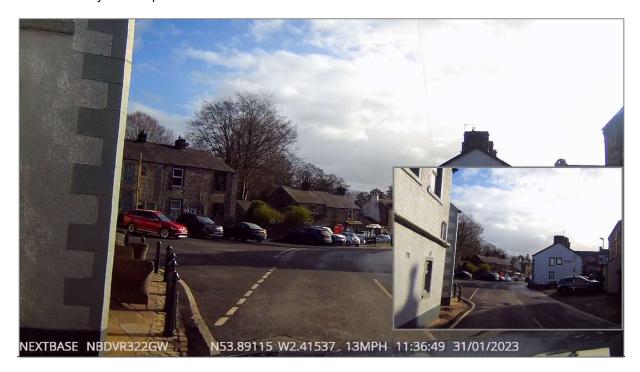
Summary: Proximity of the Higher Buck sitting area to the carriageway

RSA team has observed that the Higher Buck outside sitting area is very close to the carriageway. There is risk that vehicles travelling southeast to east (West Bradford Road) unintentionally overrun the sitting area, potentially resulting in vehicle to pedestrian conflicts and causing serious injuries to pedestrians. The risk is exacerbated by the sharp turn at this location.

Figure 4 Location of sitting area runs beside the carriageway

It is recommended to build out this seating area to maximise the distance between main carriageway and the sitting area.

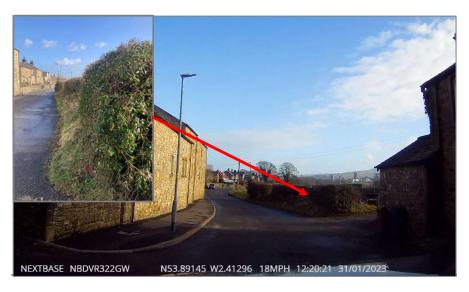
Vegetation is present across the scheme extents and around the proposed formal and informal passing places. This will impact on forward visibility as well as resulting in drivers shying away from the edge of carriageway thereby resulting in reduced carriageway width for opposing vehicles. It is recommended that the vegetation is cut back and maintained.

Figure 5 Example location of exsisting vegetation

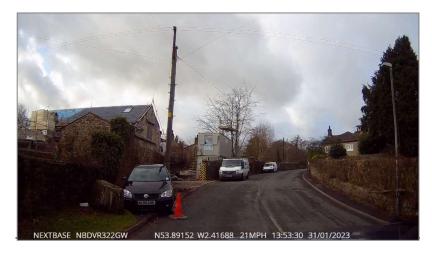
During the site visit, parked vehicles were observed at Slaidburn Road northwest within the bend where forward visibility is restricted. Parked vehicles at this location reduces the effective width of carriageway, this could result in conflict between vehicles travelling northwest and the oncoming vehicles potentially resulting in head on collisions, or sudden braking resulting in shunt collisions. Review the location of parked vehicles and enforce accordingly.

Figure 6 Location of Exsisting on street parking

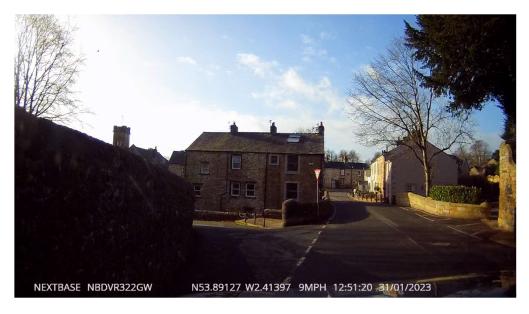
During the site visit, the RSA team has observed that the proposed informal passing place on the West Bradford Road, located 45m east of priority junction with B6478, is a minor road (Branch Road) approach. Vehicles using Branch Road may be frustrated by the stopped vehicles at this informal passing place. It is recommended that during the operation of the scheme Branch Road is closed. Closing this minor road will create a formal passing place at this location.

Figure 7 Location of Branch Road approach and Passing place
