**STRUCTURAL CONVERSION ASSESSMENT**  
**LITTLE DUDLANDS FARM, RIMINGTON LANE, RIMINGTON, BB7 4EA**

### **STRUCTURAL CONVERSION ASSESMENT AND METHOD STATEMENT LITTLE DUDLANDS FARM RIMINGTON LANE, RIMINGTON, BB7 4EA**

A structural inspection of the above property was carried out on 10 December, 2013, to examine and report on the current state and safety of an existing barn for conversion purposes.

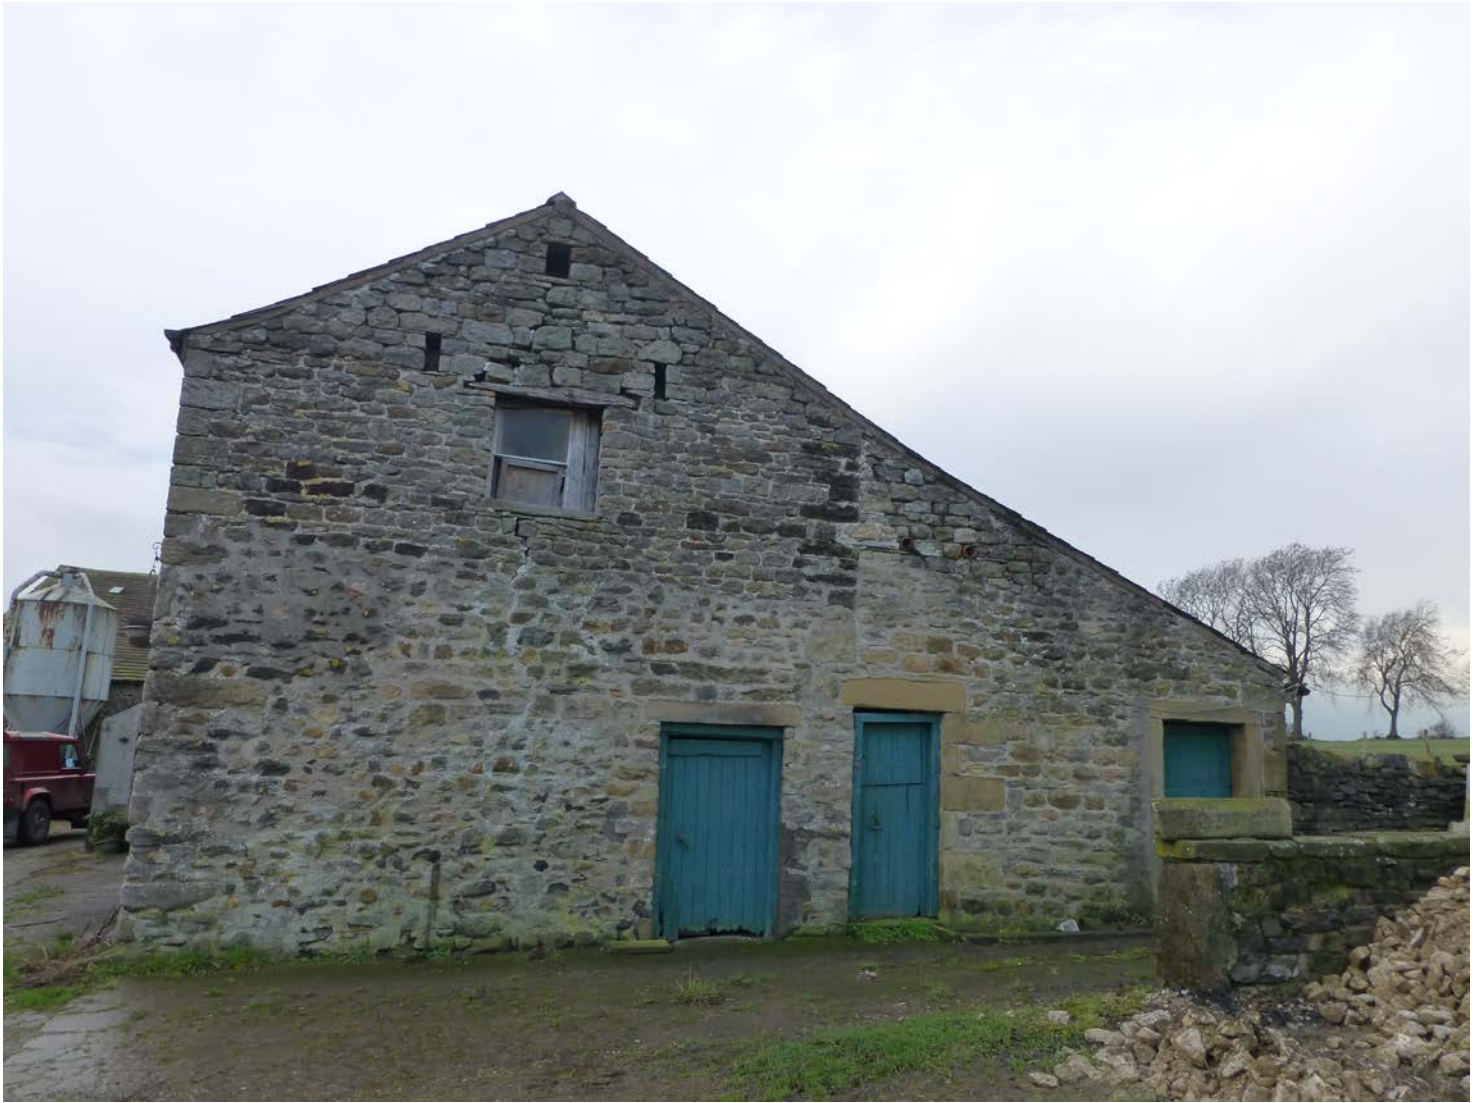
Photograph No. 1

The main barn wall which is shown on the plans as position number 1 and 2 of the photographs showed excessive bulging at the top of the wall near the apex. All the pointing is in poor condition.

The top section of the wall as shown in positions 1 & 2 must be rebuilt locally to remove the bulging and cracking with stone to match existing.

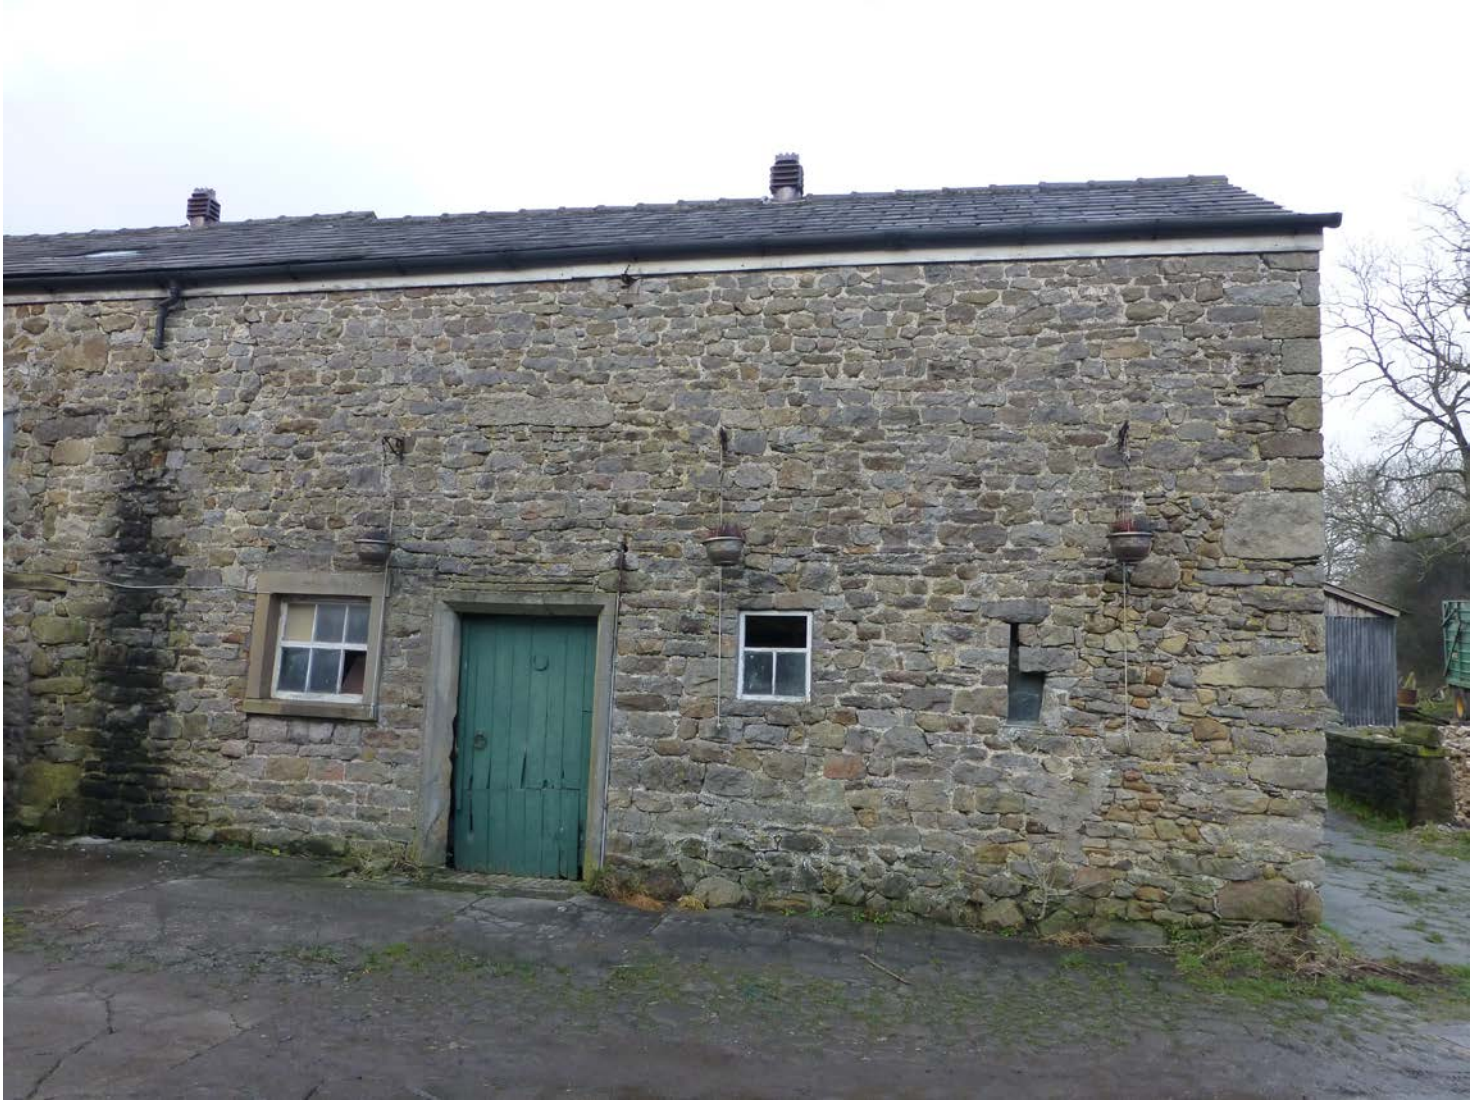
Photograph No. 3

The two external walls shown on the plans as positions 3, 5 & 8 are reasonably plumb and in good condition showing no real signs of excessive movement or large cracking. All the pointing however is in poor condition. Cracking to the walls internally could also be seen in numerous areas to the plan positions 5.

All areas require the existing pointing to be removed and replaced. Any loose stonework must also be replaced as necessary once the pointing has been removed with stone work to match; this should be carried out both externally and internally

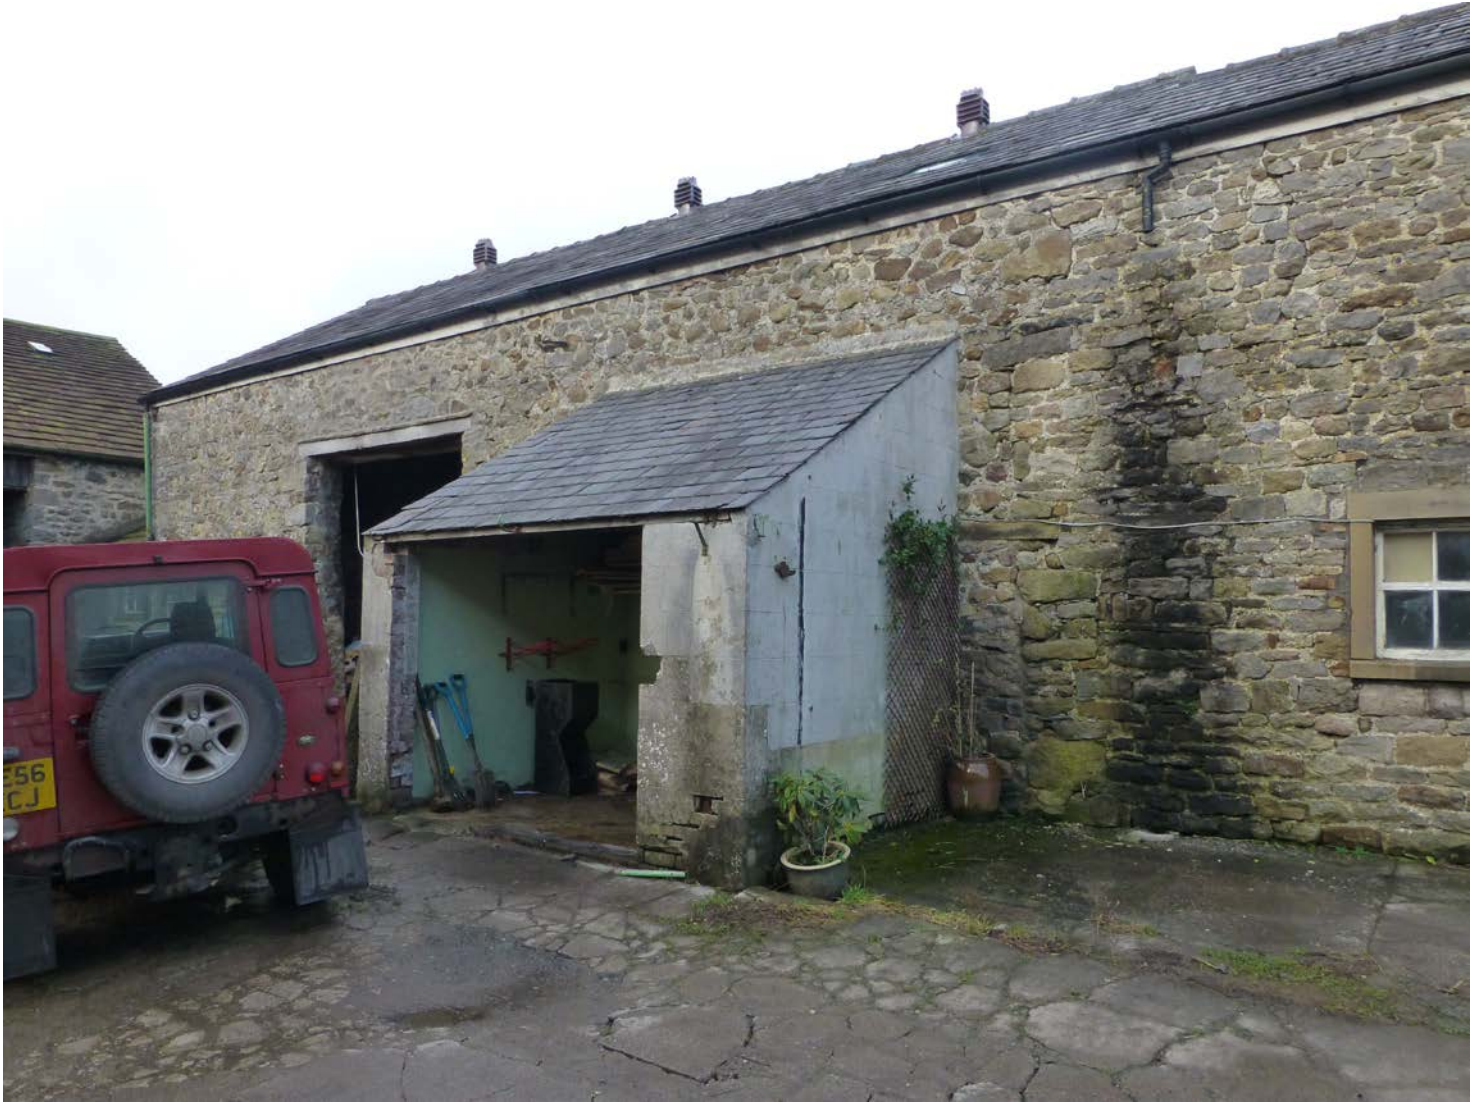
Photograph No. 4

An existing single storey brick built store that can be seen on photograph number 4 was generally in poor condition and was obviously not original construction as it was standard red brick construction.

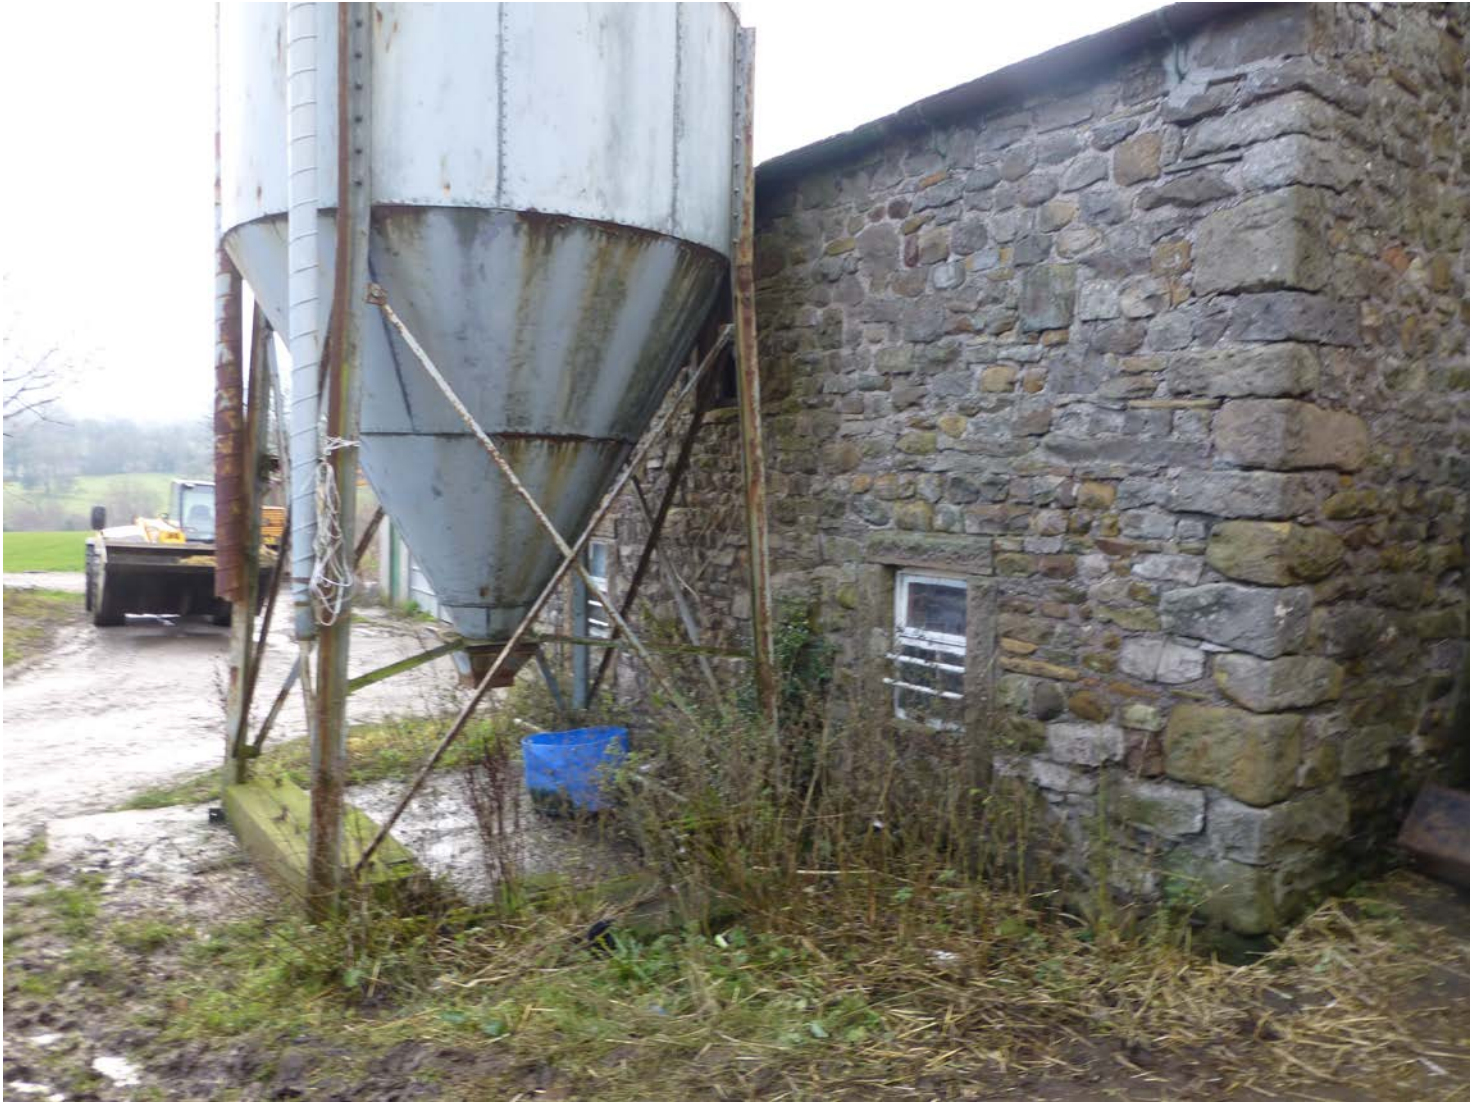
Photograph No. 7

The external wall shown on the plans as position 7 is reasonably plumb and in good condition showing no real signs of excessive movement or large cracking. All the pointing however is in poor condition.

All areas require the existing pointing to be removed and replaced. Any loose stonework must also be replaced as necessary once the pointing has been removed with stone work to match; this should be carried out both externally and internally

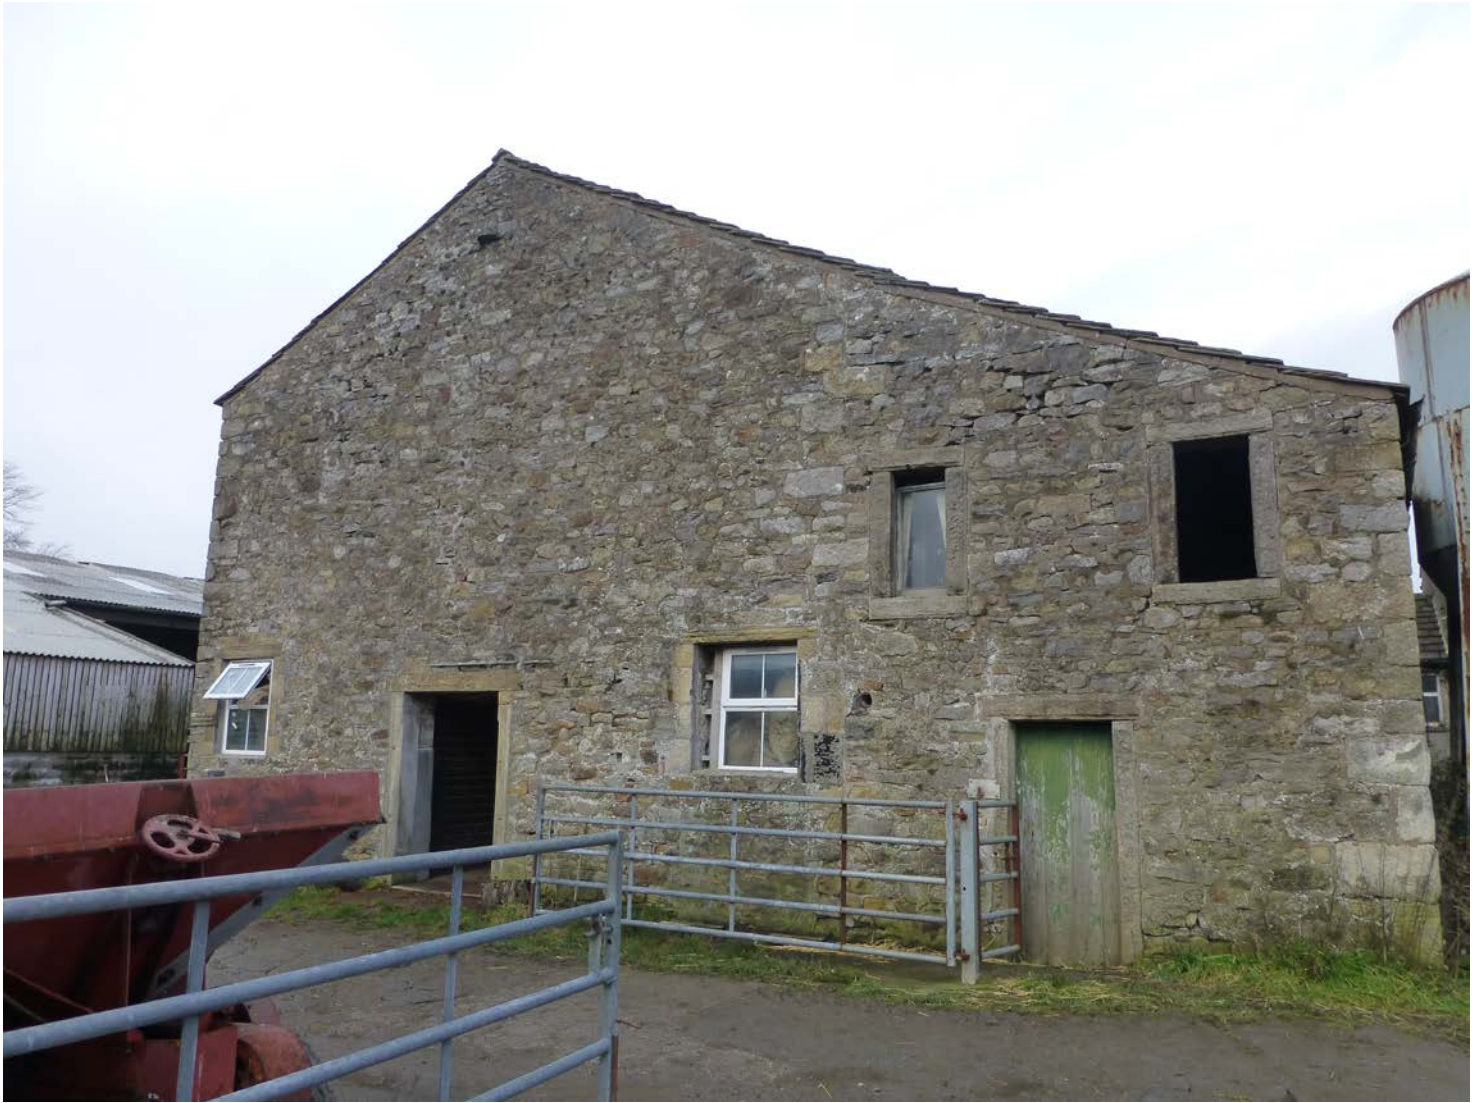
Photograph No 8

The main barn wall which is shown on the plans as position number 8 (also seen as the photograph position as shown on drawing number 1041-01) of the photographs showed areas of cracking which will need to be addressed. Cracking to the walls internally could also be seen in numerous areas.

All internal and external cracks are to be repaired by either locally rebuilding using larger stones or using a standard stitch preparatory system such as helifix bars and resin which are hidden within the wall construction.

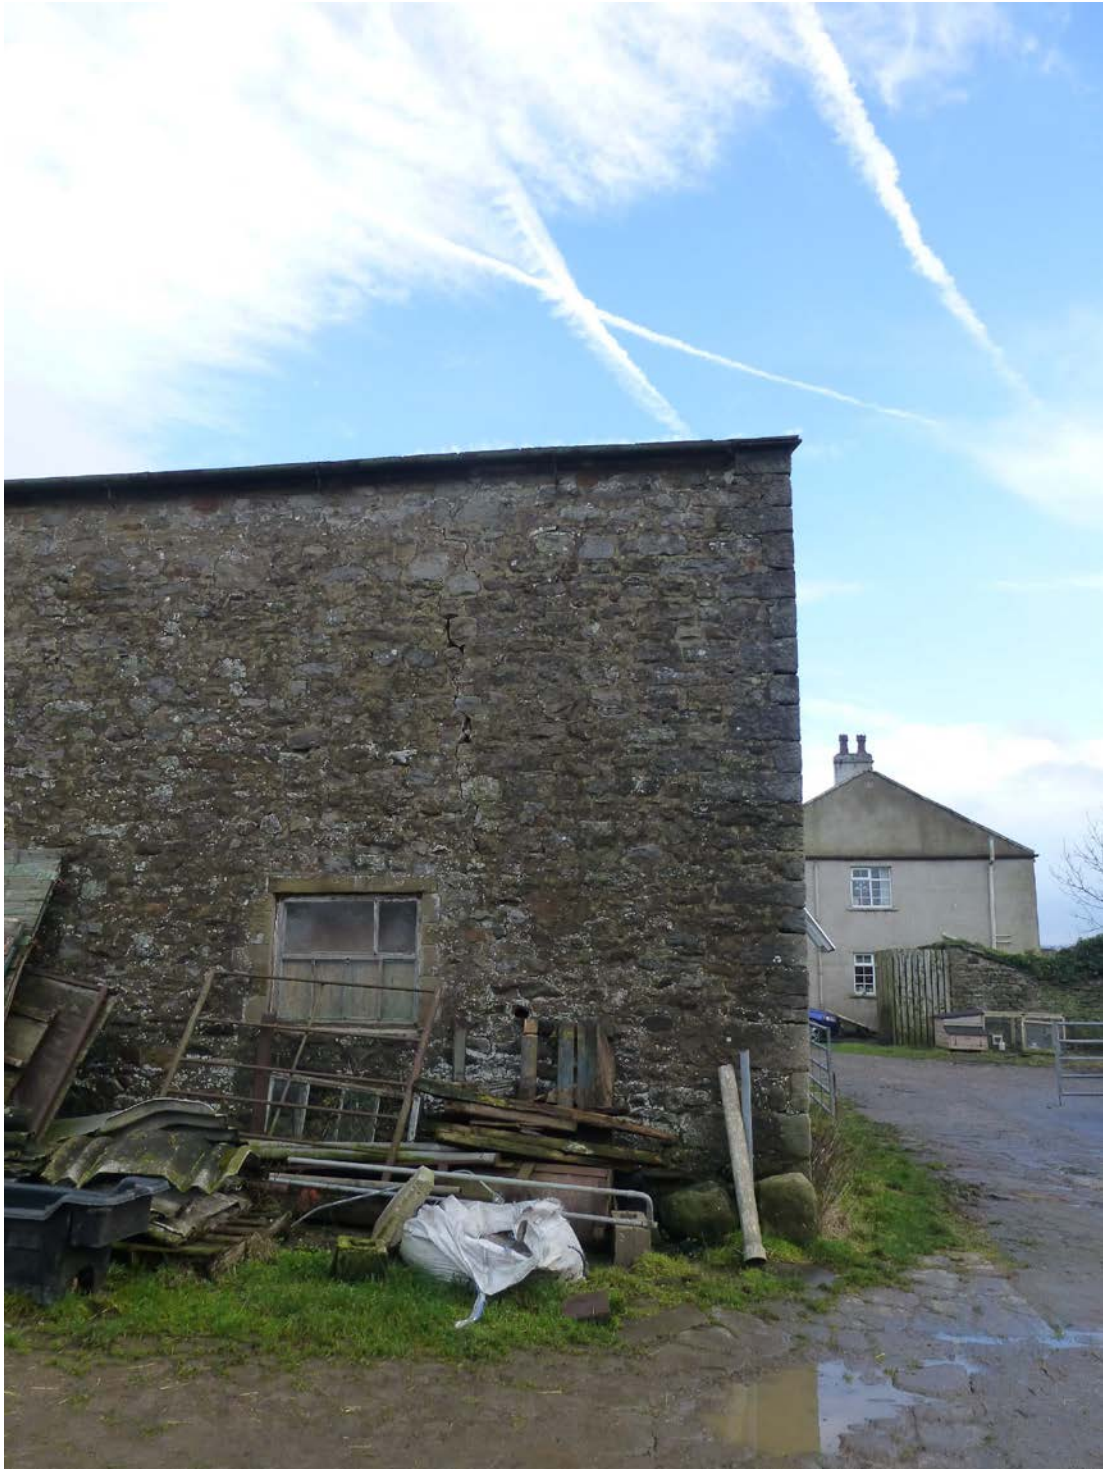
Photograph No. 9

The external wall shown on the plans as position 9 is reasonably plumb and in good condition showing no real signs of excessive movement or large cracking, except to one position near the corner. All the pointing however is in poor condition.

All areas require the existing pointing to be removed and replaced. Any loose stonework must also be replaced as necessary once the pointing has been removed with stone work to match; this should be carried out both externally and internally

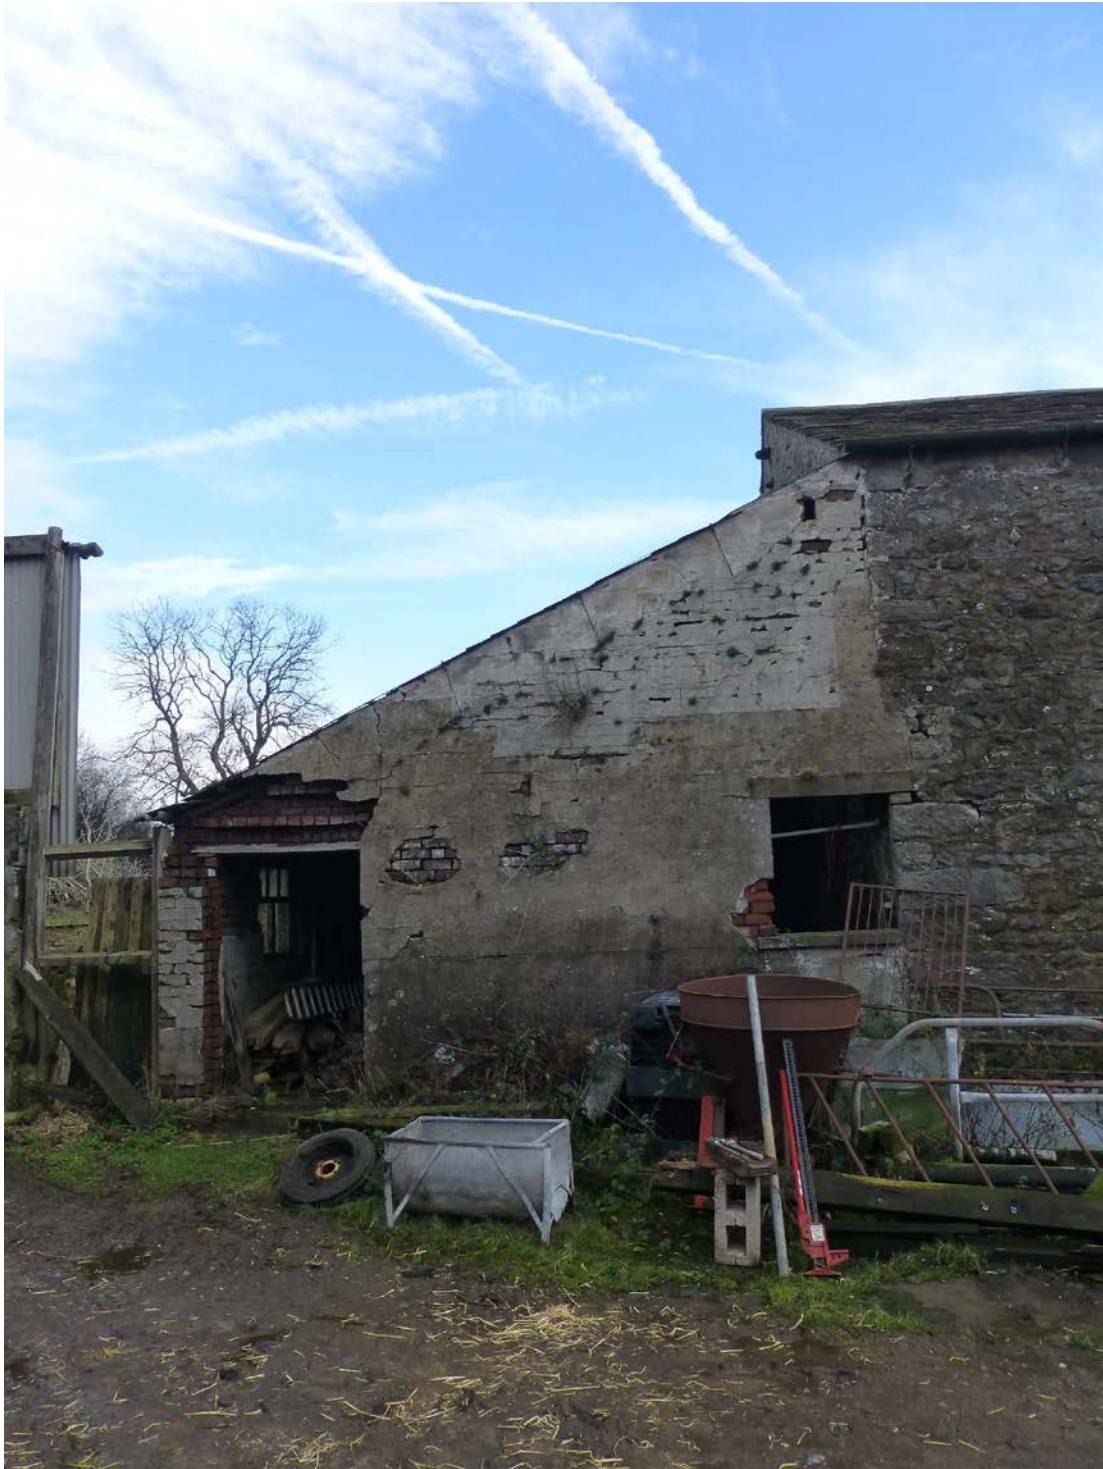
Photograph No. 10

The external wall construction that can be seen within photograph number 10 is in a poor state of condition and is only a red brick built lean too that was not built at the same time as the main barns.

The main barn wall (red brick section) as shown as position number 10 needs to be totally re-built off a new concrete strip footing. The wall construction will consist of an outer leaf of random stone with a 100mm thick concrete back blocking. This will be tied to an internal leaf of 140mm thick concrete block with ties as per the Architects details as supplied at the time of any Building Regulation application.

The above wall should only be removed once adequate support has been provided to the existing roof and floor construction. The contractor must also provide lateral support to the existing barn flank walls whilst the wall in question is being re-built.

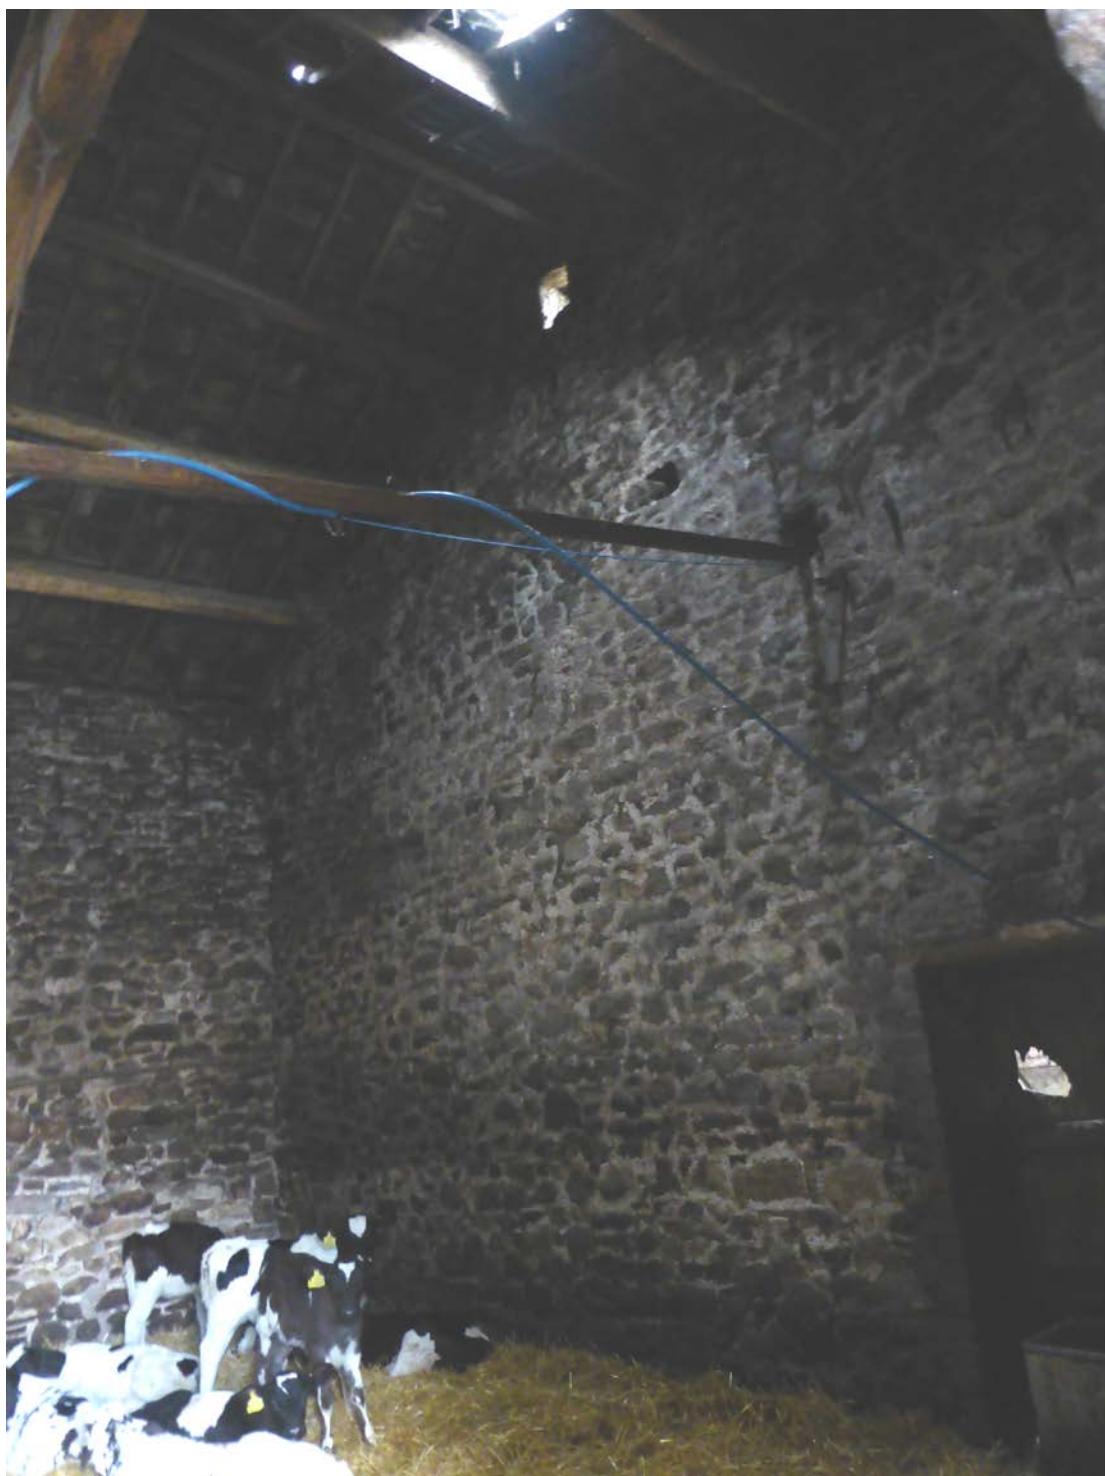
Photograph No. 11

The external wall construction that can be seen within photograph number 11 is in a poor state of condition and is only a red brick built lean too that was not built at the same time as the main barns.

The main barn wall (red brick section) as shown as position number 11 needs to be totally re-built off a new concrete strip footing. The wall construction will consist of an outer leaf of random stone with a 100mm thick concrete back blocking. This will be tied to an internal leaf of 140mm thick concrete block with ties as per the Architects details as supplied at the time of any Building Regulation application.

The above wall should only be removed once adequate support has been provided to the existing roof and floor construction. The contractor must also provide lateral support to the existing barn flank walls whilst the wall in question is being re-built.

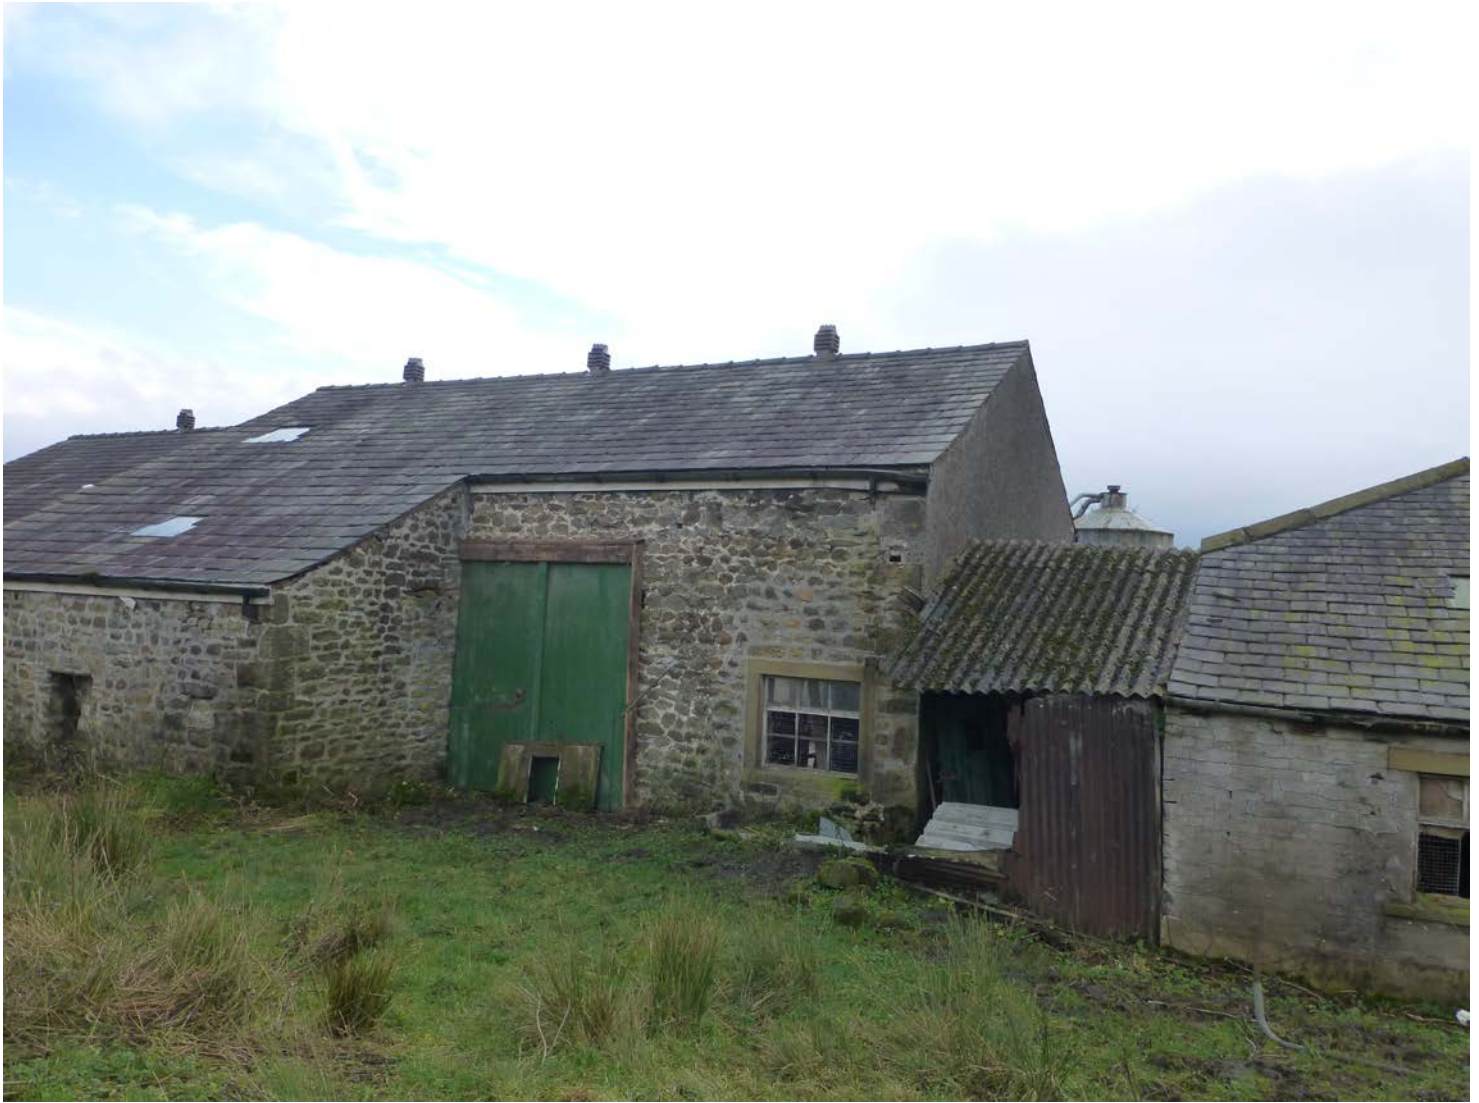
Photograph No.12

The external walls shown on the plans as positions 12 & 13 are reasonably plumb and in good condition showing no real signs of excessive movement or large cracking. All the pointing however is in poor condition.

All areas require the existing pointing to be removed and replaced. Any loose stonework must also be replaced as necessary once the pointing has been removed with stone work to match; this should be carried out both externally and internally
