HERITAGE STATEMENT AND METHOD STATEMENT

For
Alterations and General Repairs
At
Bridge End Farm, Wood House Lane, Slaidburn BB7 3AH
Grid Reference SD 70308 53609

Prepared by:
Paul Lewis BSc(Hons) MRICS
RICS Accreditation in Building Conservation
Lewis Historic Building Consultants Ltd. Penrith CA11 8UR
Ref: PL/JL/2023.39

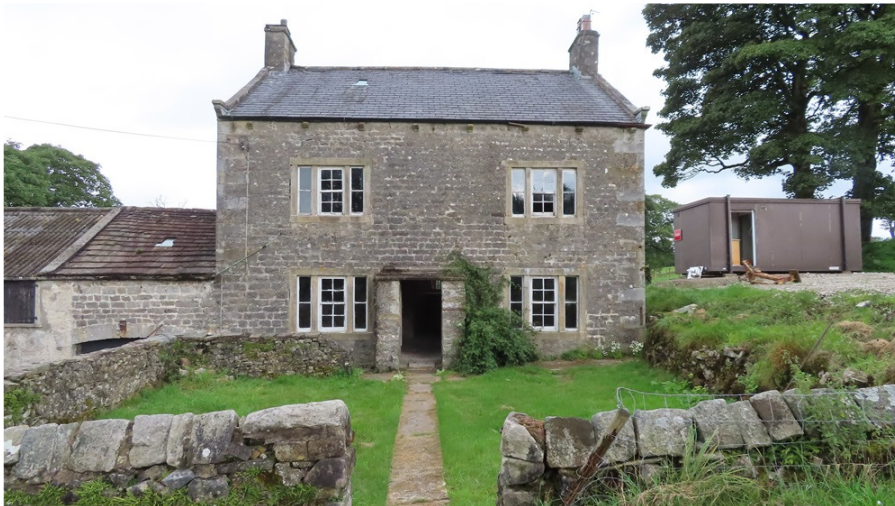
1.

The features that pertain to this locality are the tripartite windows on the front elevation; R W Brunskill in “Vernacular Architecture – An illustrated Handbook” (2000 Edition) states that this style was common throughout the Pennines and Westmorland with central sliding sash and fixed side casements (Plates 1,2). The arrangement of the windows that light the staircase are also unusual in their ‘T’ arrangement (Plate 3) but both have been substantially altered with the insertion of larger glass panes and 2-over-2 style sash in the late 19th century.

Some unsympathetic alterations exist in the front and rear porches and improvised window arrangements at rear ground floor level (Plates 1 and 3).

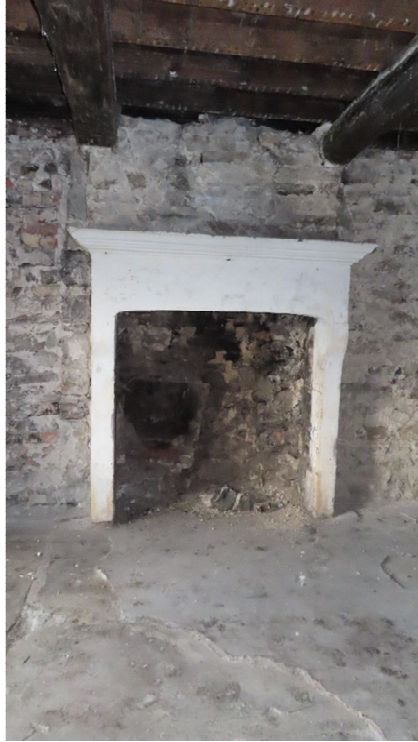
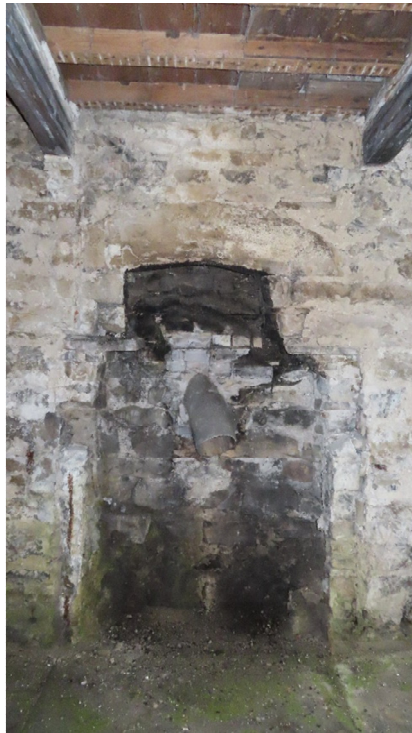
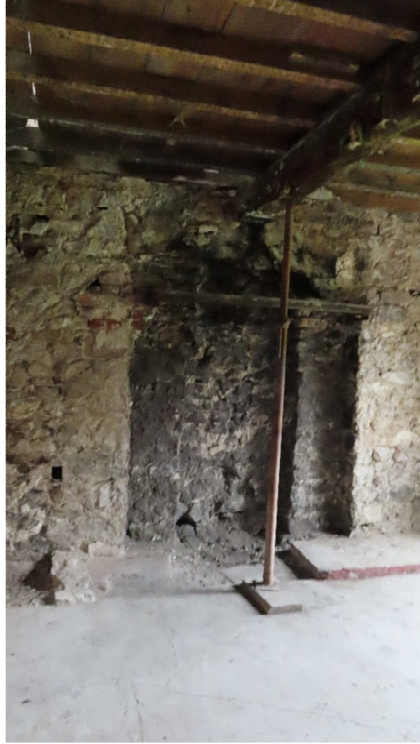
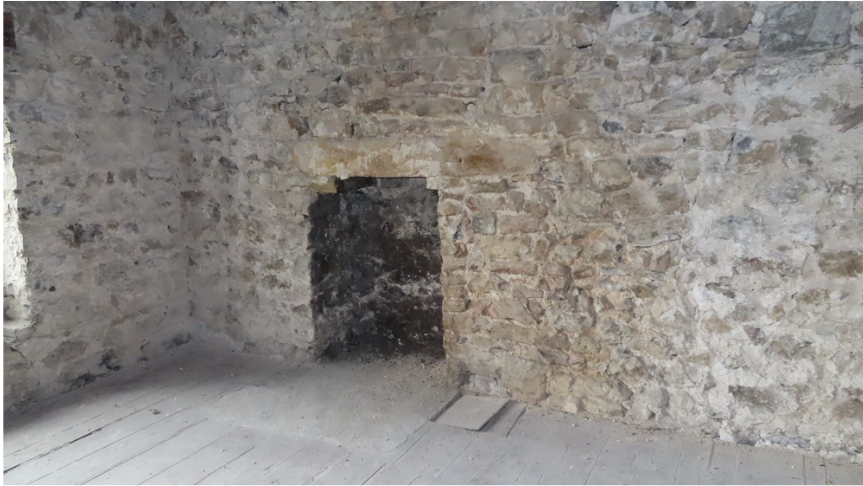
Internally, whilst the original arrangement of rooms remains, the internal plaster finishes, ceilings, joinery and fittings have been removed at an earlier date. None of the fireplaces remain as only the structural openings are evident; one surround remains (Plates 4 - 7). Plaster finishes originally extended over floor beams and joists (Plate 8). The original front door remains (Plate 9) and will be retained. The staircase is simple with unornamented newel posts and stick spindles (Plate 10). The lower floors are stone flag but in poor condition and heavily fractured (Plate 11).

6. Open fireplaces will be repaired with stonework and brickwork where needed to recreate the original openings; flues will remain open and be fitted with vents or closure plates as appropriate where log burning stoves are installed.

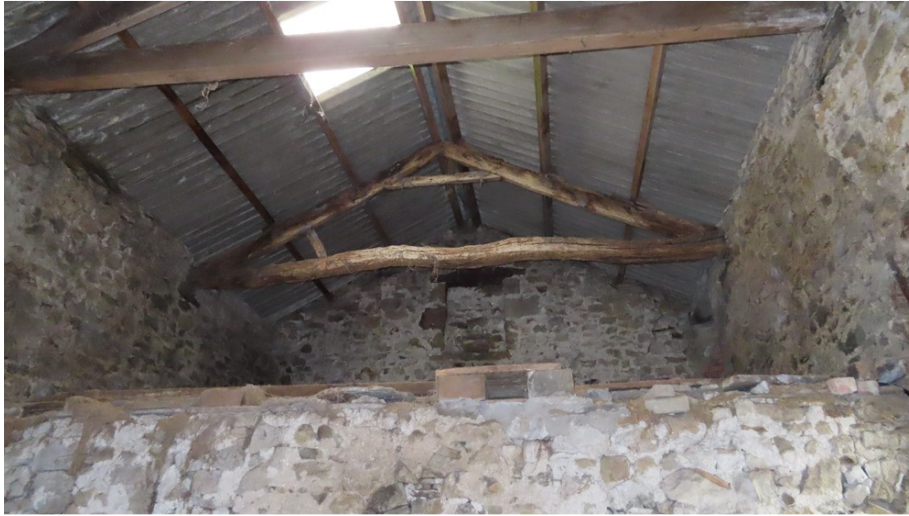
12. Closed hay forking door evident in the former gable of the barn, now forming the left (west) wall of the trap house

The coursing of the masonry indicates that the trap house was built at the same time as the dwelling. There is evidence that both were constructed against an existing field barn structure; there is a closed forking hatch to the hay loft that was closed when the trap house was built (Plate 12). The hand-worked style of the roof trusses in the barn indicates a construction date of the mid-18th century when over-purlins were commonly employed, albeit these have been removed when sheet roofing materials were added in modern times.

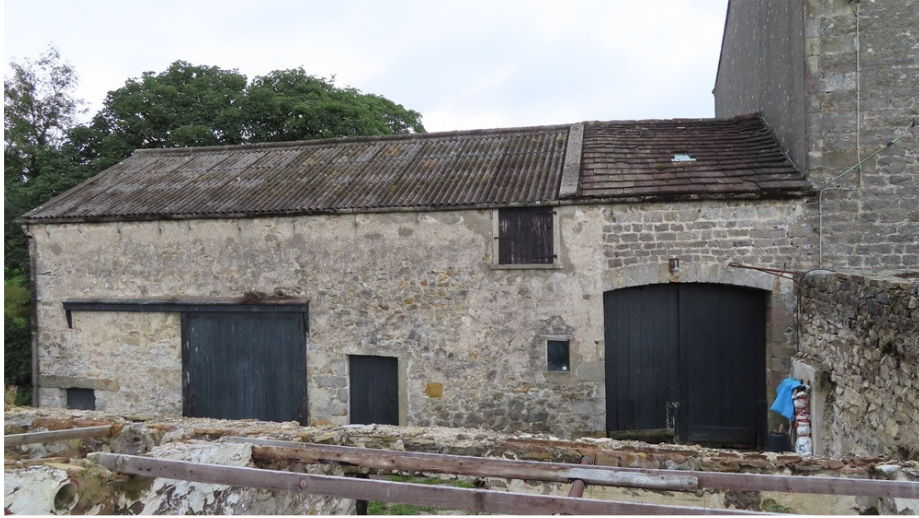
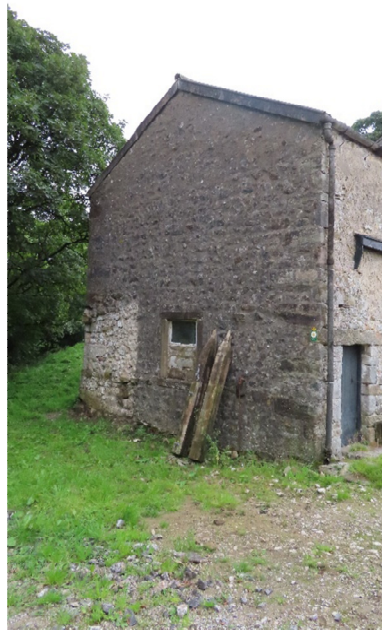
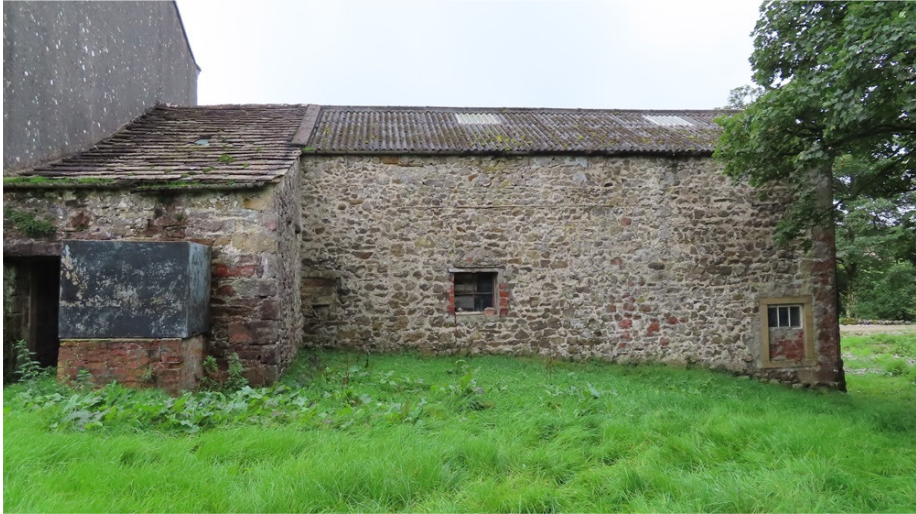
The main masonry walls of the barn are random rubble bond with some 19th century alterations to window and door openings; the overall style of construction is mid to late 18th century (Plates 13, 14 and 15).

- Exterior
 - Removal of asbestos cement sheeting and slender purlins; reinstatement with new ridge and purlins to Engineer's design; reclaimed stone flag finishes
 - Reopening of closed window on rear elevation and incorporation of new single glazed timber window, painted
 - Replacement of decayed windows to existing openings, as above
 - Provision of new pair painted timber doors to barn re-employing ironwork from trap house door
- Interior
 - No interventions

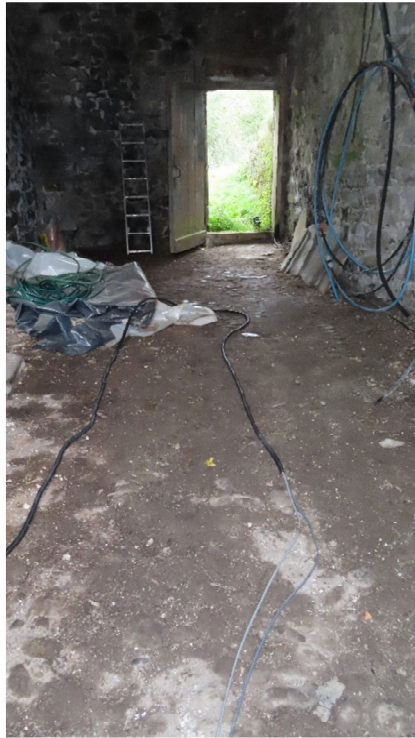
16.

The trap house presents traditional stone flags to the pitched roofs with stone copings over the barn gable. Internally, the structure is simple with a heavily worn cobble surface (Plate 16) and simple purlin roof structure (Plate 17).

- Exterior
 - Relocation of existing ironmongery from entrance doors to new doors on barn; incorporation of new glazed screen with entrance door
 - Incorporation of conservation-style skylights
 - Insertion of new window opening into rear wall to light utility room
 -
- Interior
 - Removal of degraded cobble and earth floor and reinstatement with reclaimed sandstone flags on new floor slab as in house
 - Construction of internal partitions, finishes and fabric to create ancillary accommodation comprising entrance hall, boot room, shower room, utility room
 - Insertion of independent blockwork partition walls, plastered
 - External stone walls to be insulated lime plaster as before
 - Insertion of new suspended timber floor, insulated, plaster ceilings below
