The Talbot Hotel and adjacent barn  
Talbot Street, Chipping, Lancashire:  
Historic Buildings Assessment

June 2011

# The Talbot Hotel and adjacent barn Talbot Street, Chipping, Lancashire: Historic Buildings Assessment

### HISTORIC BUILDINGS ASSESSMENT

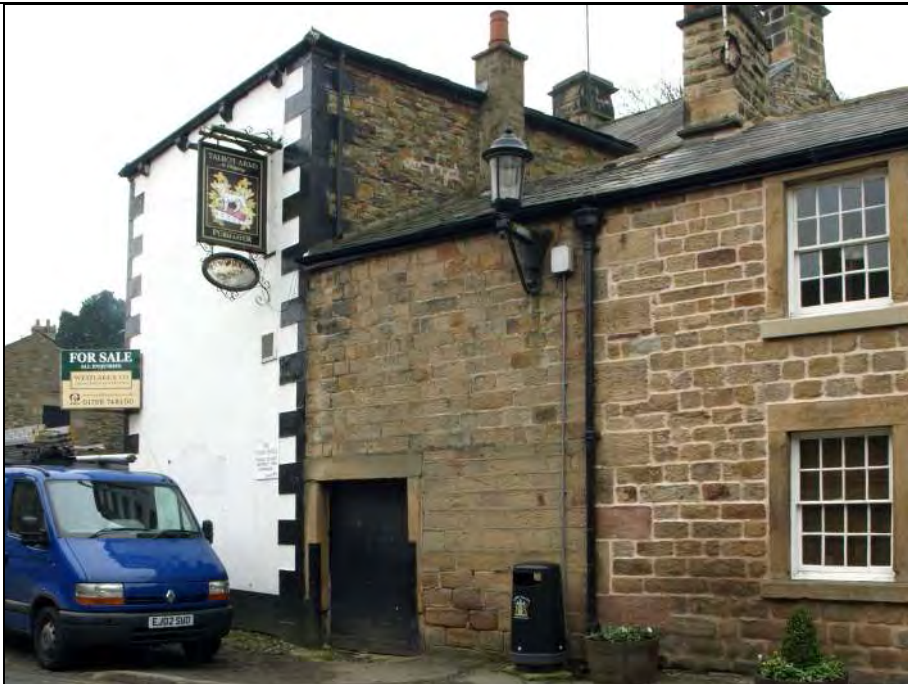
- 4.3 Between 1844 and 1891, two single storey additions were made to the north-east of **B**. The smaller of these (**D**; photo 7) seems to have been a store, creating an infill in the street frontage between the inn and the cottage to the east (the cottage being dated 1825), while the larger (**E**) stands at the rear of the building, and was a back kitchen. A late 20th century timber shed now links these two 19th century additions (**F**). Also of this very late date is a single storey rear extension which provides a doorway serving the car park, and a stone walled and slate roofed conservatory (**G**).

- 4.13 The infilling of the narrow, irregular gap between the coach house and the adjacent cottage provided a rudimentary single storey building, with a street doorway and another entrance to the rear (**D**). The rafters are charred,

indicating that it has suffered a fire at some time, and breeze block stores have been built within it.

Photo 7: Street frontage of early 19th century coach house and late 19th century stable(?)

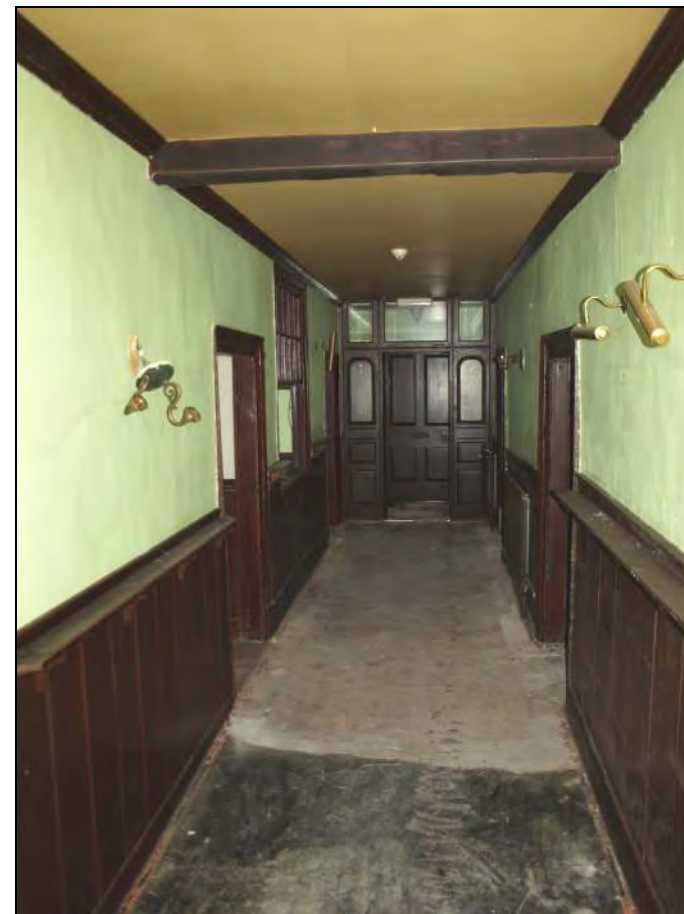
- 4.5 The 1779 building has a central entry in its symmetrical facade, leading into what was once the stairs hall, but the staircase was removed c.1991, thereby creating a passage running straight through to the rear extensions (photo 8). Otherwise, the arrangement of four rooms off this (two to the front and two to the rear) is still largely discernible, despite many modifications, particularly in the bar area: see the appendix for floor plans and lists of significant fixtures). These four rooms would all originally have been heated by their own fireplaces, three of them were probably parlours for the use of the host family and customers, but one of the rear rooms is likely to have been a kitchen (probably the east one, G4) (photos 9-11). The cellar below the 1779 house consists of a single small room, which

Photo 8: View of former stair hall on ground floor (G1), looking towards glazed screen of entrance lobby

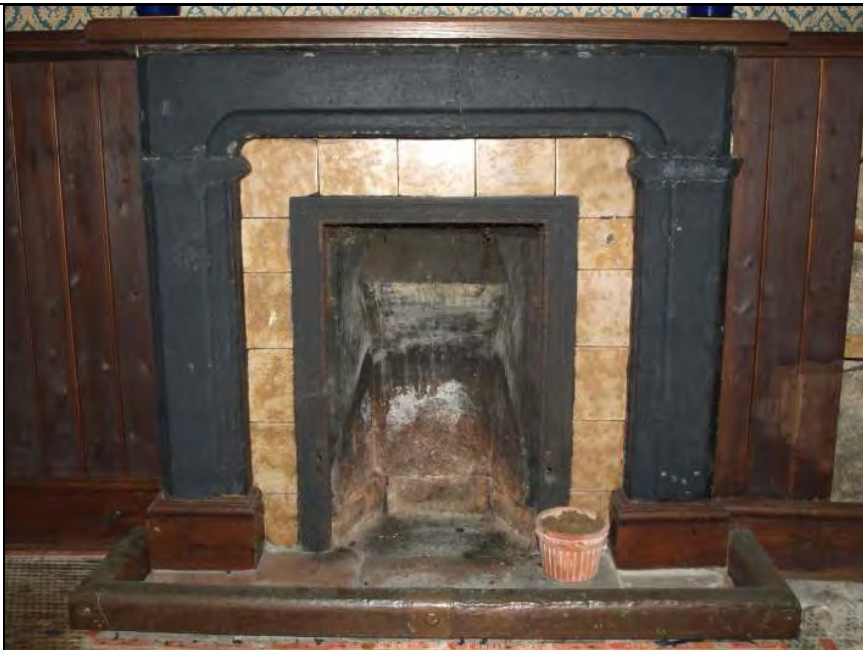
Photo 11: Fireplace in bar (room G2): original stone surround with later infill and fender

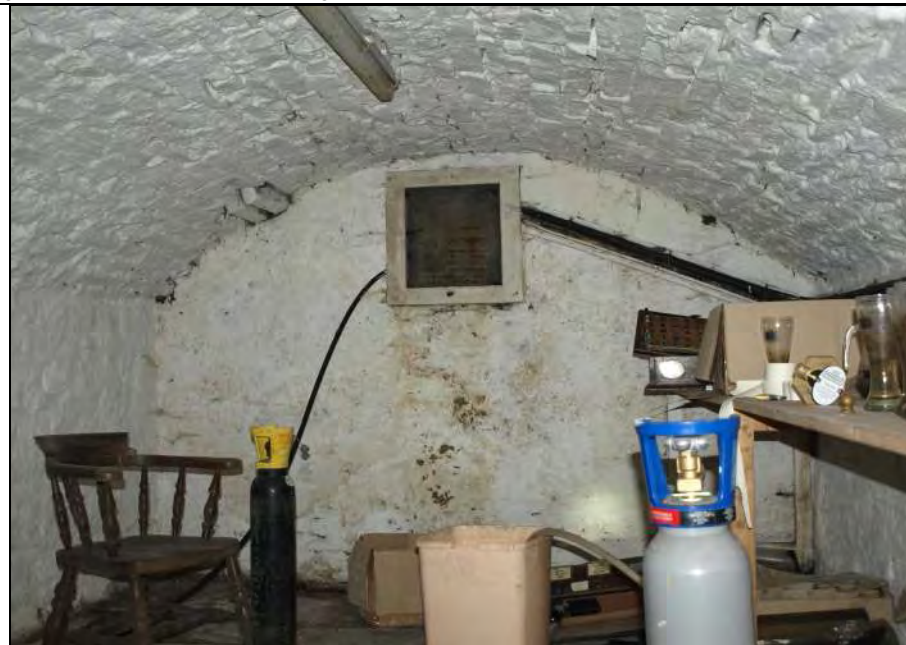
- 4.14 The larger structure of this period forms a projecting wing to the rear of **D**, and is of a single storey with vaulted cellar beneath (photo 13). It has a gable chimney and so seems to have been the back kitchen referred to in 1908, and it still serves as a kitchen today.

Photo 13: Vaulted cellar (room C3) beneath late 19th century back-kitchen

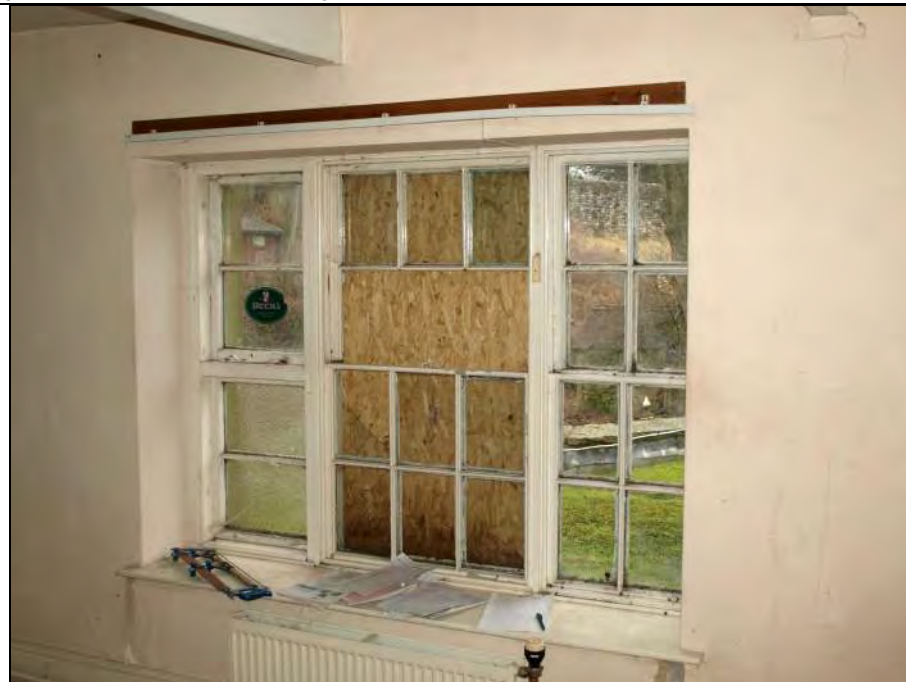
- 4.9 The 18th century building has very varied fenestration. The plain front window surrounds appear to be original, but these contain large two-pane, horned sashes of the late 19th century. Two ground floor windows in the south-west gable are late 19th or early 20th century insertions for the toilets created in this corner of the building, but the double chamfered attic window above, with hood mould, has been re-used from an earlier building. In the rear elevation, the first floor window to room F5 may have been enlarged; next to it is a straight joint

formed by redundant quoins, possibly representing another alteration to the fenestration, but with no clear explanation. The stairs window expected in a house of this design is not present, and might be accounted for by the addition of the rear conservatory having been accompanied by its blocking up, when the stairs were removed c.1991. The window to first floor room F6 is significant as it seems to have been a cross window at one time, and has a hollow chamfered moulding, although mullion and transom are missing, and it contains multi-pane sashes, an anomaly which might arise from the surround having been re-used.

Photo 17: Rear window in bedroom on first floor (F5)

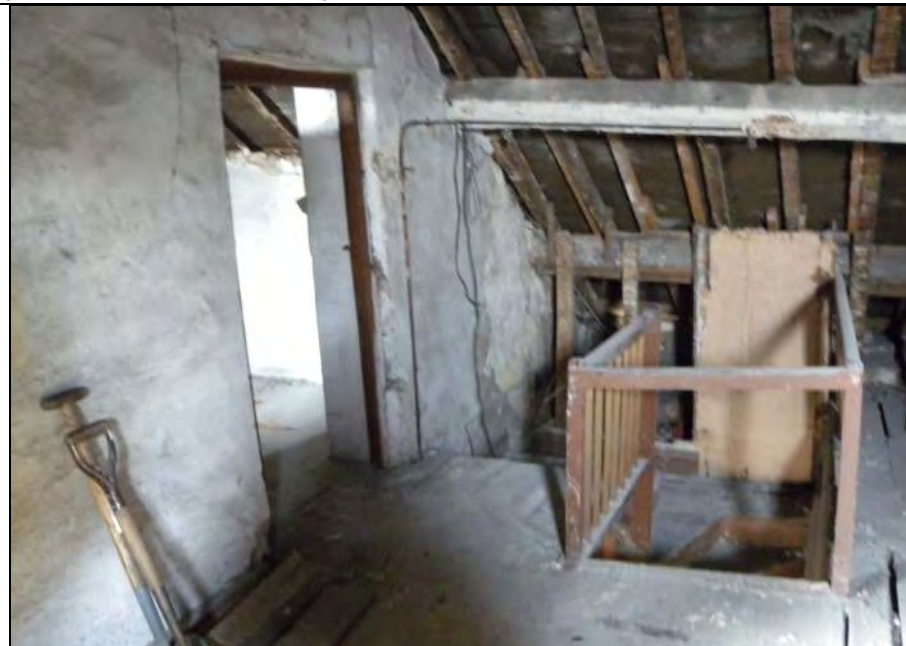
- 4.7 The attic occupying the second floor is entirely within the roof space and has clearly been disused for very many years; structural movement, decay and lack of maintenance account for its very poor condition. It seems to have provided one small and two large rooms originally, all unheated and probably for storage or habitation by servants or other lowly members of the household. The two outer rooms were lit by re-used 17th century windows, set within the thickened walls between the flues rising from the lower floors. The western room (S4/S5) is divided by a 19th century partition of panelled doors, suggesting that one of the two doorways off the landing is inserted. However, the ceiling in this room and the roof truss have been strengthened at some time, which suggests that an earlier partition may have been replaced (photos 20-22).

Photo 20: Second floor landing (S1): view towards top of stairs

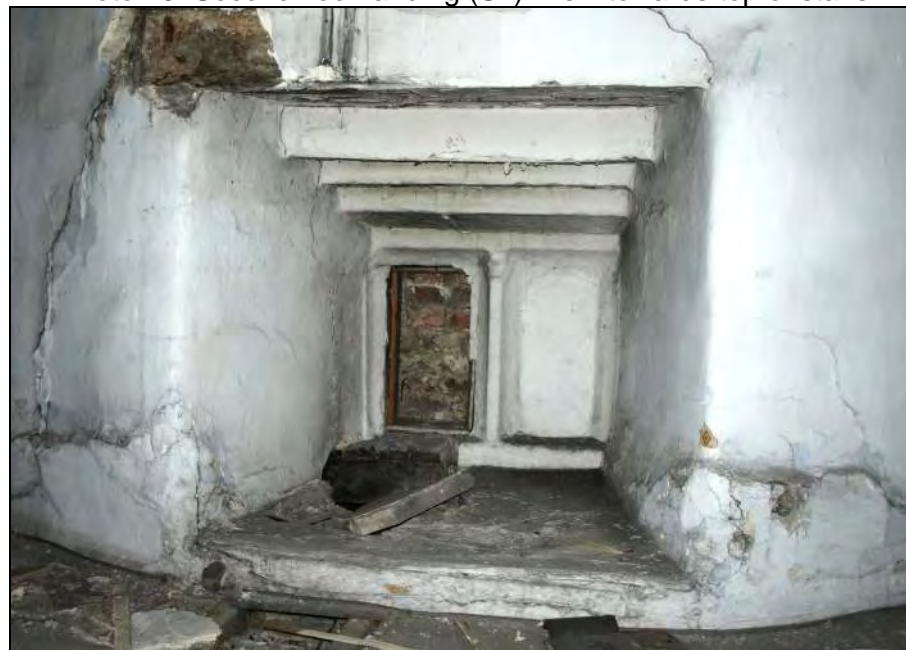
Photo 21: Blocked second floor window in north-east gable of 1779 building

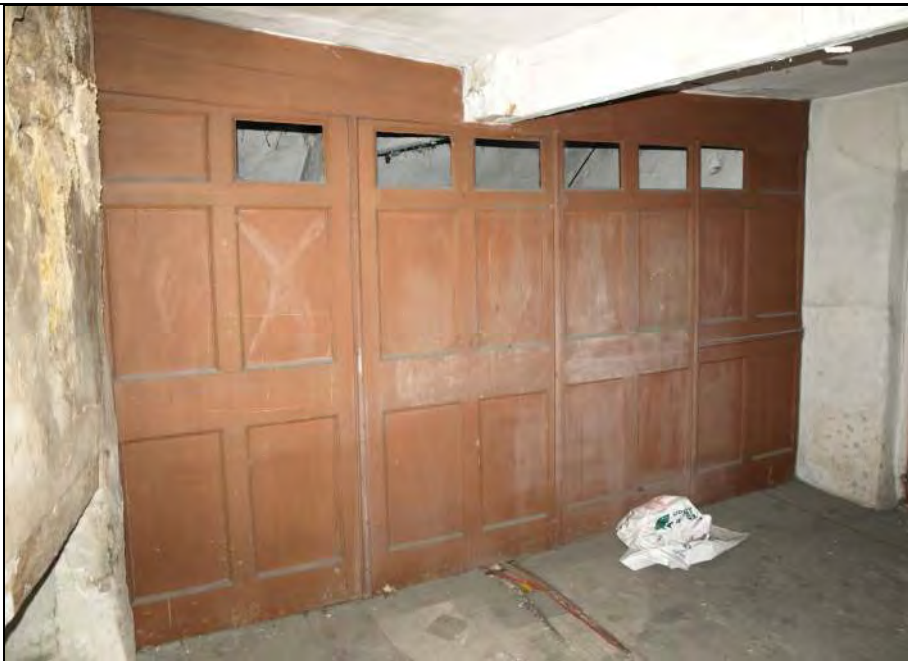
Photo 22: 19th century partition between second floor rooms S4 and S5

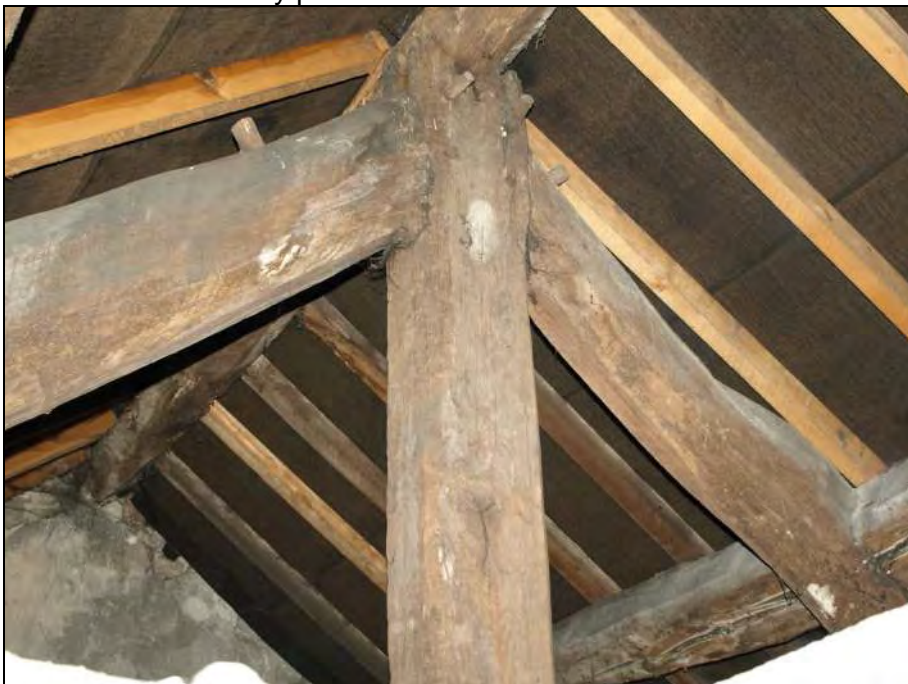
- 4.8 The roof is carried on a stone cross wall, to west of centre, as well as two trusses, of pegged king post design, which have a slightly steeper pitch than is typical for the stone slate roofs of the district (photo 23). The type of timber is not certain, and it may be oak, another locally grown hardwood, or perhaps pine, but it has been only roughly converted and is not of the square-sawn form which became common from the end of the 18th century. The purlins are of similar material and are trenched into the principal rafters, and the square ridge is diamond-set, so the roof was constructed in a traditional way, rather than according to 18th century pattern book designs.

Photo 23: King post of pegged roof truss in 1779 building
