Kirk Mill, Chipping, Lancashire

Archaeological Building Investigation

Oxford Archaeology North

August 2013

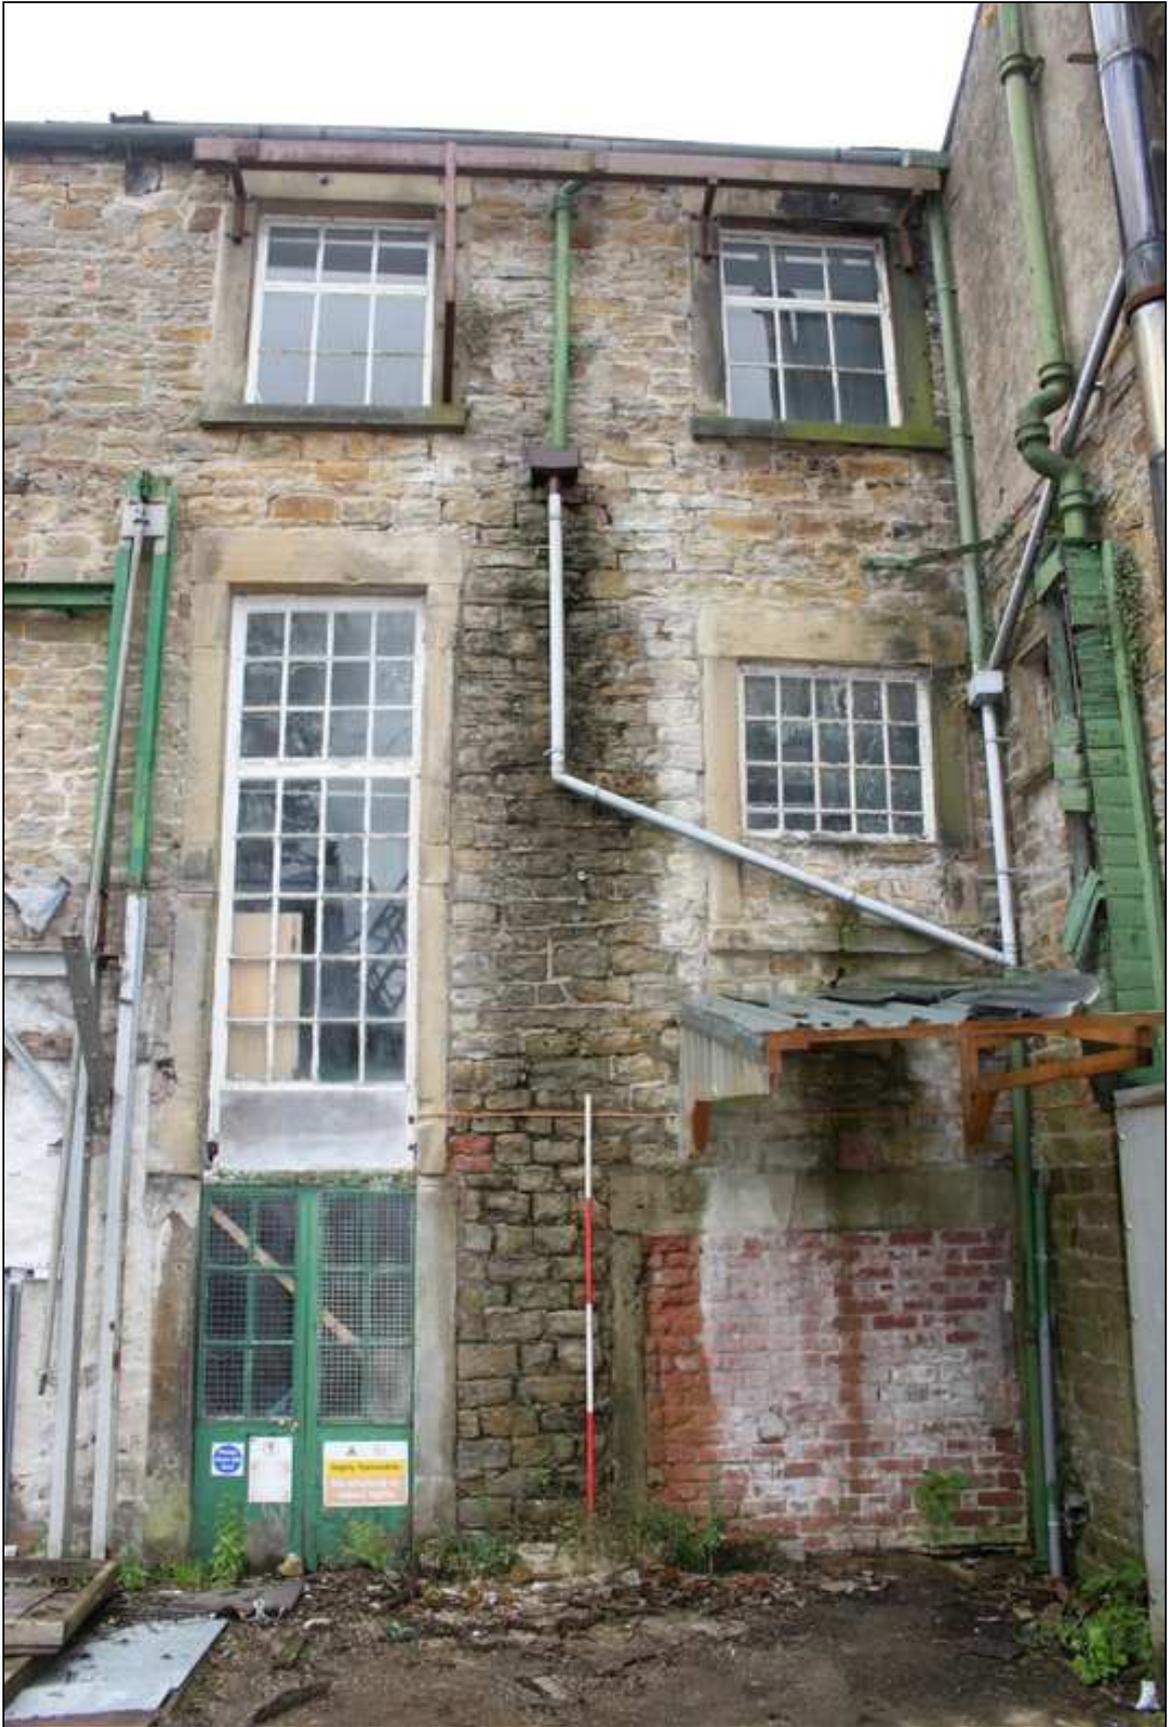
- 3.2.4 The eastern bay of the main façade houses the present waterwheel, and has similar windows to those elsewhere, at first- and second-floor level, that on the first floor having been reduced in height subsequently (Plate 8). It has a wider dressed doorway at ground-floor level, which afforded access directly to the waterwheel, presumably to allow maintenance of the buckets. This doorway was blocked with brick subsequently (Plate 8).

Plate 8: Façade of engine and wheel houses

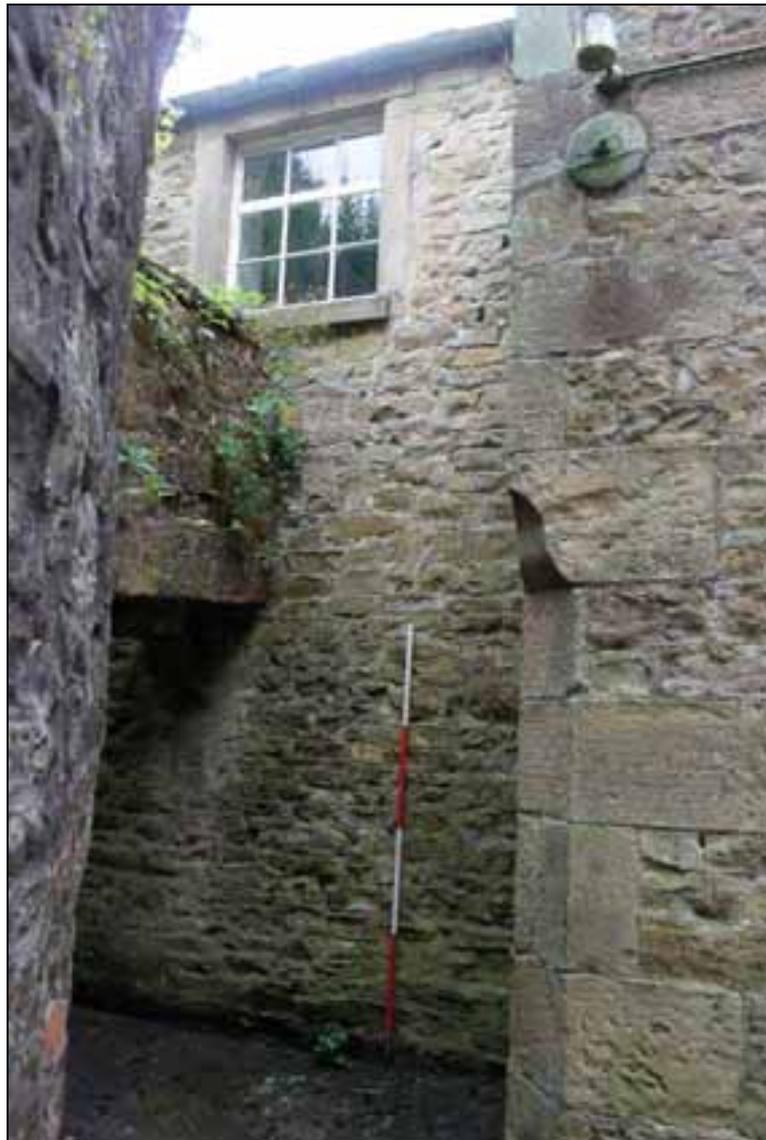
3.2.5 The earliest surviving element of the rear (northern) wall of the mill is in the position of the engine and wheel houses. This wall is of similar sandstone rubble, roughly-coursed construction, with windows at second-floor level, similar to those of the southern façade (Plate 9). At first-floor level, the headrace for the waterwheel entered the eastern bay, and comprised coursed sandstone side walls above a concrete base, with steel stirrups above a sandstone sill in the wall face (Plate 10). This was flanked by similar rubble walls, each with a large sandstone block base (Plates 9 and 11), both presumably representing earlier side walls of the head race. That to the west provides further evidence that the original waterwheel was placed in the western of the two bays, as it would have positioned the headrace into that bay. The documentary evidence suggests that the original waterwheel of the cotton mill was placed externally, and that the area was only enclosed when the wheel was replaced by a wheel in the position of that now present. However, internal evidence (*Section 3.3.29, below*) strongly suggests that the north wall of this structure was repositioned, by a distance of approximately only 4' (1.21m) to the north, almost certainly undertaken to incorporate a larger waterwheel (possibly the extant waterwheel).

Plate 9: North wall of wheel house and chamfered return of main mill

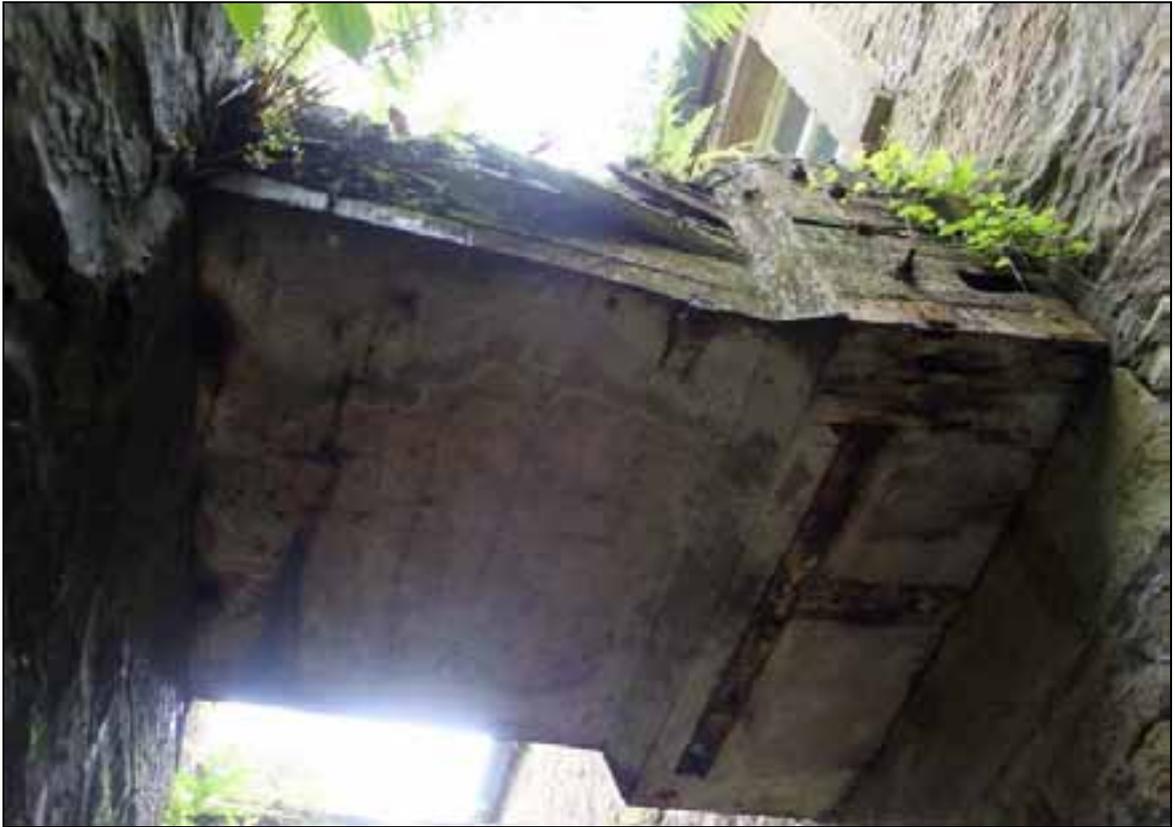
Plate 10: Concrete base of headrace

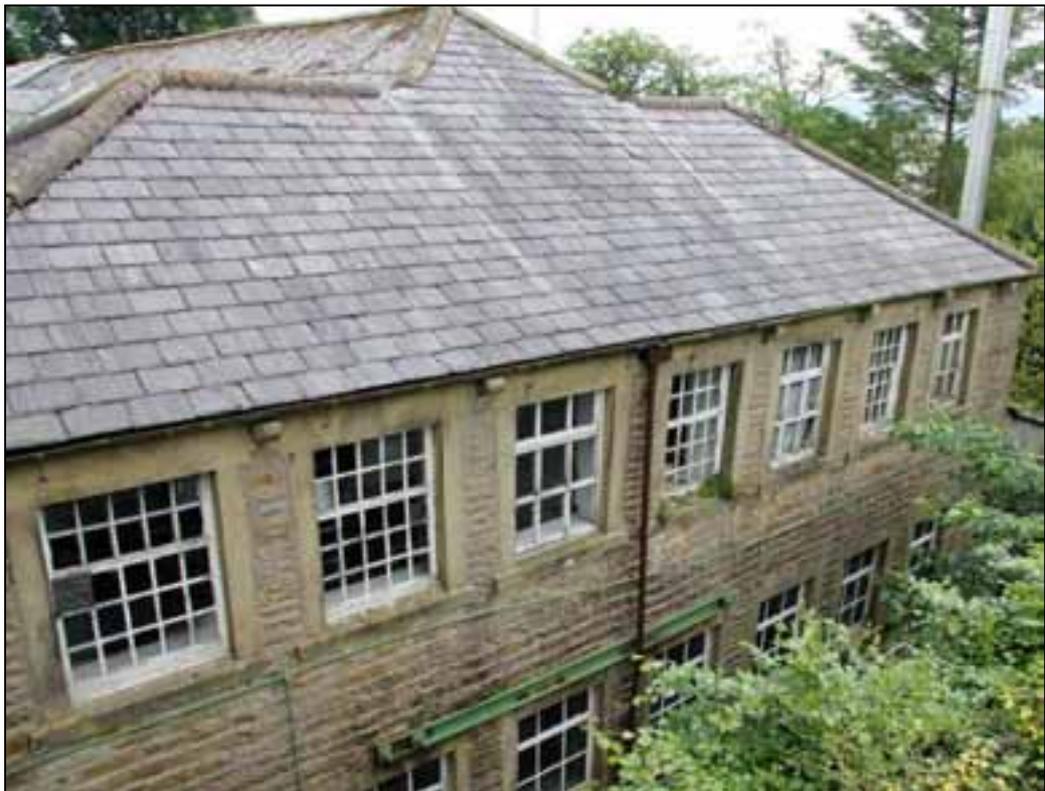
- 3.2.6 The western extension of the mill was in the form of a cross wing, and originally extended beyond both the front and north facades of the earlier structure. It was of more ordered coursed rubble construction, with dressed quoins to the elevation returns, and projecting convex corbels at eaves height, carrying the moulded gutters, similar to those of the original construction. The windows were also of similar proportions to the earlier structure (Plate 12). The north wall of the wing had a single window at second-floor level. This was quoined either side, with those to the east forming part of the return of the wing, where it was butted by the later repositioning of the north wall of the main mill (Plate 13). On the western side of the window, the quoins continued to second-floor level, where a sandstone threshold appeared to be a reused lintel from an earlier structure (Plate 13), or more probably the lintel of a doorway below, forming a loading loophole, and that was refaced subsequently following the blocking of the doorway. Slight differences in the colour of the sandstone in this area suggest this may have been the case, and have a ragged western edge, suggesting that the quoins for the lower door were removed.

Plate 12: External west elevation of the west wing

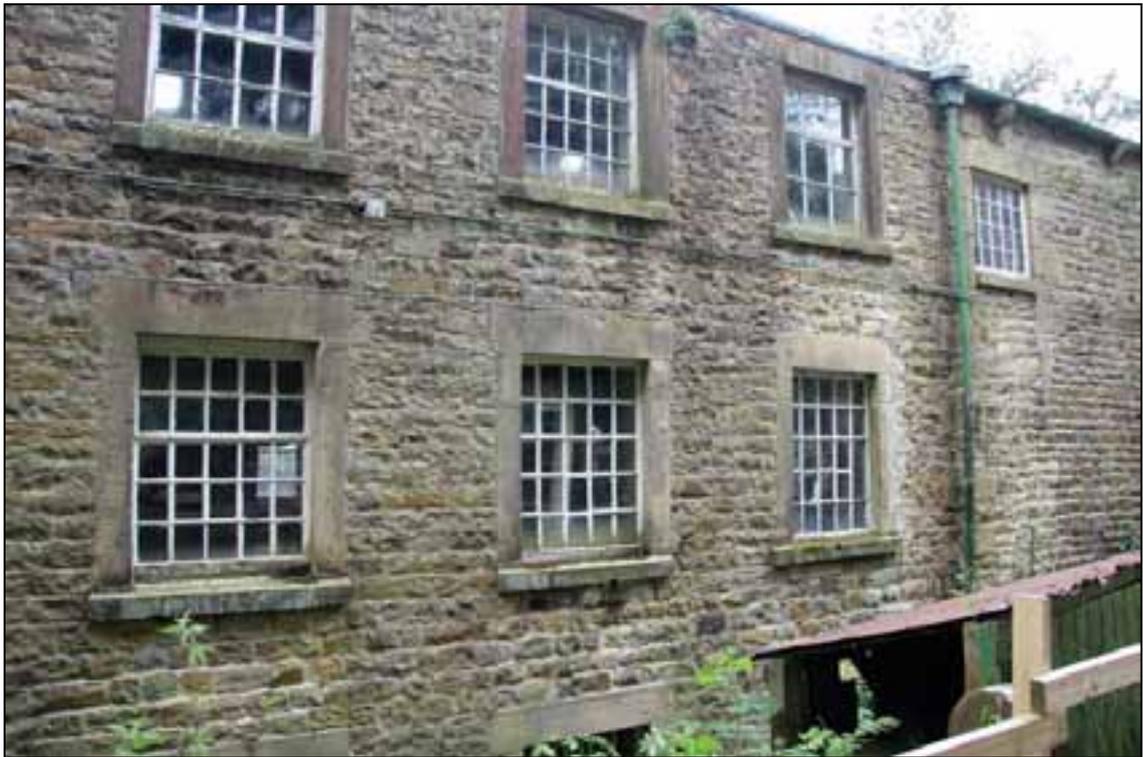
- 3.2.8 The north wall of the original mill was repositioned approximately 11' (3.35m) to the north following the erection of the western cross wing, creating a wider L-shaped plan. The new wall was of similarly coursed construction to the west wing, which it butted, and had windows of similar style to each of the three floors (Plate 14). The north-eastern corner of the new wall, which now projected beyond the wheel house, was externally chamfered at first-floor level, with a lamb's tongue stop to the quoins above (Plate 9), allowing easier passage between the mill and the reservoir wall, positioned immediately to the north (Plate 9).

Plate 14: External elevation of repositioned north wall of main mill

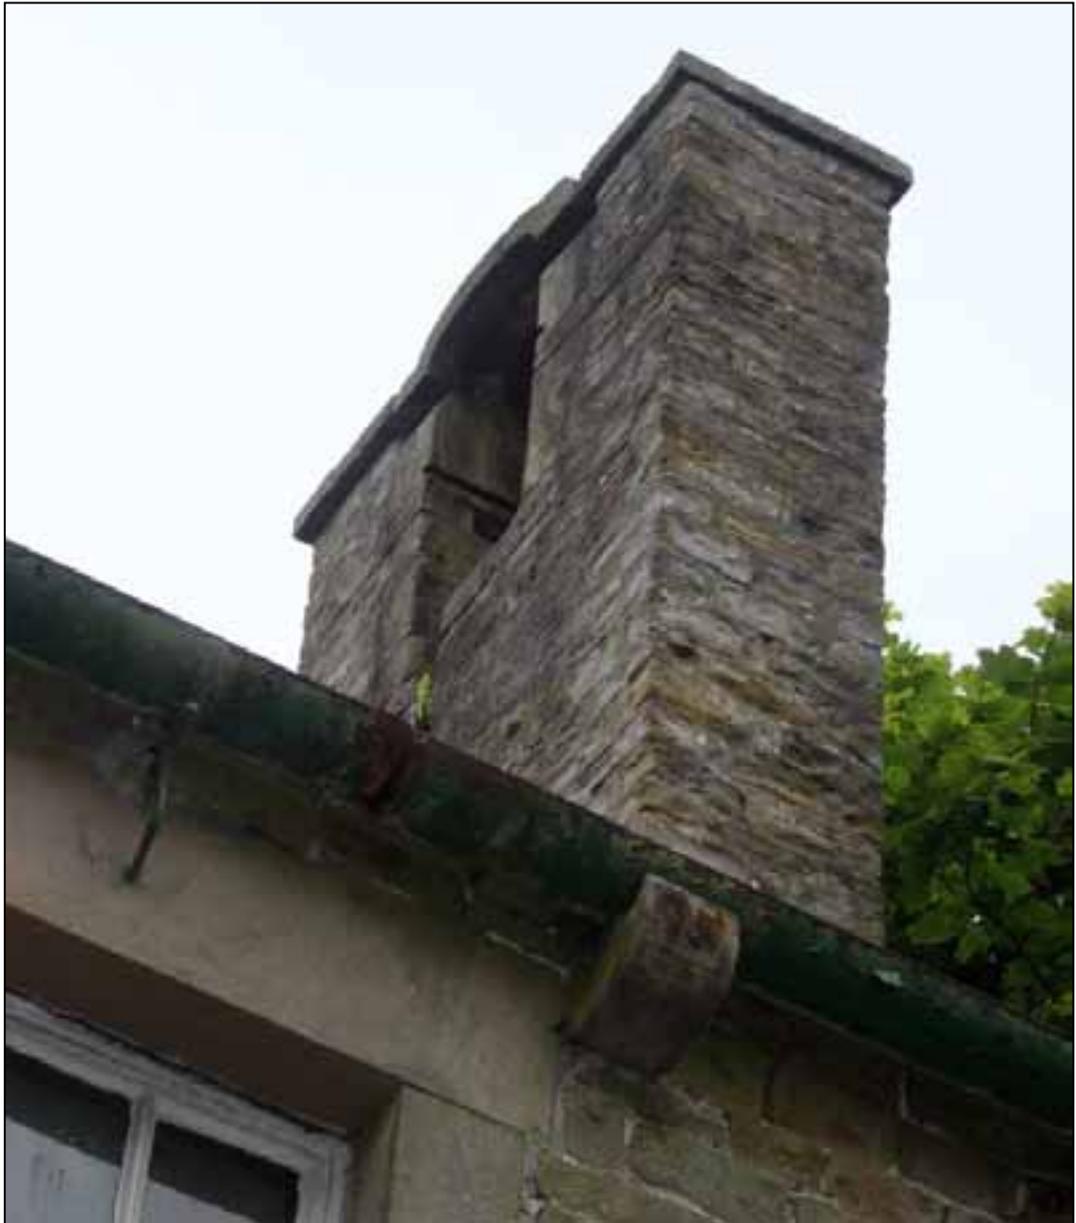
3.2.10 The tower was only visible at ground floor externally on its western side, the remainder being below external ground level at this point. It was of similar construction to the other remodelling episodes, comprising coursed local sandstone, and with quoined returns to each elevation. Unlike the earlier fabric, many of the quoins retain mason's marks (Plate 16), again possibly indicative of a secondary date of construction compared with the repositioned north wall. The north wall of the stair tower was capped with a simple bell cote, with oversailing sandstone copings (Plate 17).

Plate 17: Bell cote above stair tower

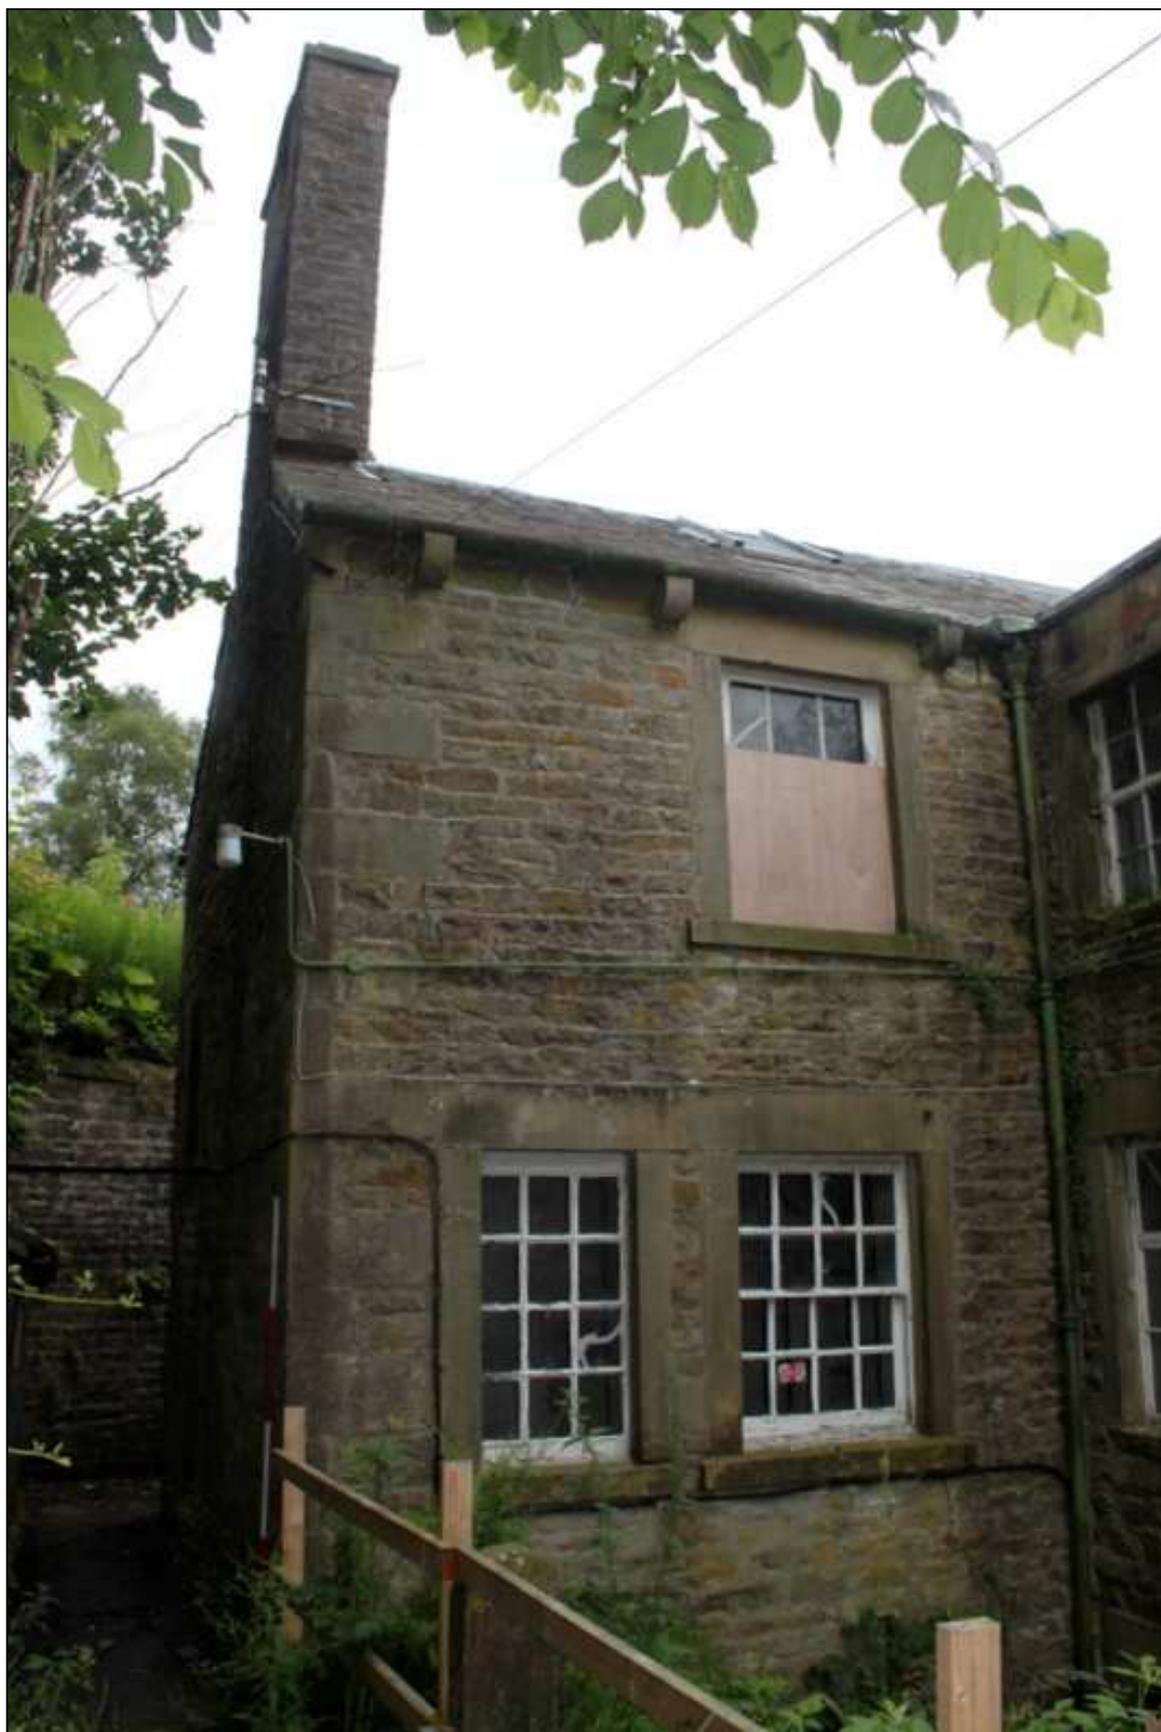
3.2.11 The windows of the west elevation of the tower were similar in size to those of the main mill, but with the southern of two ground-floor windows retaining a possibly original 16-light vertical sash windows, typical of the nineteenth century (Plate 18). The north wall had smaller lights into the stairwell, whilst the east wall had a small 16-light window to the upper floor, and a narrow double door with 10-light fanlight providing the external access into the stair tower.

Plate 18: The west elevation of the tower, showing the 16-light window

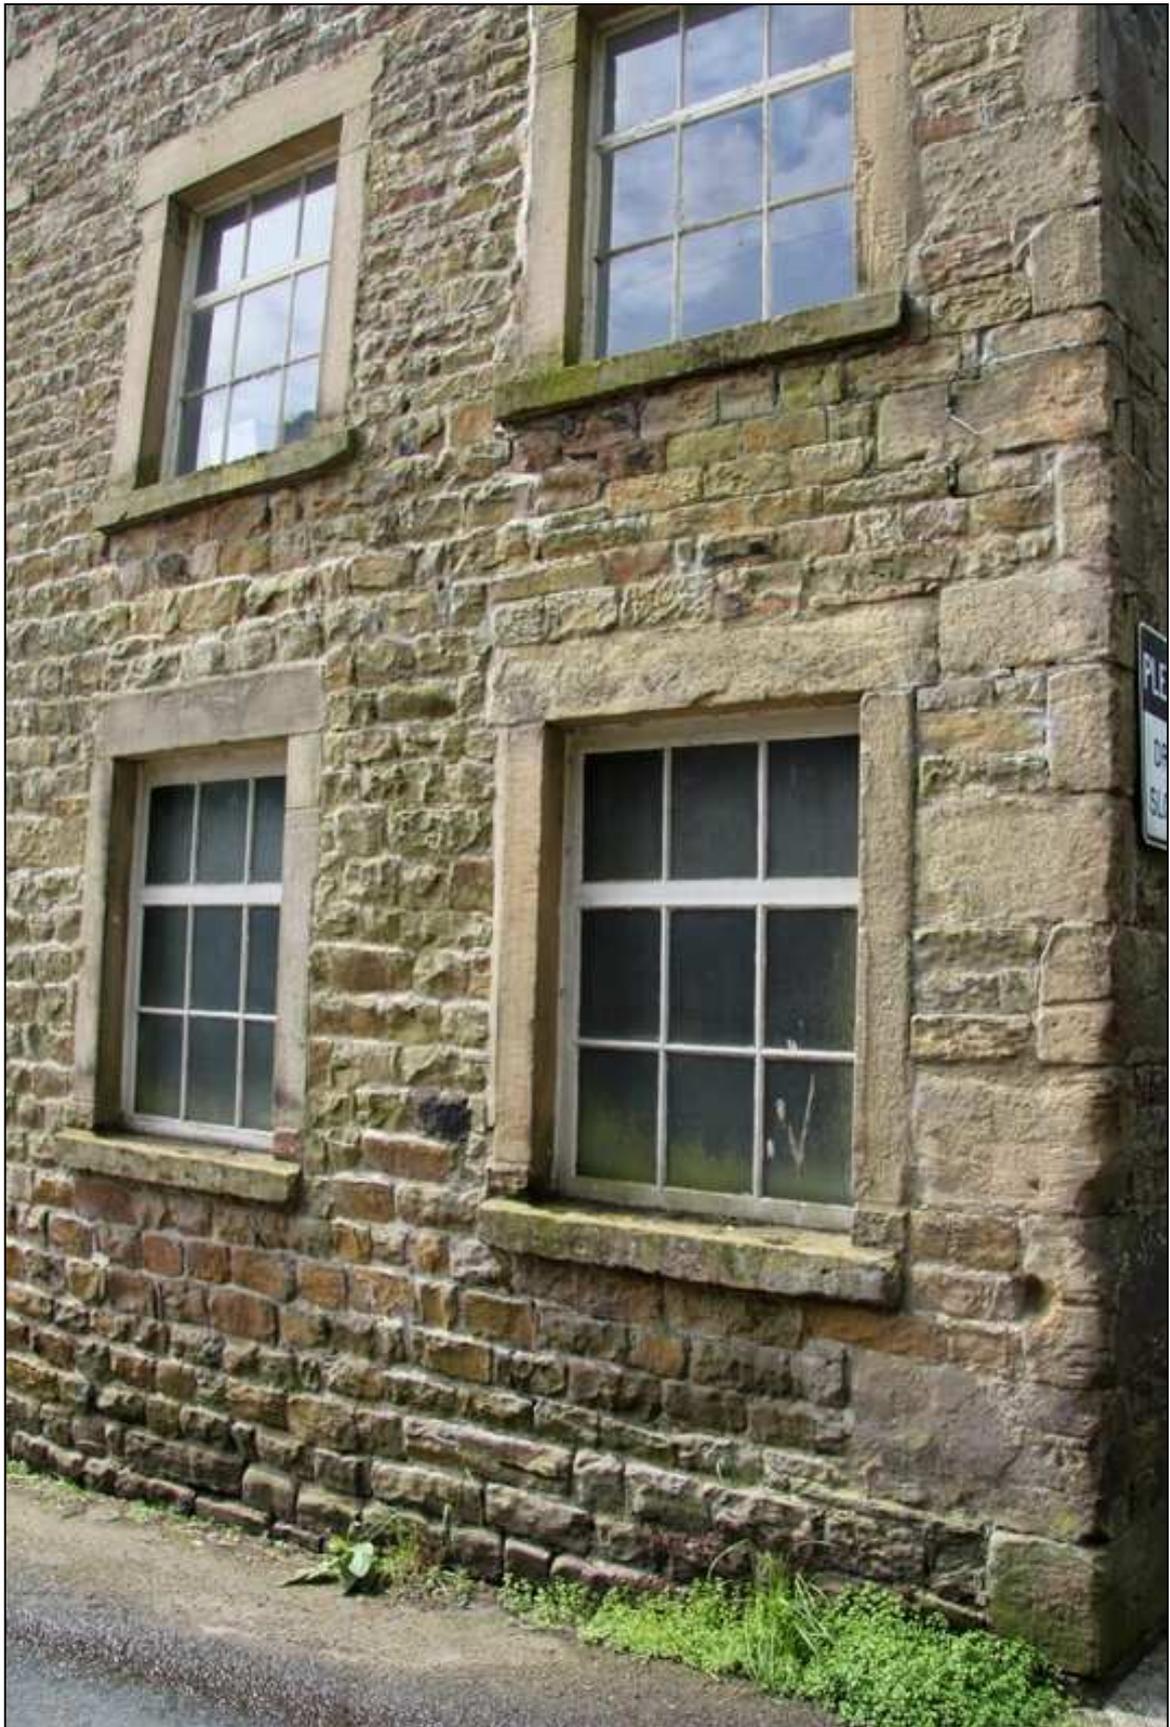
- 3.2.13 The northern wall was also repositioned subsequently, moving it flush to the wheel house, which had earlier been extended, as demonstrated by the quoins around its eastern return (Plate 11). This allowed for an extra window to be inserted at first- and second-floor level (Plates 19 and 20). The rebuilding of the wall can be seen within a subtle change in coursing and stone dressing at the northern end of the elevation, and a subtle change of gradient in the pitch of the roof (Plates 19 and 20).

Plate 20: North return of the east wing, showing rebuilt wall and inserted windows

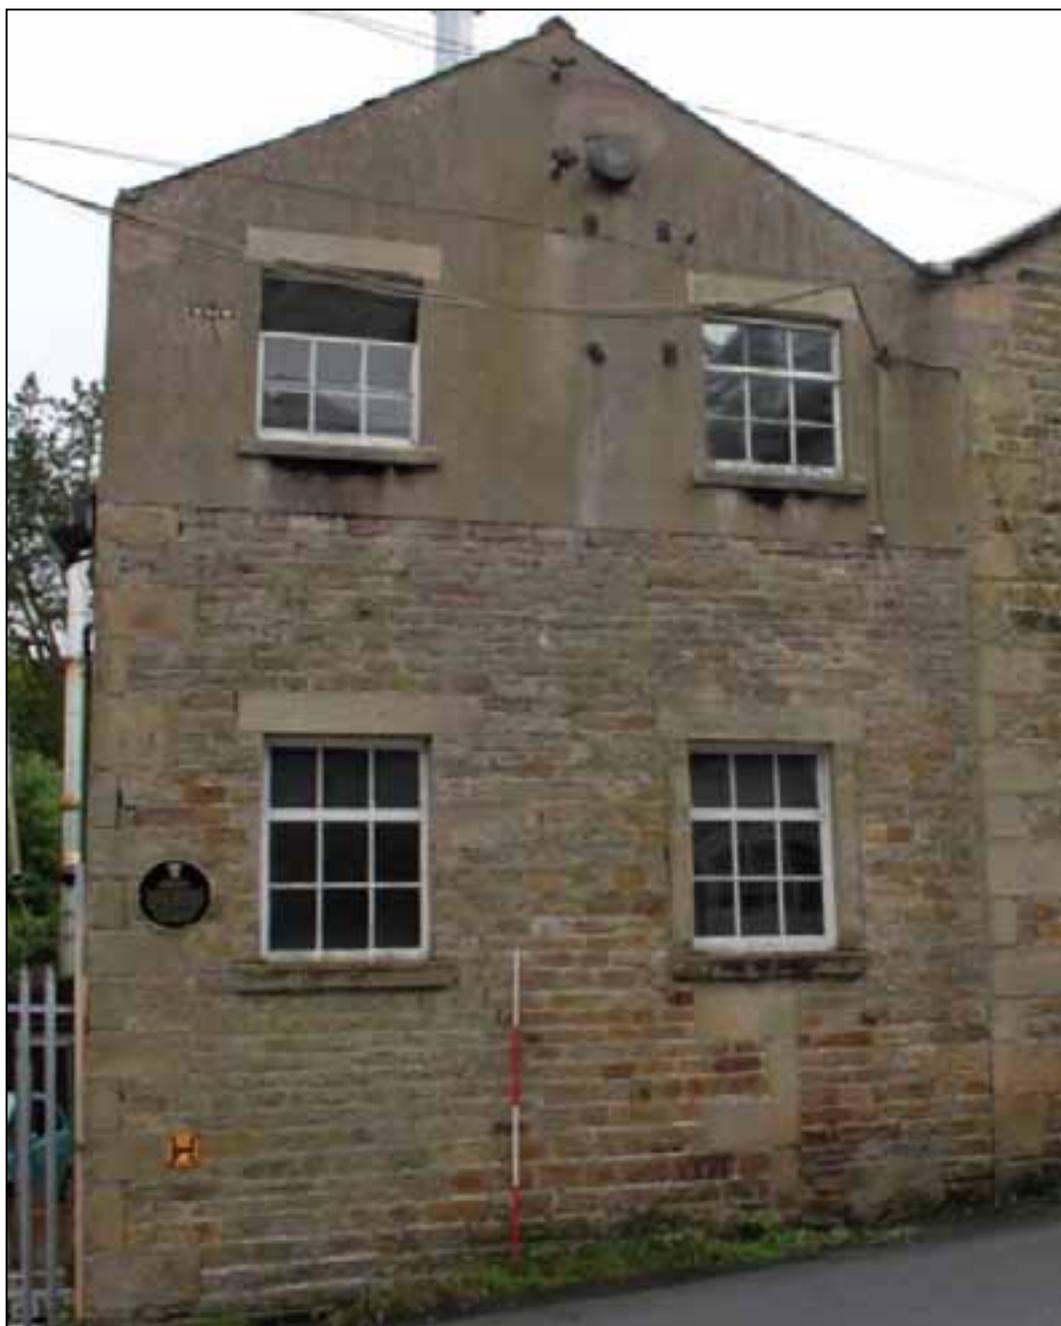
3.2.14 A 20' x 23'6" (6.11 x 7.16m) further extension was added to the southern side of the eastern extension, butting the line of quoins in its south-eastern corner (Plates 19 and 21). Its original construction in coursed local sandstone rubble was similar to that to the north, but comprised only two storeys, at ground- and first-floor level. The east wall has nine-light vertical windows at first-floor level (Plate 21), with a horizontal six-light window at first-floor level in the west wall (Plate 22), flanked on its northern side by a small four-light tilt into the privy within the extension.

Plate 21: Southern extension to the east wing

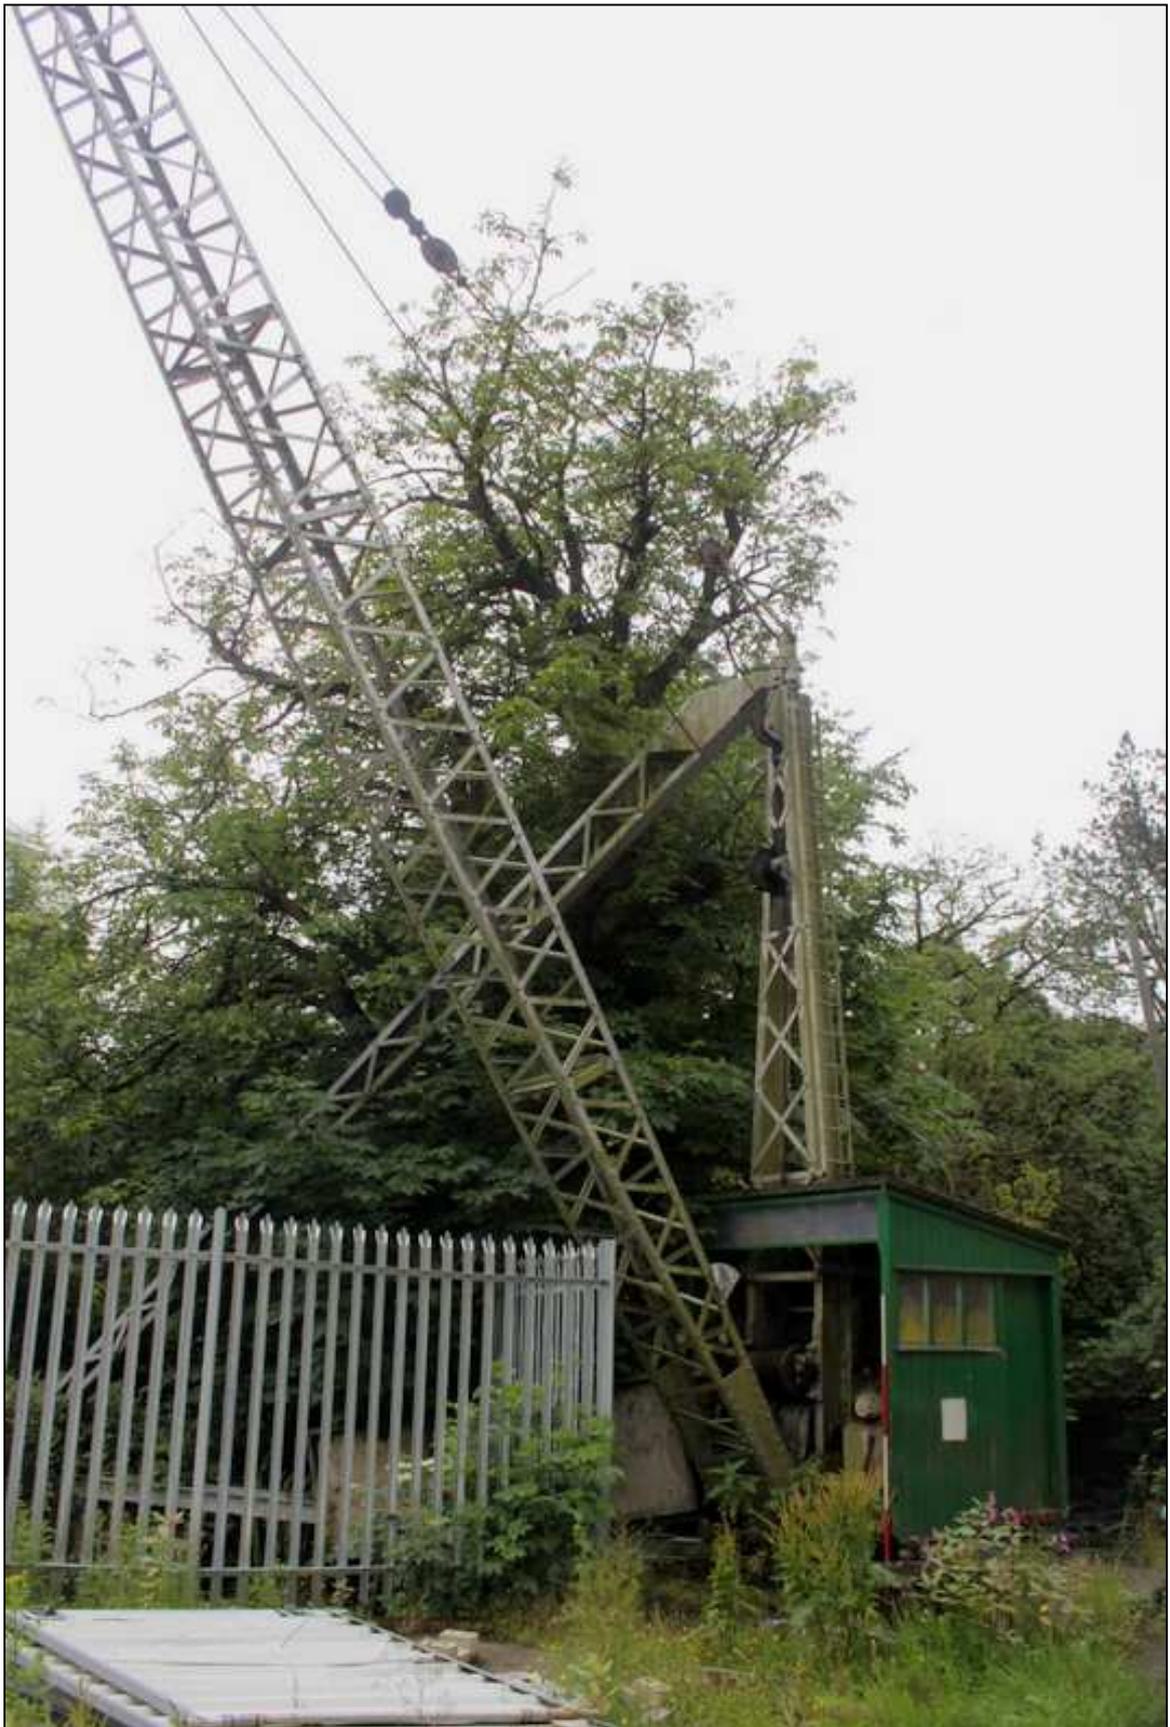
- 3.2.19 To the east, placed adjacent to the canalised brook, is a derrick crane (Plate 25). Although similar in appearance to that depicted in the photographs of 1924 and 1933 (Plates 2 and 3), the crane legs were renewed in 1954, and a new sheltered cabin was added in 1981 (Plate 24). It is probable that the gearing forms part of its original construction.

Plate 25: Derrick crane

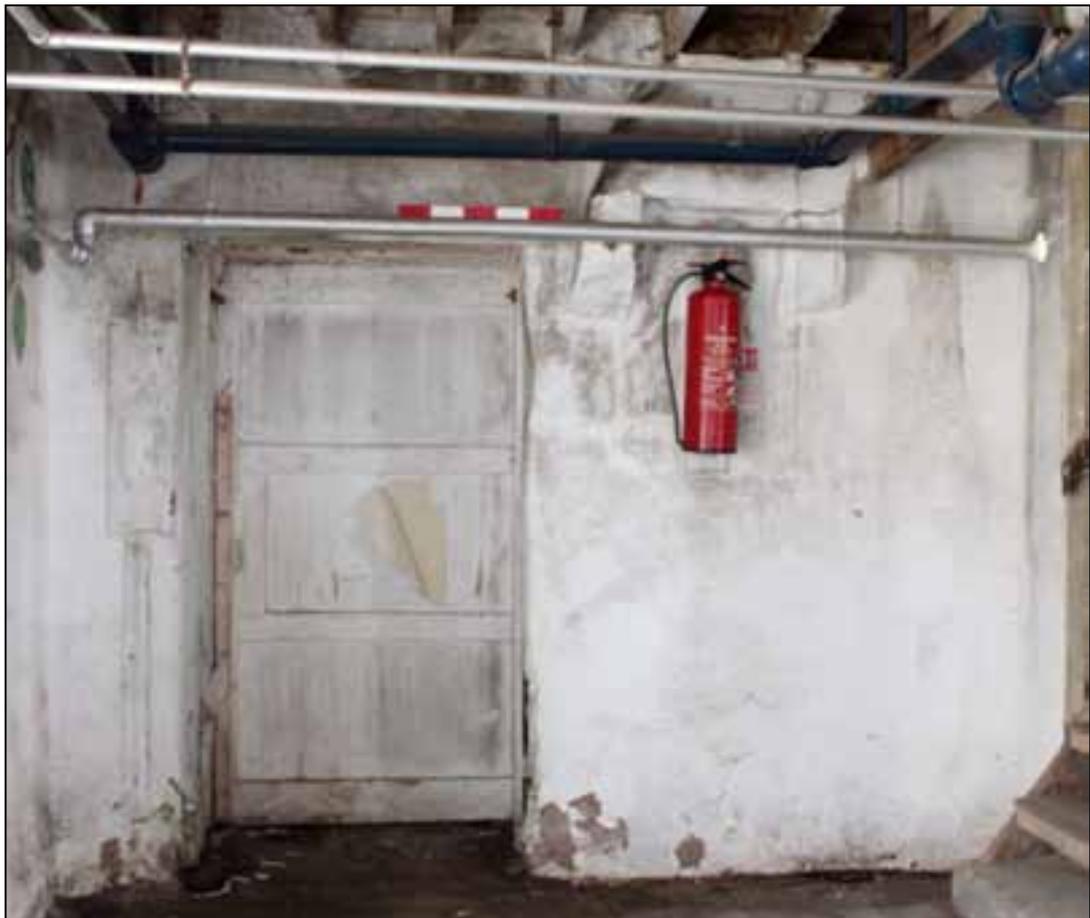
- 3.3.7 The western bay of the north wall of the extension also contains what appears to be an original doorway (Plate 34), with the corbelled footings of a hearthstone placed immediately to the east below ceiling level providing the only evidence for a fireplace on the floor above (Plate 34). An extant doorway in the adjacent bay within the west wall was inserted through a window aperture. The window to the east in the north wall had a flat sill, unlike those in the west wall, but was similarly placed 3' (0.91m) above floor level, terminating 8" (0.21m) below ceiling height.

Plate 34: Door in north wall of west wing, and corbels carrying hearth of fireplace above

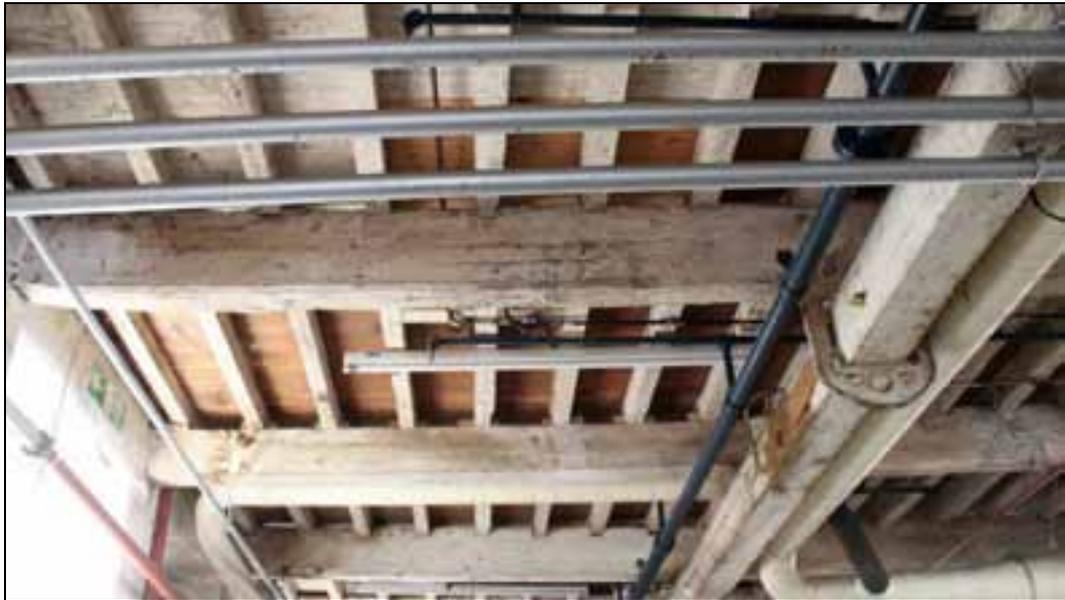
- 3.3.8 The ceiling of the extension comprises north/south-aligned 3 x 4½" (0.08 x 0.11m) joists carried on 6½ x 13" (0.16 x 0.33m) beams, the third from the southern end having Baltic timber marks at its western end. All beams, with the exception of the fourth beam from the southern end, which is a circular-sawn replacement, are stop-chamfered at either end, but not above a central north/south-aligned 8 x 10" beam with rolled-edged soffit (Plate 35). This suggests that this beam represents an insertion, originally being supported at either end by a 3½" diameter, cylindrical column with octagonal section foot. That at the southern end was removed subsequently, leaving only the scar of the column head (Plate 36). The beam was also strap-jointed to alternate beams with cast-iron brackets (Plate 35).

Plate 35: Additional longitudinal ceiling beam in west wing

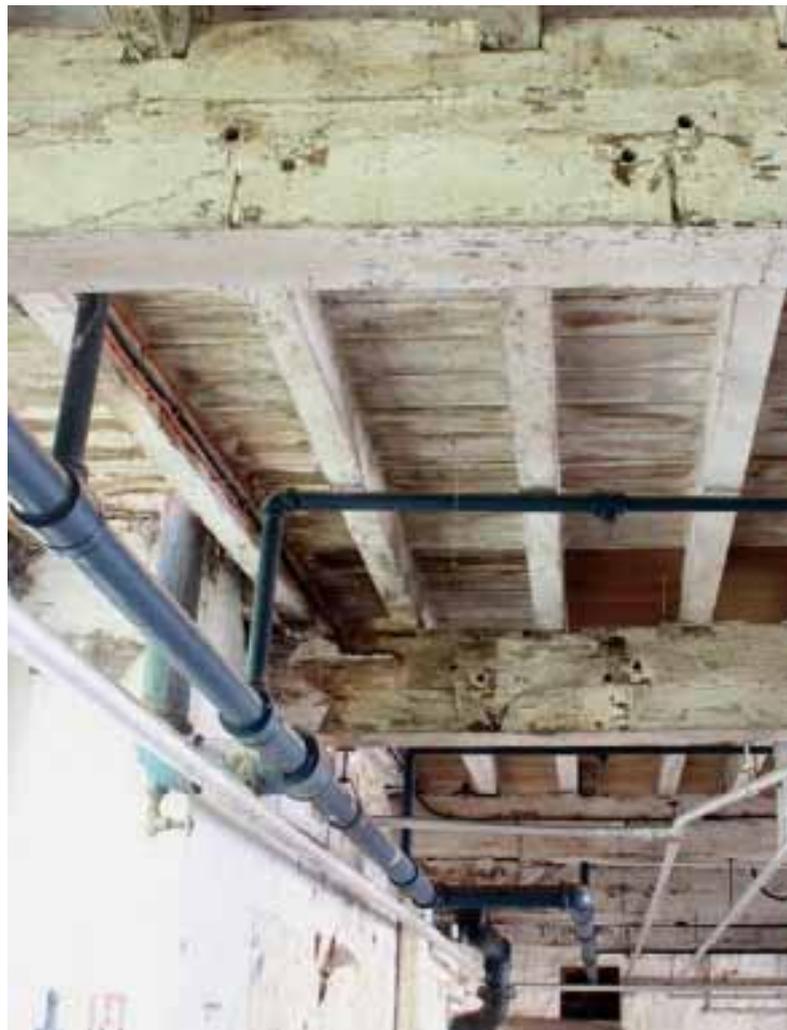
- 3.3.12 A further similar shaft was placed 40" from the north wall (Plate 40). Again the penultimate beam retained four round-headed bolts, with 4" vertical gouges on the western face, positioned 19" apart, presumably relating to drum scars. Similar scars were observed on the remaining beams (Plate 40). The bolt holes were not present in the two beams to the east of the late stairs to the first floor, but both of these comprise circular sawn replacements, the original beams to the east being 6 x 12" pit-sawn beams with narrow chamfers. The main body of the western original beam is flanked by timber 9½ x 2" fitch plates for the majority of its original length, blocking the early cut-outs for shafting. This beam and the adjacent ones, also have a second semi-circular cut-out.

Plate 40: Bolt holes and scars for northern line shaft, with end bearing in background

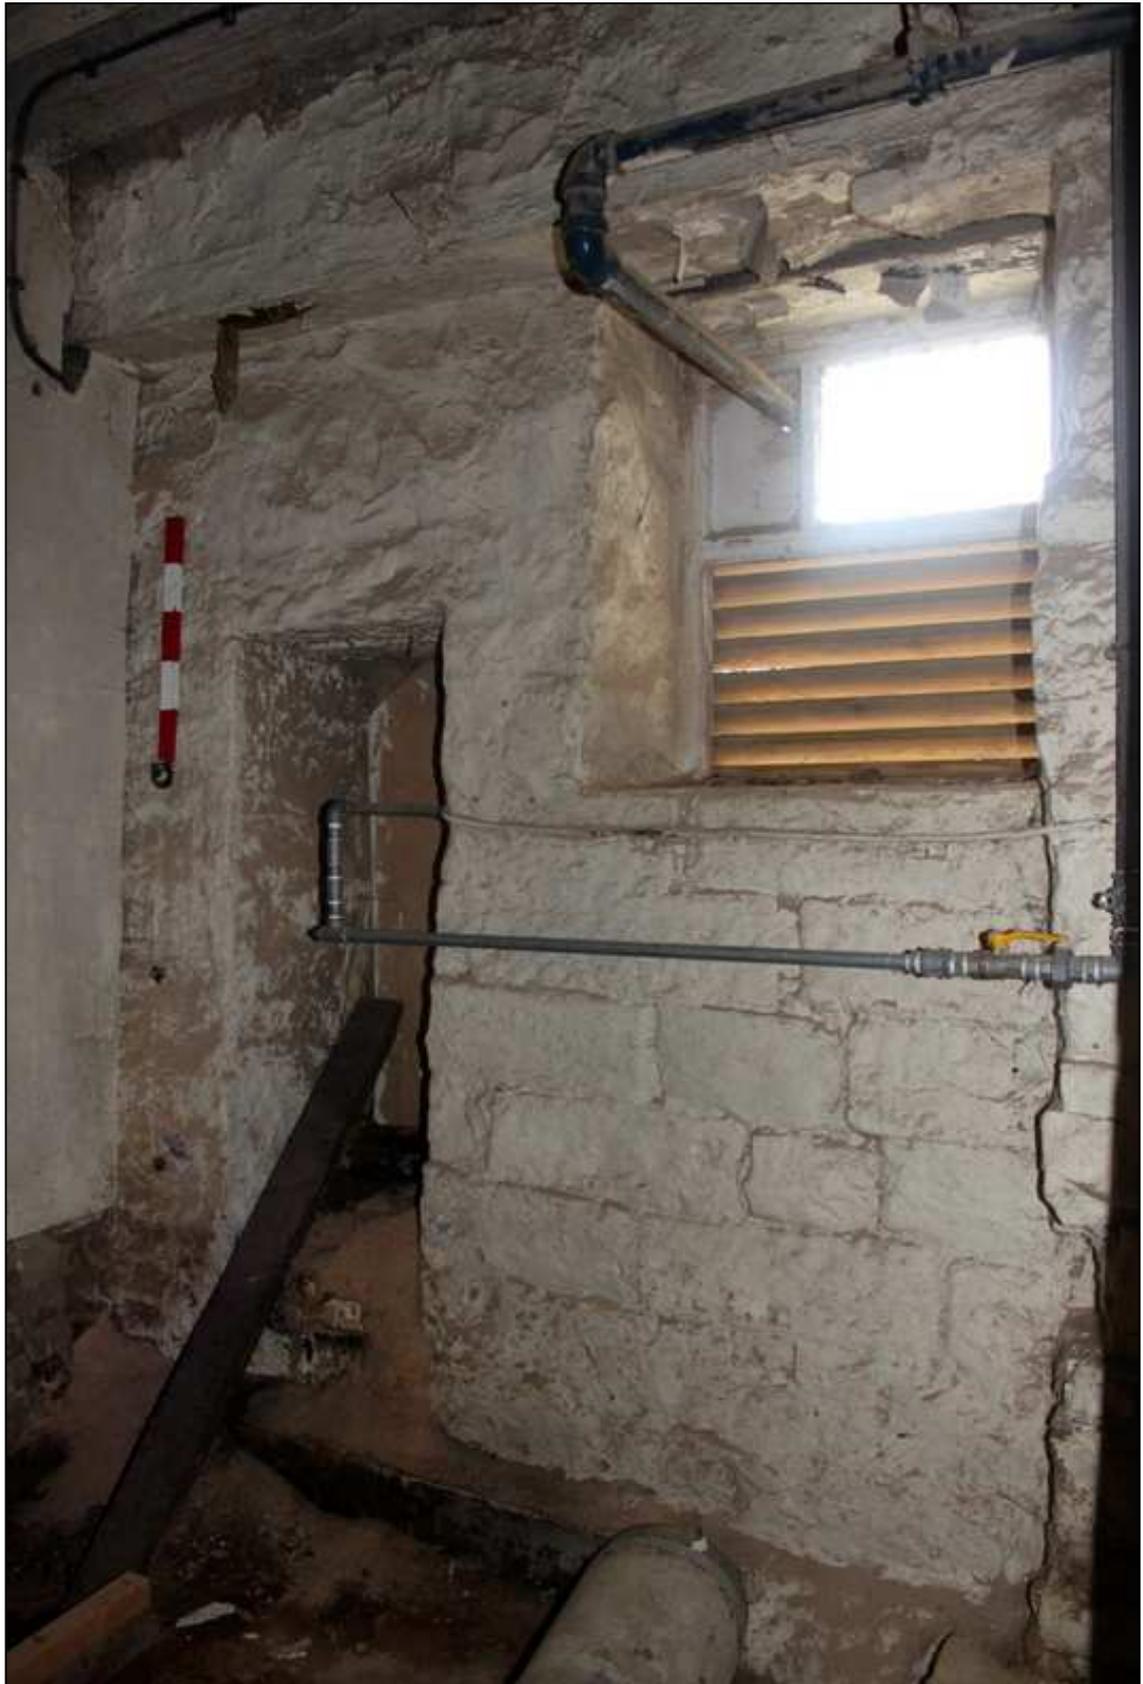
3.3.16 In the eastern bay of the ground floor of the original structure, a partitioned area latterly housed a large machine linked to the main dust extraction unit. The window aperture appears remodelled to the full width of the bay on its eastern side, with a timber lintel above a stone wall infilling, recessed 6" behind the original wall face. This housed a 31" wide, 3' high casement adjacent to a 19 x 53" vertical aperture, externally stone blocked and with a projecting internal sill (Plate 44). This is similar in style to a rope drive bearing aperture, but possibly housed the drive to an external pit saw.

Plate 44: Blocked aperture in the south wall of the engine house, with possible bearing box on the left
