Kirk Mill, Chipping, Lancashire

Archaeological Building Investigation

Oxford Archaeology North

August 2013

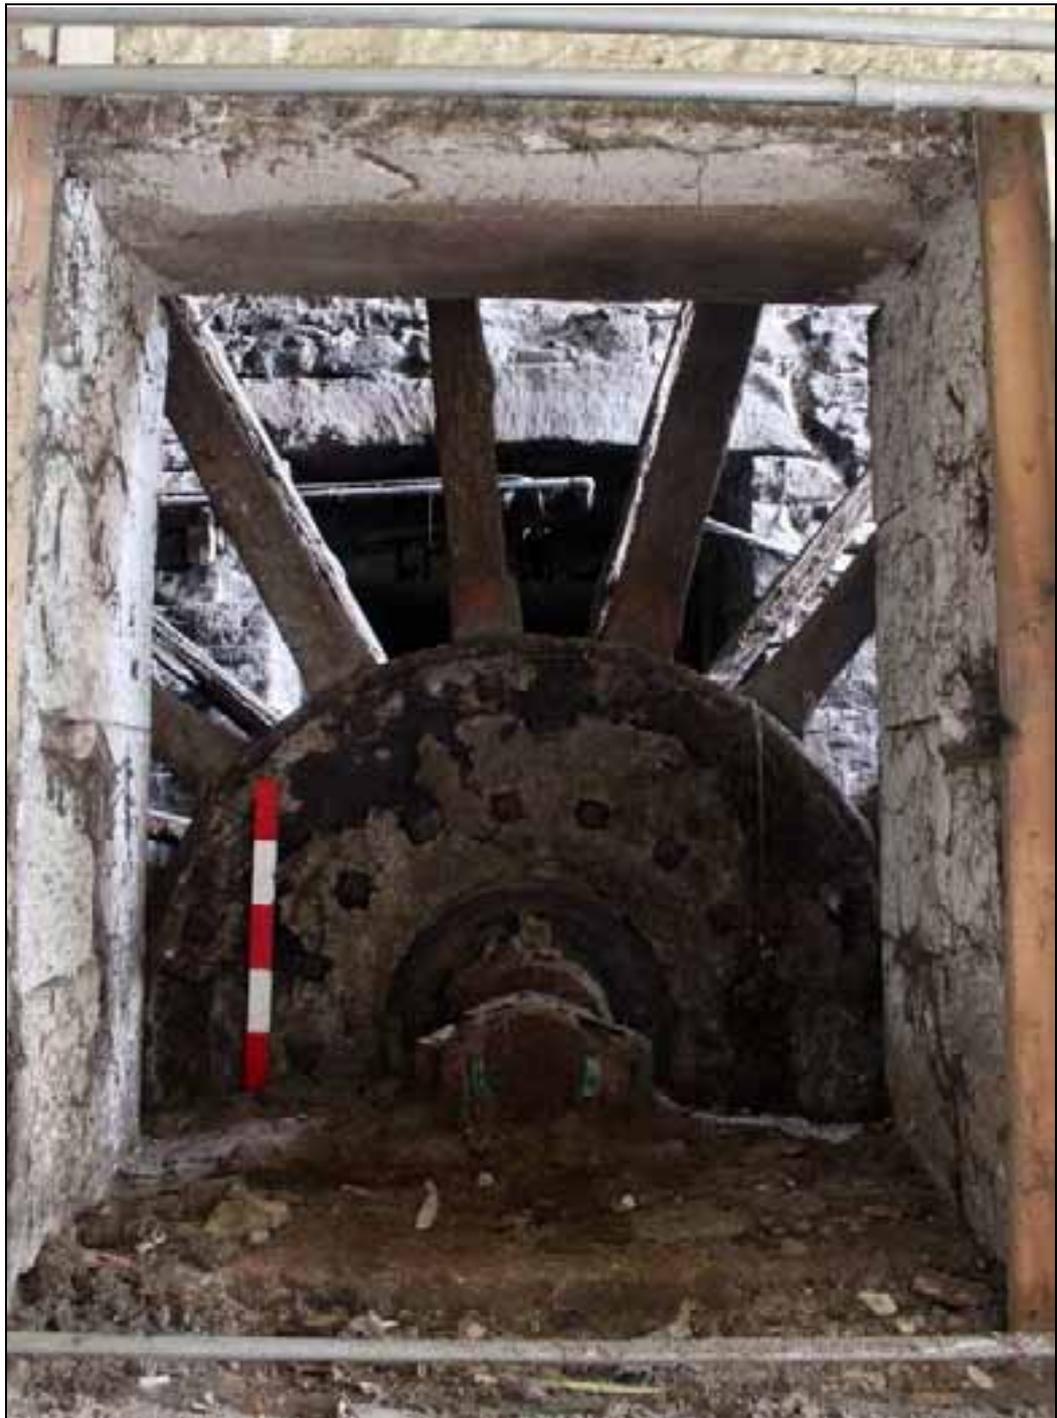
3.3.18 The east wall has a brick-blocked doorway at its southern end, adjacent to a full-height doorway in the south wall, which appears original. The west wall has a corbel at its northern end, placed below beam height in the main structure to the west, but significantly below the rebuilt ceiling within this bay. A 3' 6" x 4' 6" aperture to the south houses the axle of the extant waterwheel, and is of dressed block construction (Plate 46). The 5¼" diameter iron axle has a phosphorus bronze lining to its mounting, the top plate of which has been removed (Plate 46).

Plate 46: Waterwheel axle

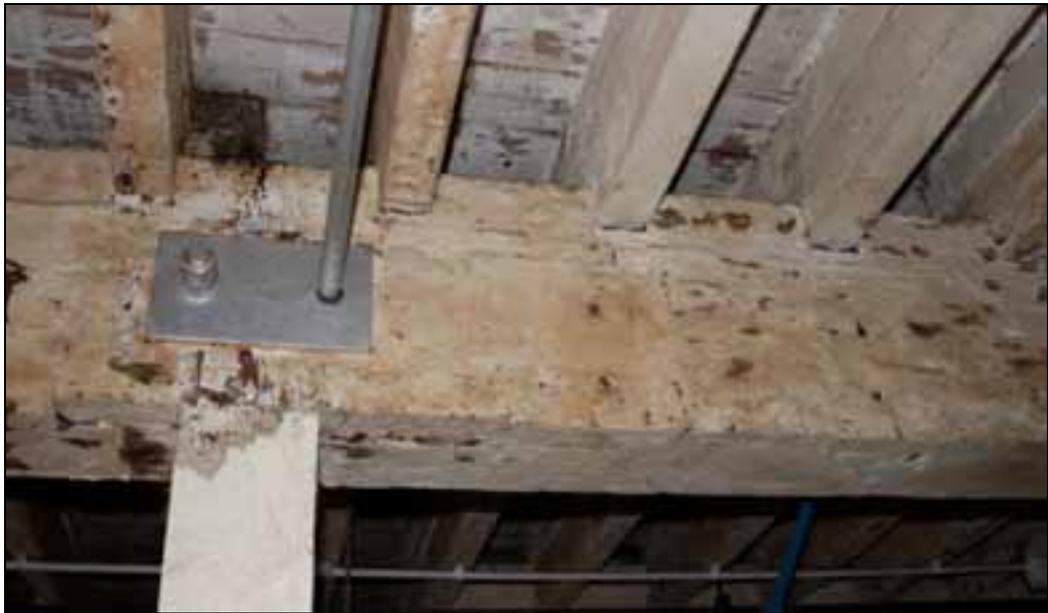
3.3.21 The western beam has a replaced section on its eastern face, which possibly relates to the end of the original line shaft. The infilling timber has bolt holes relating to later hangers (Plate 51), observed on each beam to the east, the last of which has an apparently associated scar for a very large wheel or drum (possibly 6' diameter), the joists above all being replaced (Plate 48). This drive aligns with a large blocked bearing box in the east wall (Plate 48), associated with the extant gearing for the present waterwheel. Circular cut-outs in the eastern three beams relate to an earlier line shaft, placed almost immediately to the south, whilst the adjacent beam has a repaired soffit, presumably infilling the earlier cut-out. The third beam has a 2' wide 1" deep scar for a drum on its western face, and a large strengthening timber bolted below (Plate 52). The beam to the west has a similar strengthening member projecting from the south wall.

Plate 51: Timber fillet in beam face and later line shaft hanger bolt holes

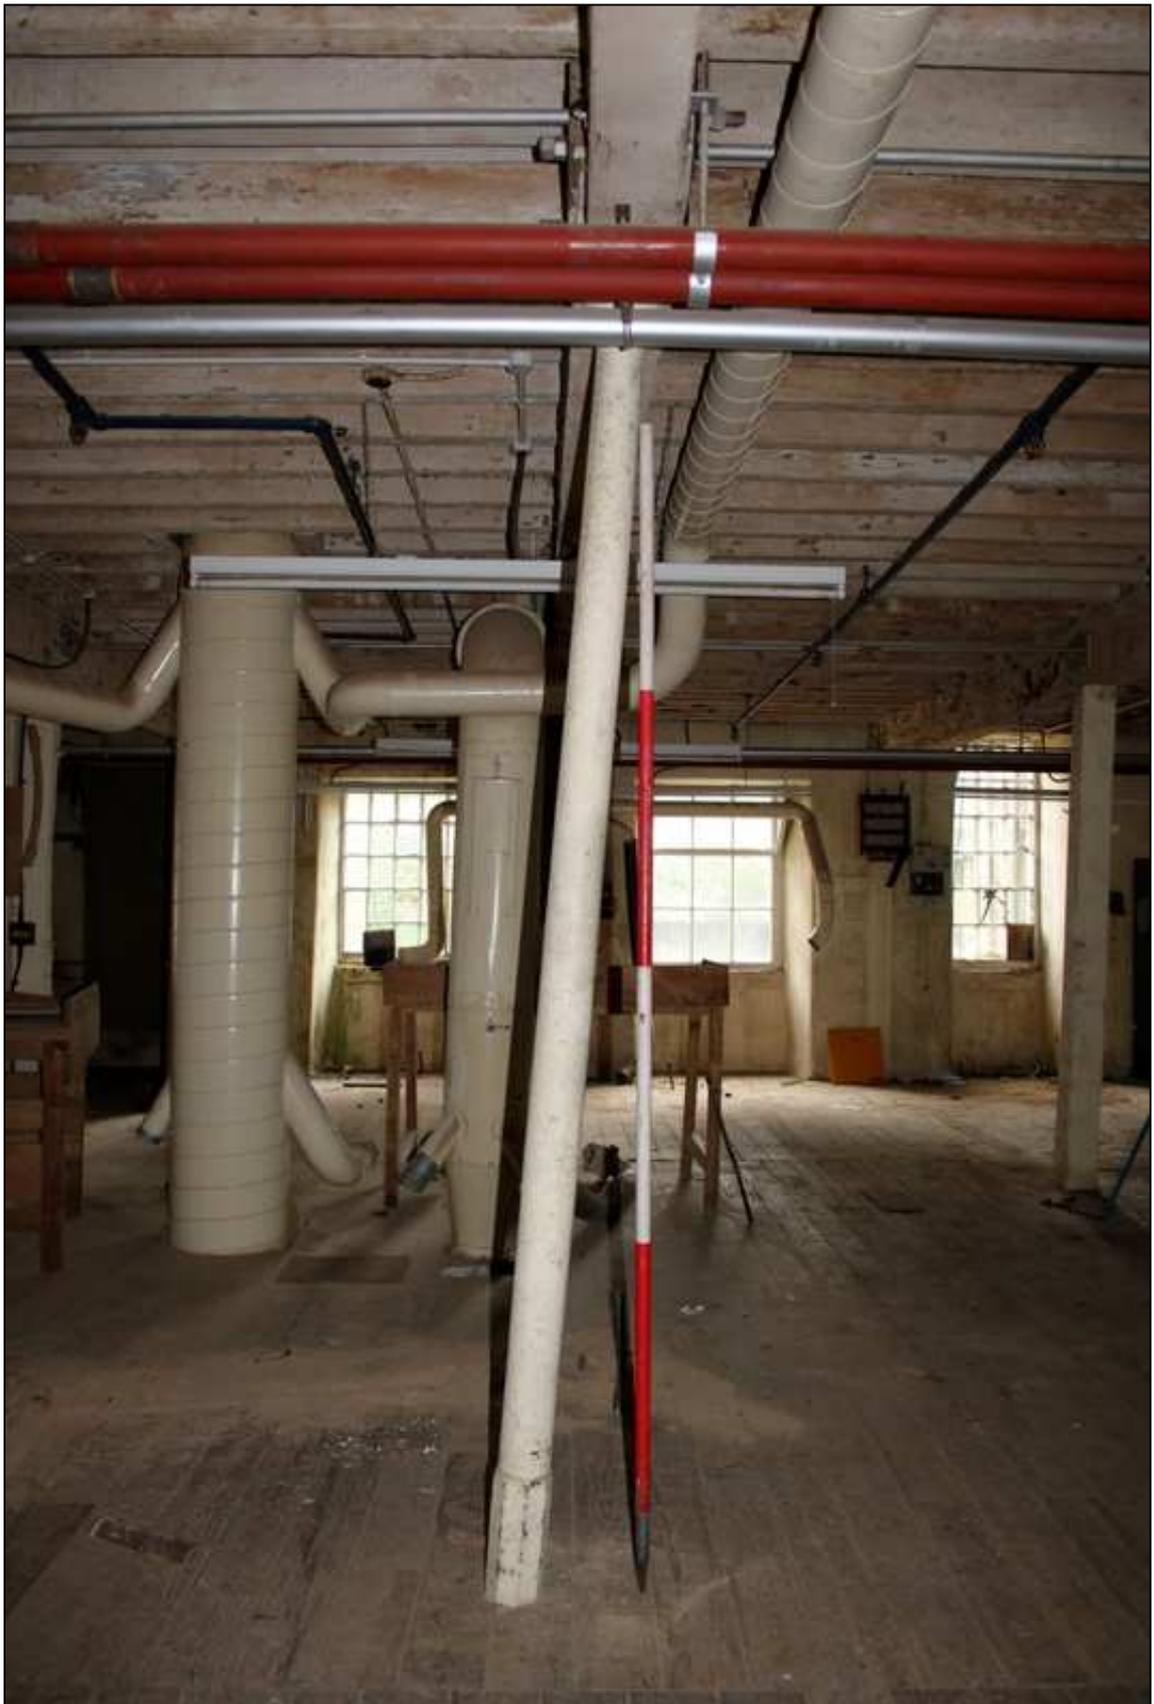
Plate 54: Deflection of first-floor column

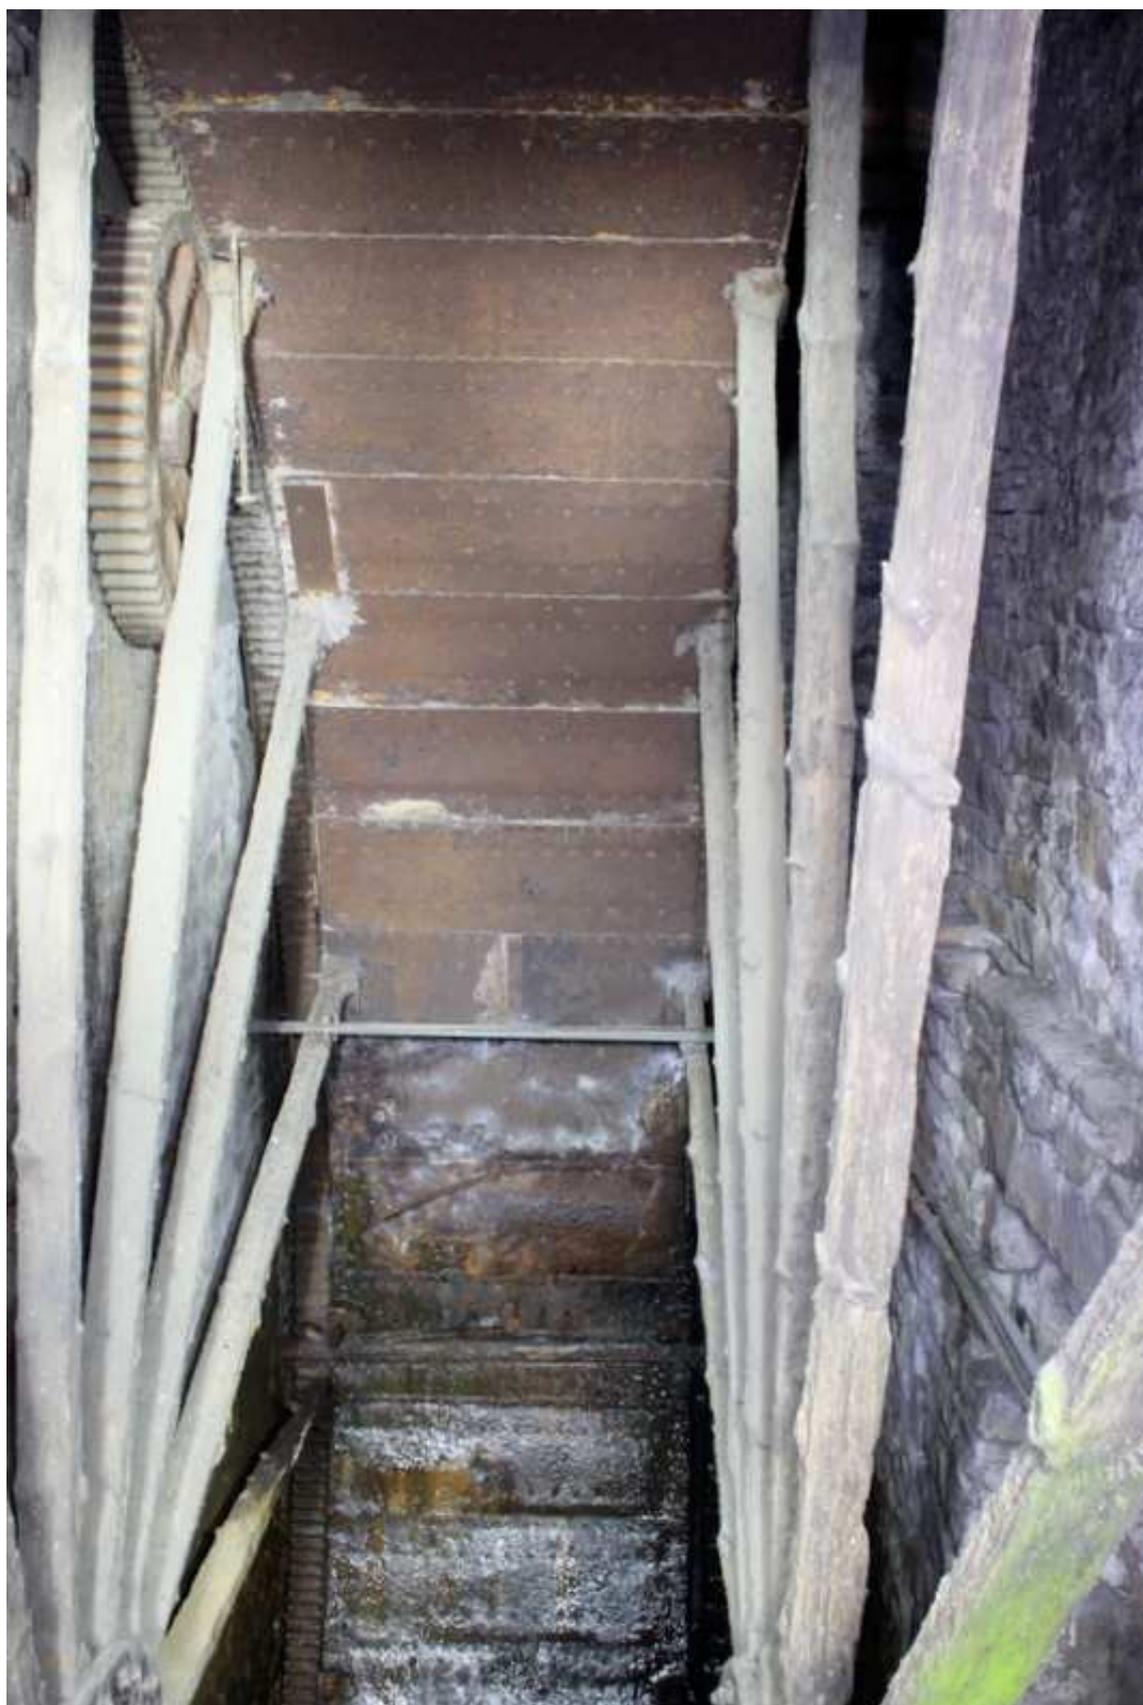
- 3.3.32 The current waterwheel is the full height of the ground and first floors, and almost the full 7' width of the bay in which it is housed (Plates 69 and 70). This represents an extension to the original mill, with this waterwheel probably being erected whilst an original waterwheel continued to function in the adjacent bay to the west. The high breast-shot wheel has cast-iron rims housing metal sheet elbow-buckets (Plate 71), supported by slender timber spokes socketed into a small diameter cast-iron hub (Plates 69 and 70).

Plate 69: Extant waterwheel with slender timber spokes

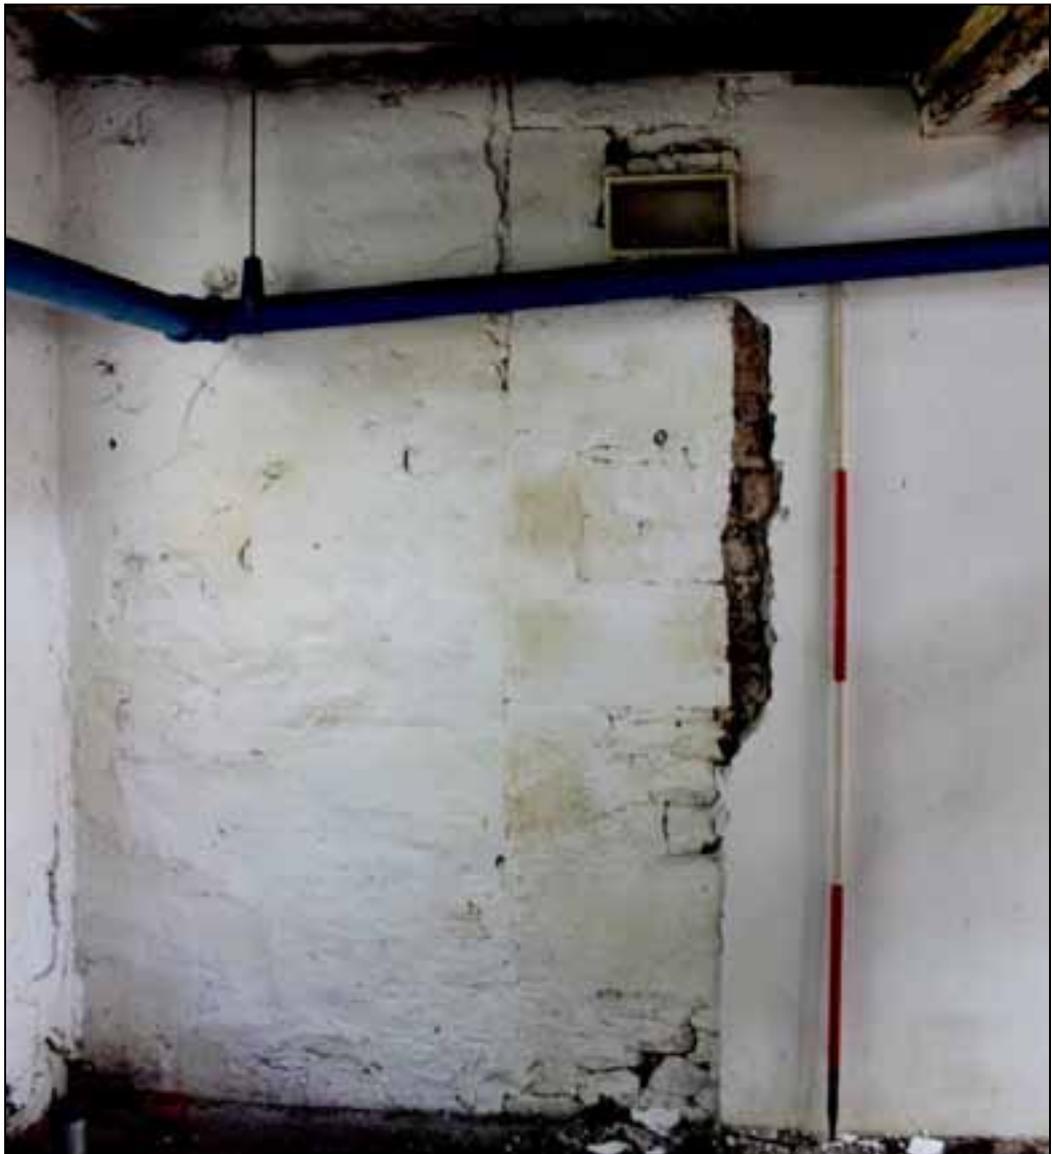
3.3.39 In the north-east corner of the original main body of the mill, a butt joint between two phases of construction was clearly visible (Plate 81). This has dressed sandstone blocks on the southern side, demonstrating that this originally represented an original southward return of the wall, and therefore that the waterwheel house was extended beyond the mill, prior to the repositioning of the north wall of the spinning block. An end-bearing box, placed immediately below ceiling height within the dressed blocks of the wall return (Plate 81), represents a late insertion, and demonstrates that a line shaft was placed within this position following the extension of the mill, matching those on the floors below. Evidence for a further line shaft, placed immediately north of centre within the original structure was observed as on the floors below, with bolt-hole pairs, and cut-outs in each tie beam (Plate 77), with additional drum scars on the eastern face of several timbers (Plate 77). Similar bolt pairs for a line shaft on the opposite side of the timber props to the tie beam were also observed, and were similar to those on the floors below.

Plate 81: Quoins of wheel house in east wall of main mill

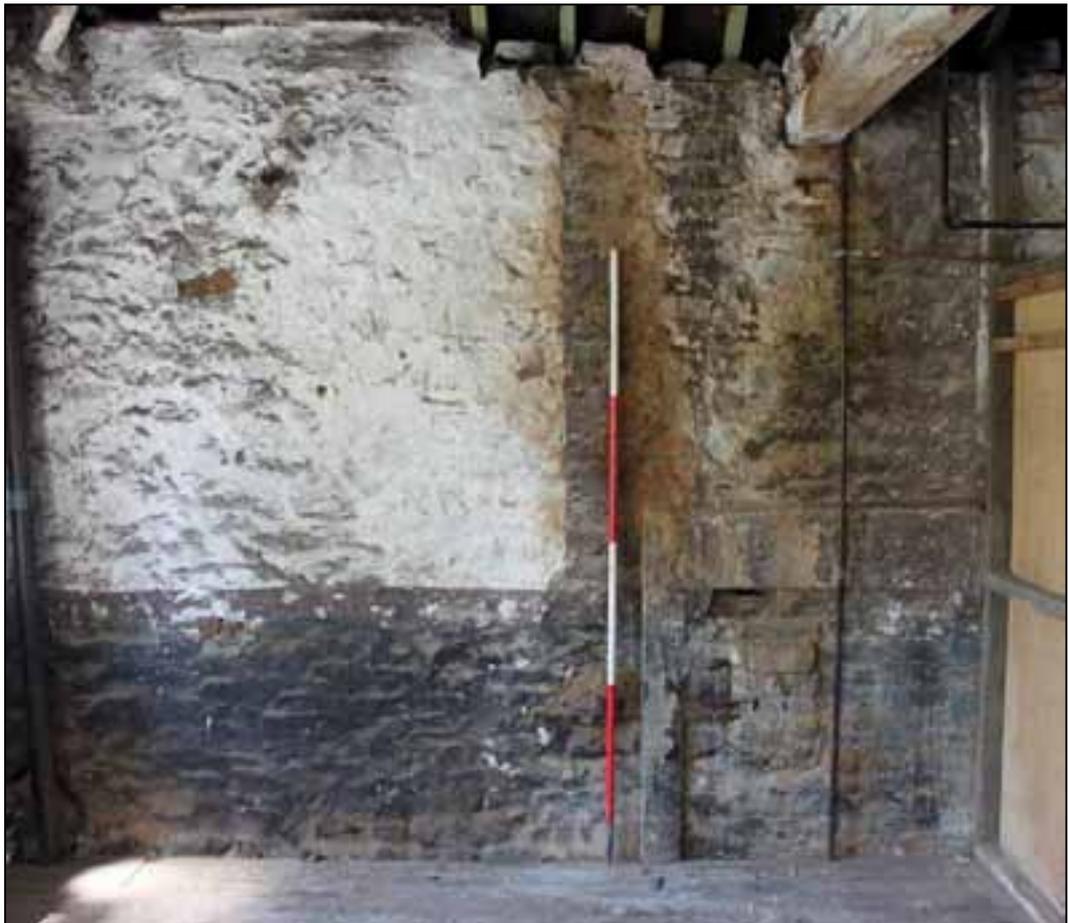
- 3.3.41 Within the western extension of the mill, a blocked aperture in the north wall had dressed stone jambs and lintel, and appeared to have formed a fireplace (Plate 82). This may have formed a small office in the original construction of the west wing, where it extended beyond the main mill at that time. It was presumably blocked when the earlier structure was extended, with the whole of the western extension forming part of the enlarged spinning floor.

Plate 82: Jamb and lintel of fireplace in north wall of west wing

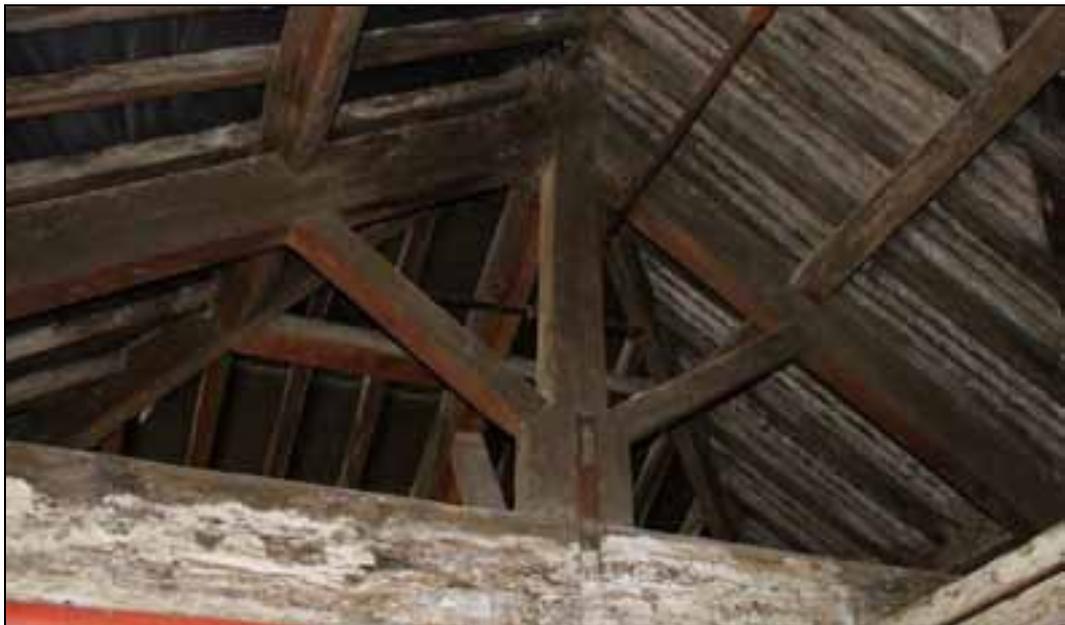
- 3.3.43 The western extension of the mill has a perpendicular roof formed of braced king post trusses, with the king post stirruped to the tie beam with an iron strap (Plate 85). Despite the obstruction caused by the king posts, longitudinal trimmers between the tie beams have double-tenon mortices in their faces for floor joists (Plate 86), indicating that the roof space was utilised.

Plate 85: King post truss above west wing

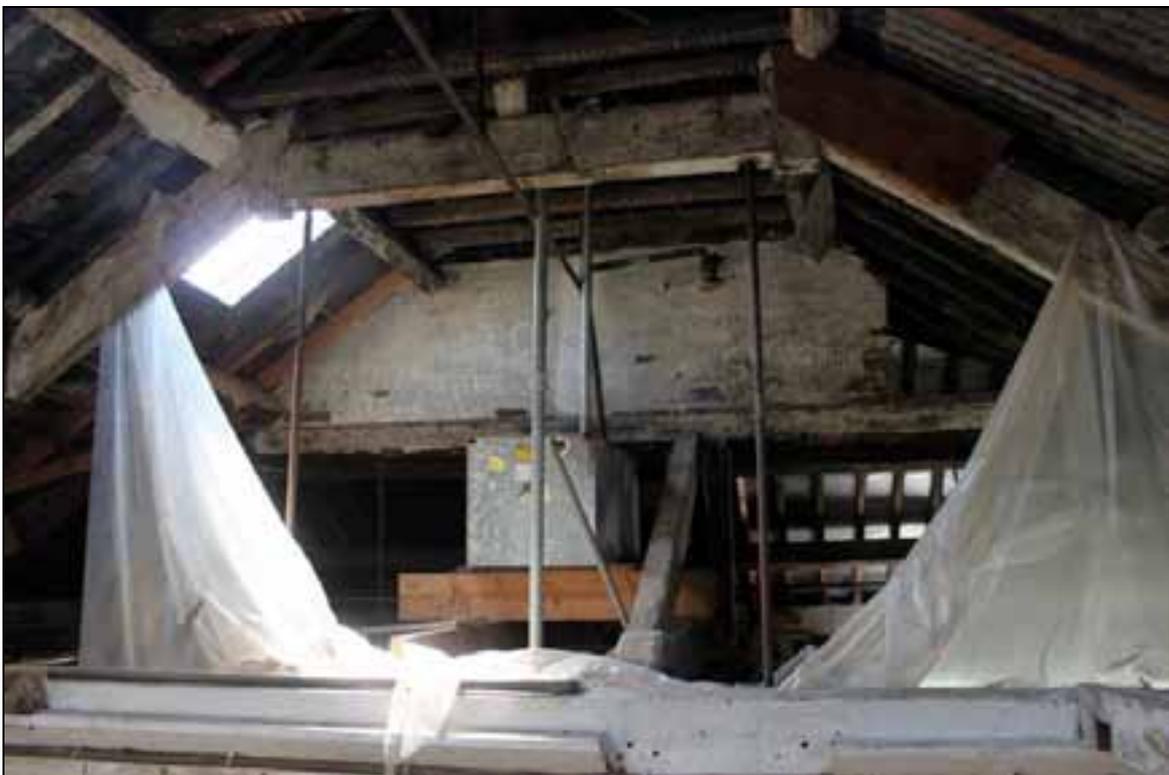
- 3.3.44 The western end of the roof was presumably originally hipped, and thus a new truss needed to be installed to carry the ridge from the original roof to that of the perpendicular extension, in order to avoid a valley between the two roofs. The truss installed was of queen post type, with two vertical members having a jowled head (Plate 87), carrying the shorter principal rafters, a straining beam placed between the two posts, and the weight of the upper purlin, which was housed in a notch within the head (Plate 88). These queen posts were also cut subsequently, and replaced with a pair of iron rods, placed immediately on their inside (Plate 87).

Plate 87: Lath and plaster partition between roofs of main mill and west wing, and queen post truss with replacement iron rods

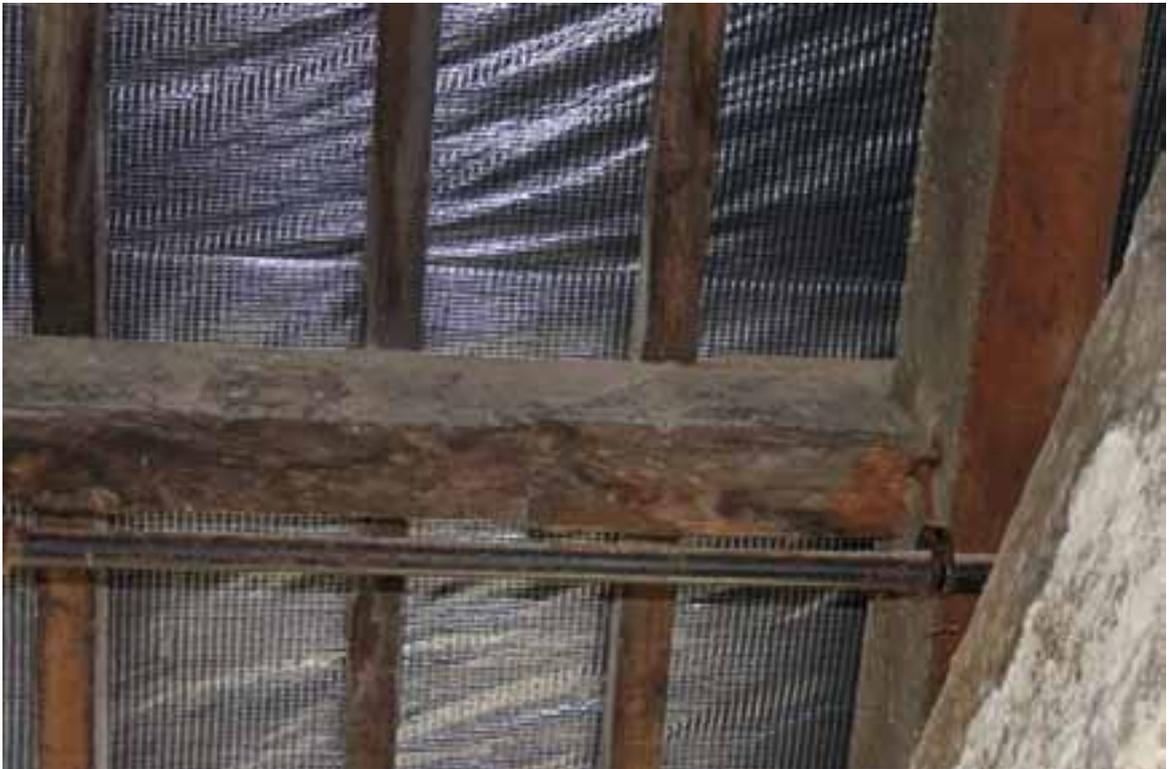
- 3.3.45 A lath and plaster wall was also inserted into the roof space between the two roofs (Plate 87). The purlins of the new west roof were trenched, through purlins, rather than being butt-ended, as in the earlier roof, and were longitudinally jointed with simple splayed scarf joints (Plate 89).

Plate 89: Scarf joint in purlin of west wing
