Structural Inspection Report Knott Gate Farmhouse, Slaidburn

John Forrester Ltd

Ref: L39613.001/JRP/WEL

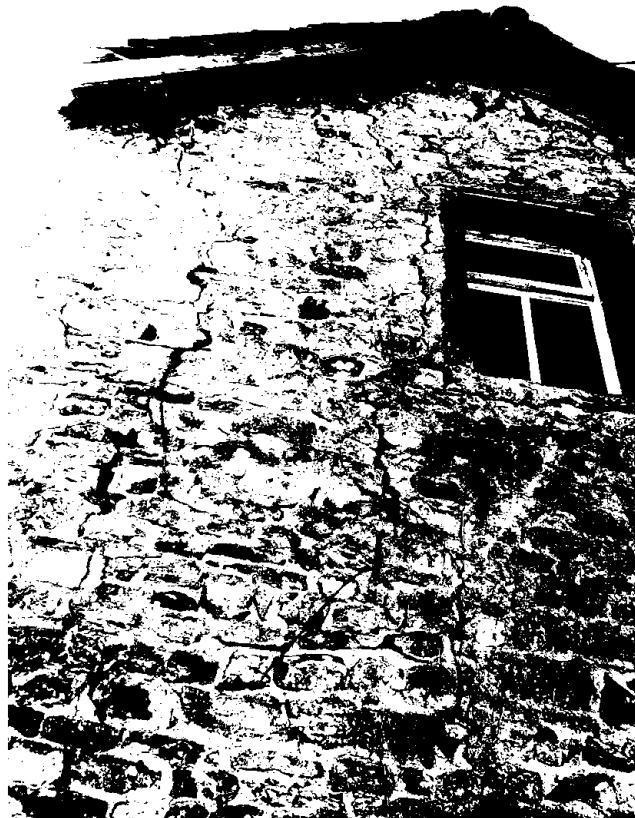
Gable Wall

The gable wall cracking is directly below the bearing points of the purlins and lintels over the window has failed.

The cracking and movement is of a historic, long standing nature and simple precast concrete lintel crack stitching, re-seating of beams and purlins will stabilise the structure, restraint of the walls tying the floors to walls and localised rebuilds will ensure standard refurbishment works can be undertaken as outlined on the Mason Gillibrand Architect's drawings. See the following typical repair details.

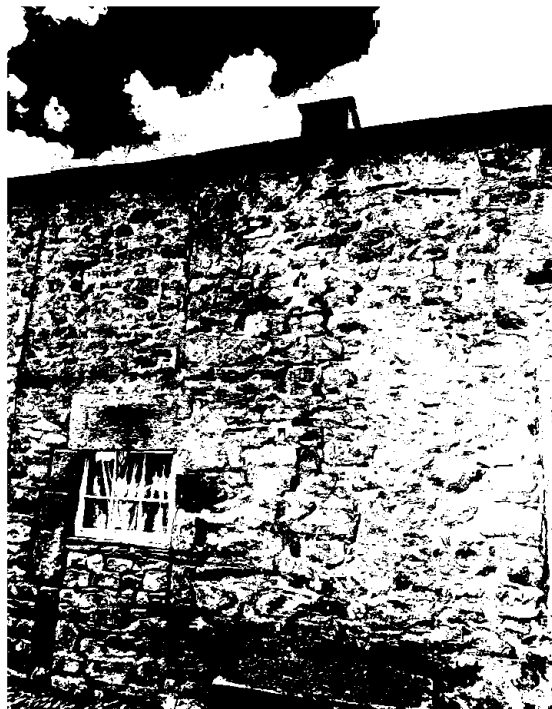
Front Wall

Parts of the wall have been remodelled in the past to create windows and doors etc.

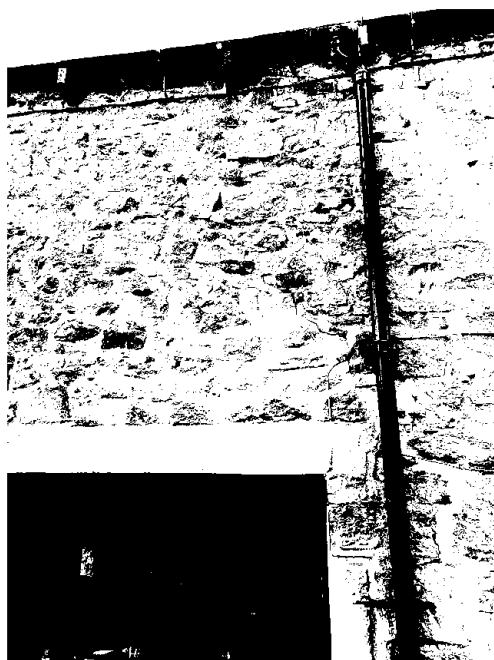
The front elevation has cracking and open vertical joints between different structural interventions.

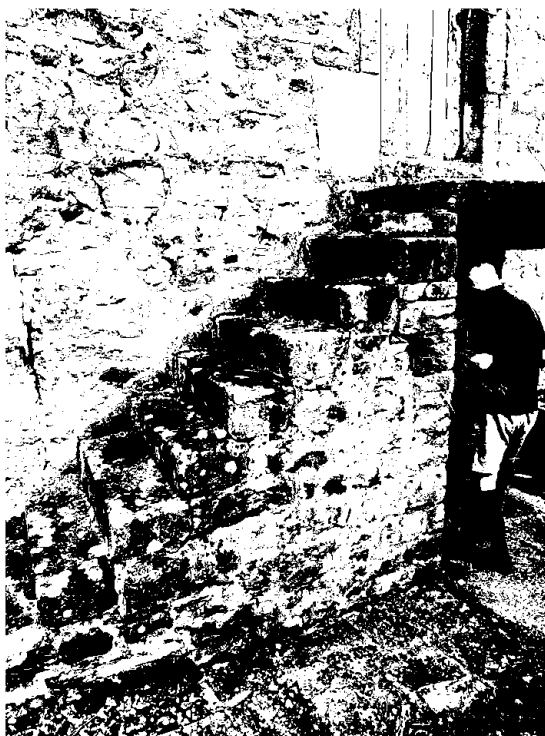
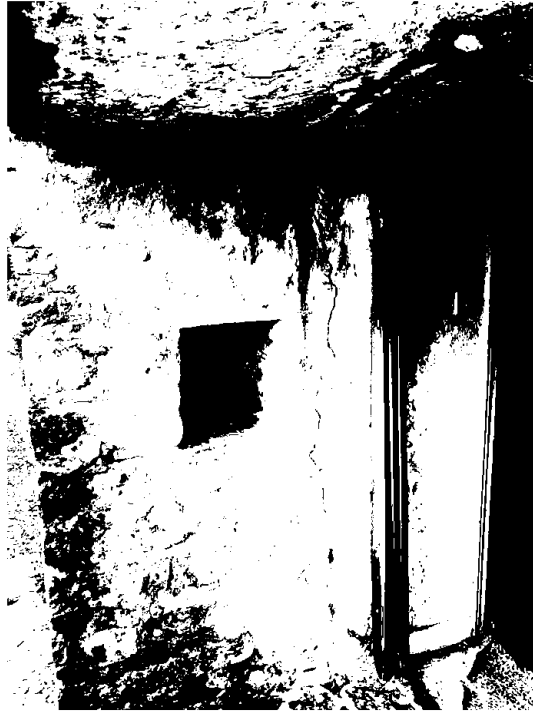
The external staircase to the rear of the building is constructed with cut stone trends on a random masonry base and there has been some slight differential movement between the main rear wall and the steps. There is no handrail.

Minor Cracking between stairs and rear wall
