Tree Condition Report

Crow Trees Barn, Chatburn

24/05/2023

Job Ref: 1779

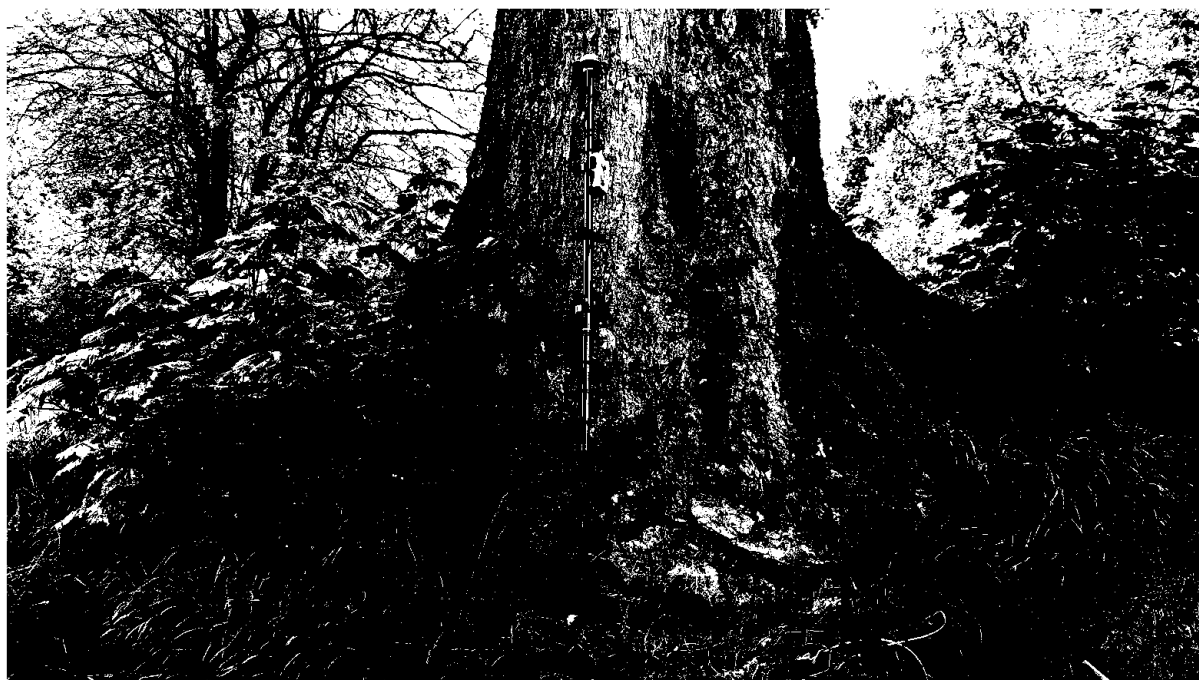
Size category	Large							
Age class	Mature							
Height	20+ meters							
Diameter at Breast Height (DBH)	100+ cm (1.5m above ground level)							
Crown Spread	North	8 m	South	8 m	East	8 m	West	8 m
Canopy clearance above ground level	5+ meters							
Location of tree	Far end of grassed garden							
Root system assessment	Large Ganoderma fungal brackets found at base of tree.							
Buttress assessment	Large Ganoderma fungal brackets found at base of tree.							
Stem assessment	Visually no defects externally but decay detected internally from resistograph test.							
Scaffold and secondary branches assessment	No significant visual defects.							
Twigs, buds, and leaves assessment	the tree has developed a full canopy of leaves that does not have any areas of defoliation. Leaf size, shape, and colour or all normal.							
Advanced decay detection (if applicable)	I have carried out a resistor graph test in 12 locations around the base of the tree near the fungal brackets and extending to 3 m above ground level. These locations have been tagged with temporary numbered identifications markers to show specifically where the drill testing has been carried out. The findings are that's around the base of the stem there is extensive internal decay, and this decay has expanded through the centre of the stem rising to at least 3m in height where marker 12 is located.

Overall Physiological condition	Good							
Overall Structural condition	Poor – due to internal dysfunction / decay.							
Remaining Safe contribution (years)	<10 years							
Retention quality (BS5837 rating)	U							
Targets within falling distance of tree	Garden / Public Footpath / Road

Base of tree with 2m pole for scale.

Overall risk imposed from tree in relation to identified defects	High
Recommendations	From these findings it is my recommendation that the tree is removed to ground level on the grounds of safety due to the proximity of the main road as the tree is within falling distance. It is recommended is that the tree is removed within the next 6 months before any potential storm events occur during the coming autumn / wintertime.
Overall risk imposed from tree after recommended works undertaken	Low
Timescale for action	Within 6 months of writing this report.
Review period	Not applicable for this tree due to removal.
Additional comments	Remaining trees on site should have continued assessments every 2 – 3 years.

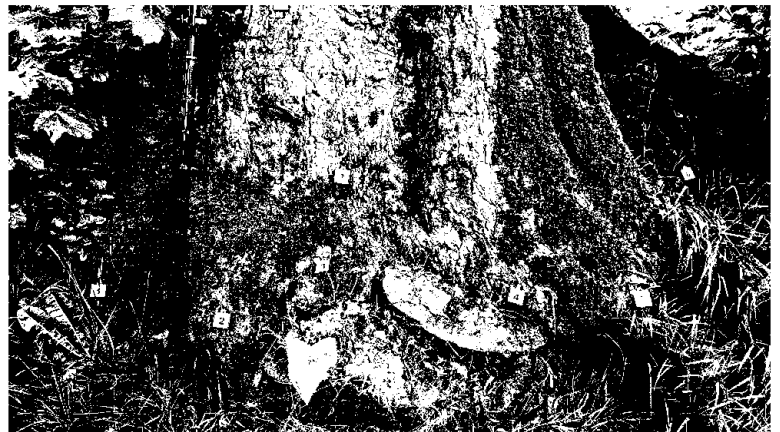
Tree showing 12x numbered tags where resistograph test drills were carried out.

Pole is 2m tall for scale.

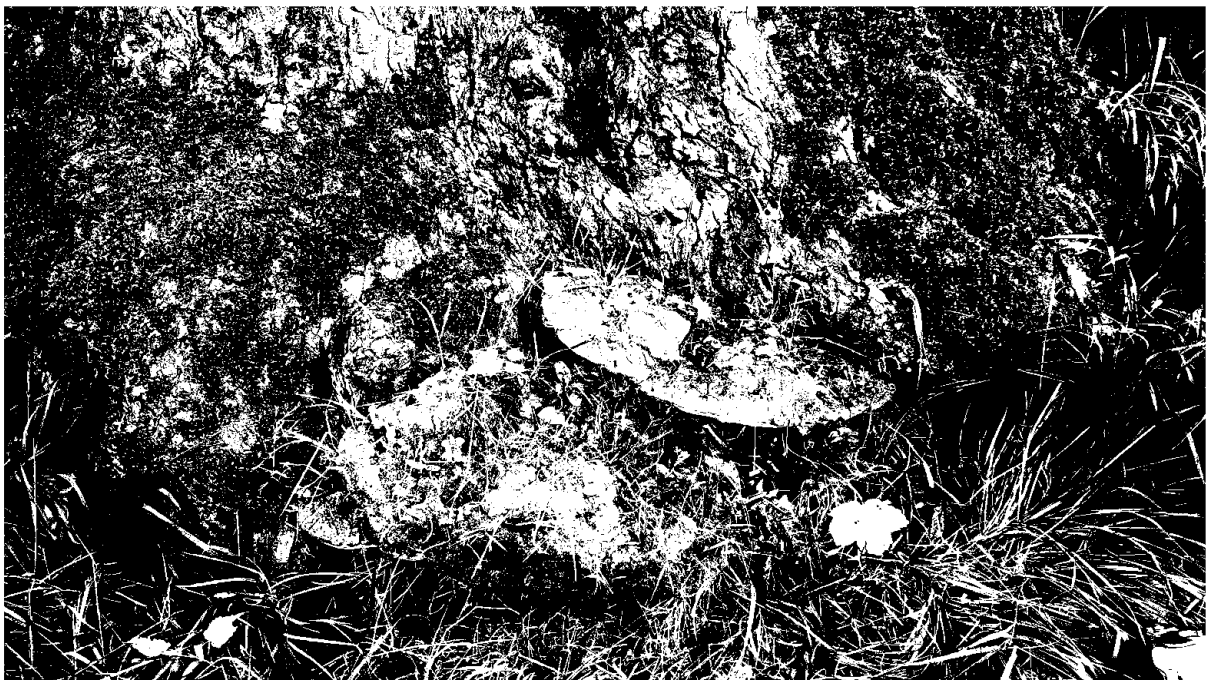
At the time of inspection, a large fungal bracket was found at the base of the tree, but the tree was not in leaf due to the time of year. I recommended that a follow up inspection was carried out when the tree should be in full leaf to get a fuller assessment of the trees condition as retention of this prominent tree was the preferred option if the risk was acceptable.

Close up of Ganoderma brackets at base of tree.

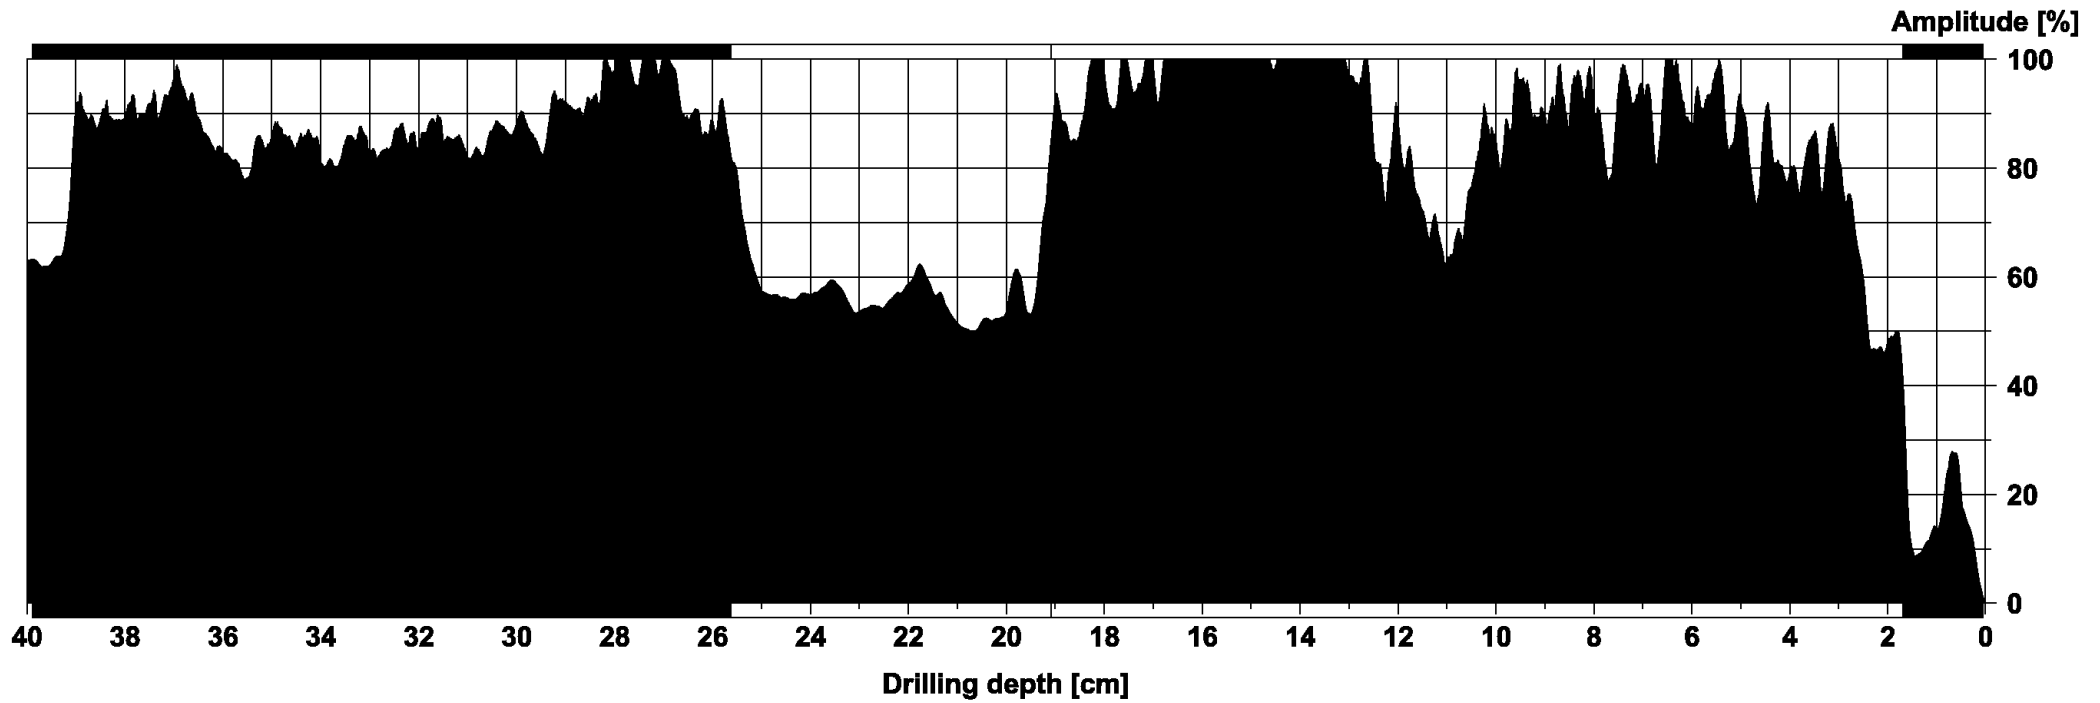
Measurement no. : 1	Needle speed : 2500 r/min	Diameter :
ID number : T1-SYC-1	Needle state : ---	Level :
Drilling depth : 40,00 cm	Tilt : ---	Direction :
Date : 01.01.2001	Offset : 140/254	Species :
Time : 00:06:04	Avg. curve : off	Location :
Feed speed : 200 cm/min		Name :

■	From	0,1 cm	to	1,7 cm	:	Bark
□	From	1,7 cm	to	19,1 cm	:	structural wood
□	From	19,1 cm	to	25,6 cm	:	dysfunctional wood
■	From	25,6 cm	to	39,0 cm	:	structural wood
■	From	39,0 cm	to	39,9 cm	:	dysfunctional area
□	From	0,0 cm	to	0,0 cm	:

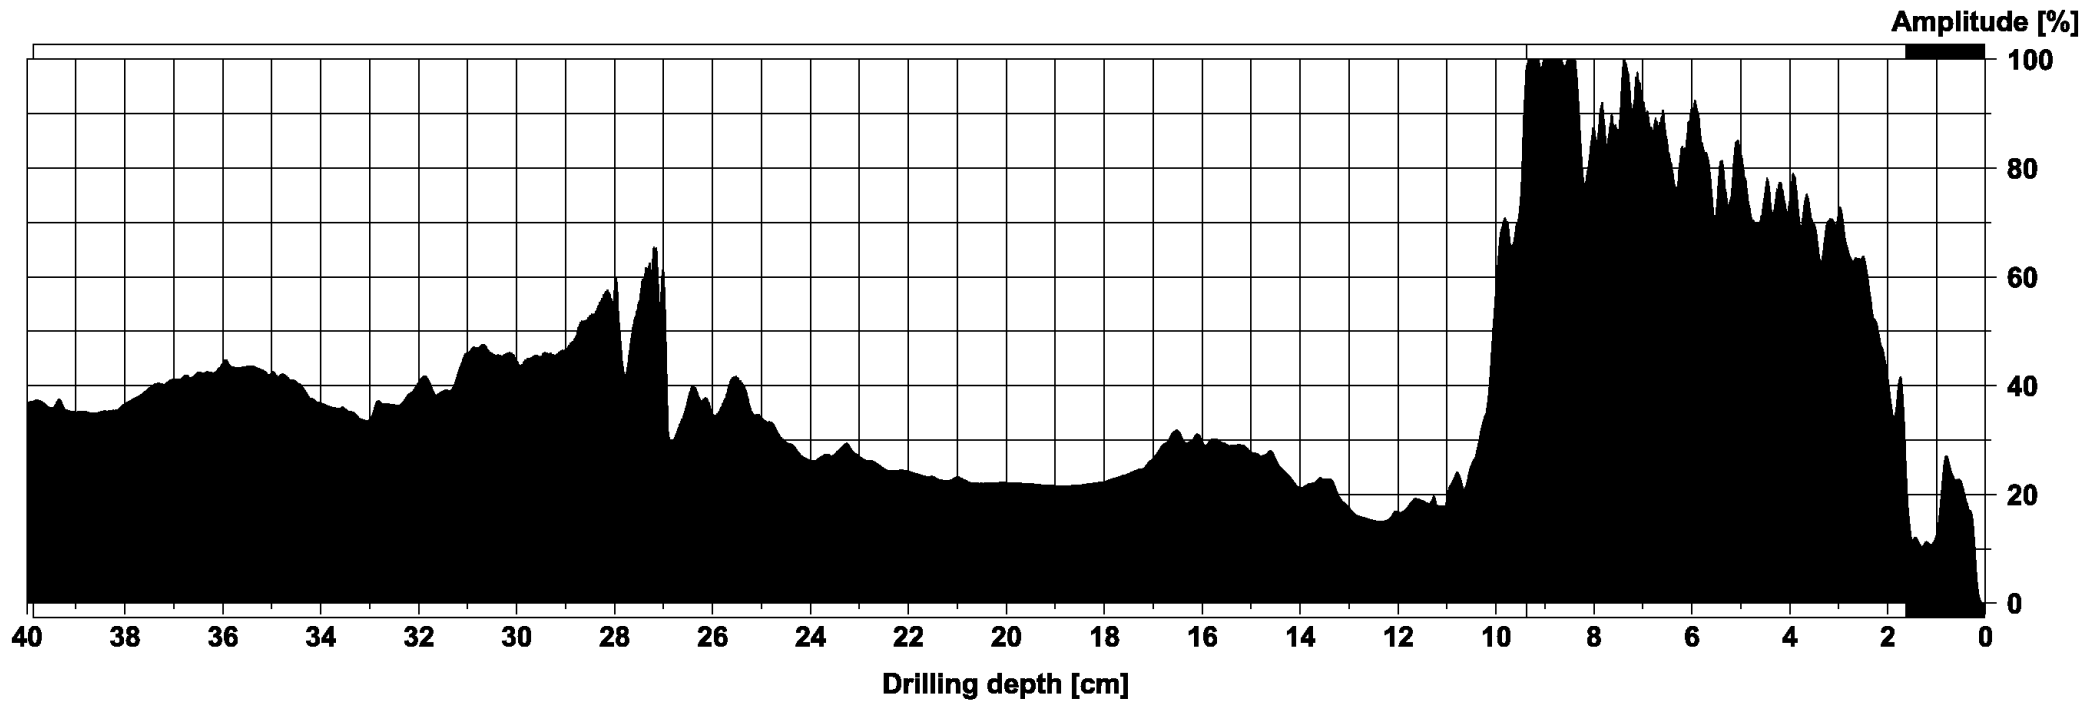
Measurement no. : 2	Needle speed : 2500 r/min	Diameter :
ID number : T1-SYC-2	Needle state : ---	Level :
Drilling depth : 40,00 cm	Tilt : ---	Direction :
Date : 01.01.2001	Offset : 132/266	Species :
Time : 00:06:48	Avg. curve : off	Location :
Feed speed : 200 cm/min		Name :

■	From 0,0 cm to 1,6 cm :	Bark
□	From 1,6 cm to 9,4 cm :	structural wood
□	From 9,4 cm to 39,9 cm :	dysfunctional wood
□	From 0,0 cm to 0,0 cm :	
□	From 0,0 cm to 0,0 cm :	
□	From 0,0 cm to 0,0 cm :

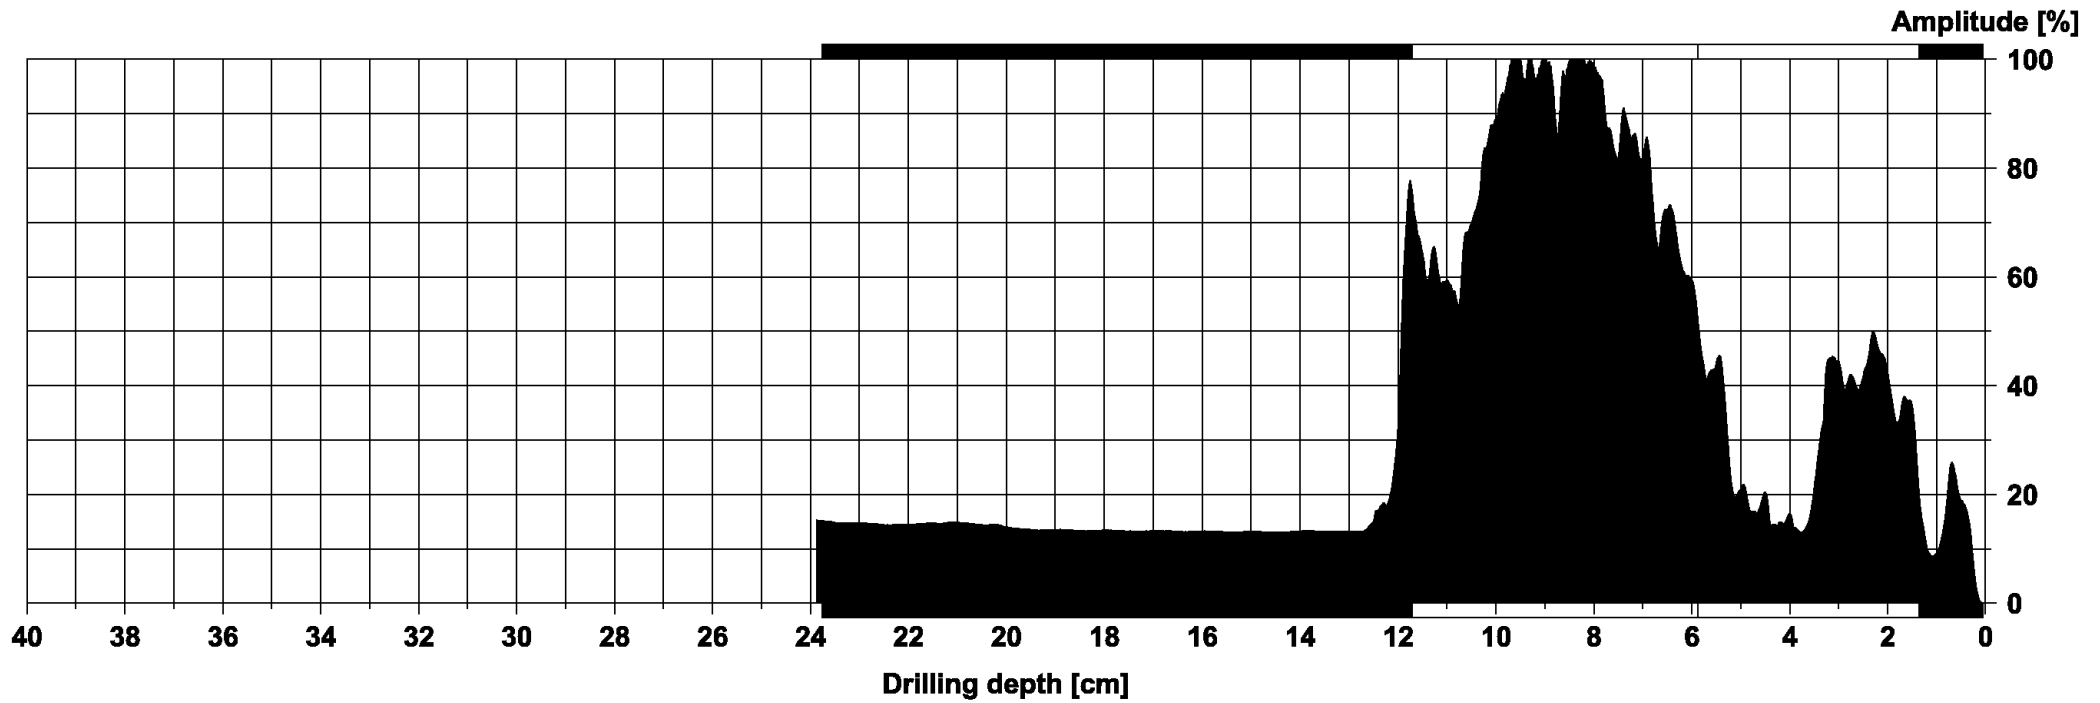
Measurement no. : 3	Needle speed : 2500 r/min	Diameter :
ID number : T1-SYC-3	Needle state : ---	Level :
Drilling depth : 23,87 cm	Tilt : ---	Direction :
Date : 01.01.2001	Offset : 128/262	Species :
Time : 00:07:27	Avg. curve : off	Location :
Feed speed : 200 cm/min		Name :

■	From	0,1 cm	to	1,4 cm	:	Bark
□	From	1,4 cm	to	5,9 cm	:	dysfunctional wood
□	From	5,9 cm	to	11,7 cm	:	structural wood
■	From	11,7 cm	to	23,8 cm	:	dysfunctional area
□	From	0,0 cm	to	0,0 cm	:	
□	From	0,0 cm	to	0,0 cm	:

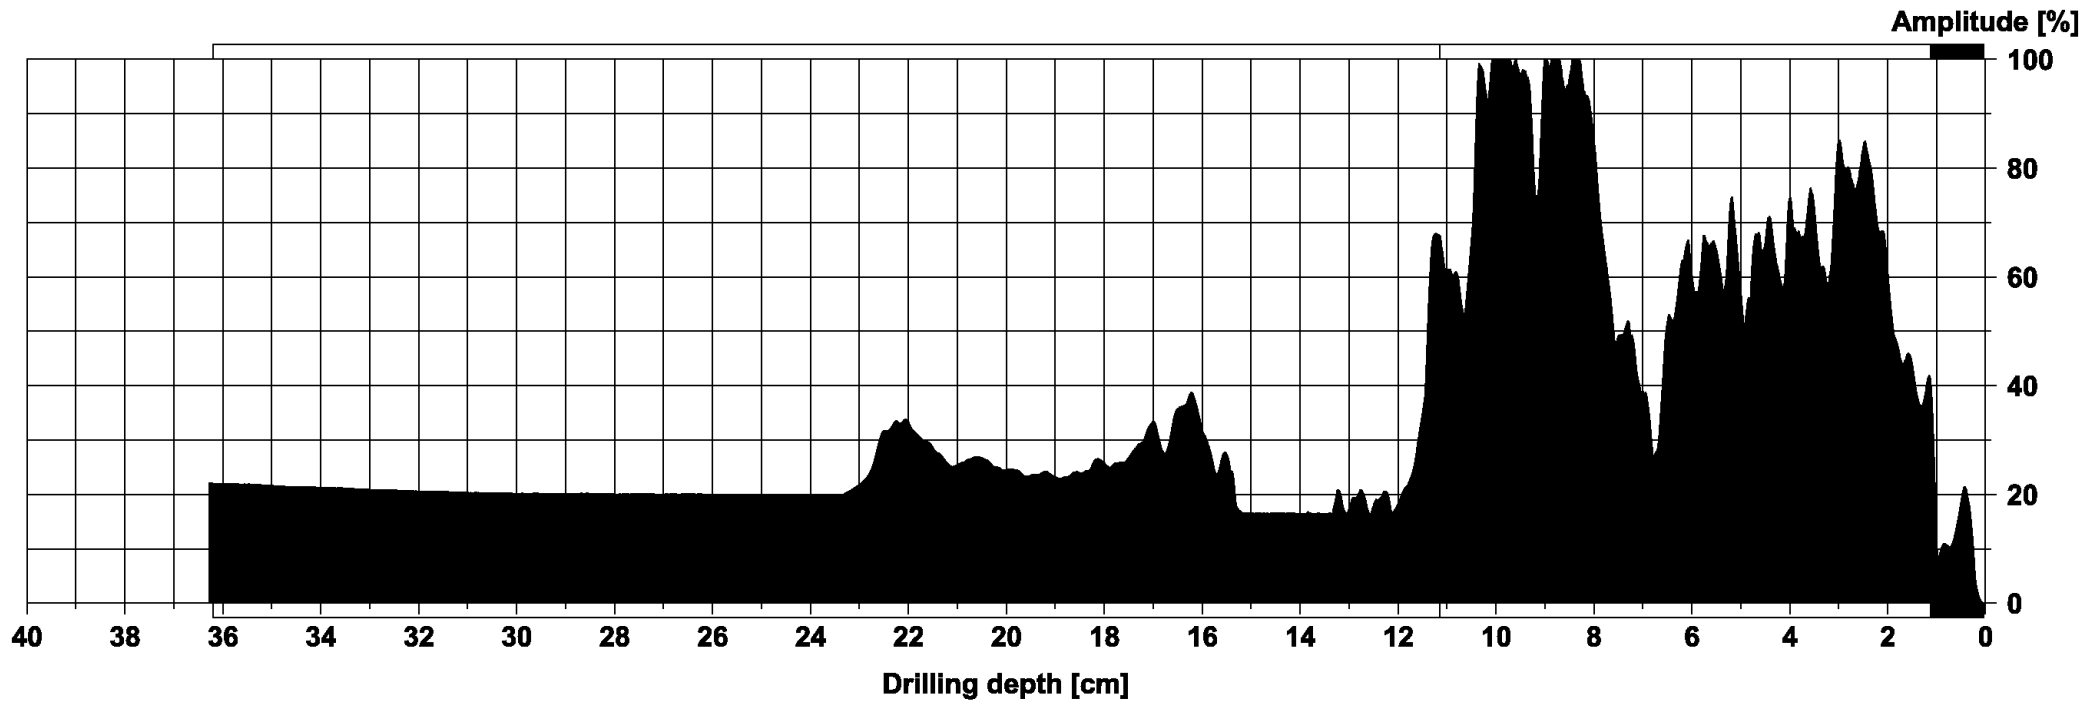
Measurement no. : 4	Needle speed : 2500 r/min	Diameter :
ID number : T1-SYC-4	Needle state : ---	Level :
Drilling depth : 36,28 cm	Tilt : ---	Direction :
Date : 01.01.2001	Offset : 131/258	Species :
Time : 00:07:57	Avg. curve : off	Location :
Feed speed : 200 cm/min		Name :

■	From	0,0 cm	to	1,1 cm	:	Bark
□	From	1,1 cm	to	11,1 cm	:	structural wood
□	From	11,1 cm	to	36,2 cm	:	dysfunctional area
□	From	0,0 cm	to	0,0 cm	:	
□	From	0,0 cm	to	0,0 cm	:	
□	From	0,0 cm	to	0,0 cm	:

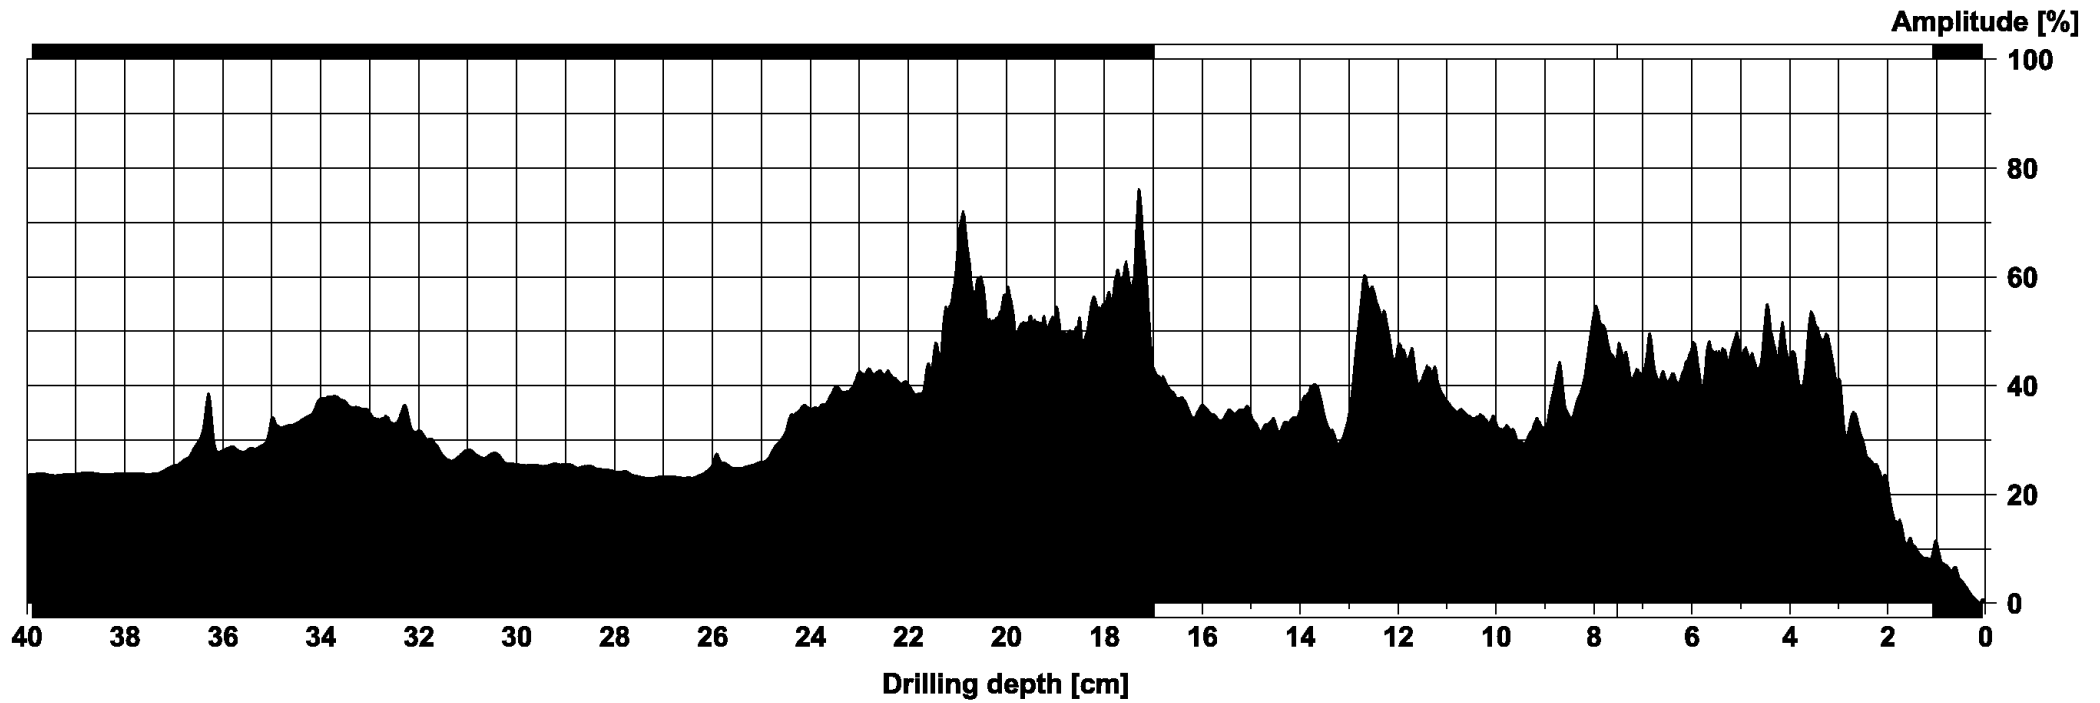
Measurement no. : 6	Needle speed : 2500 r/min	Diameter :
ID number : T1-SYC-5	Needle state : ---	Level :
Drilling depth : 40,00 cm	Tilt : ---	Direction :
Date : 01.01.2001	Offset : 90/282	Species :
Time : 00:08:56	Avg. curve : off	Location :
Feed speed : 100 cm/min		Name :

■	From	0,1 cm	to	1,1 cm	:	Bark
□	From	1,1 cm	to	7,5 cm	:	structural wood
□	From	7,5 cm	to	17,0 cm	:	dysfunctional area
■	From	17,0 cm	to	21,1 cm	:	structural wood
■	From	21,1 cm	to	39,9 cm	:	dysfunctional area
□	From	0,0 cm	to	0,0 cm	:

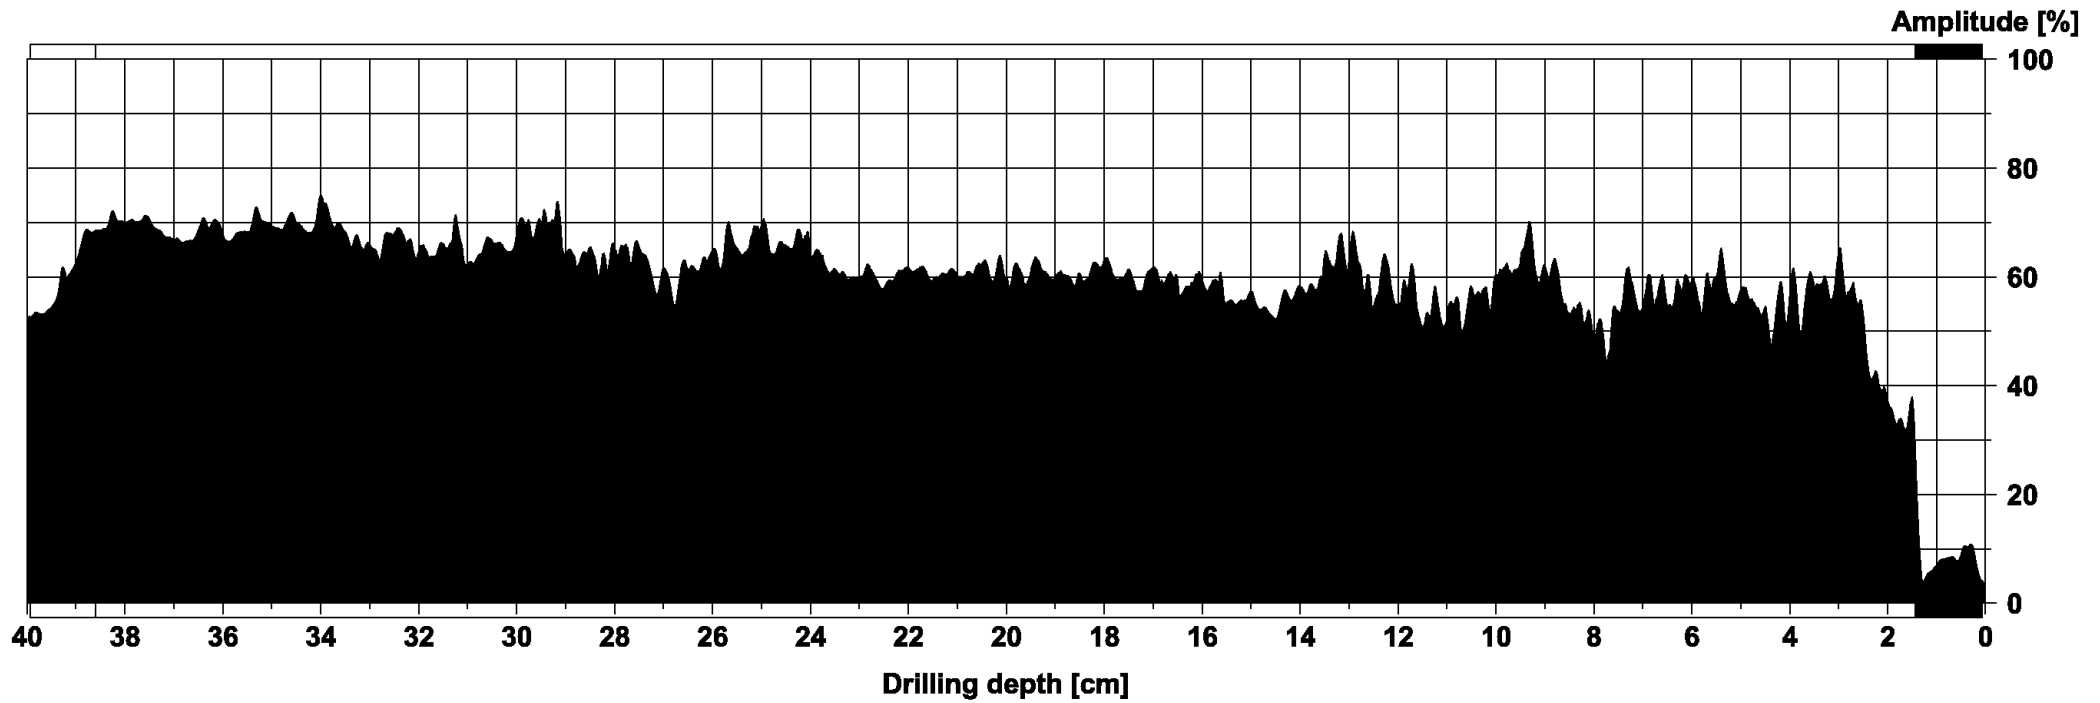
Measurement no. : 7	Needle speed : 2500 r/min	Diameter :
ID number : T1-SYC-6	Needle state : ---	Level :
Drilling depth : 40,00 cm	Tilt : ---	Direction :
Date : 01.01.2001	Offset : 99/284	Species :
Time : 00:09:48	Avg. curve : off	Location :
Feed speed : 100 cm/min		Name :

■	From	0,1 cm	to	1,4 cm	:	Bark
□	From	1,4 cm	to	38,6 cm	:	Structural wood
□	From	38,6 cm	to	39,9 cm	:	Dysfunctional area
□	From	0,0 cm	to	0,0 cm	:	
□	From	0,0 cm	to	0,0 cm	:	
□	From	0,0 cm	to	0,0 cm	:

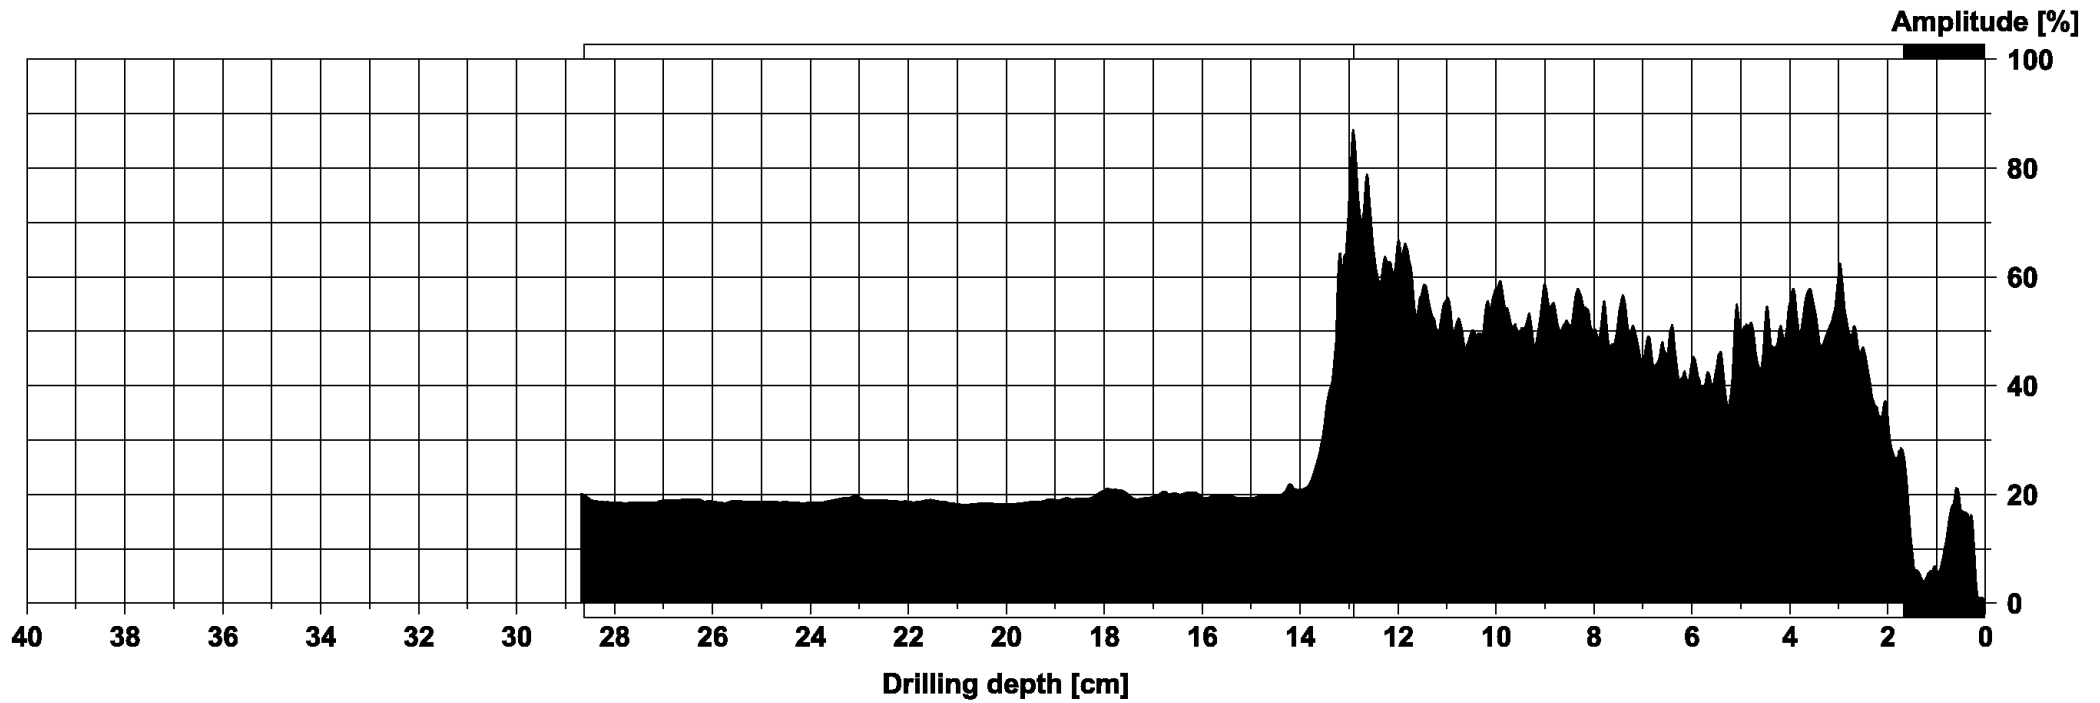
Measurement no. : 8	Needle speed : 2500 r/min	Diameter :
ID number : T1-SYC-7	Needle state : ---	Level :
Drilling depth : 28,69 cm	Tilt : ---	Direction :
Date : 01.01.2001	Offset : 93/275	Species :
Time : 00:10:39	Avg. curve : off	Location :
Feed speed : 100 cm/min		Name :

■	From	0,0 cm	to	1,7 cm	:	Bark
□	From	1,7 cm	to	12,9 cm	:	Structural wood
□	From	12,9 cm	to	28,6 cm	:	dysfunctional area
□	From	0,0 cm	to	0,0 cm	:	
□	From	0,0 cm	to	0,0 cm	:	
□	From	0,0 cm	to	0,0 cm	:

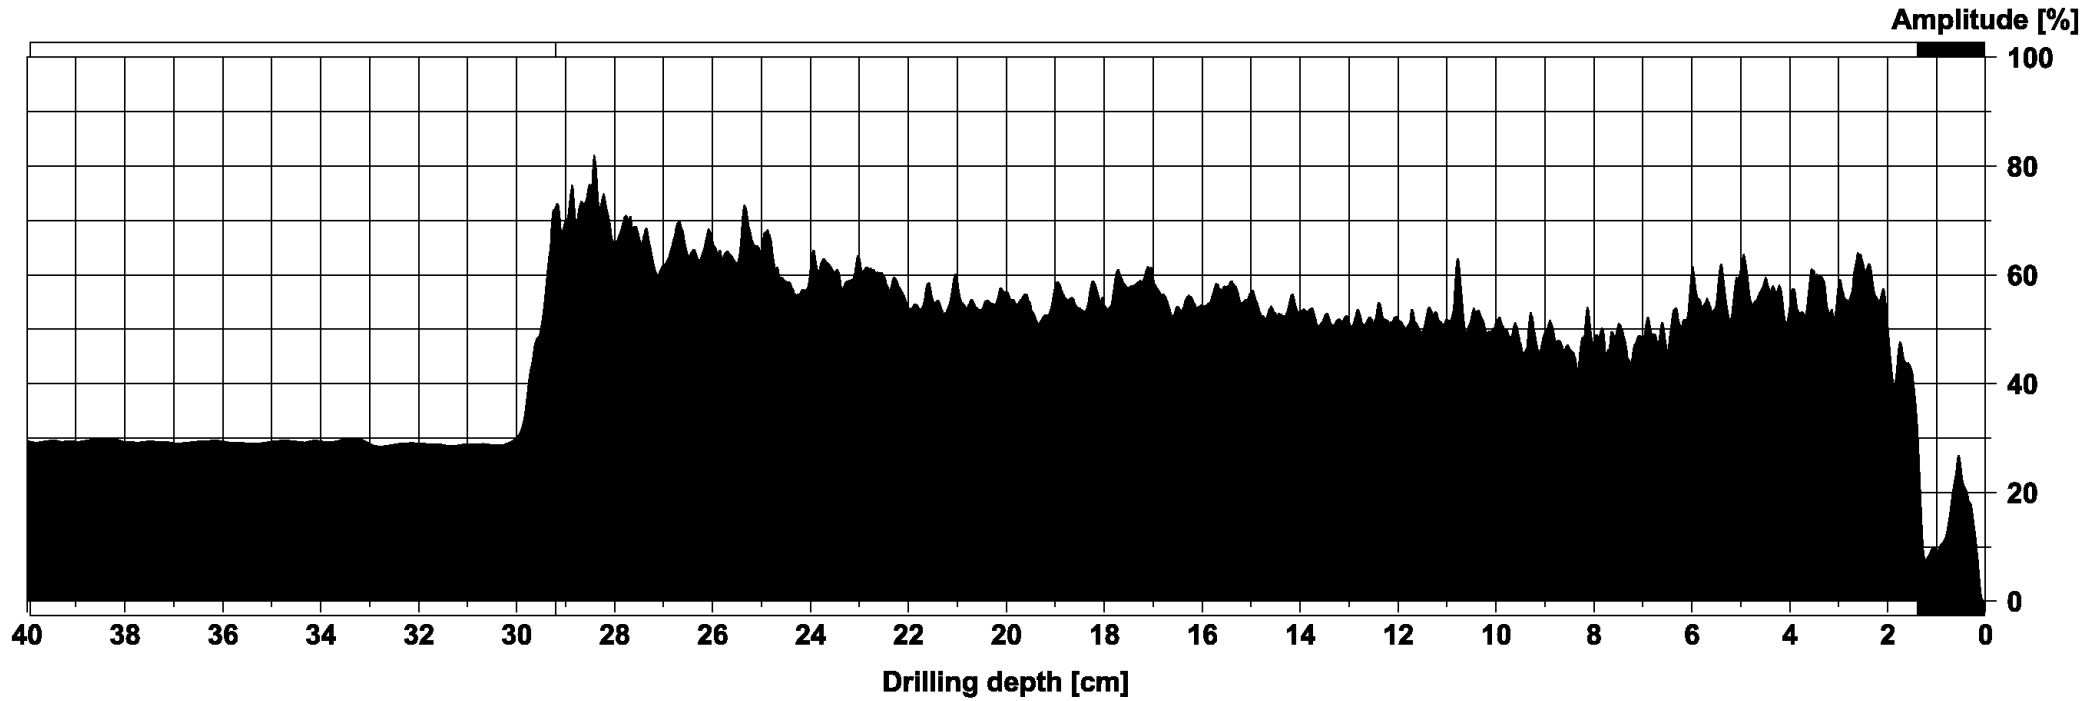
Measurement no. : 9	Needle speed : 2500 r/min	Diameter :
ID number : T1-SYC-8	Needle state : ---	Level :
Drilling depth : 40,00 cm	Tilt : ---	Direction :
Date : 01.01.2001	Offset : 97/281	Species :
Time : 00:11:24	Avg. curve : off	Location :
Feed speed : 100 cm/min		Name :

■	From	0,0 cm	to	1,4 cm	: Bark
□	From	1,4 cm	to	29,2 cm	: Structural wood
□	From	29,2 cm	to	39,9 cm	: dysfunctional area
□	From	0,0 cm	to	0,0 cm	:
□	From	0,0 cm	to	0,0 cm	:
□	From	0,0 cm	to	0,0 cm	:

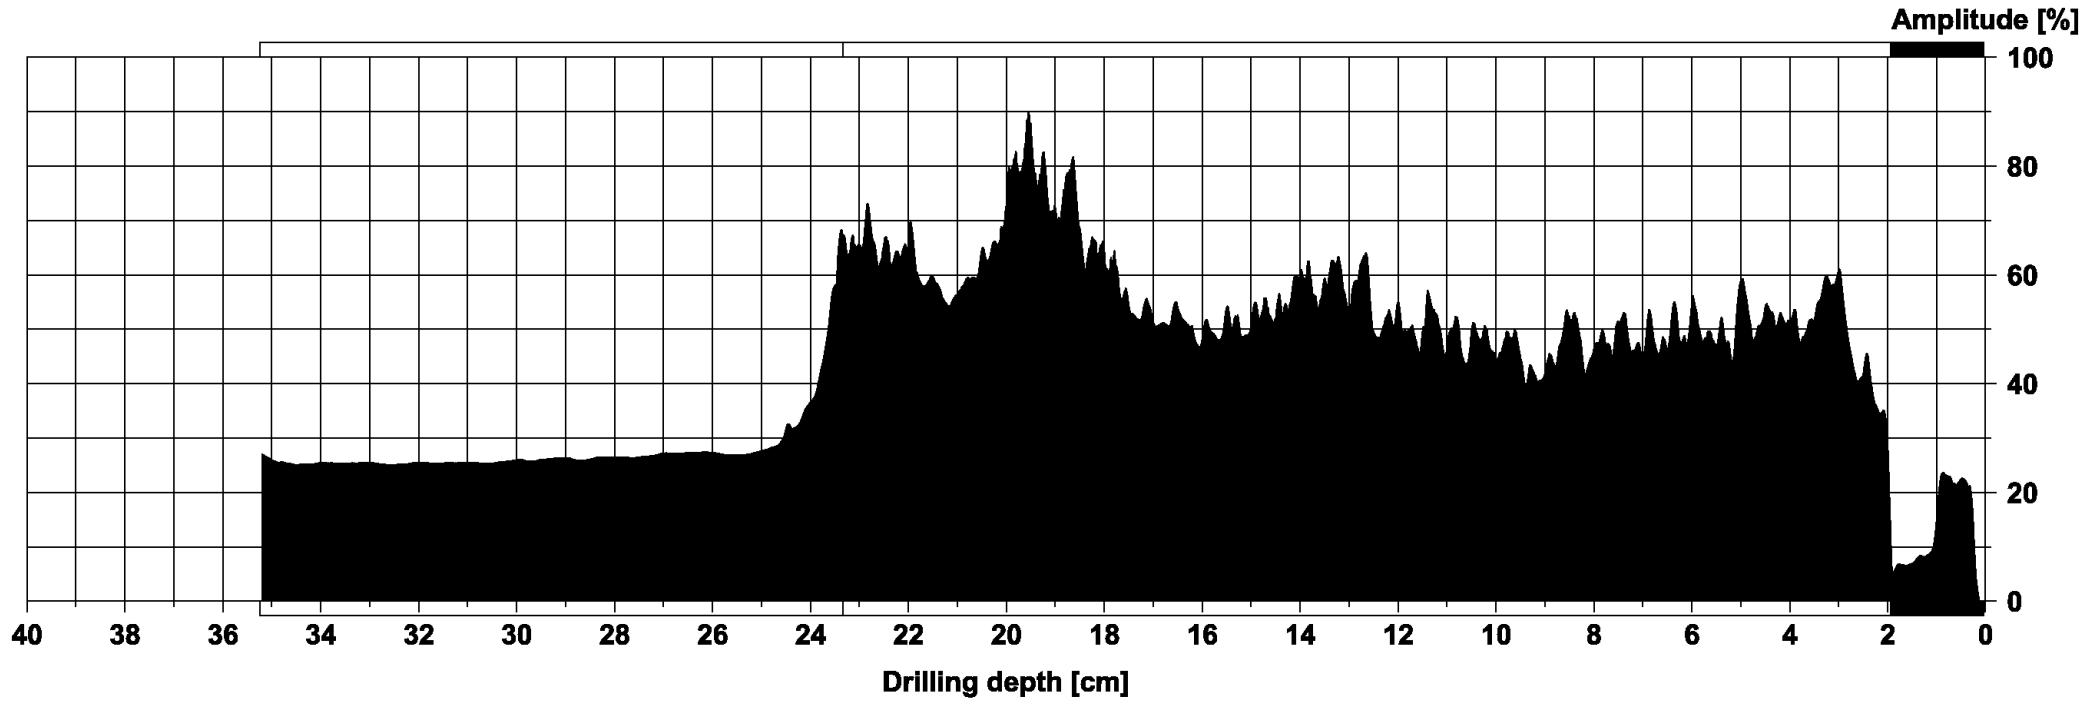
Measurement no. : 10	Needle speed : 2500 r/min	Diameter :
ID number : T1-SYC-9	Needle state : ---	Level :
Drilling depth : 35,20 cm	Tilt : ---	Direction :
Date : 01.01.2001	Offset : 112/299	Species :
Time : 00:12:58	Avg. curve : off	Location :
Feed speed : 100 cm/min		Name :

■	From	0,0 cm	to	1,9 cm	:	Bark
□	From	1,9 cm	to	23,3 cm	:	Structural wood
□	From	23,3 cm	to	35,2 cm	:	dysfunctional area
□	From	0,0 cm	to	0,0 cm	:	
□	From	0,0 cm	to	0,0 cm	:	
□	From	0,0 cm	to	0,0 cm	:

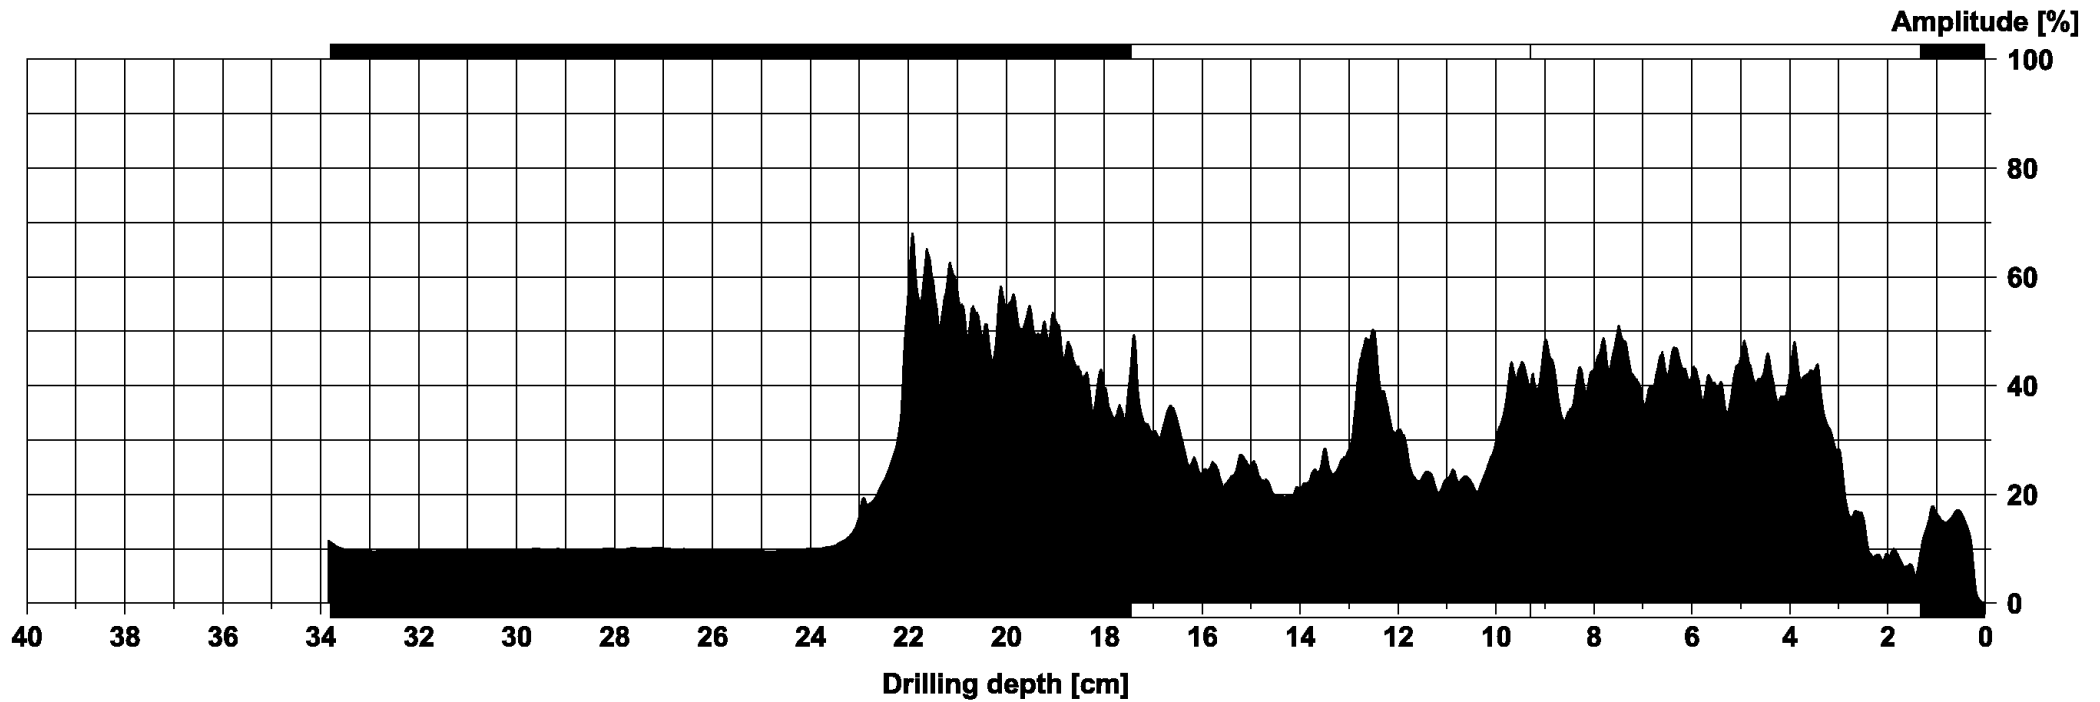
Measurement no. : 12	Needle speed : 2500 r/min	Diameter :
ID number : T1-SYC-10	Needle state : ---	Level :
Drilling depth : 33,84 cm	Tilt : ---	Direction :
Date : 01.01.2001	Offset : 102/299	Species :
Time : 00:14:50	Avg. curve : off	Location :
Feed speed : 100 cm/min		Name :

■	From	0,0 cm	to	1,3 cm	:	Bark
□	From	1,3 cm	to	9,3 cm	:	structural wood
□	From	9,3 cm	to	17,5 cm	:	dysfunctional area
■	From	17,5 cm	to	22,0 cm	:	structural wood
■	From	22,0 cm	to	33,8 cm	:	dysfunctional area
□	From	0,0 cm	to	0,0 cm	:

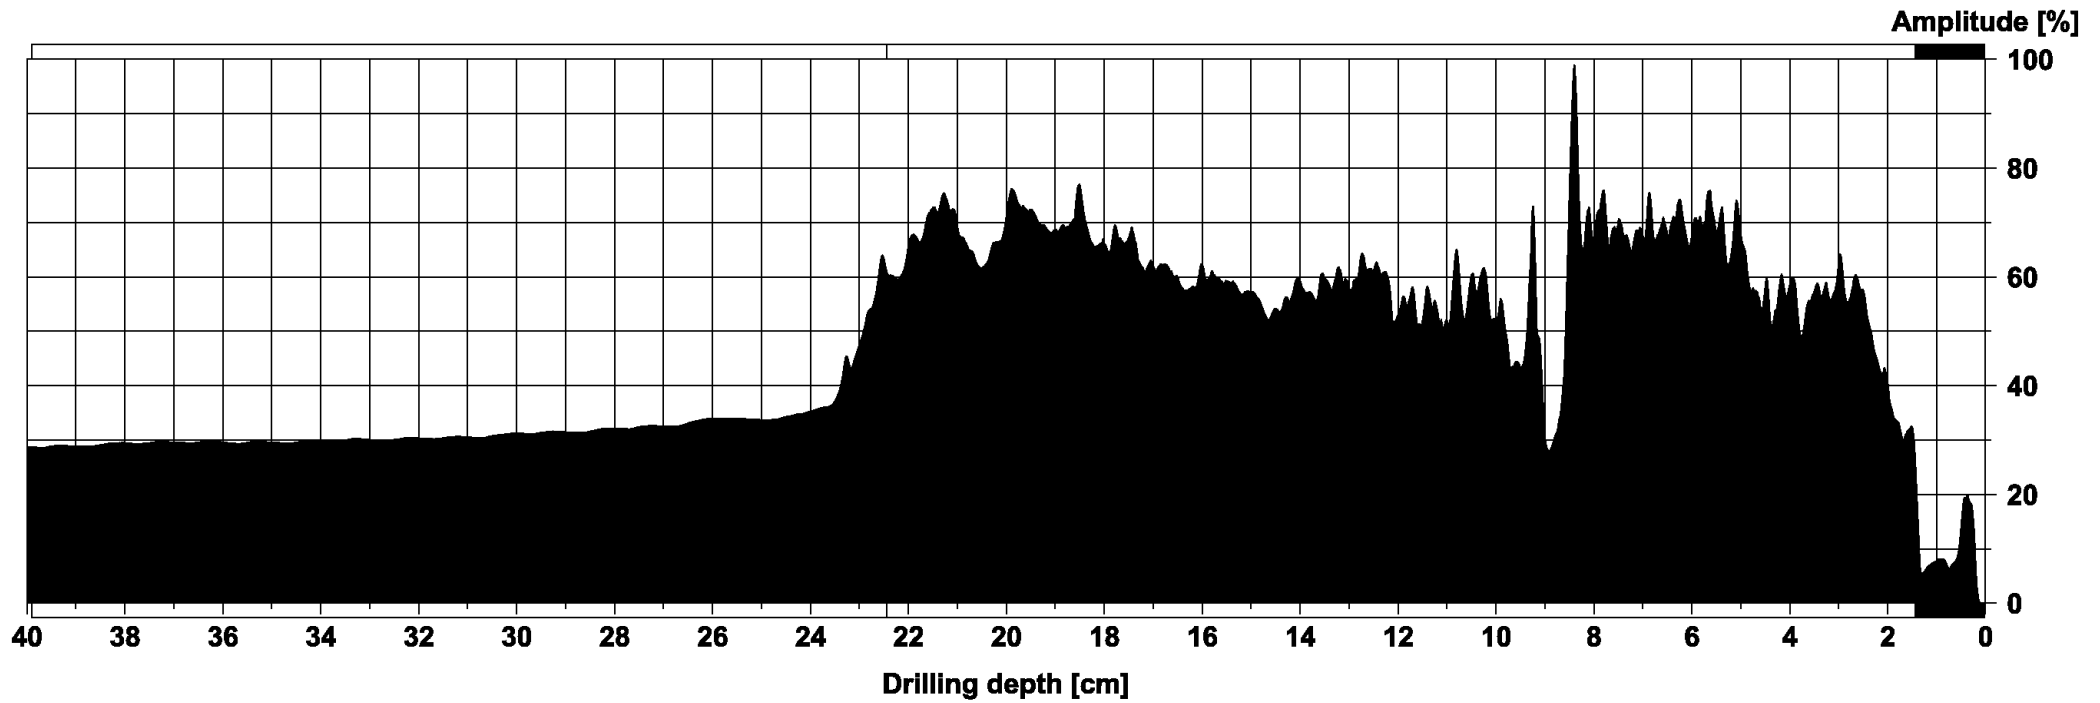
Measurement no. : 14	Needle speed : 2500 r/min	Diameter :
ID number : T1-SYC-11	Needle state : ---	Level :
Drilling depth : 40,00 cm	Tilt : ---	Direction :
Date : 01.01.2001	Offset : 114/255	Species :
Time : 00:27:16	Avg. curve : off	Location :
Feed speed : 100 cm/min		Name :

■	From	0,0 cm	to	1,4 cm	:	bark
□	From	1,4 cm	to	22,4 cm	:	structural wood
□	From	22,4 cm	to	39,9 cm	:	dysfunctional area
□	From	0,0 cm	to	0,0 cm	:	
□	From	0,0 cm	to	0,0 cm	:	
□	From	0,0 cm	to	0,0 cm	:

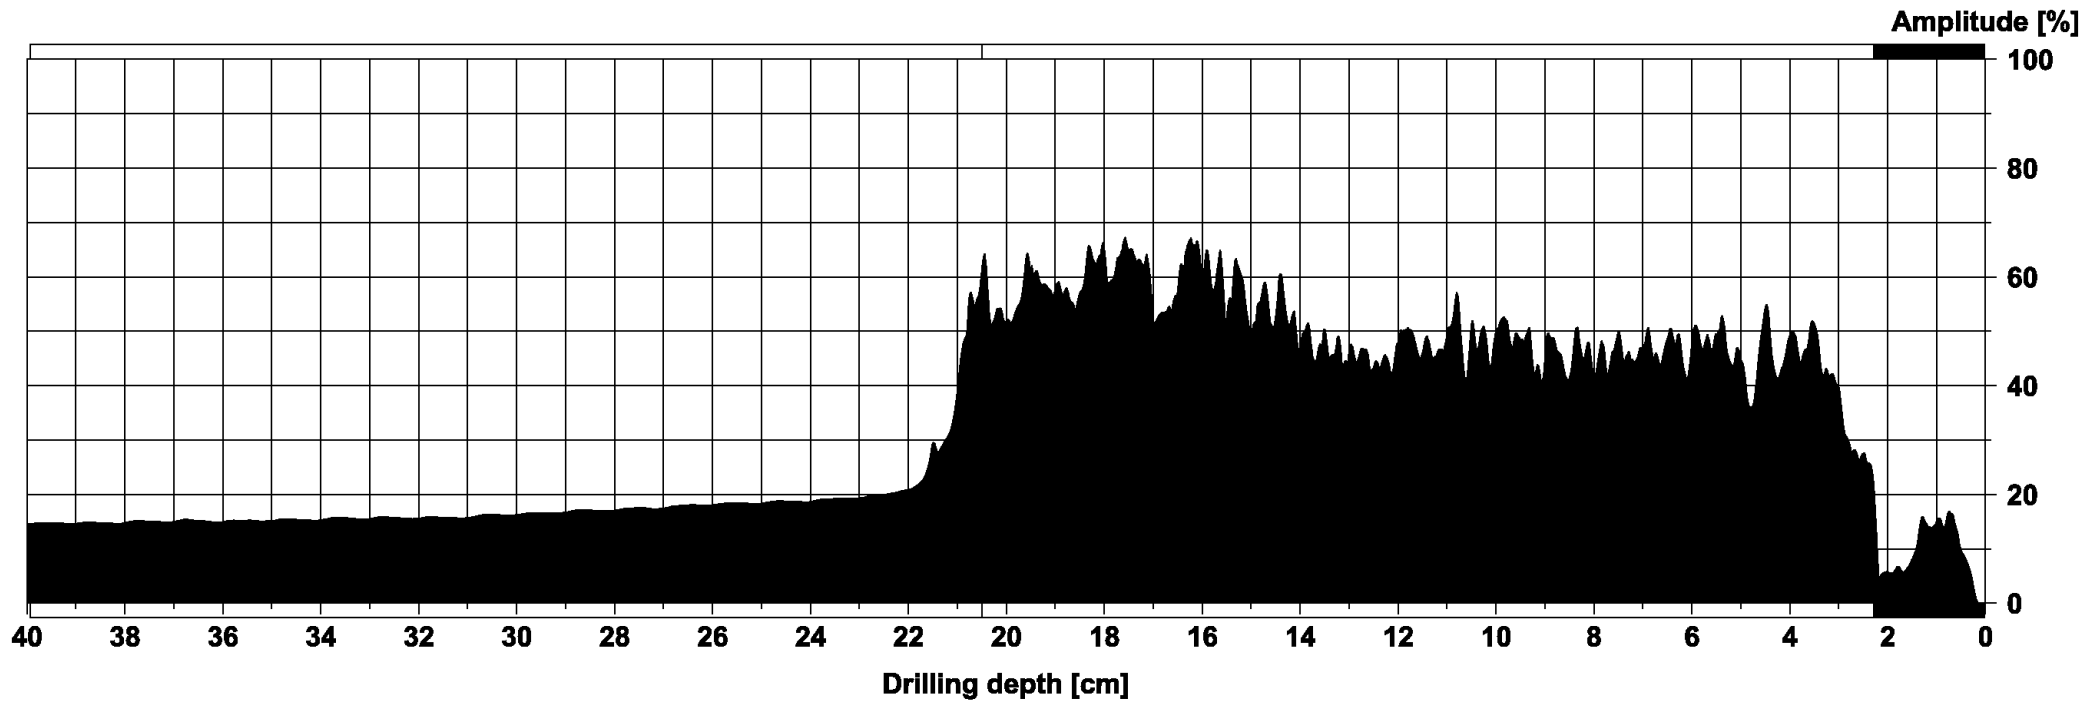
Measurement no. : 15	Needle speed : 2500 r/min	Diameter :
ID number : T1-SYC-12	Needle state : ---	Level :
Drilling depth : 40,00 cm	Tilt : ---	Direction :
Date : 01.01.2001	Offset : 112/257	Species :
Time : 00:28:23	Avg. curve : off	Location :
Feed speed : 100 cm/min	Name :

■	From	0,0 cm	to	2,3 cm	:	bark
□	From	2,3 cm	to	20,5 cm	:	structural wood
□	From	20,5 cm	to	39,9 cm	:	Dysfunctional area
□	From	0,0 cm	to	0,0 cm	:	
□	From	0,0 cm	to	0,0 cm	:	
□	From	0,0 cm	to	0,0 cm	:
