Statement of Significance And Condition Report

Betty Barn
Slaidburn Road
Waddington

For Mr Michael and Dr George Fisher
December 2018

Ref. [REDACTED]
Rev A 07/02/19

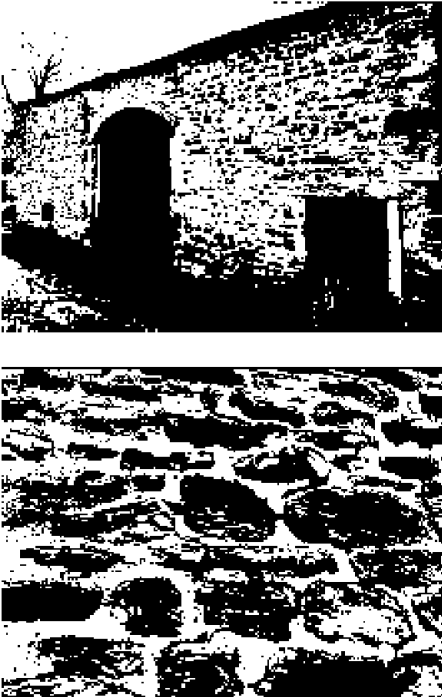
<p>Walls, north</p>

<p>Sandstone rubble walls with dressed quoins. Walls are pointed in a hard mortar and evidence of a softer build mortar is visible below. There is a large cart doorway with dressed jambs and voussoir stones. A smaller personnel door and window have dressed sandstone surrounds. To the right of the cart door is a slit vent that has been blocked up.</p>	<p>Wall is plum. At the north east corner there is evidence of some structural movement. There is also evidence of structural movement over the cart door on the right hand side which correlates with movement internally around the end of the truss tie. Lack of rainwater goods may be part of the cause, see later comment. The mortar on this elevation is more intact than others, it is however much too hard and is causing accelerated decay to the stone. There is grass growing from the joints in the stone at low level, particularly towards the east end.</p>

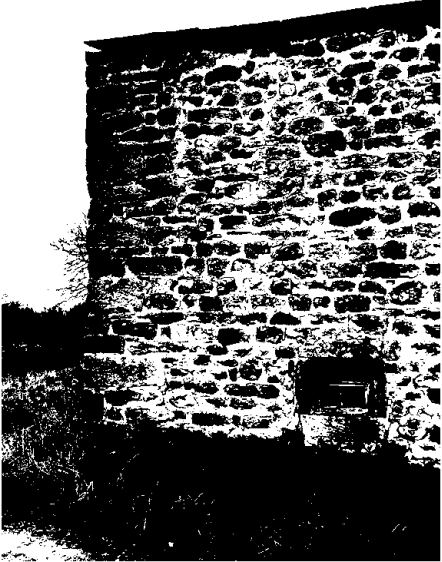
<p>There are no rainwater goods on any part of the building.</p>	<p>Lack of rainwater goods will be resulting in water running down face of walls, washing out joints and core and destabilising walls. It will also be leading to the pooling of water at the base of the walls which could be a contributing factor to the structural movement at the base of the south east corner wall. Concentration of pooling water at the base of walls will also be exacerbating the problem of vegetation growth.</p>

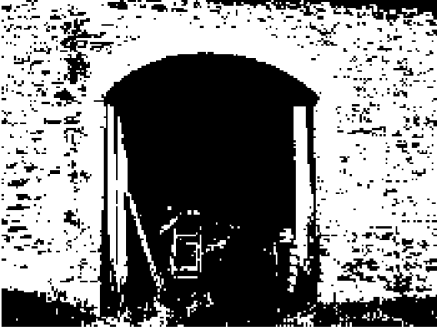
<p>Cart door, north elevation</p>

<p>Doors are timber, on hinges but no frame.</p>	<p>Doors are in very poor condition and no longer functioning having come off their hinges. At the base the doors are severely decayed.</p>
<p>Personnel door, north elevation</p>	<p>Door is timber and chained shut.</p>	<p>Again door is in very poor condition and very decayed at base.</p>
<p>Personnel door, east elevation, south</p>

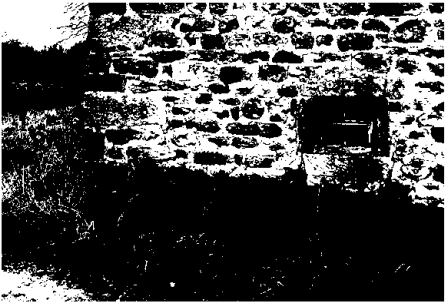
<p>Window, north elevation</p>

<p>Timber window with opening light.</p>	<p>Window is in very poor condition. The glass is all broken and almost all missing. Decoration is almost completely gone and as a result the timber is decaying.</p>
