# **Ancillary Barn Conversion at Hougher Hall Farm, Old Clitheroe Road, Ribchester. PR3 2YU**

## **Structural Appraisal Report**

S1440 rev0

May 2011

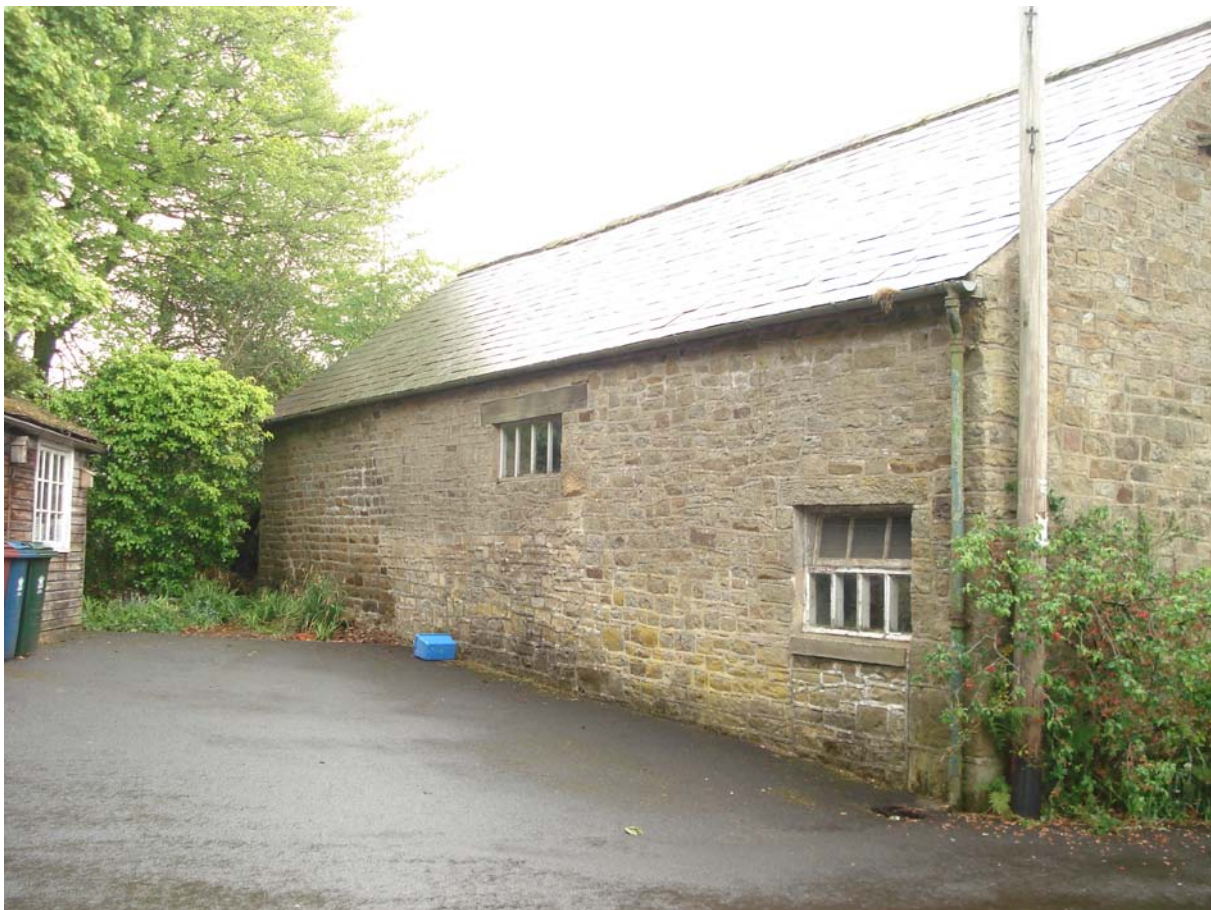
*Barn Rear Elevation*; Plate 01 refers to the west facing rear elevation of the 'Barn' structure. The slate finishes to the rear elevation roof pitch exhibit evidence of previous historic deflection of underlying structural members, although not considered significant or detrimental based upon age and nature of construction. Significant lateral displacement (40mm) is noted approximately 2.0m from the corner junction with the rear elevation for full height (Plate 02), attributable to the 'spread' of the corresponding internal 'Cruick frame/truss'. The remaining length of elevation demonstrates 20-40mm measured over a 1.0m length of external vertical displacement from ground to eaves levels. A timber lintel, situated above a central window opening head exhibits shrinkage cracks (Plate 03), whilst vertical and diagonal mortar cracking emanating from the right hand side masonry lintel bearing is evident to the window opening adjacent to the gable corner (Plate 04), attributable to historic movement.

Plate 01 – Main Barn rear elevation

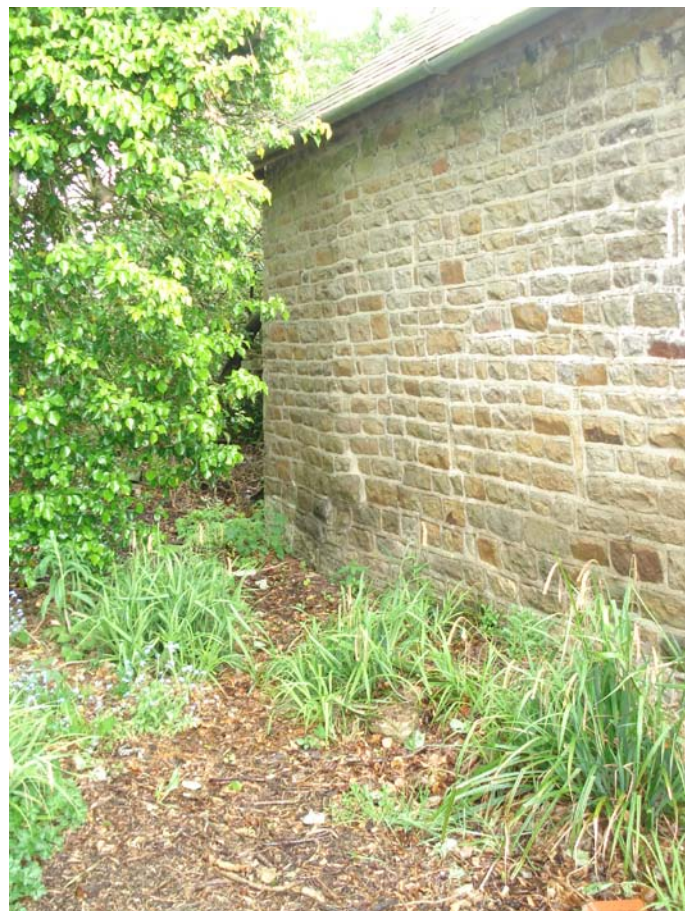
- 2.0.5 Significant, full elevation height lateral ‘bulging’ within the ‘Barn’ rear elevation is attributable to the historic ‘spread’ of the corresponding internal ‘Cruck’ frame adjacent to northern gable elevation. Based upon the extensive lateral movement, we would recommend the full height demolition of a 5.7m partial rear elevation length, extending from the corner junction of the northern gable, attributable to approximately 6% of the property’s total existing elevation area. Demolition should be taken down to existing ground level and rebuilt from existing substructure masonry, ensuring the rebuilt elevation ‘ties’ into the remaining wall elevation beyond. We would suggest that the inner and outer leaf masonry blocks are re-used, fully tied with a cavity formed and insulation requirements

Plate 02 – 'Bulge' within rear elevation adjacent to northern gable

to current standards. The re-built elevation should be fully bonded/'toothed' into adjoining wall elevations.

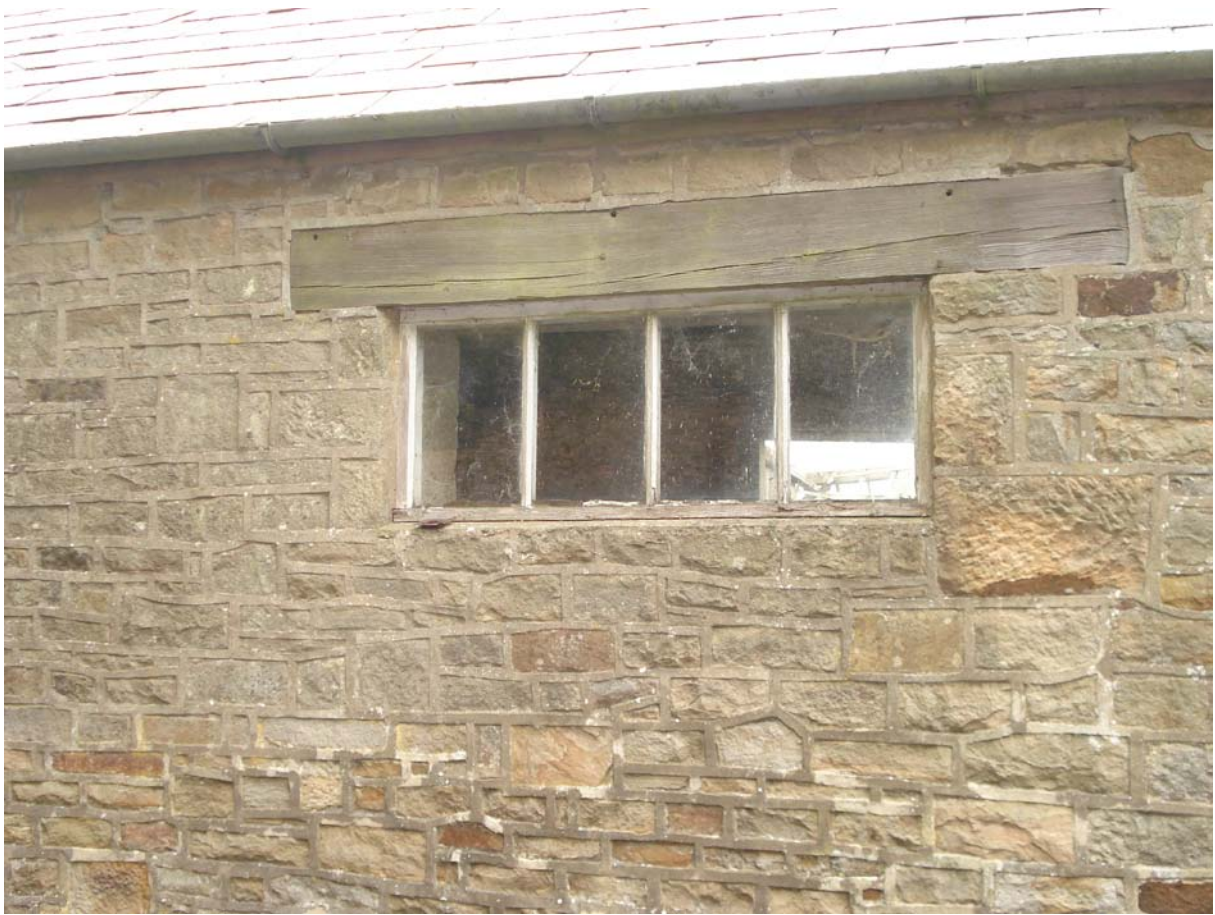
Plate 03 – Thermal cracking to timber lintel within Barn rear elevation

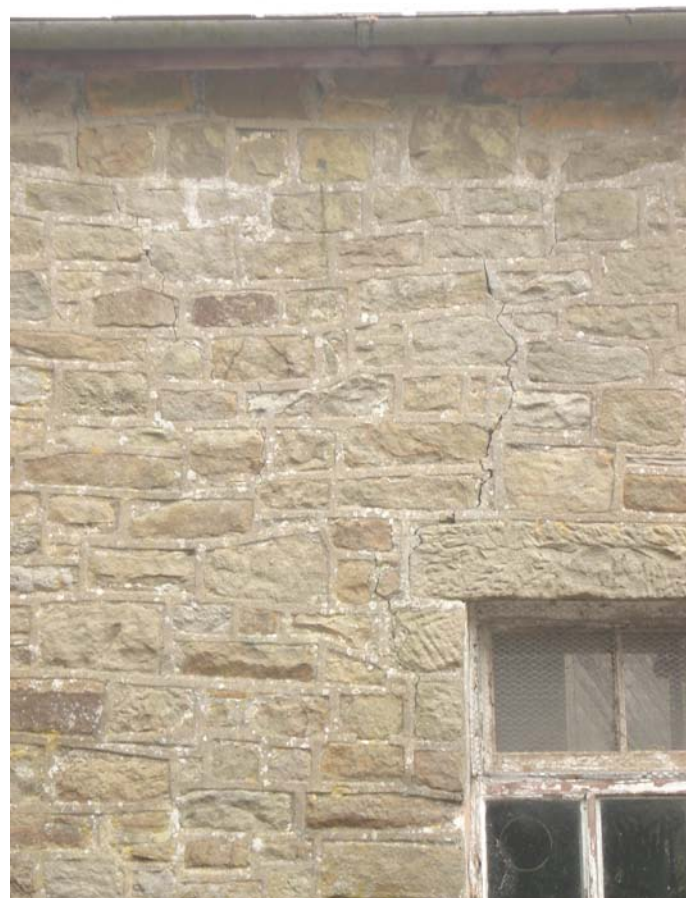
Plate 04 – Vertical cracking at lintel bearing within Barn rear elevation

- 2.0.5 Where vertical mortar cracking is noted within the Barn rear and gable elevations, we are of the opinion that such is attributable to a potential combination of the historical 'spread' of roof members and thermal movement, particularly based upon their proximity to return openings. Proprietary mid steel straps should be secured internally with appropriate fixings, across the crack location at 300mm maximum vertical centres for the length of the crack. This remedial measure we feel is the most appropriate as it is assumed that a blockwork 'lining' wall is to be adopted.

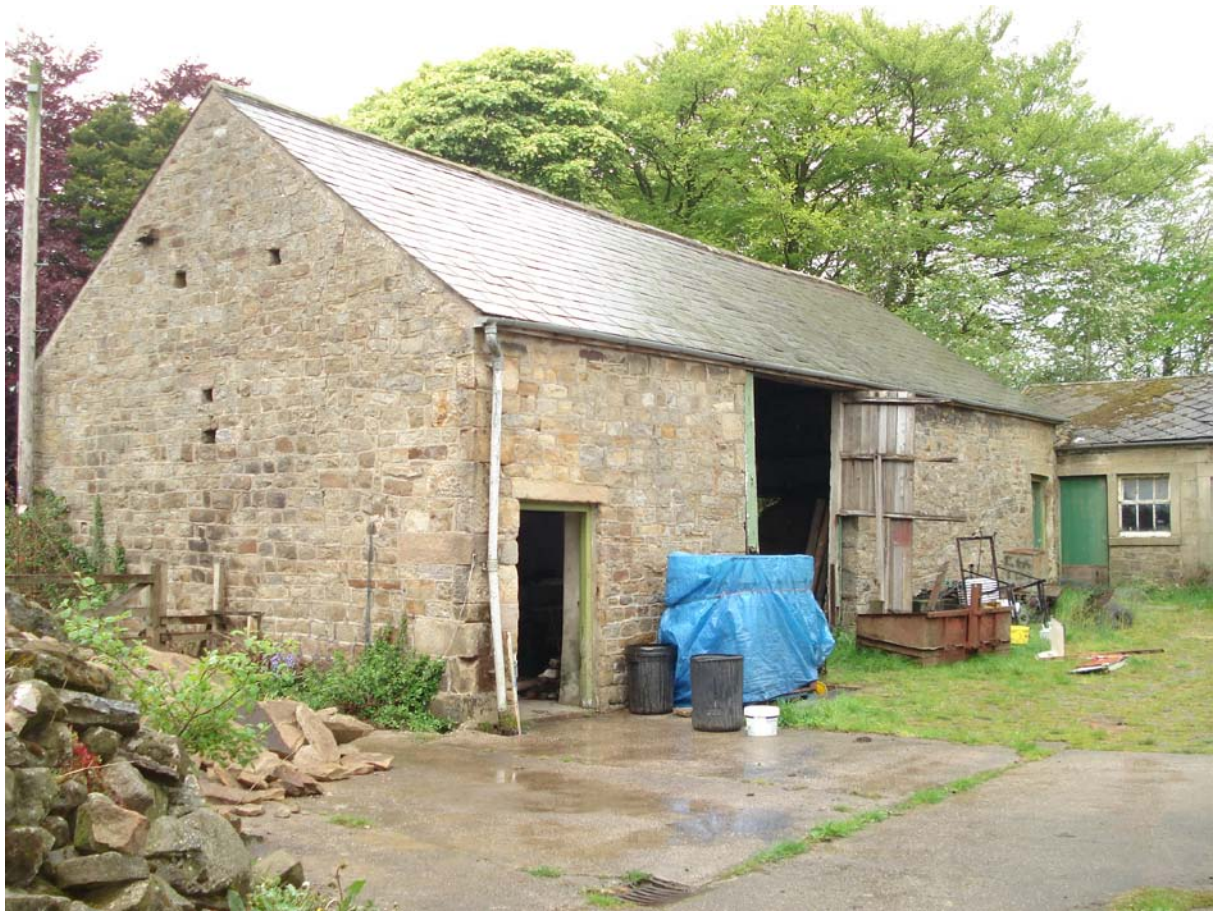
*Barn Gable Elevation*; Plate 05 provides record of the gable elevation general appearance. Apparent, the elevation 'leans' from ground to eaves level; 20mm over a 1.0m measured length. Prominent vertical cracking of mortar beds and perpends extends from eaves towards ground level, terminating approximately 1.0m above grade level adjacent to the corner junction with the Barn front elevation (Plate 06). We are of the opinion that such is a result of Thermal expansion/contraction and a lack of controlled movement joints.

*Barn Front Elevation (Courtyard)*; The east facing front elevation of the structure is detailed within Plate 05. The slate finishes to the visible roof pitch exhibit evidence of historic underlying member deflection, not deemed excessive. The masonry facade along its length is generally plumb, with vertical displacement from ground to eaves level recorded at a maximum 10mm over a 1.0m length. An area of lateral displacement is noted to the right hand side of the main barn door opening for full elevation height, measured at 20mm from adjacent elevation lines. Cracking noted at lintel bearings of the single door opening within the front elevation (Plate 07) adjacent to the gable corner is attributable to historic differential movement of both elevations with respect to one another, together with a lack of restraint offered by both.

Plate 05 – Barn Gable and Front elevations

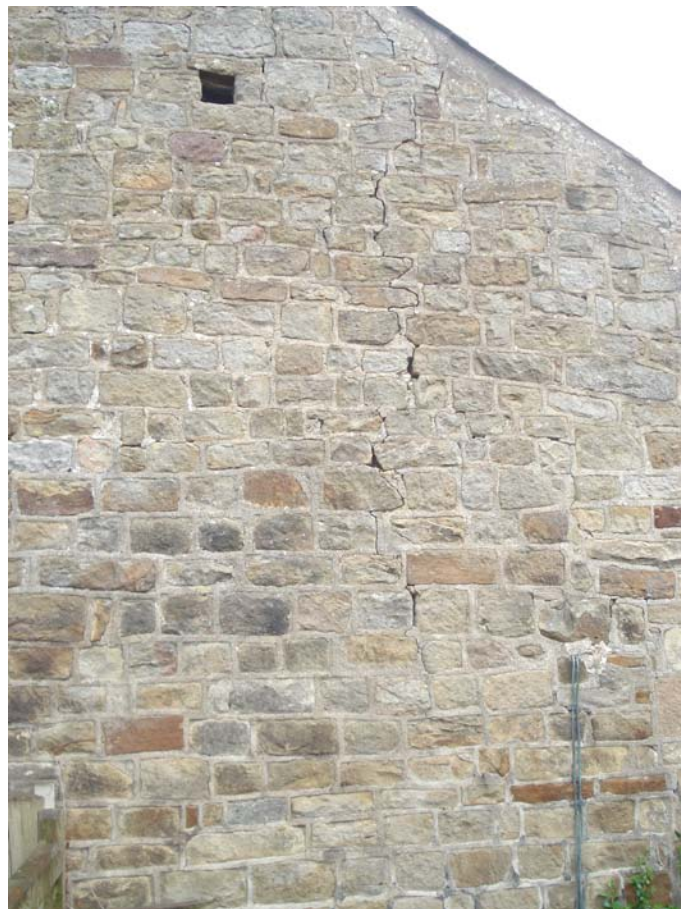
Plate 06 – Vertical cracking within Barn gable elevation

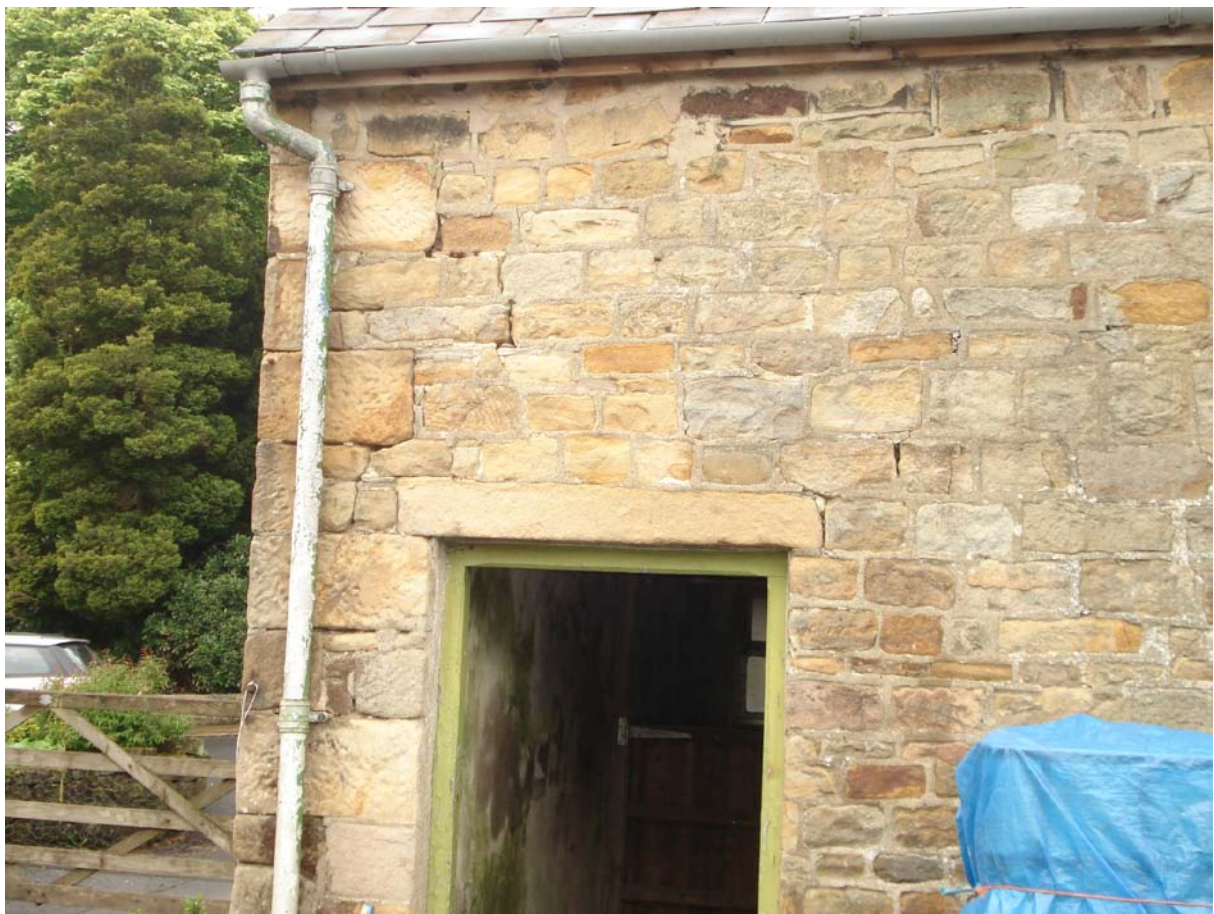
Plate 07 – Historic movement/visible cracking within Barn front elevation

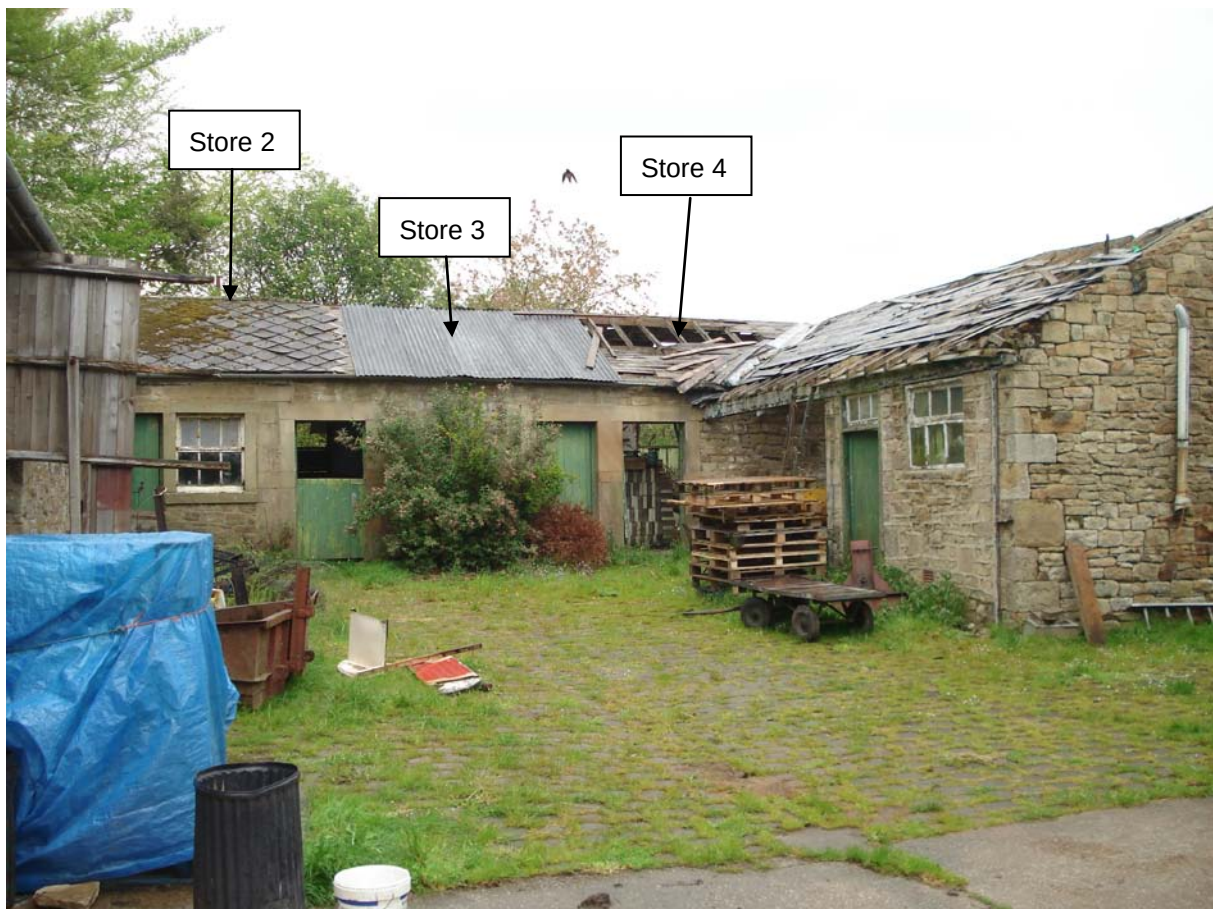
*Store Front Elevation-South facing (Courtyard)*; As evident from Plate 08, the combined roof finishes of asphalt tiles, corrugated sheet metal profile and exposed timber boarding are in a severe state of dilapidation. The masonry wall elevation, comprising significant door openings is reasonably vertically and laterally plumb.

Plate 08 – Store (northern) front elevation

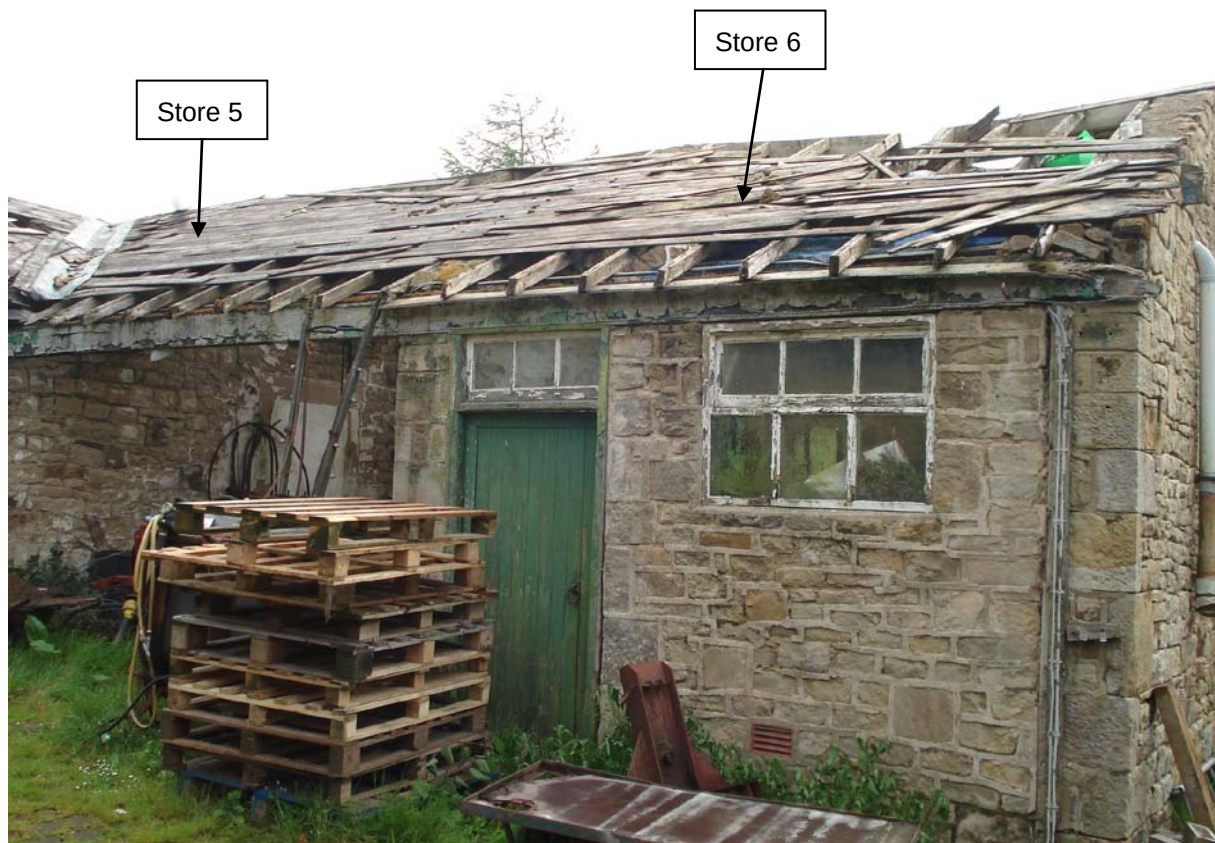
*Store Front Elevation-West facing (Courtyard)*; Plate 09 records the condition of this annexe. As is clearly evident, the roof is in a severely dilapidated state, with areas of underlying rafters exposed. The wall elevation is reasonably plumb, however heavily weathered. The junction of the courtyard and gable elevations is not tied/bonded, with a full height vertical 'butt' joint (Plate 10) offering evidence of more formative repointing remedial works having been undertaken.

Plate 09 – Store (western) front elevation

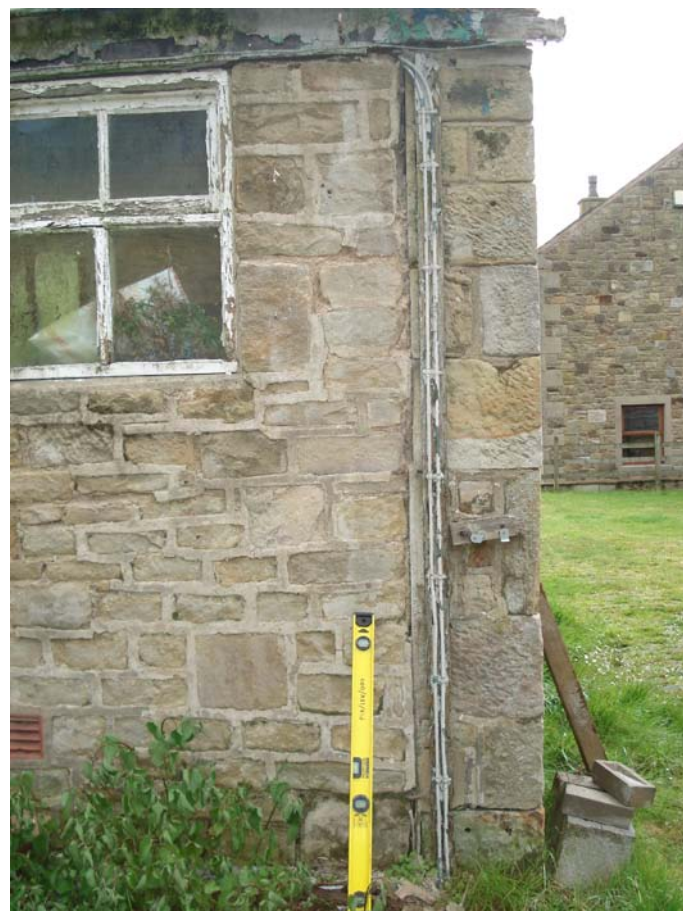
Plate 10 – Butt joint @ Store 6 front/gable elevations

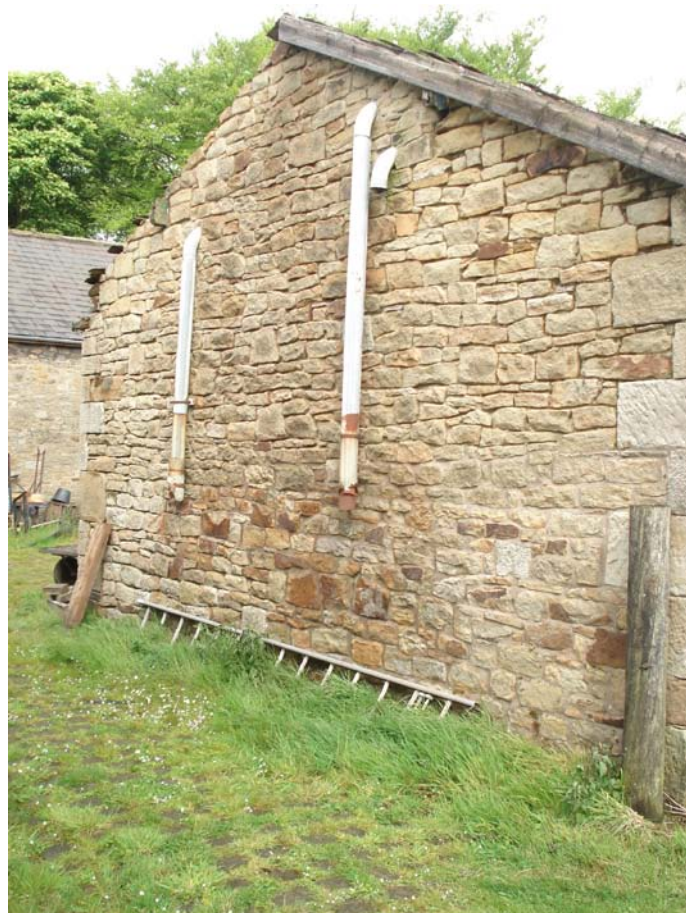
*Store Gable Elevation*; As evident within Plate 11, the gable elevation holds significantly weathered fascias, mortar bed and perpend joints. The elevation whilst reasonably plumb, measures 10mm vertical displacement from ground to eaves level.

Plate 11 – Store 6 gable elevation

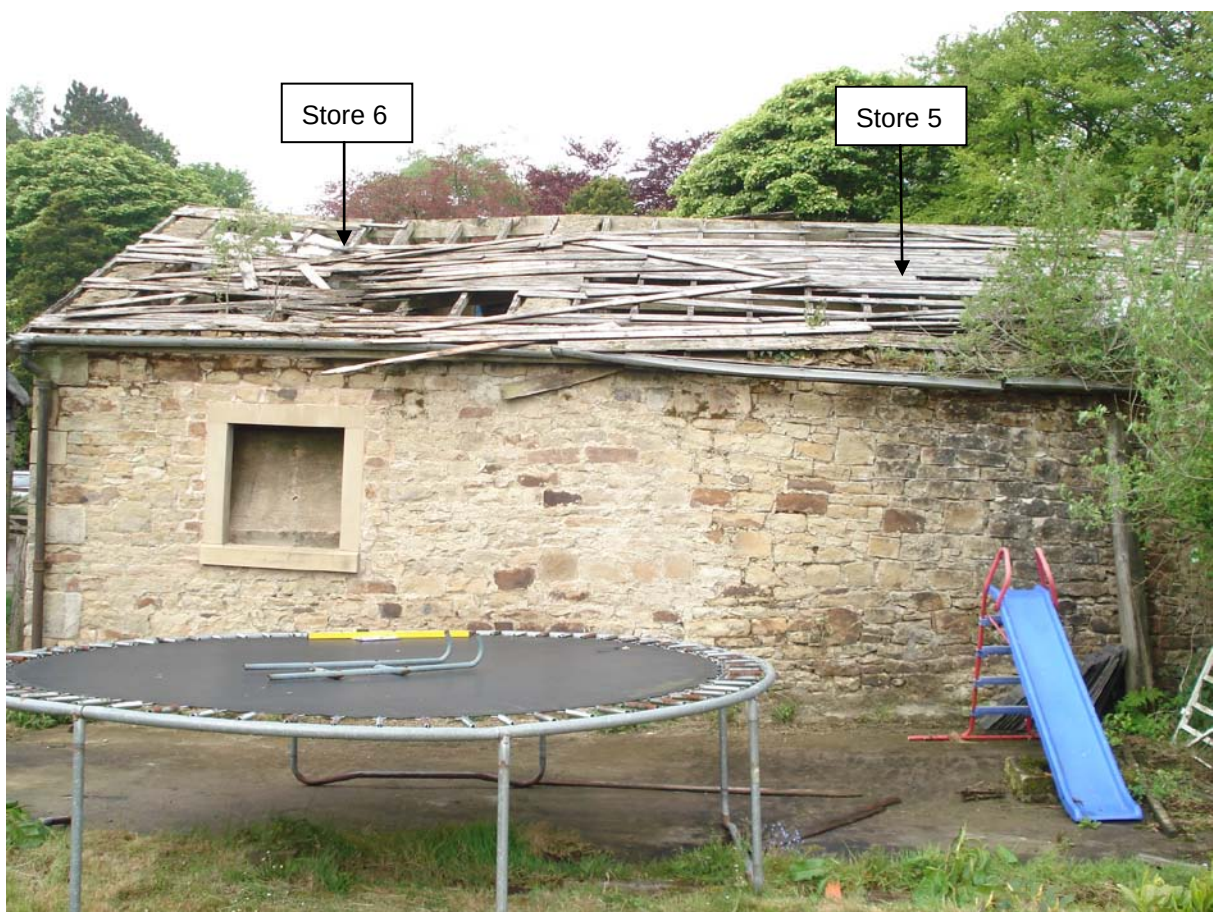
*Store Rear and Gable Elevation-East facing*; Likewise with the front roof pitch of this annexe, the roof is in a severely dilapidated state, with areas of underlying rafters exposed (Plate 12). Beneath the window opening contained within the rear elevation, a 20mm

Plate 12 – Stores 5 & 6 rear elevation

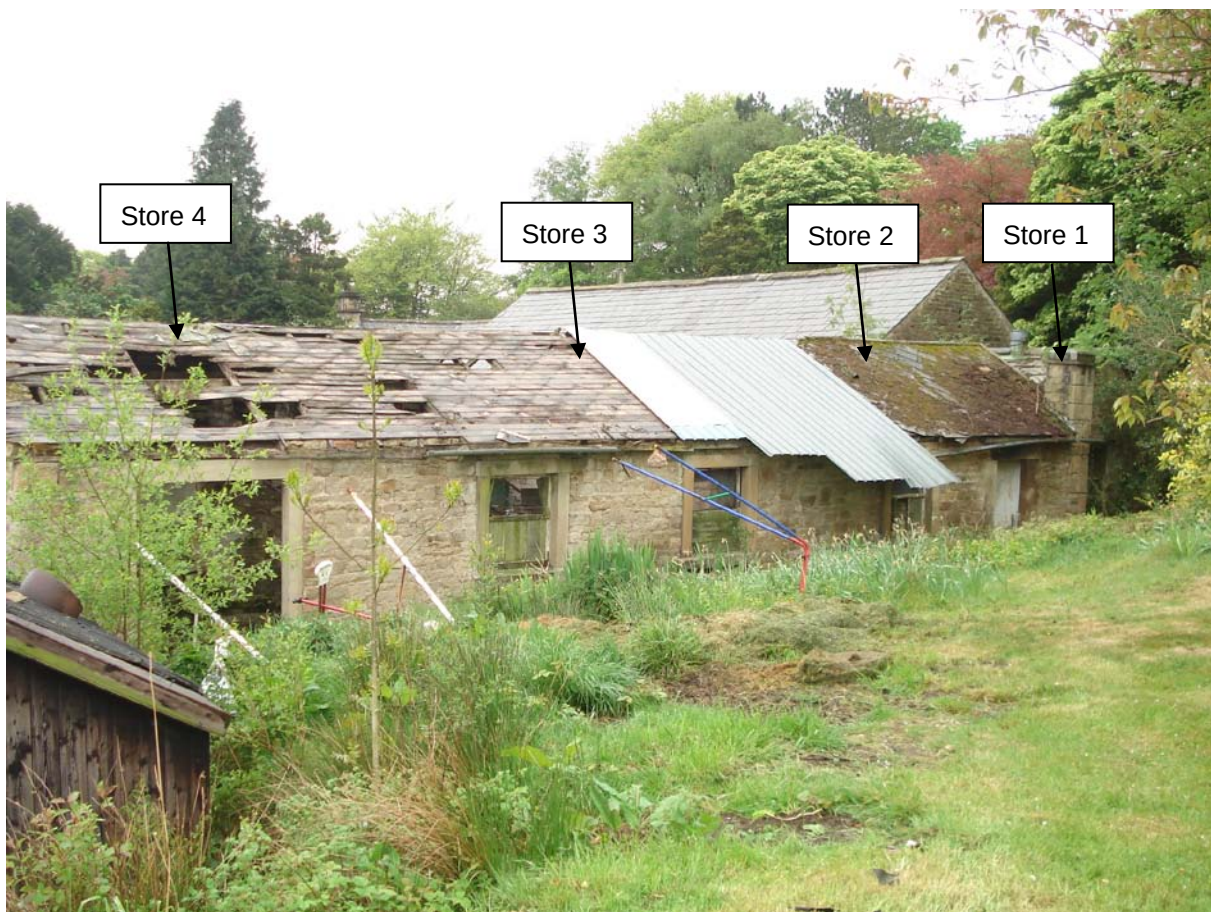
*Store Rear Elevation-North facing;* This comprises of the store rear and barn gable elevations (Plate 13). The roof finishes and condition 'mirror' those detailed for the front roof pitch. Throughout the elevation, formative replacement of all door and window opening head, jamb and sill members had been undertaken with 'Artstone' members. The elevation generally exhibits weathered fascias, mortar bed and perpend joints, however reasonably vertically aligned. The masonry pier situated between the double door opening (adjacent to Store east facing elevation corner) and adjacent window opening 'bows' laterally, of the magnitude of 20mm within the pier width. The Barn gable elevation is reasonably plumb, more formatively subjected to remedial re-pointing works. The existing window opening situated within the gable elevation would appear to have been a previously infilled door opening (Plate 14). Adjacent to the rear elevation, a more formative blockwork retaining wall has been constructed, retaining adjacent garden areas. The wall leans 20mm from base to coping.

Plate 13 – Stores (northern) rear elevation

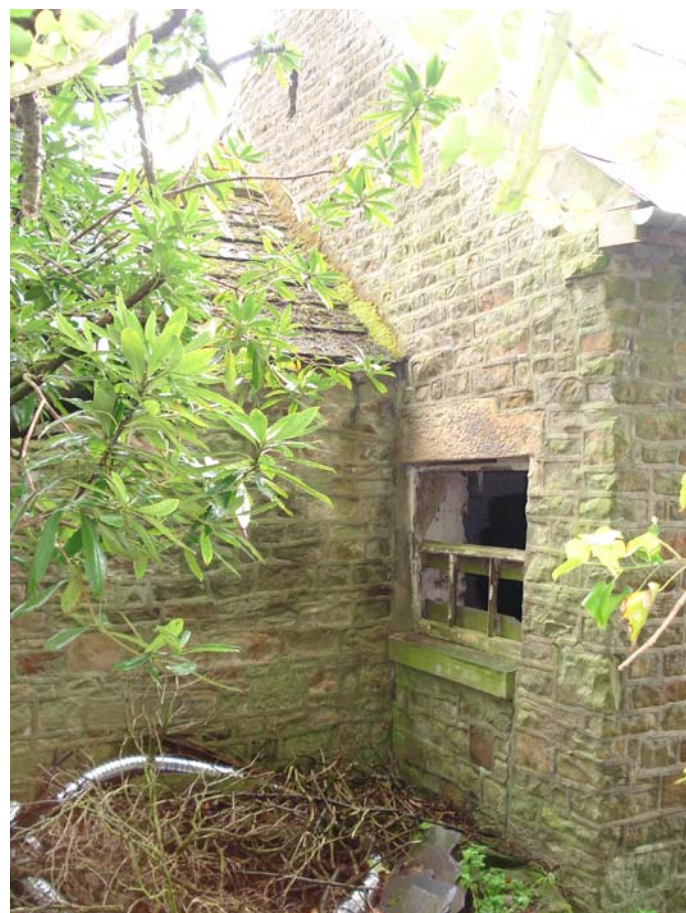
Plate 14 – Infilled former door within Barn north gable elevation

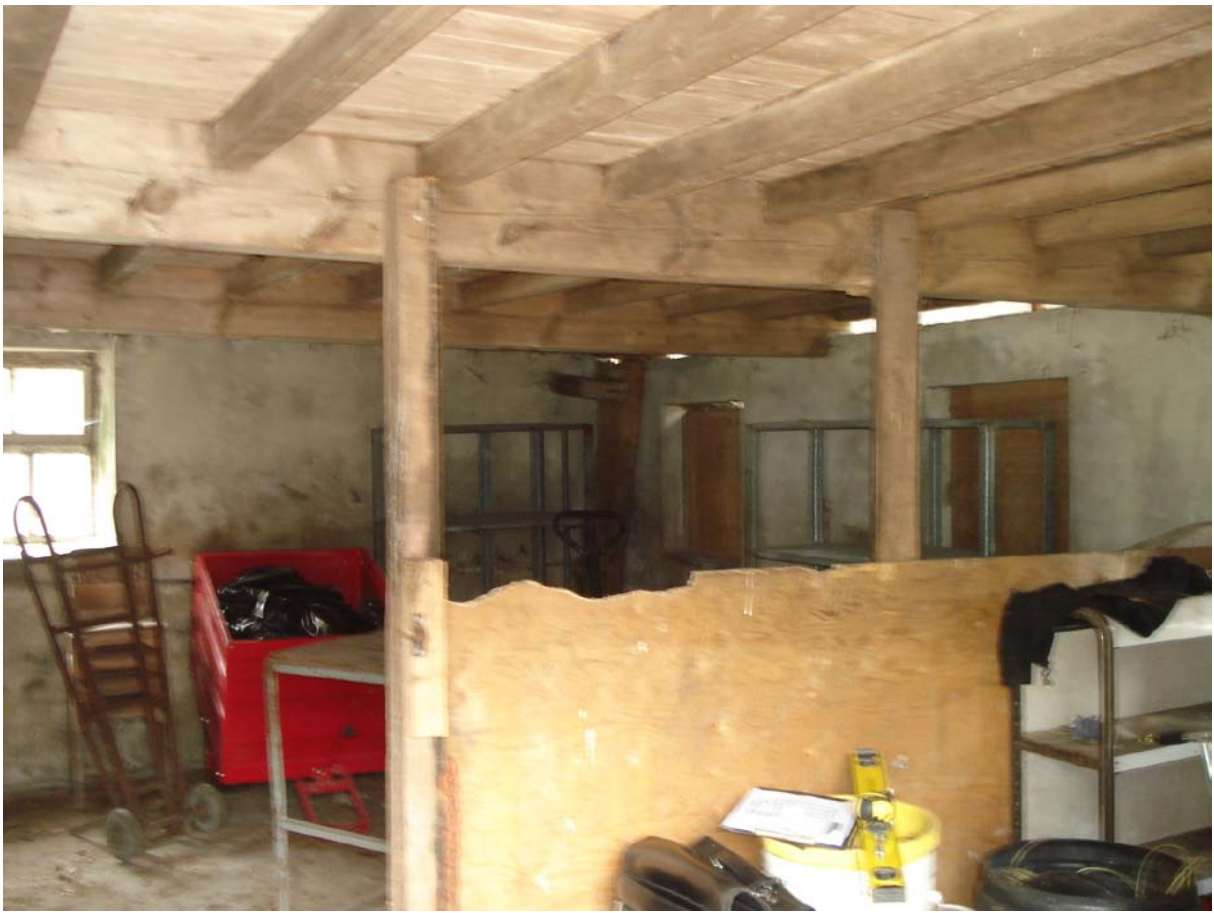
*Agricultural Barn Stalls;* Within the Main Barn structure, 'stalls' have been created within and area adjacent to the south facing gable elevation (Plate 15), partitioned from the barn area by means of a single storey height, load bearing masonry partition. Additionally, a more formative timber first floor provides a 'storage platform', supported by intermediate timber beams spanning from gable to partition. All internal wall elevations hold a rendered façade. The internal aspect of the front elevation is vertically plumb, whereas the gable and rear elevations over a 1.0m length offer vertical misalignment of 10 and 30mm respectively (Plate 16). First floor 86x78 joists @ 450mm centres span from front to rear, supported intermediately by two number 230x100 timber beams spanning the width of the stall area. Visual evidence of wood boring insect infestation of the floor beam members is apparent; however excessive deflection/overstress of the structural members is not noted. The ground floor is of solid ground bearing concrete construction, visibly sloping from partition to gable elevations, however not offering any evidence of historic or recent movement.

Plate 15 – ‘Stalls’ within Main Barn structure

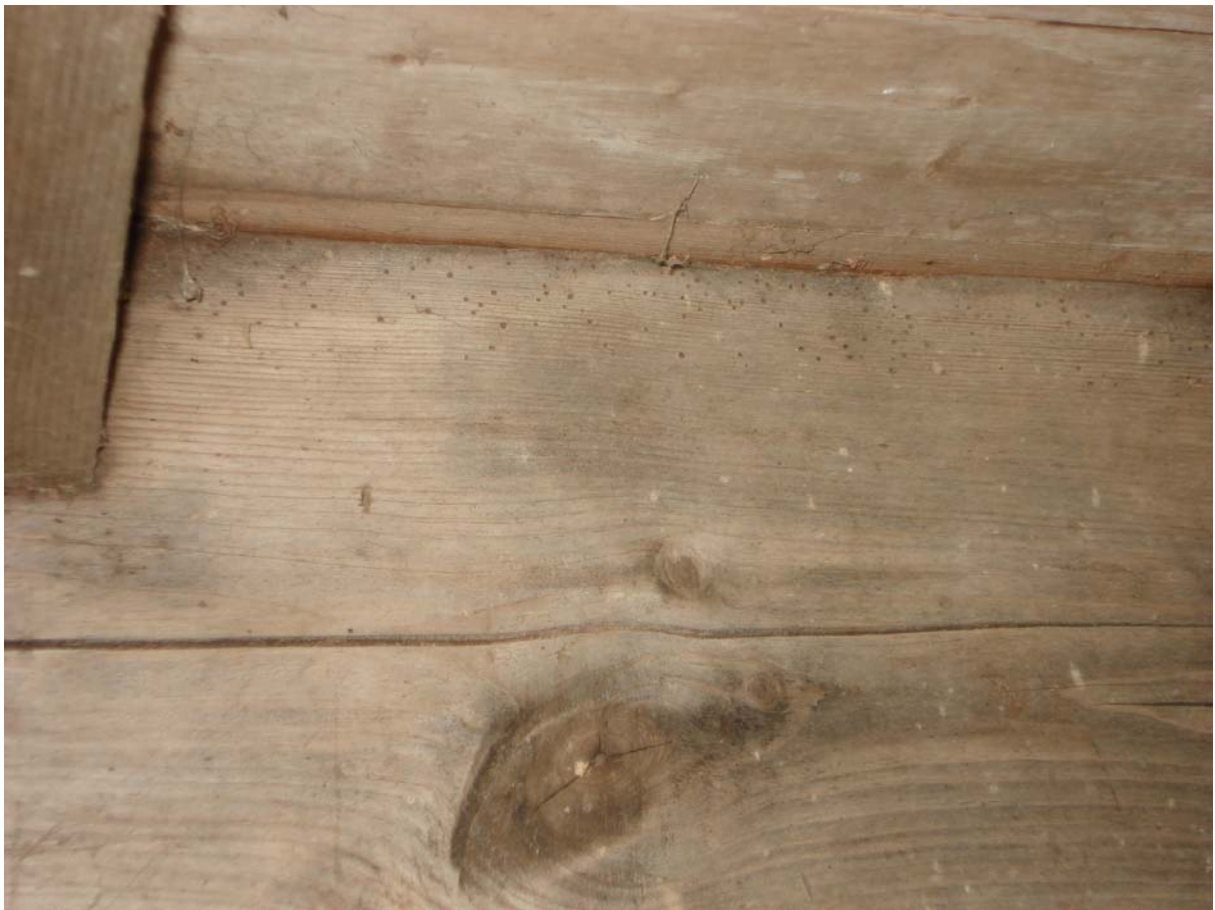
Plate 17 – Wood boring insect infestation to first floor beam (Stalls)

- 2.0.4 Should a timber survey determine that the existing ‘Stalls’ first floor members are free from rot, damp and wood boring insect infestation, structural assessment of their capability to sustain proposed domestic floor loading prior to redevelopment is required.

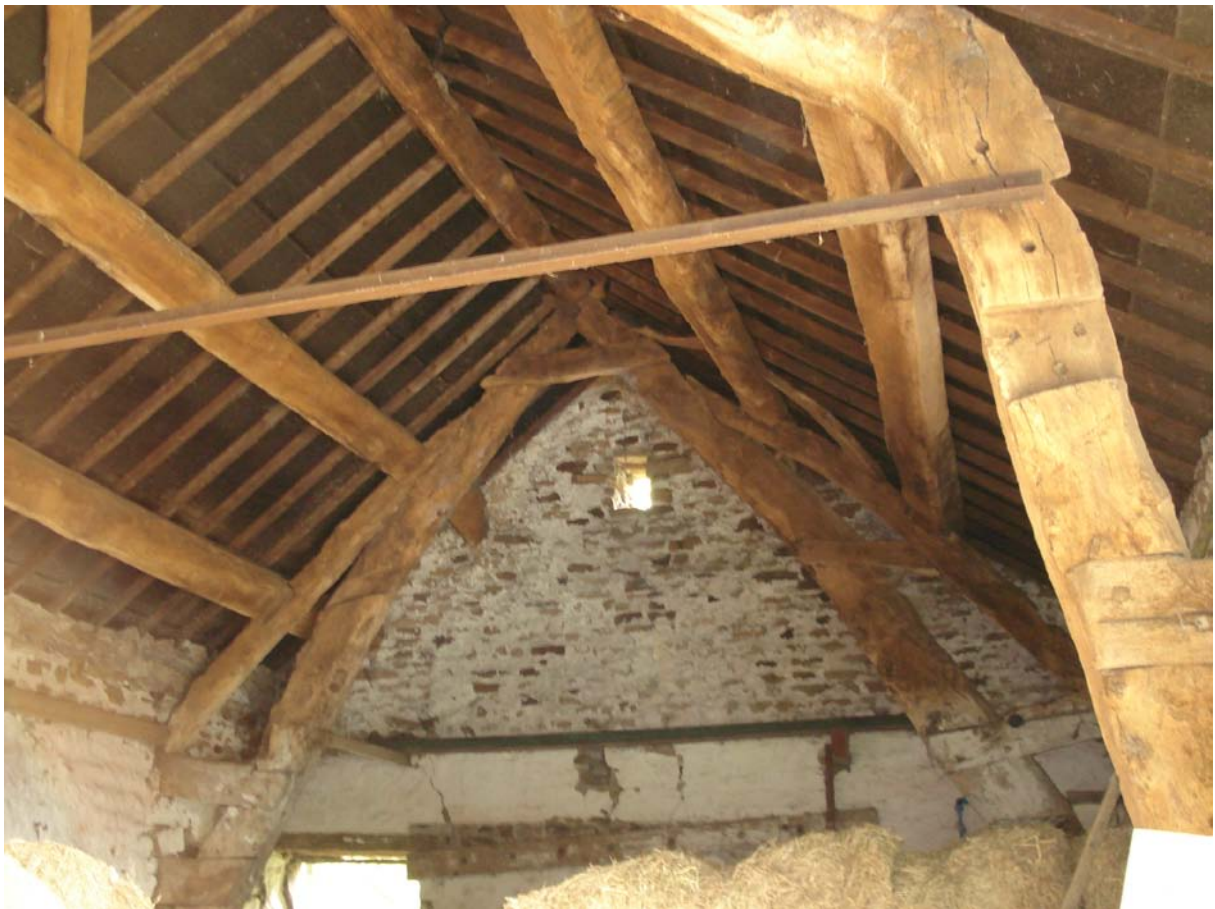
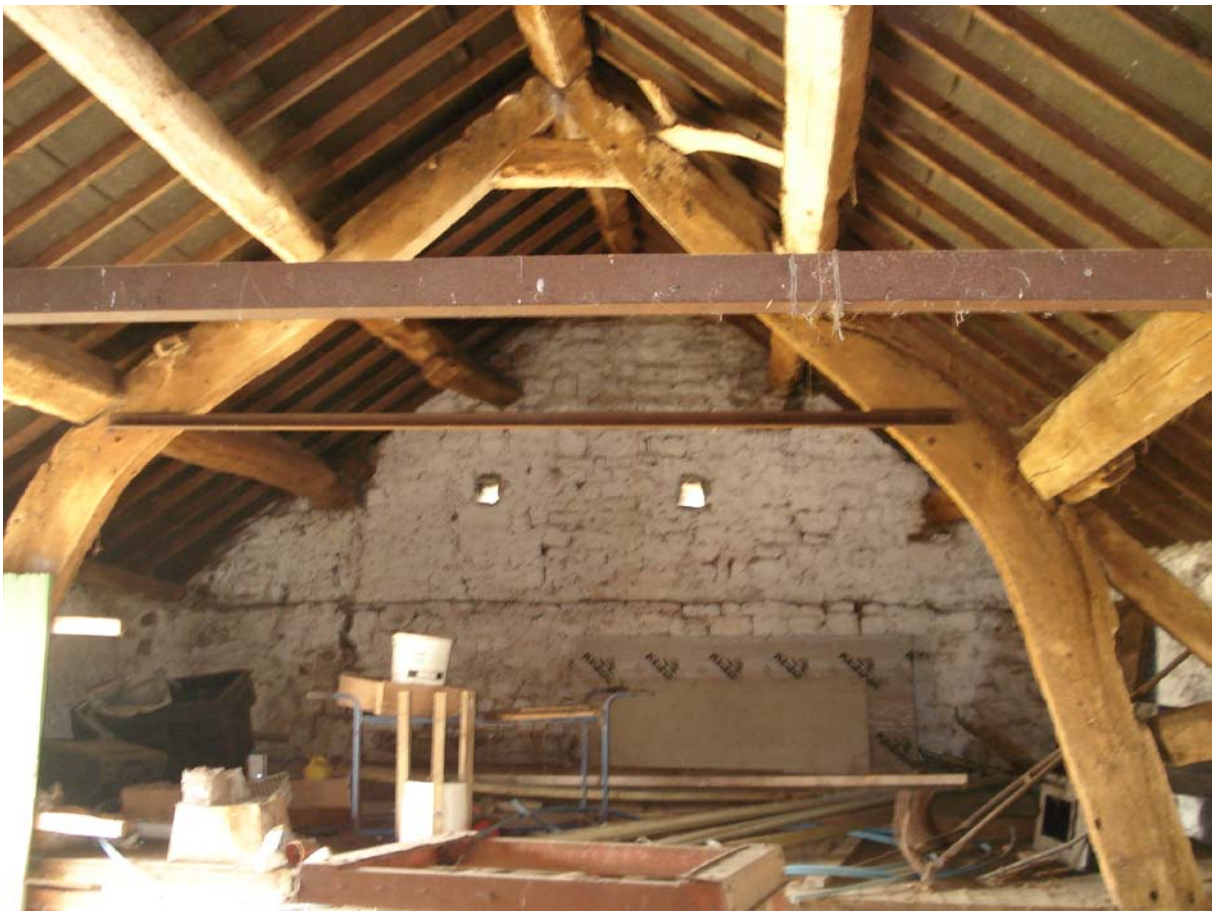
*Agricultural Barn;* Plates 18 and 19 identify the original Barn structure to be that of a timber 'Cruck' frame/truss configuration. Comprising of three internal frames supporting original

Plate 18 – Main Barn 'Cruck' frames (north facing)

Plate 19 – Main Barn 'Cruck' frames (south facing)

However, it is our considered opinion that the existing timber roof structure throughout the property and ‘Cruck’ frame/trusses are structurally inadequate to sustain proposed loading. Based upon our perception of the planning process, we would fully expect that the retention of the ‘Crux’ frames to be conditioned within any planning permission granted. However, we would suggest that their retention be limited to that of an aesthetic purpose, and in no way an integral element of the structural fabric of the proposed dwellings due to their dilapidated condition.

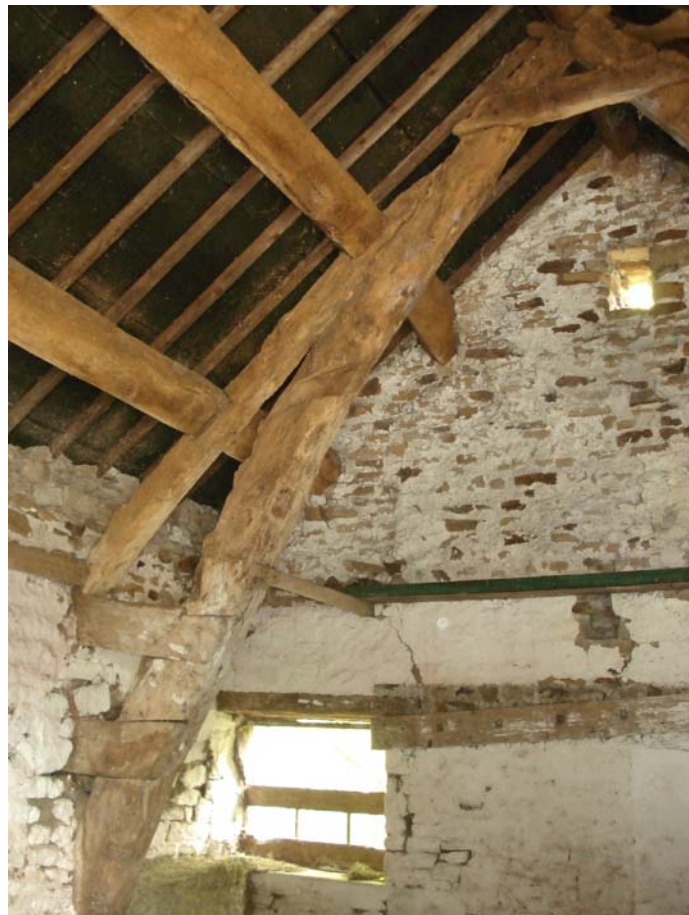
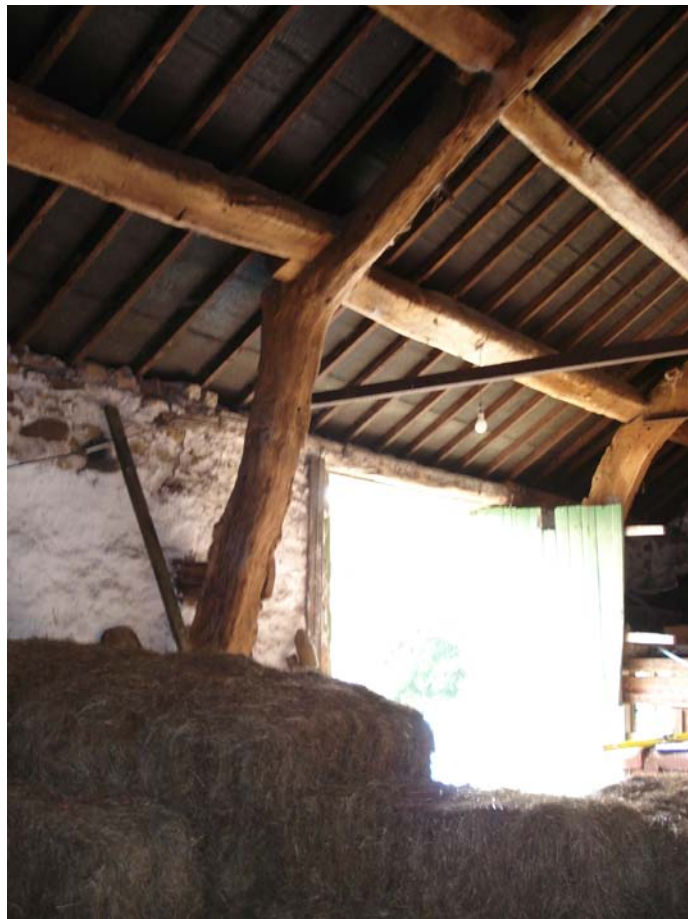
timber purlin members, all original timber is of greatly reduced section, having been subject to historic damp/rot penetration and wood boring insect infestation (Plates 20 & 21). The rafter members to the roof have been more formatively replaced, and offer no evidence of similar infestation, nor rot/damp penetration when viewed from ground level. In terms of verticality, the internal gable elevation is considered plumb, with the internal elevations of the front and rear elevations 'leaning' 40 and 30mm over a one metre length from ground to eaves respectively. Several areas of the internal elevations exhibit spalled mortar beds and perpend joints (Plate 22). The existing floor incorporates a 400mm step running centrally across the area width. Although inspection was severely restricted due to the presence of stored haylage, it is presumed that the floor is of solid ground bearing construction, formed by stone sets, sloping from gable to partition elevations.

Plate 20 – 'Cruck' frame historic deterioration/section reduction

Plate 21 – 'Cruck' frame historic deterioration/section reduction

- 2.0.2 It is recommended that consideration of a “specialist” timber survey is undertaken throughout the proposed redevelopment area. Such a survey should identify the nature and extent of any wood boring insect infestation, dry/wet rot and fungal attack within all pertinent structural timber members (roof and lintels) and where appropriate, recommend the extent of remedial works necessary to arrest such.

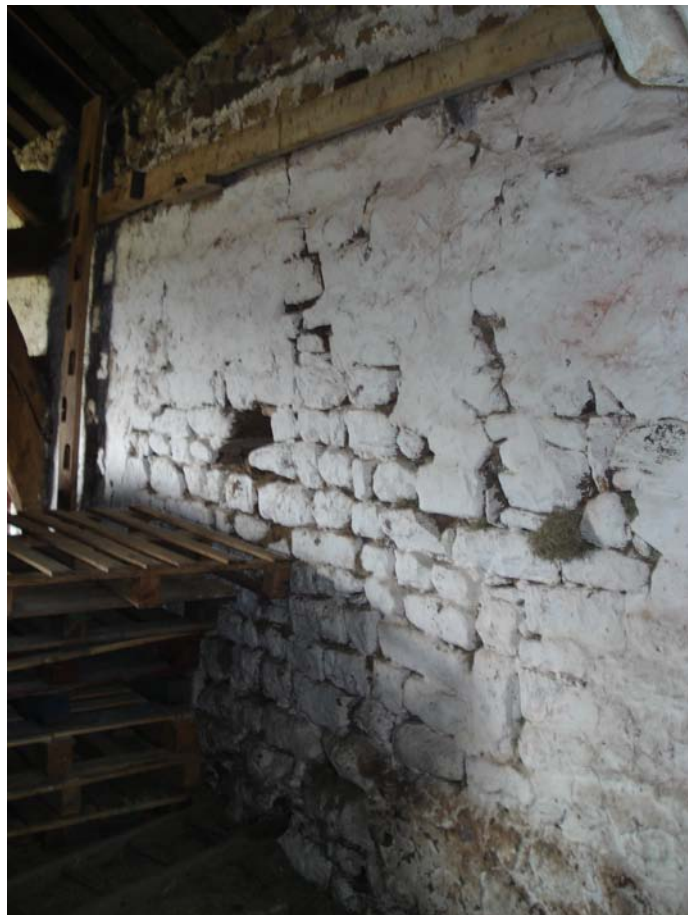
Plate 22 – Spalled mortar within internal aspect of Main Barn

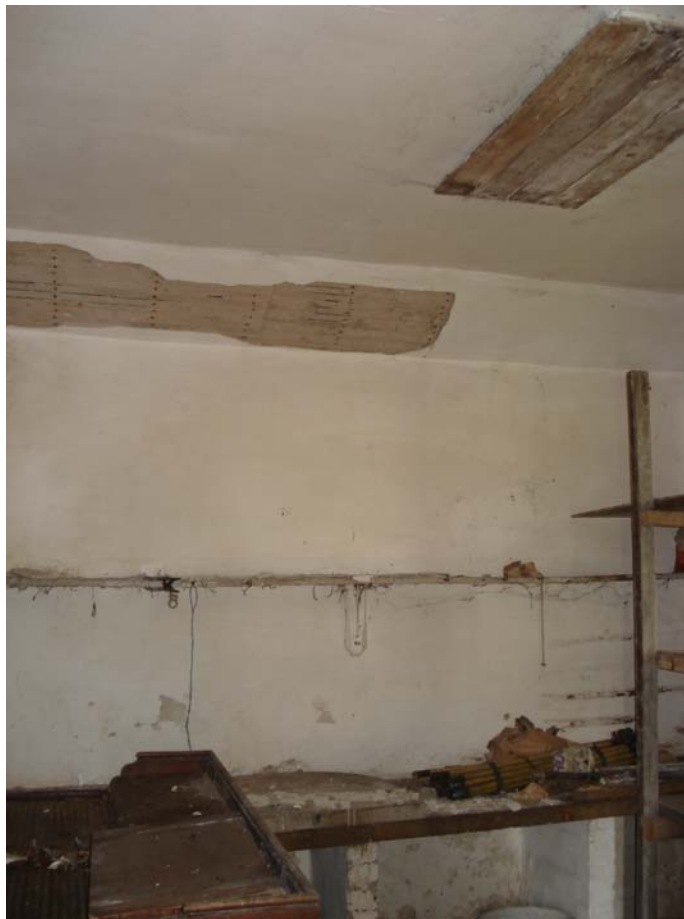
Plate 23 – Spalled ceiling finishes within Store 1
