# **Ancillary Barn Conversion at Hougher Hall Farm, Old Clitheroe Road, Ribchester. PR3 2YU**

## **Structural Appraisal Report**

S1440 rev0

May 2011

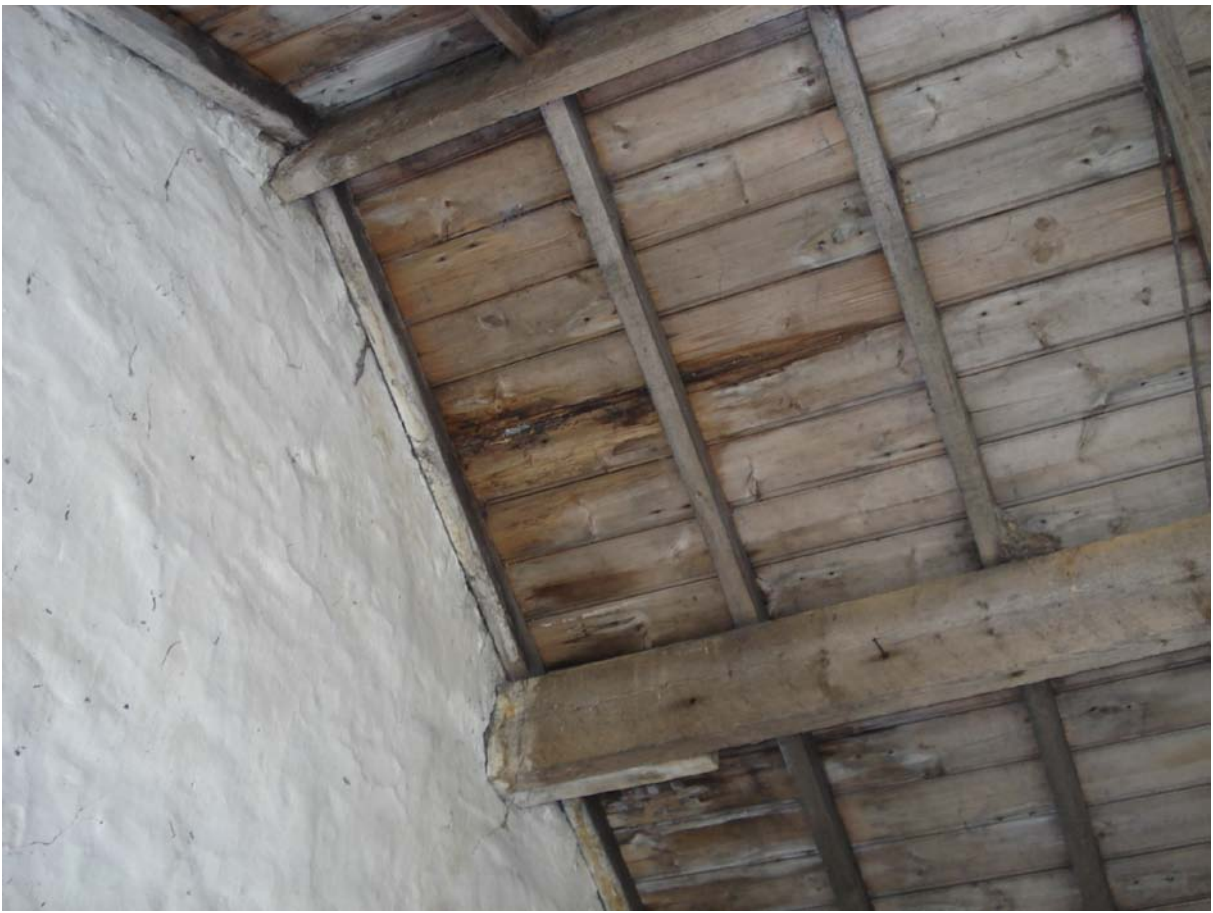
Store 2 (Plate 24) is presently utilised for the storage of agricultural sundries. The roof holds no internal finishes, exposing damp penetration of boarding, rafter and purlin members (Plate 25). Similarly, the timber lintel member spanning the door and window opening contained within the front elevation exhibits similar rot. All internal wall elevations hold a whitewashed render application, reasonably plumb. A full height vertical joint is evident at the junction of the rear elevation and the partition to Store 3. Offering no evidence of significant movement, the joint indicates a lack of 'bond' between the two elevations (Plate 26). Again, a concrete, presumed ground bearing floor slab falls from rear to front, however not offering evidence of historic or recent settlement/movement.

Plate 25 – Store 2 internal roof finishes

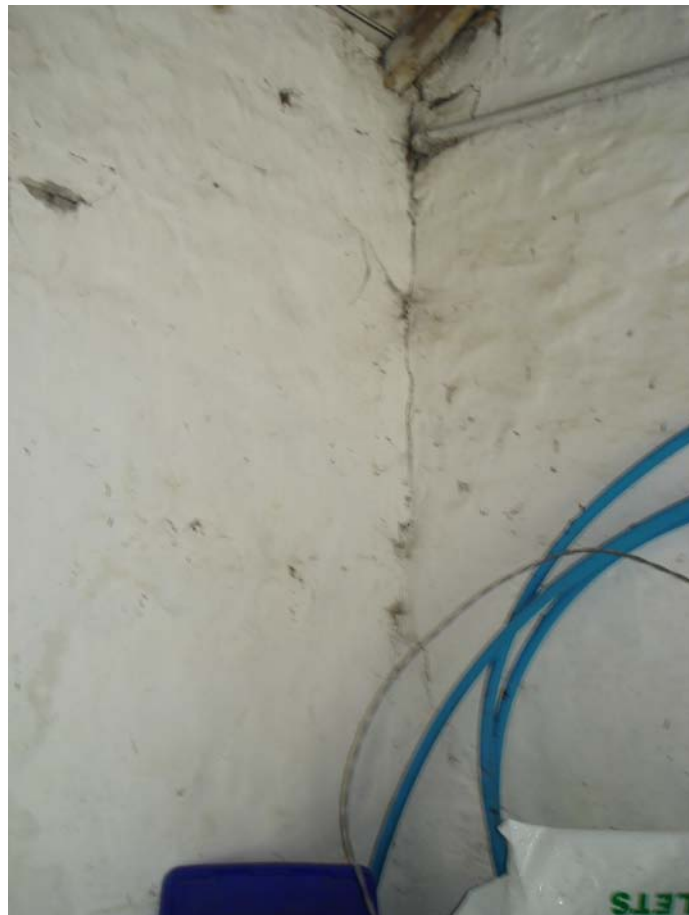
Plate 26 – Store 2/3 internal partition butt joint with rear elevation

- 2.0.6 Within the Store areas, where brickwork internal partitions have been constructed abutting front and rear elevations, proprietary mid steel straps should be secured internally with appropriate fixings across the joint location at 225mm maximum staggered vertical centres for the height of the elevation. Where a 'butt' joint is formed between Store 6 front and gable elevations, internal proprietary corner strapping is to be provided at 450mm vertical centres.

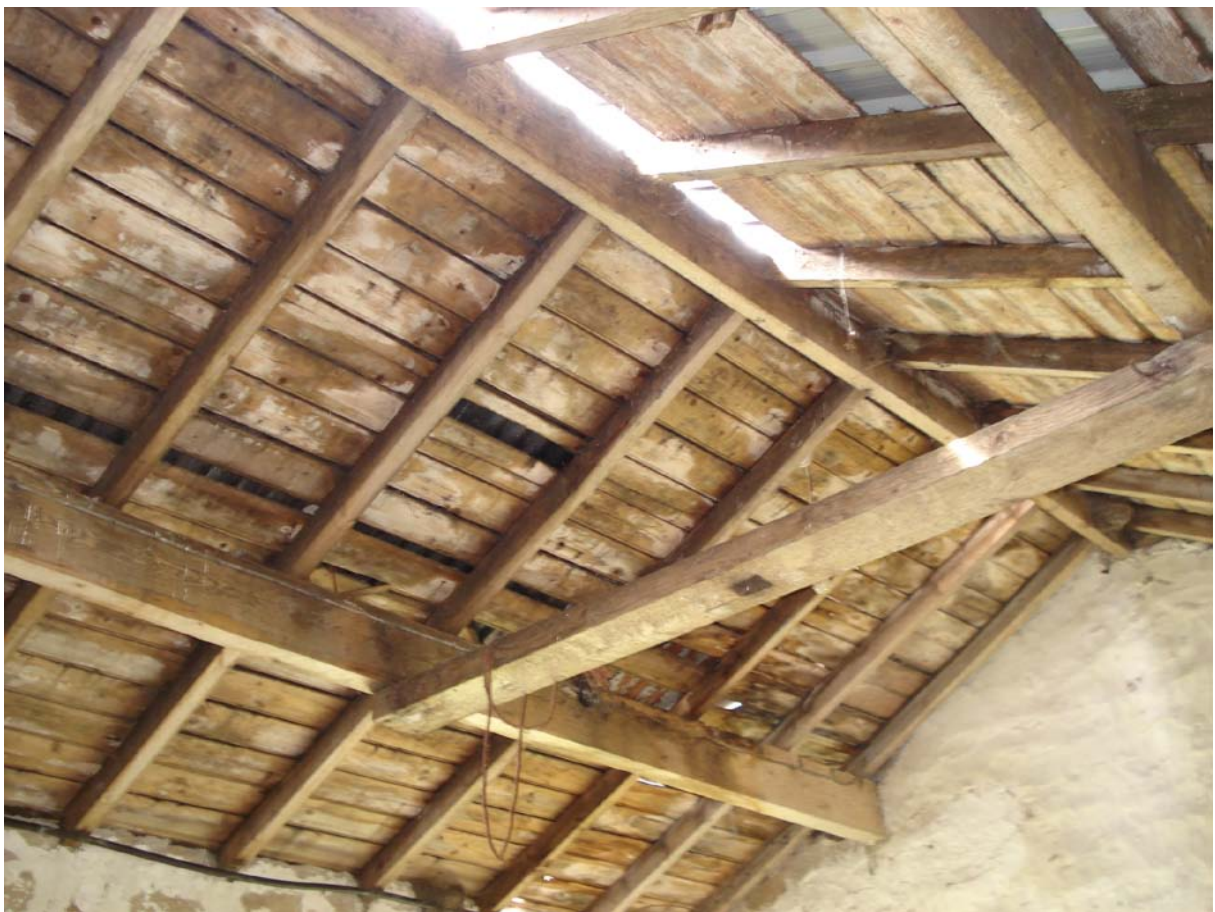
Store 3 (Plates 27-29 inclusive) again holds no ceiling finishes, exposing boarding, rafter and purlin members subjected to historic damp penetration. All internal wall elevations are reasonably plumb. The partitions segregating Stores 2 and 4 are more formatively

Plate 29 – Store 3 internal roof finishes

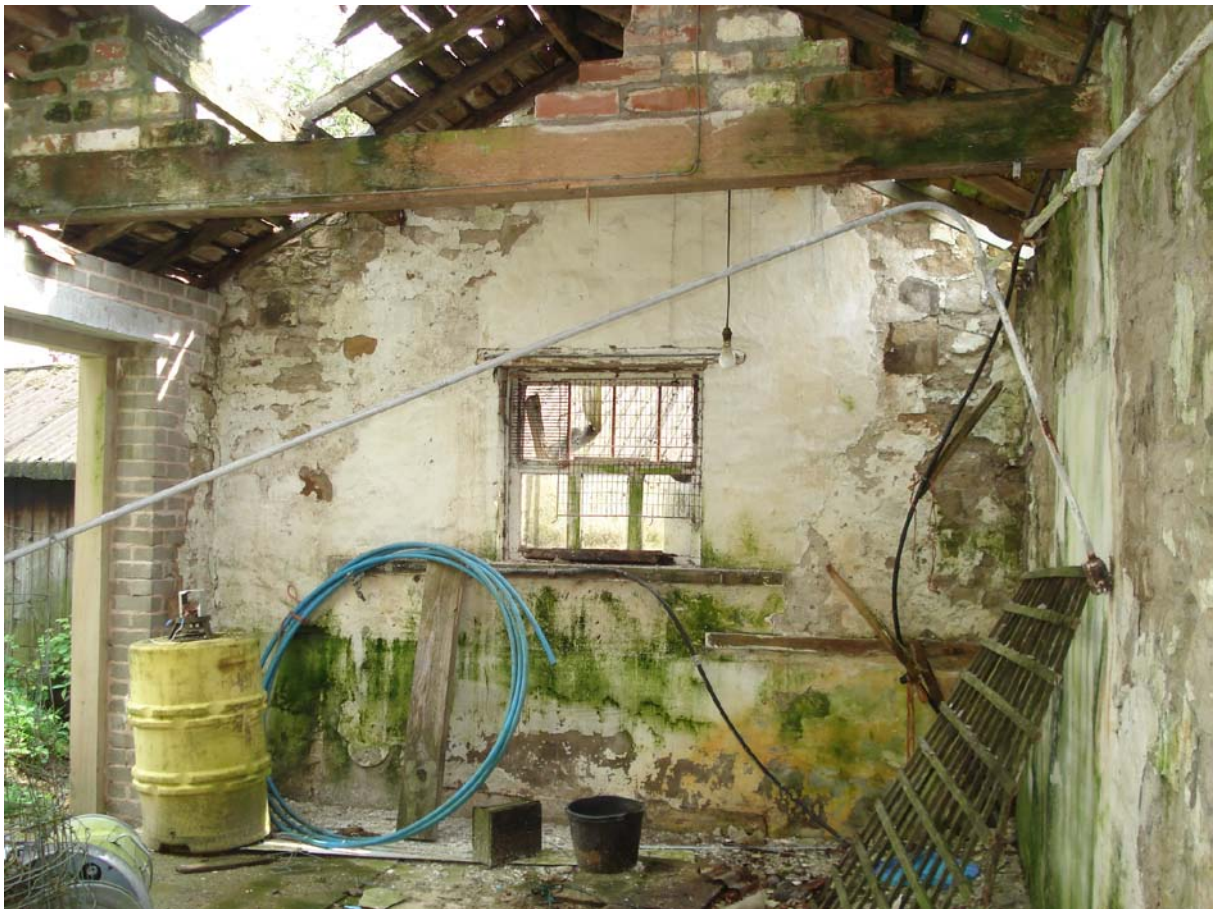
Store 4 (Plate 30) is in a severely dilapidated condition. Obviously exposed to historic weathering, timber boarding is missing, exposing rafter and purlin members to moisture, rot and wood boring insect penetration. Similarly, the internal timber lintel member above the front elevation exhibits similar deterioration (Plate 31). All wall elevations offer obvious damp penetration, however reasonably plumb. A concrete, presumed ground bearing floor slab falls from rear to front, however not offering evidence of historic or recent settlement/movement.

Plate 30 – Store 4 internal gable elevation

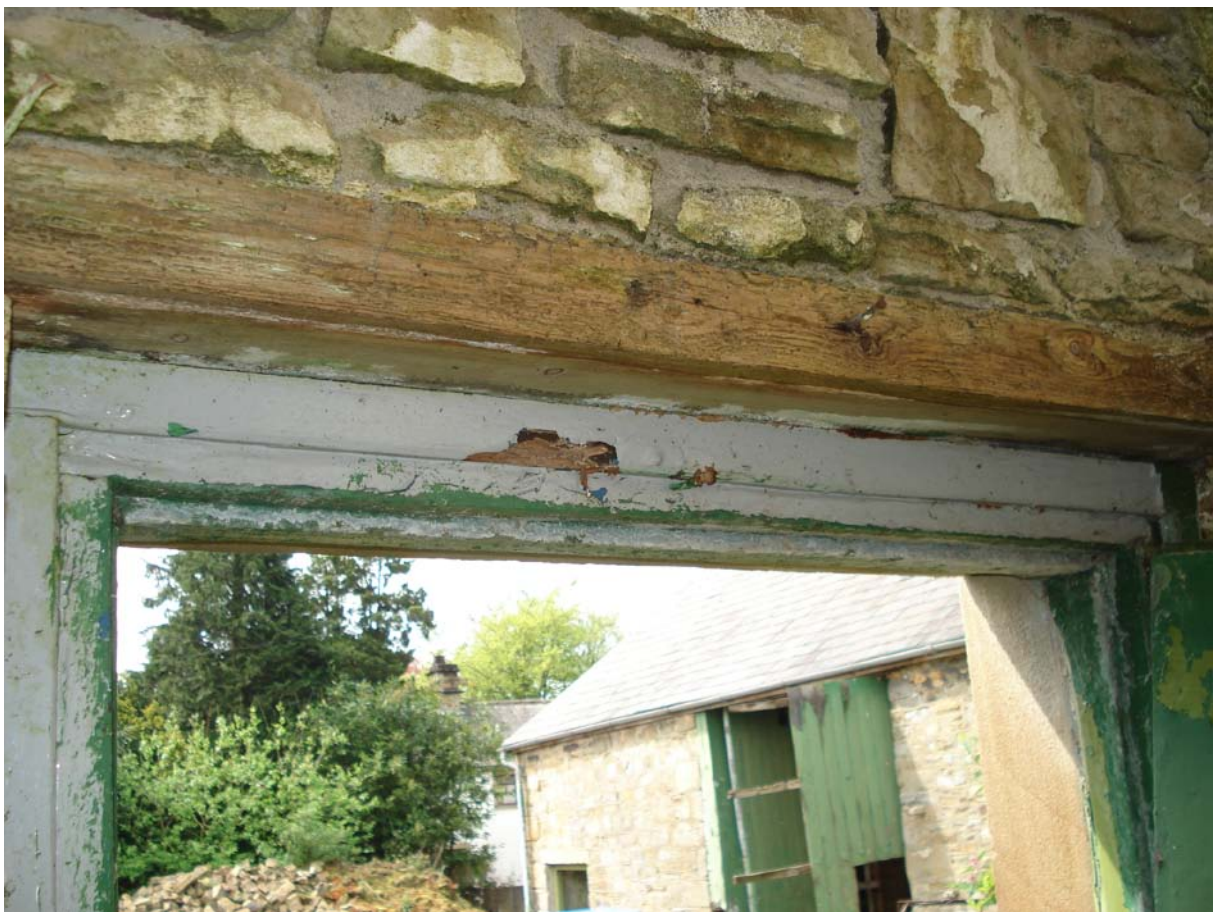
Plate 31– Store 4 timber lintel member (front elevation)

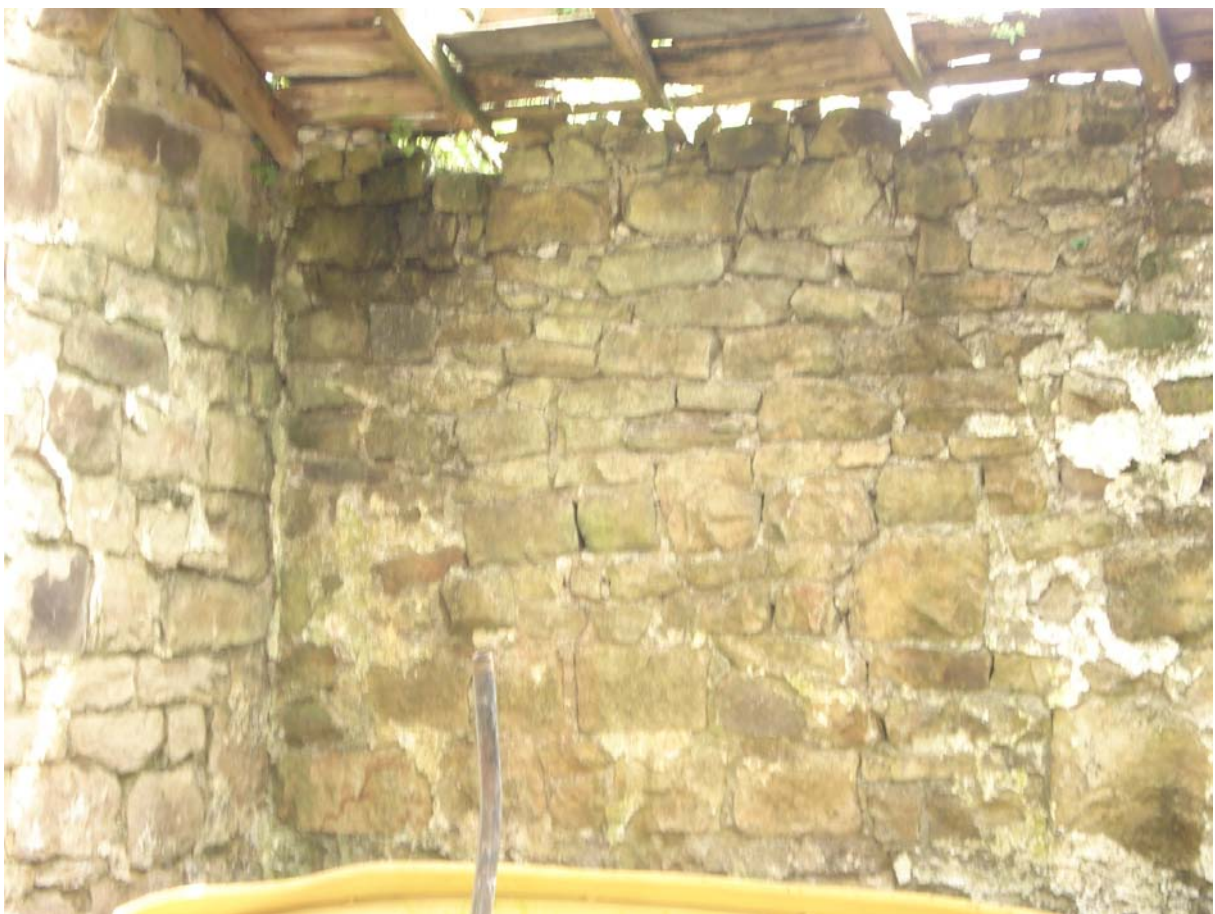
Plate 34 – Store 5 rear elevation – weathered mortar bed and perpend joints

- 2.0.7 Whilst not necessarily of structural significance, we would recommend that where noted, all weathered and cracked mortar bed and perpend joints are re-pointed, particularly where vertical cracking is noted within the external elevations, previously addressed by internal strapping recommendations.

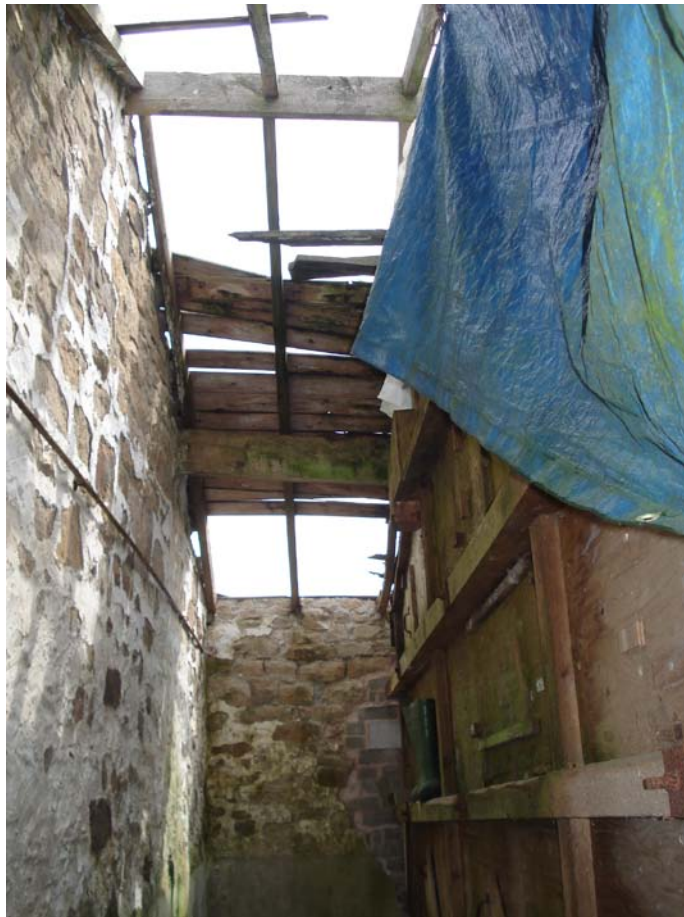
Within Store 6, a timber coop has been constructed, severely restricting inspection of this area (Plate 35). Only partial viewing of the roof structure can be undertaken, where so again demonstrating a severe state of deterioration. The only visible wall elevation is that of the load bearing masonry partition to Store 5. Reasonably plumb, the elevation exhibits obvious damp penetration, demonstrated by the spalled whitewash application (Plate 36).

Plate 35 – Store 6 internal partition and roof adjacent to Store 5

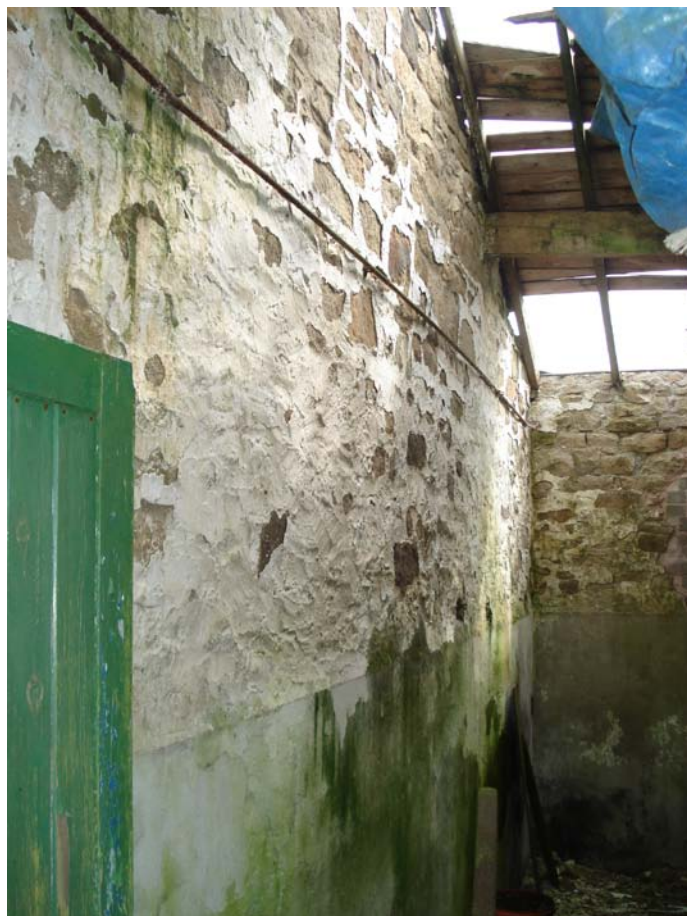
Plate 36 – Spalled whitewash finish to Store 5/6 partition

- 2.0.3 Whilst not of a structural concern, we would recommend a “damp” survey be undertaken to all masonry elevations within the proposed area of refurbishment. If as expected, the level of the moisture within the wall elevations is excessive, remedial treatment solutions should be considered if necessary, particularly as proposal necessitate the ‘physical connection/tie’ to a blockwork lining wall.
