**Structural Appraisal  
of  
Mill Building at  
Chipping, Lancashire  
for 53N**

**Date: October 2013**

**Job Number 12-155**

# DEFECT SURVEY REPORT

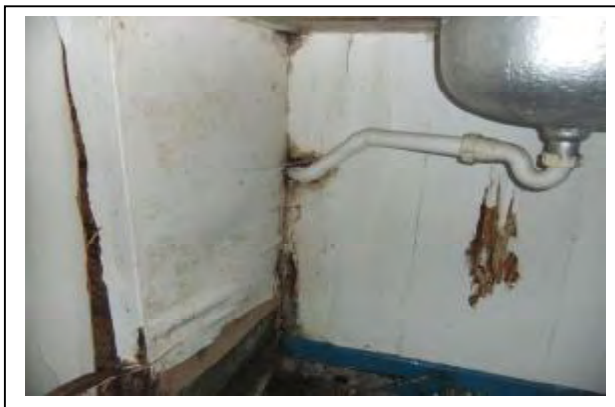
Dry Rot noted to the panelling affixed to the front elevation of the third floor former showroom

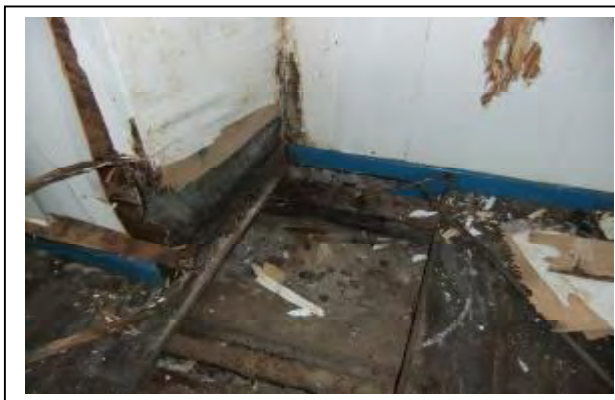
Further exposure works to the panelling and floor boards within the alcoves forming the front elevation

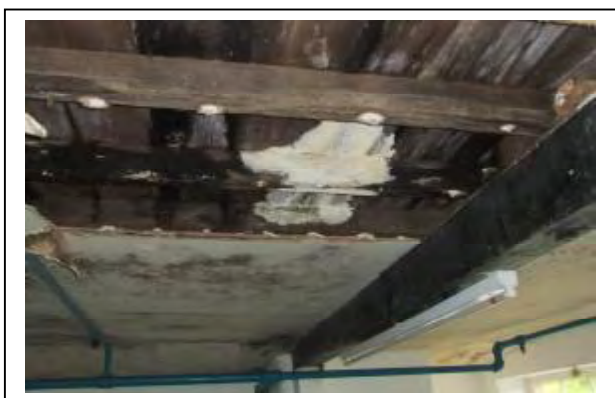
Sheet Mycelium growth to the underside of the mezzanine floor above the former showroom

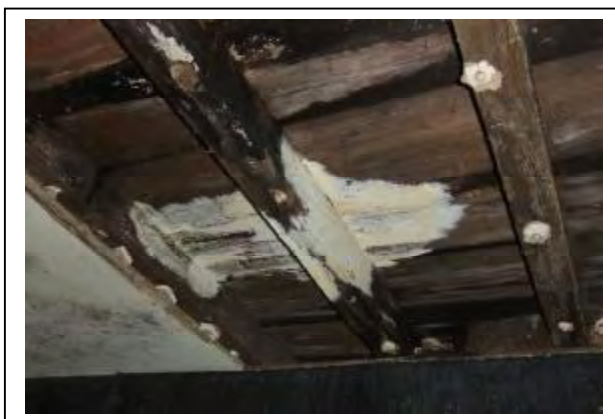
Closer view of Dry rot outbreak. Cut out and treat adjoining timbers as detailed within the report
