Treestyle CONSULTANCY

February 2015

BS5837
Trees
in Relation
to design, demolition &
construction survey

A potential Driveway and barn
At
Pinfold Farm Barn
Preston Road
Ribchester
PR3 3YD

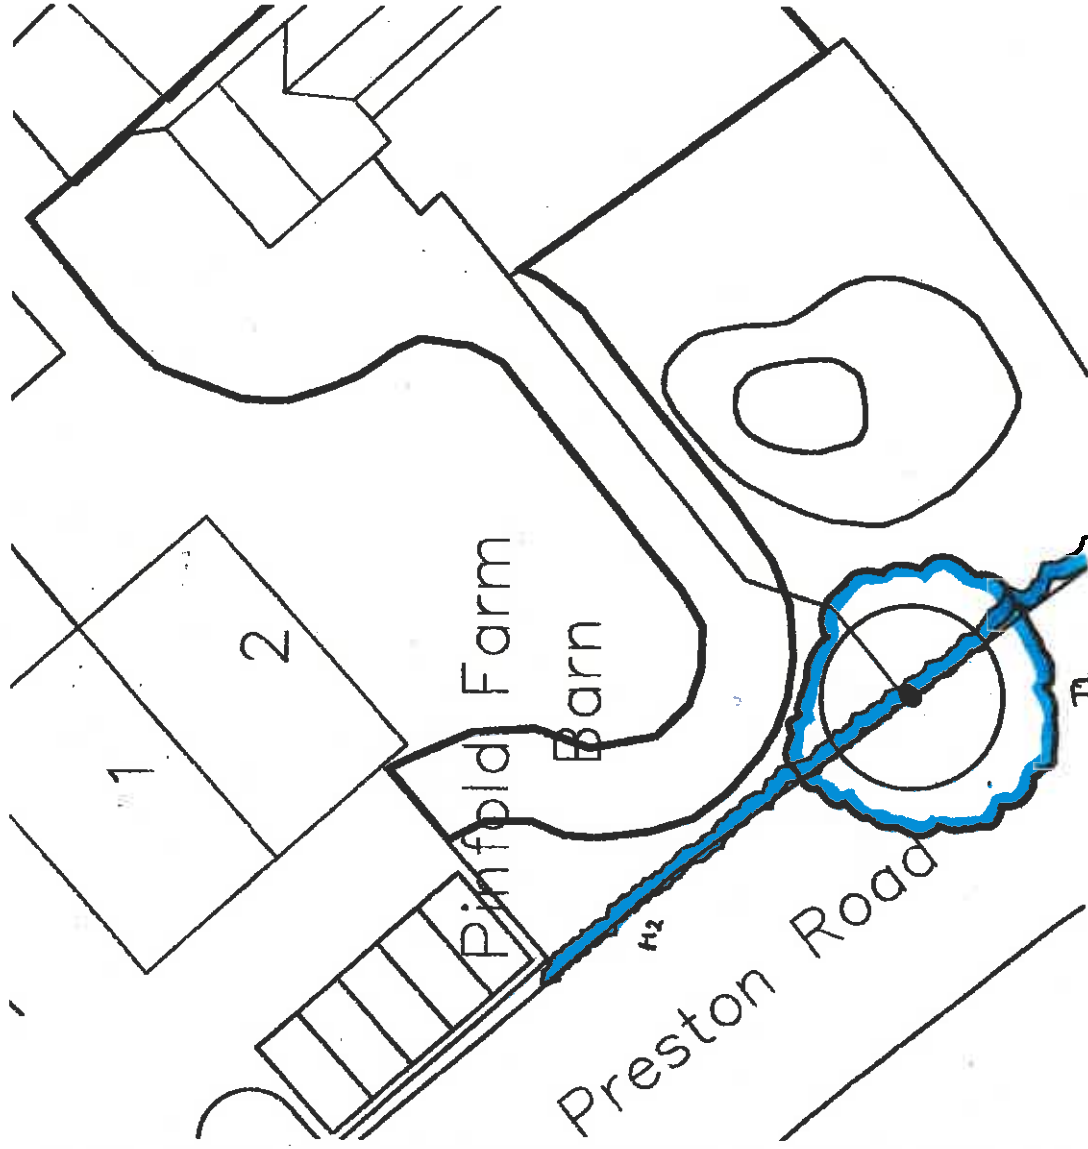
14.2 Mapping – Tree Categorisation

9.1 T1 Lime (*Tilia cordata*) has been down graded to category B tree because of its poor crown canopy. The leaves are shrivelled and not complete and with a minor disease on its leaves. The RPA of T1 is greater on the garden side because of the none permeable surface of the road. This extends to 8.2m and there will be an area where the road overlaps the RPA. This is the Geocell surface will protect the roots from compaction. Driving over this root plate will crush and damage the root system that will then allow an entry point for fungi into the tree. The installation of the geocell membrane will prevent this from damaging the root system. The hedge H2 will also require protective fencing.

Green – High quality,
Blue - Moderate quality,
Grey – Low quality,
Red cannot realistically be
retained as living trees in the
context of current land use

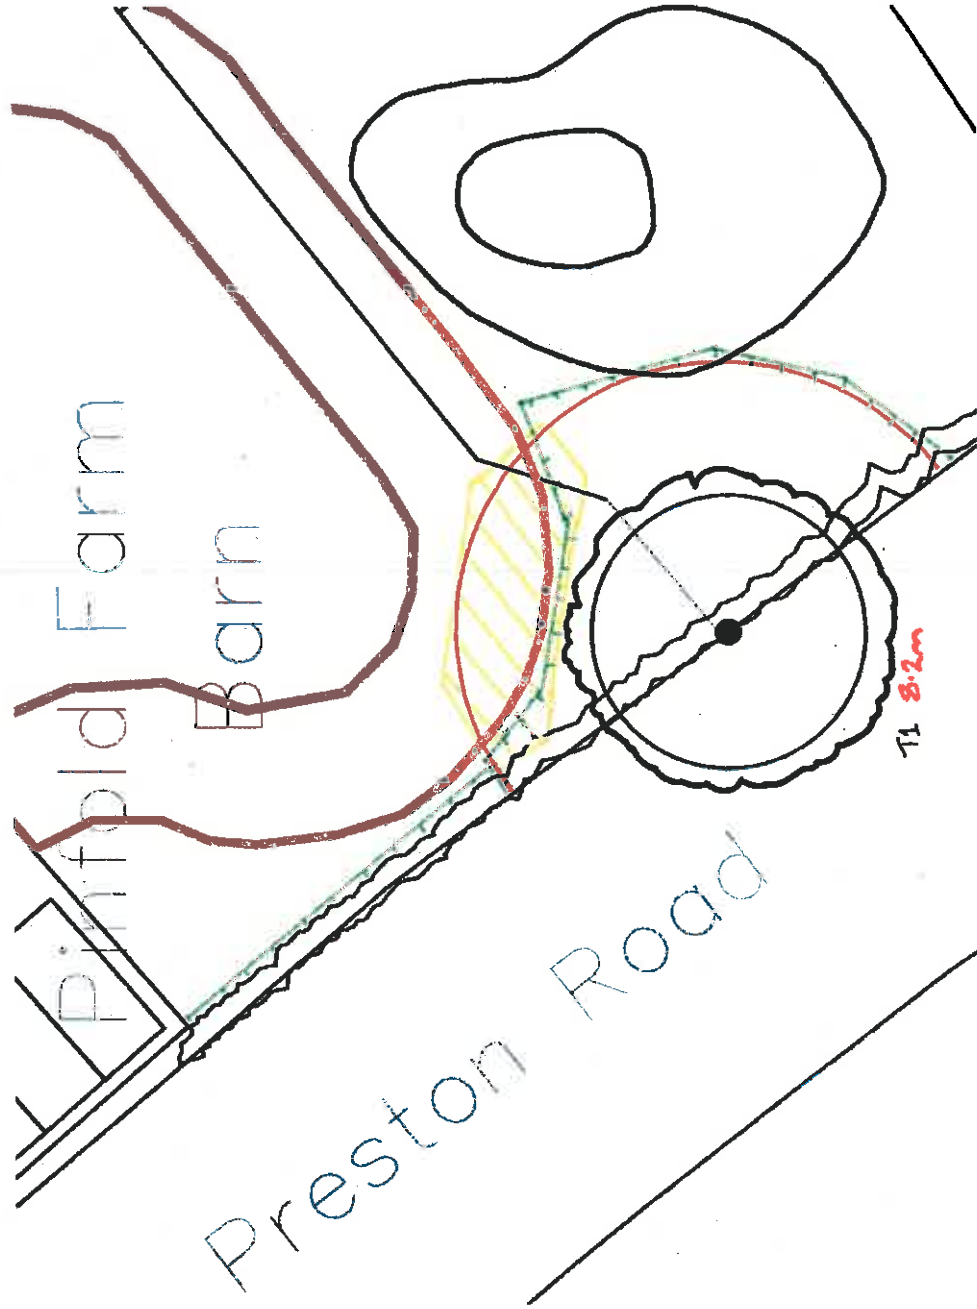
14.3 Mapping – Root protection areas

Orange indicates the RPA

Yellow is the Geocell membrane

Green is the protective fencing to be installed after the membrane has been fitted. Then the works can commence

9.2 For the construction to take place within the RPA of T1, **only hand tools** maybe used in this area. The area that has been identified where the driveway and RPA of T1, see below;

Once installed then the fencing can be installed on top of the 1 metre overlap, this will allow a .5m work area.

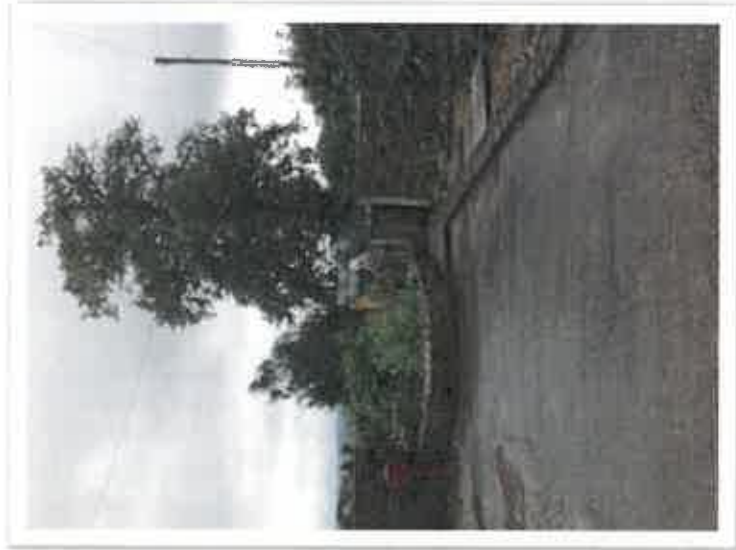
Left; Looking south, T1 overhanging the potential driveway.

5.1 Crown clean of T1, removal of dead, dying and any crossing and rubbing branches. A small crown lift will allow access beneath to aid construction.

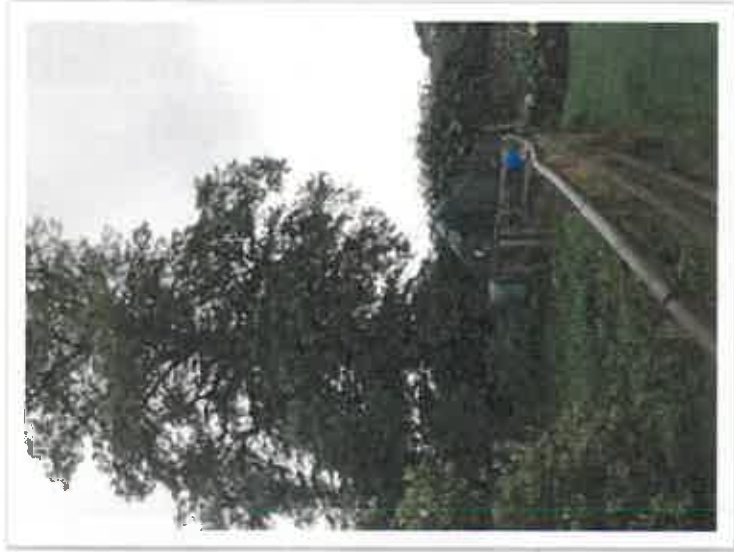
Above left; Looking west at T1 and the potential driveway.

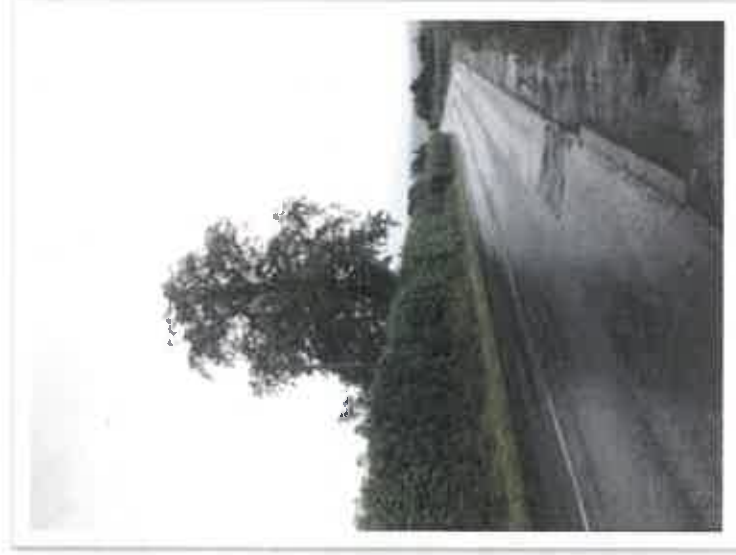
Right; View from the road.
