# ACCIDENT ANALYSIS

## BAE SAMLESBURY

**ASHLEY ♦ HELME  
ASSOCIATES LTD**

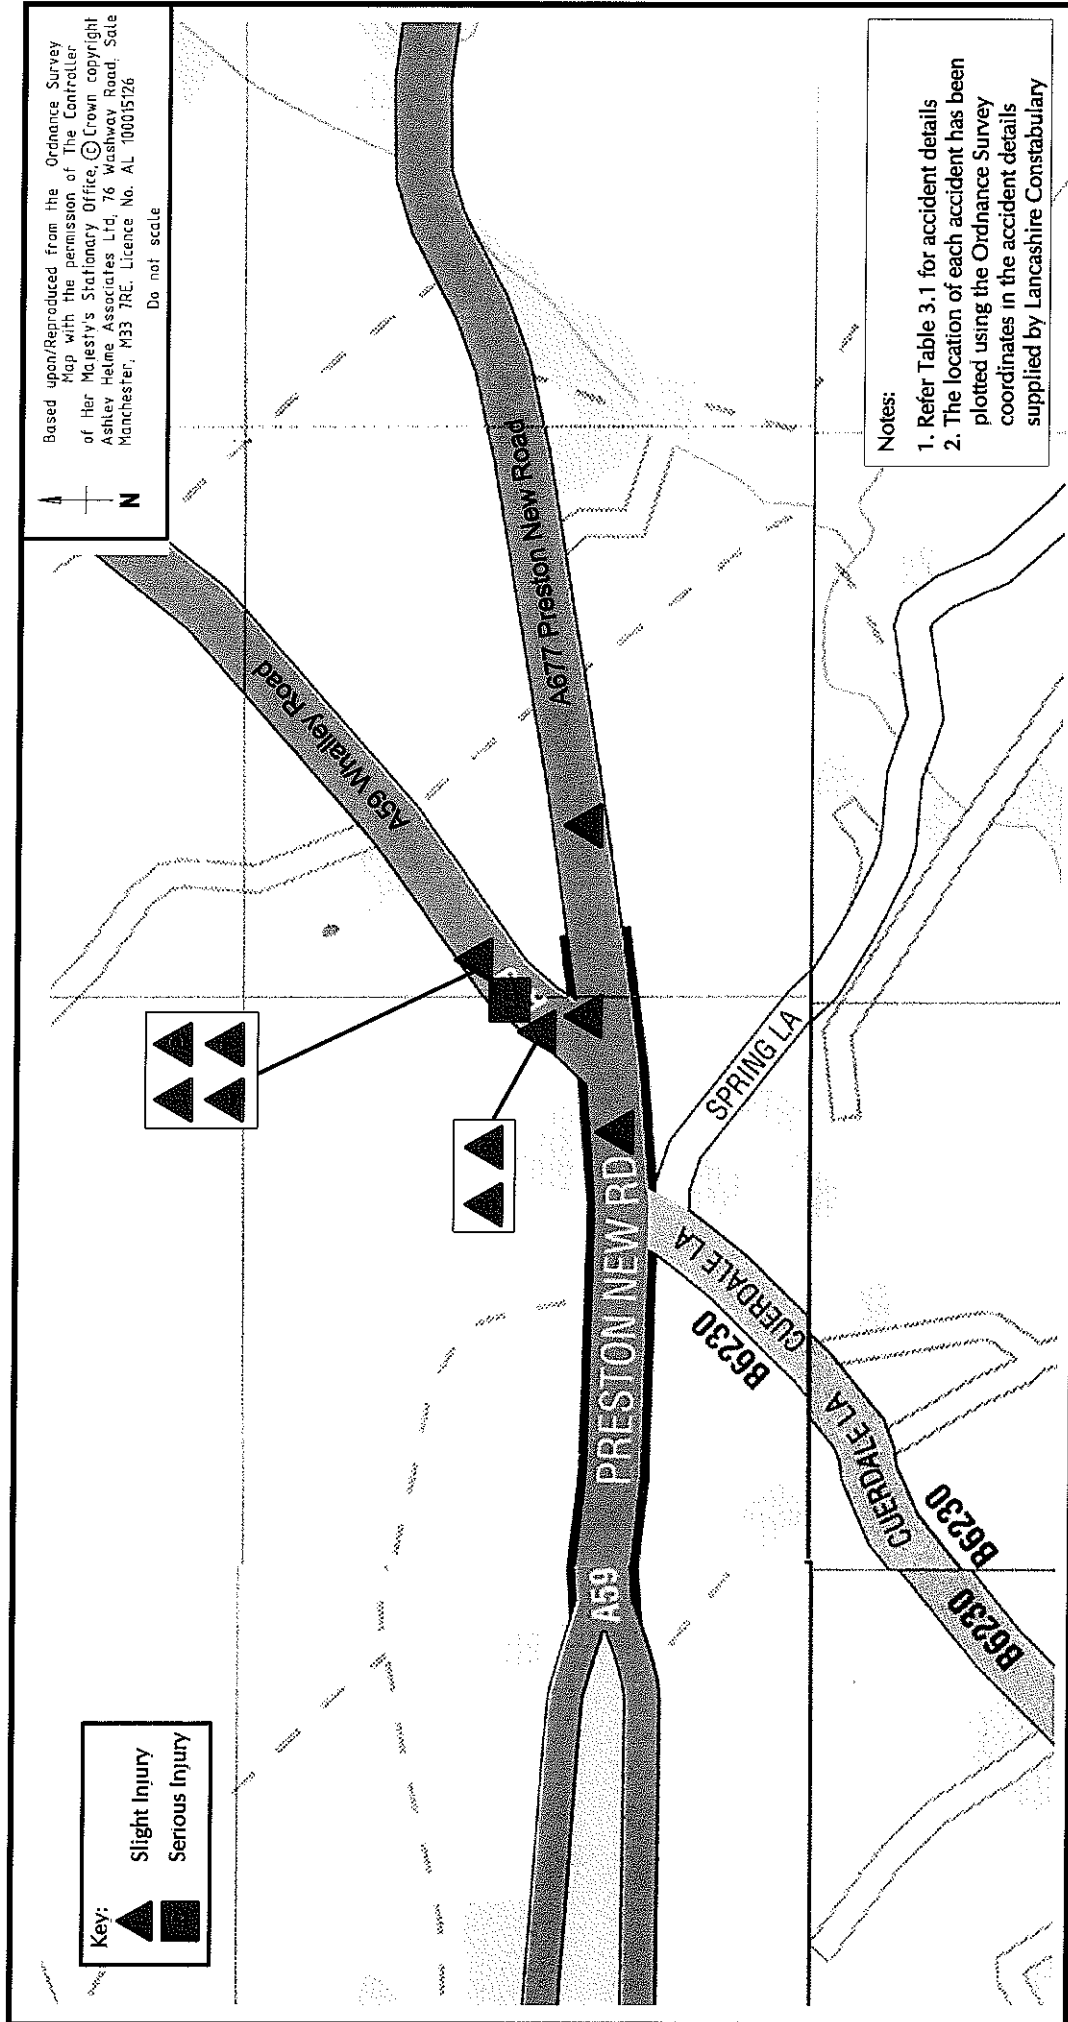
FIGURE 3.1

- 3.1 There are 11 recorded accidents within Area 1. The location of these is indicated on Figure 3.1. This represents an average of 2.2 accidents per year.

- 3.2 There appears to be a cluster of 10 accidents concentrated on the A59 Whalley Road/A677 Preston New Road section of the Swallow junction. These are all 'Slight' injury accidents, except for 1 'Serious'. Table 3.1 presents a summary of this accident cluster, referred to as 'Cluster 1'.

- 3.3 Review of Table 3.1 identifies that 50% of the Cluster 1 accidents are recorded as involving a vehicle turning right across the path of an oncoming vehicle. Unfortunately, the accident record data provided by Lancashire Constabulary includes no further information about the right-turn manoeuvre involved in the accidents. Review of Figure 3.1 does not suggest any clear explanation of the right-turn manoeuvre referred to in the accident record, and thus no firm conclusions can be drawn about the causal explanation for these accidents; (the Figure 3.1 plots the location of the accidents using the OS coordinates in the Constabulary accident records).

- 3.4 A further 30% of the Cluster 1 accidents involve a 'shunt' type collision whilst a vehicle is waiting at the traffic signals. This may indicate that approaching vehicle speed and visibility are factors to be considered at the junction in terms of identifying accident mitigation works.

- 3.5 Within the Cluster 1, accidents occurring during the early part of the recorded data (Years 2000 /2000 /2002) tend to involve vehicles attempting to turn right across the path of oncoming cars. However accidents occurring during the latter part of the recorded data (Years 2003-2005) tend to involve a greater proportion of shunt type accidents. This may suggest that the right-turn accident problem has been resolved/remediated, and the shunt problem has not. This can be considered further with the development proposals for improving the junction, which should resolve the problem.

- 3.6 There is one additional accident, outside the Cluster 1 accidents summarised in Table 3.1. Accident No 11 (refer Figure 3.1) involved 2 vehicles travelling eastbound on the A677. Vehicle 2 attempts to overtake Vehicle 1 before the carriageway returns to one lane. Vehicle 2 fails to complete the manoeuvre and collides with Vehicle 1. This appears to be an isolated incident type that has not been repeated.

6.2.1 There are 11 recorded accidents in the vicinity of the Swallow Junction, representing an average of 2.2 per year. This is the highest average occurrence of accidents of all the study 'cluster' locations identified on the study network. Improvement of the junction can contribute to addressing the accident problem(s) and reducing the future occurrence of accidents

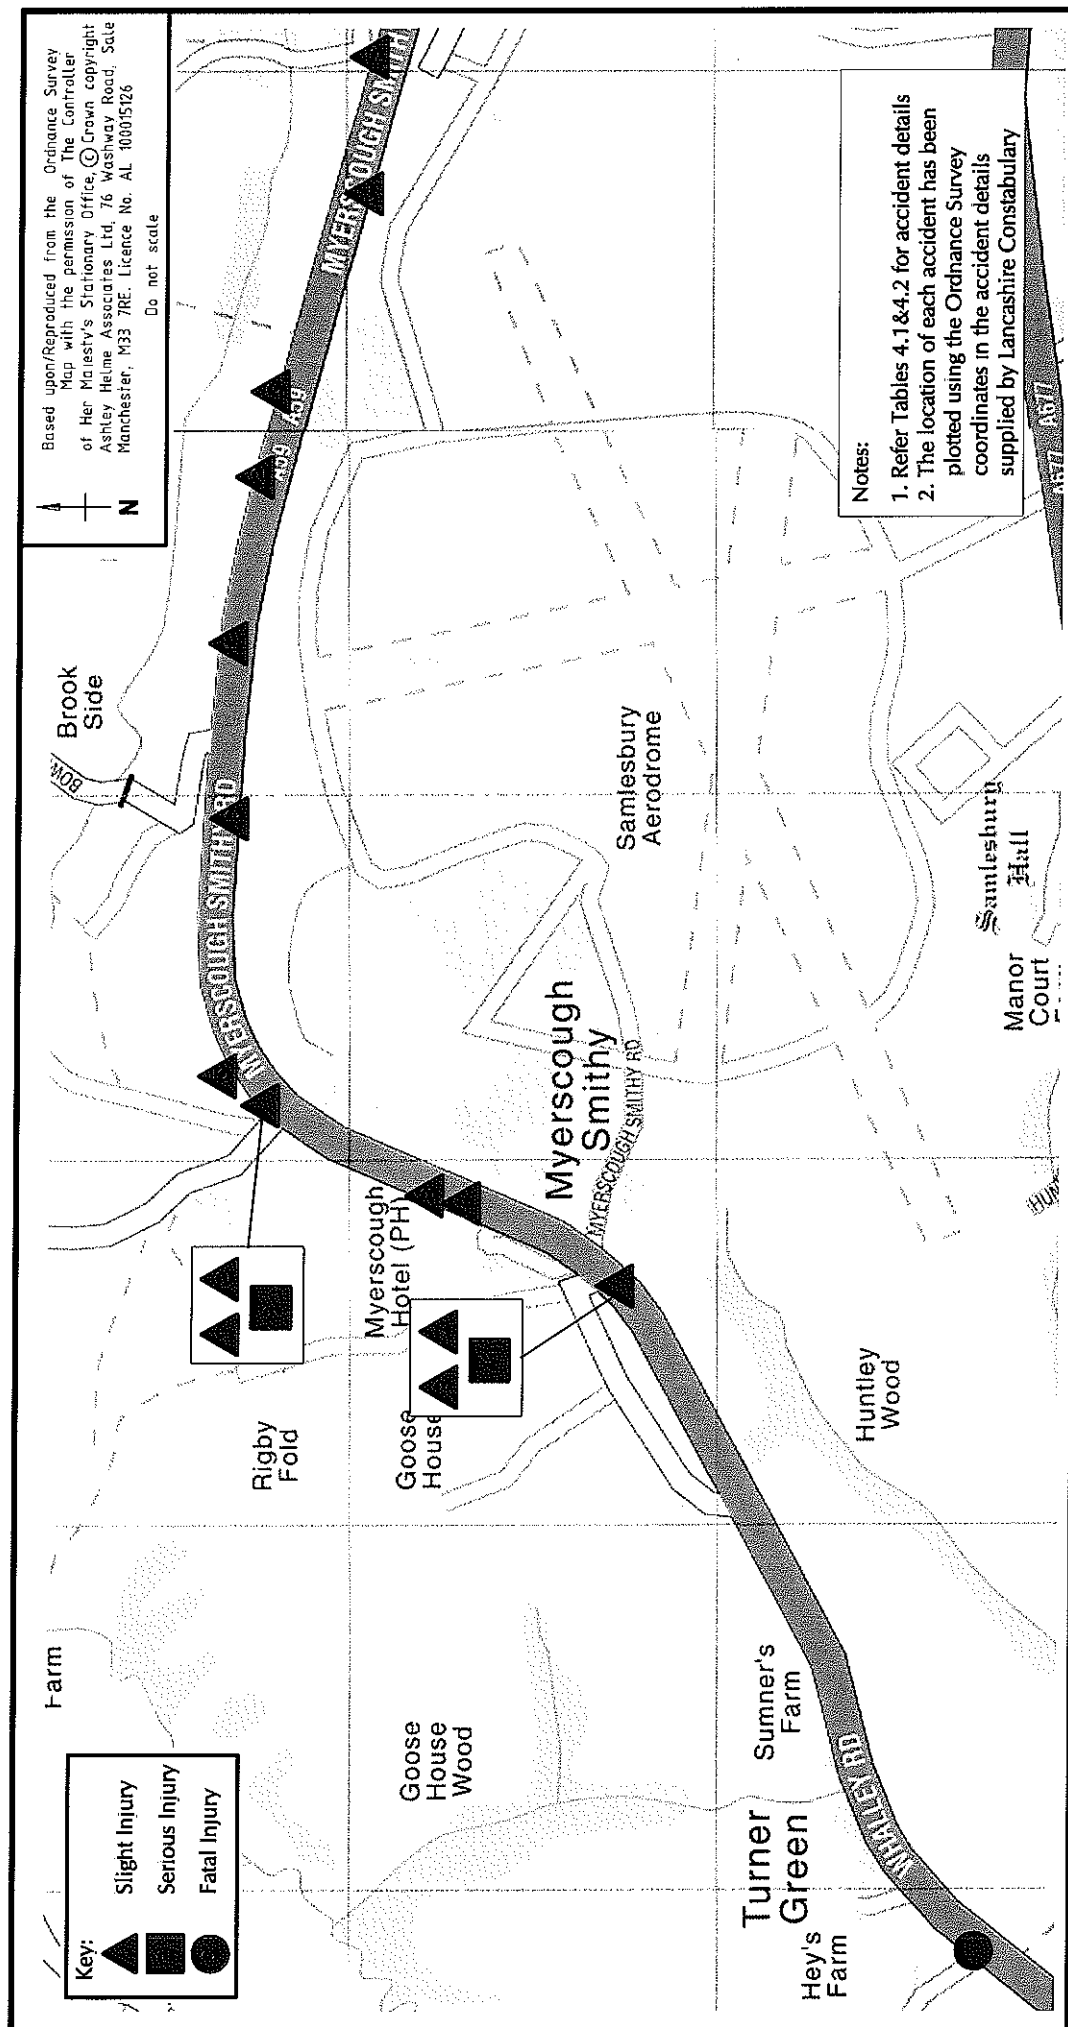
FIGURE 4.1

4.1 There are 17 recorded accidents in Area 2. The location of these is indicated on Figure 4.1.

4.2 There are two identified accident clusters, referenced as :

4.4.1 Two of the entrances to the BAE site are located within Cluster 2: Main Gate and Stoop Lane Gate. Three accidents occurred at Stoop Lane Gate, 2 of which involved a rear end shunt when a vehicle was slowing down. There are no recorded accidents at Main Gate.

4.4.2 A recurring factor in many of the Cluster 2 accidents is failure to reduce speed and misjudgement of the driver.

4.4.3 Of the 9 Cluster 2 accidents, 6 occurred with the first 2 years of the recorded data, and 3 within the last 3 years. This indicates a decline in accidents within the Area 2 Cluster 2. This may suggest that driver speed management and control is improving.

Three of the 6 Cluster 3 accidents involve overtaking manoeuvres, representing only 0.5 accidents per year of this type. There is in total, an average of 1.2 accidents per year, which does not represent an occurrence for which mitigation works would usually be sought.

6.3.2 It appears that a contributory factor to the number of accidents is likely to be vehicle speed. Another associated factor is likely to be the horizontal alignment of the A59, specifically the 'bend' of the road. A reduction in the speed limit from the current unrestricted, to say 50mph, is likely to be beneficial in contributing to a reduction in accidents.

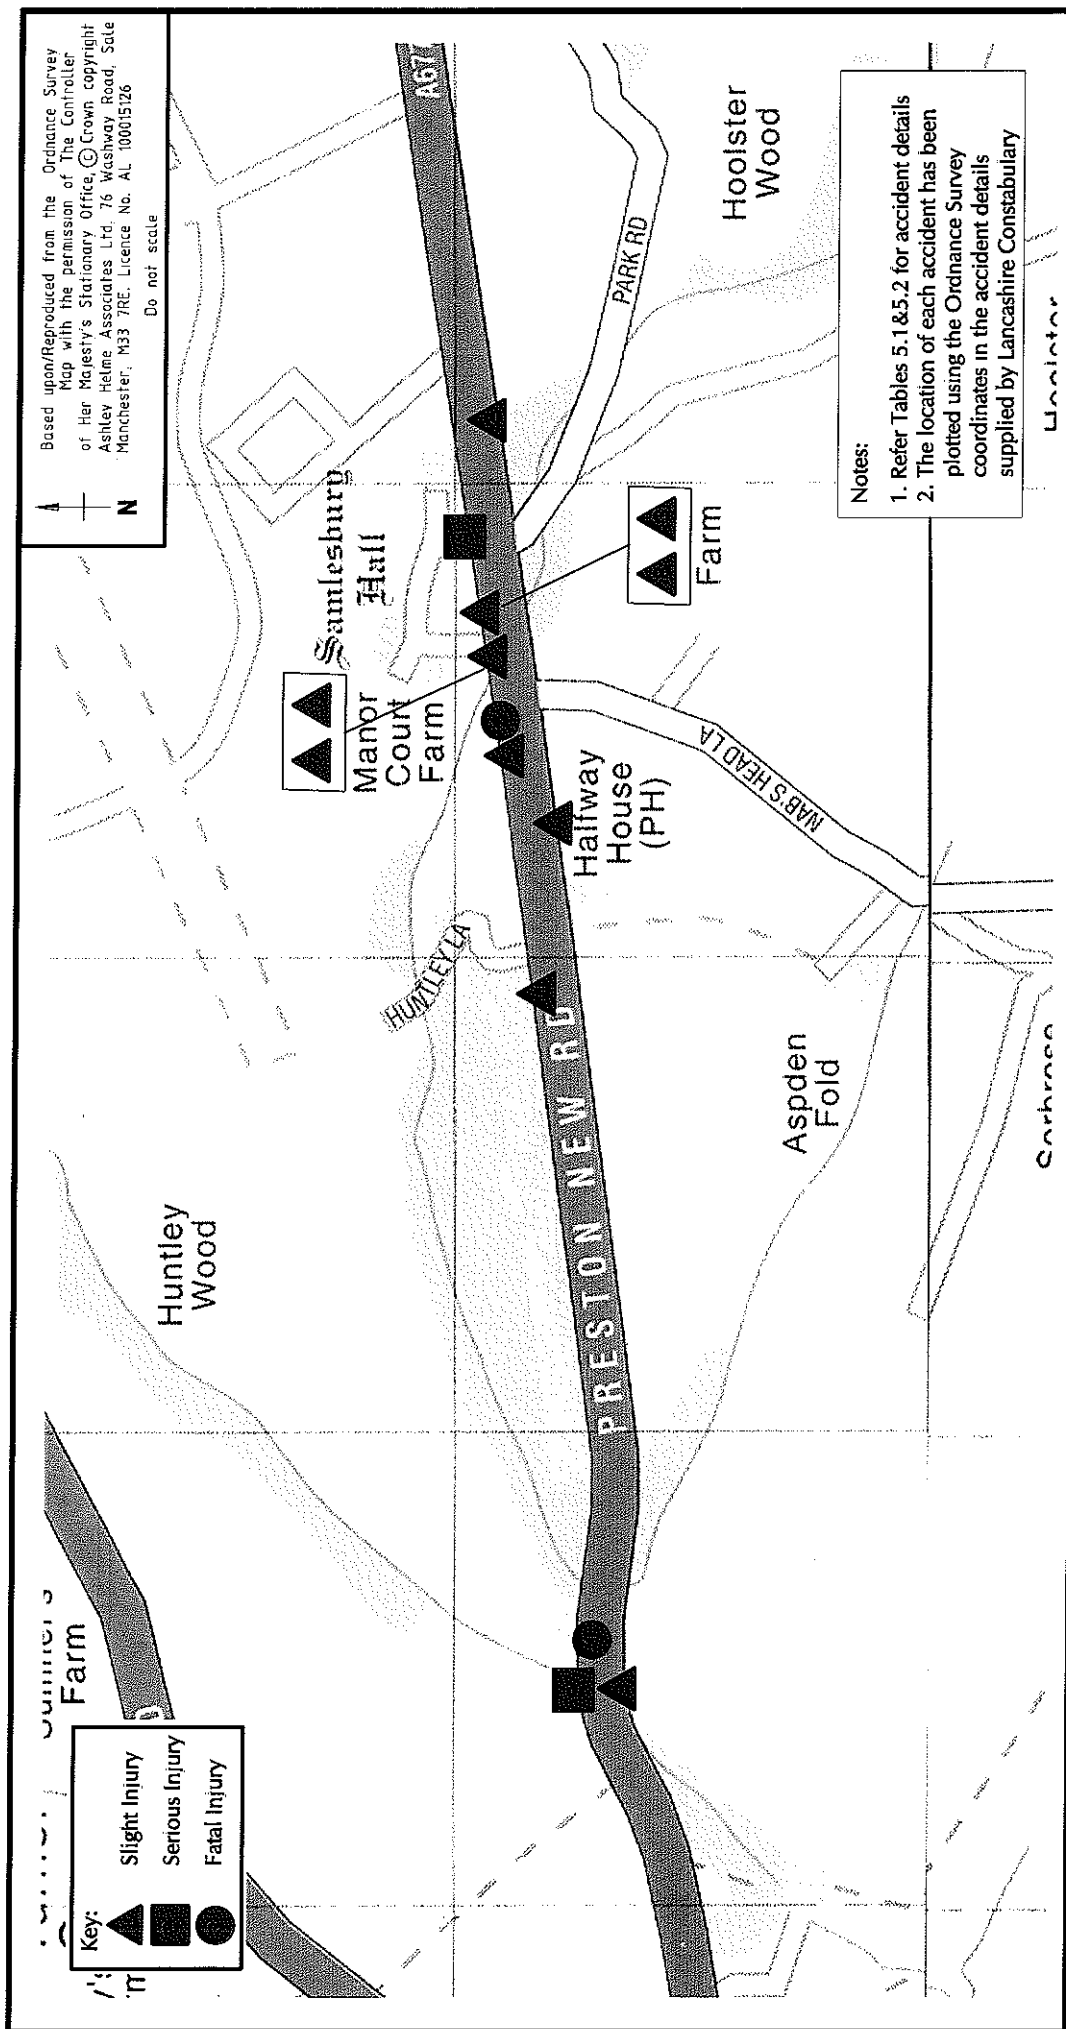
FIGURE 5.1

5.3.1 In each of the three Cluster 4 accidents, the driver lost control of the vehicle. This is likely to be due to the speed of travel.

5.3.2 The most recent accident in the Cluster 4 area was in July 2003. As there has been no accident in the past circa 3 years, it is concluded that there is no current accident problem in this locale.

5.4.2 As indicated on Figure 5.1, within Cluster 5 there are 2 priority (give-way) control junctions on the A677: at Nab's Head Lane and at Park Road. Samlesbury Hall and the Halfway House Pub are also located within close proximity of these two junctions. It seems likely that there will be vehicles slowing to turn into either Nab's Head Lane, Park Road or into Samlesbury Hall or the Halfway House Pub. This is also indicated in the data; 30% of the accidents involve shunt type accidents, and 30% of the accidents involve vehicles attempting to overtake.

5.4.3 It appears that accidents are not decreasing in the locale of Cluster 5, as 80% of the accidents occurred during 2003 and 2004.

6.4.3.1 There are two junctions and additionally the accesses to Samlesbury Hall and the Halfway House Pub located in close proximity to each other. Rear end shunt type accidents represent 30% of the recorded accidents. These are likely to be due to vehicles slowing for one of the two junctions or for one of the two accesses. Another 30% of accidents involve vehicles overtaking along this section.

6.4.3.2 Accidents are not decreasing in the locale of Cluster 5. This indicates that the contributory factors to these accidents have not been resolved.

6.4.3.3 A reduction in the speed limit from the current 50mph, to say 40mph, is likely to be beneficial in contributing to a reduction in accidents.

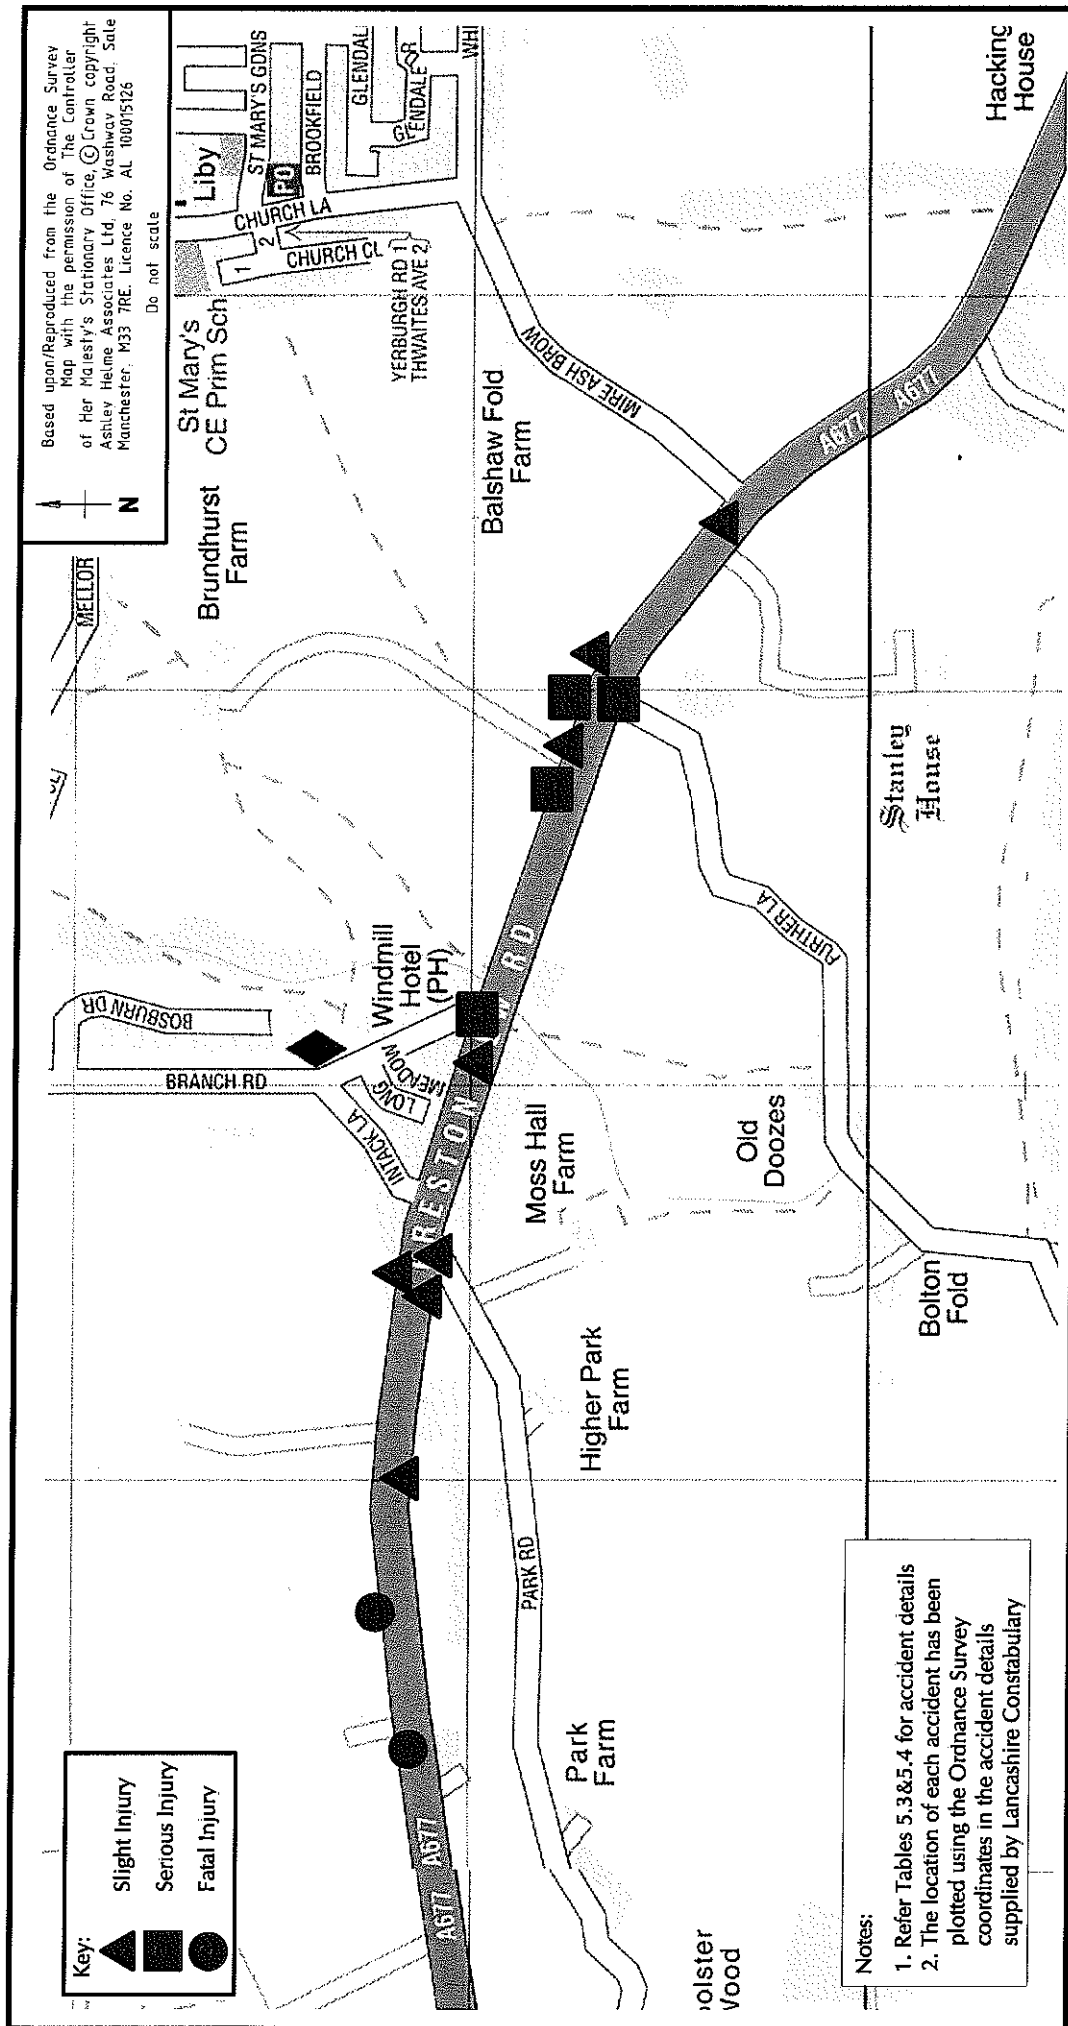
FIGURE 5.2

5.5.1 There are 8 accidents in Cluster 6: 5 slight, 1 serious and 2 fatalities. This is a predominately residential area with many direct driveway accesses on the A677 Preston New Road, although only 1 accident is due to vehicles emerging from a driveway.

5.5.2 Four of the recorded accidents (Nos 14,19, 20 & 21) are due to drivers losing control, 3 of which occurred at night, and all in wet conditions. There has typically been 1 accident per year of this type

5.5.3 As with Cluster 4, the main contributory factor to the accidents seems to be vehicle speed.

5.5.4 Similar to Cluster 5, there are 3 priority junctions within Cluster 6: Park Road, Intack Lane and Branch Road. There is a shunt type accident recorded at the Park Road junction and another recorded at the Intack Lane junction. There is no recorded accident at the Branch Road/A677 junction.

5.6.2 Within Cluster 7, 50% of the accidents have a common cause. It appears that drivers travelling westbound on the A677 experience difficulty following the path of the road as it turns to the left, resulting in collision with an oncoming vehicle. Speed may be a contributory factor but this is hypothesis, as there is no information available to inform this.

5.6.3 The majority of the recorded accidents in Cluster 7 occurred early in the accident records. This would suggest that accidents are decreasing in this location, and at the very least not increasing.

6.4.4.5 Whilst there appears to be a consistent level of occurrence of accidents, there is no identifiable cause of a recurring accident problem. The conclusion is that perhaps a reduction in the speed limit may be beneficial and/or worthy of further consideration.

There is an average of only 1.2 accidents per year, and accidents appear to be decreasing. Whilst this would not tend to indicate a recurring accident problem to be targeted for accident remedial works, a common cause of accidents is vehicles failing to follow the horizontal alignment of the road. Thus, a reduction in the speed limit from the current 50mph, to say 40mph, may be beneficial in contributing to a further reduction in accidents.
