**APPRAISAL**

**BARNS REF: B1**

**ELMRIDGE FARM**  
**Chipping**

**W/12/550**

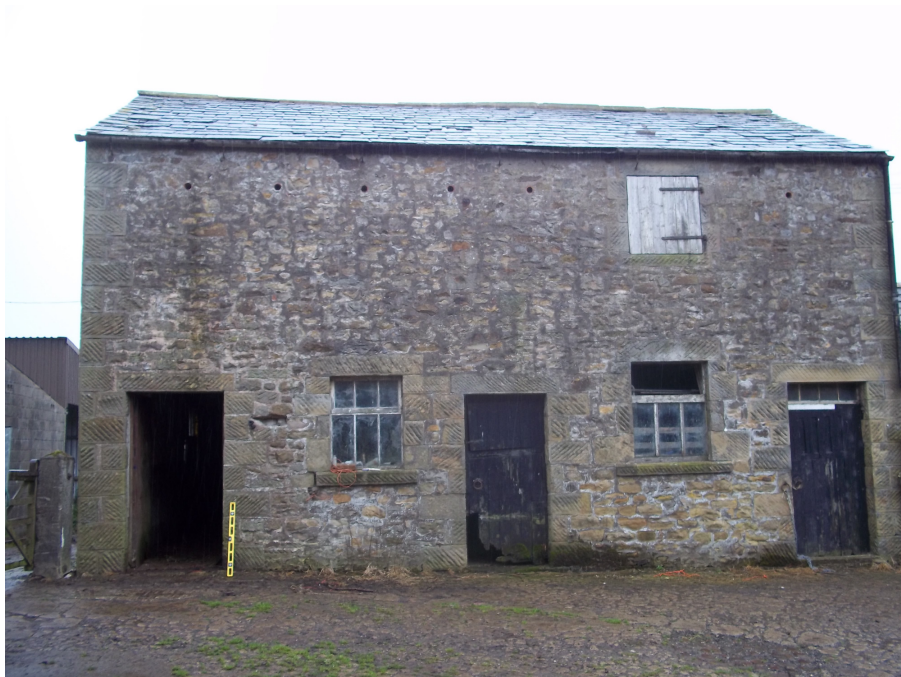
Front Elevation

a) Front Elevation-Left Hand Building

The wall was checked at ground floor level.

The walls are virtually plumb.

The window cills and door heads are virtually level.

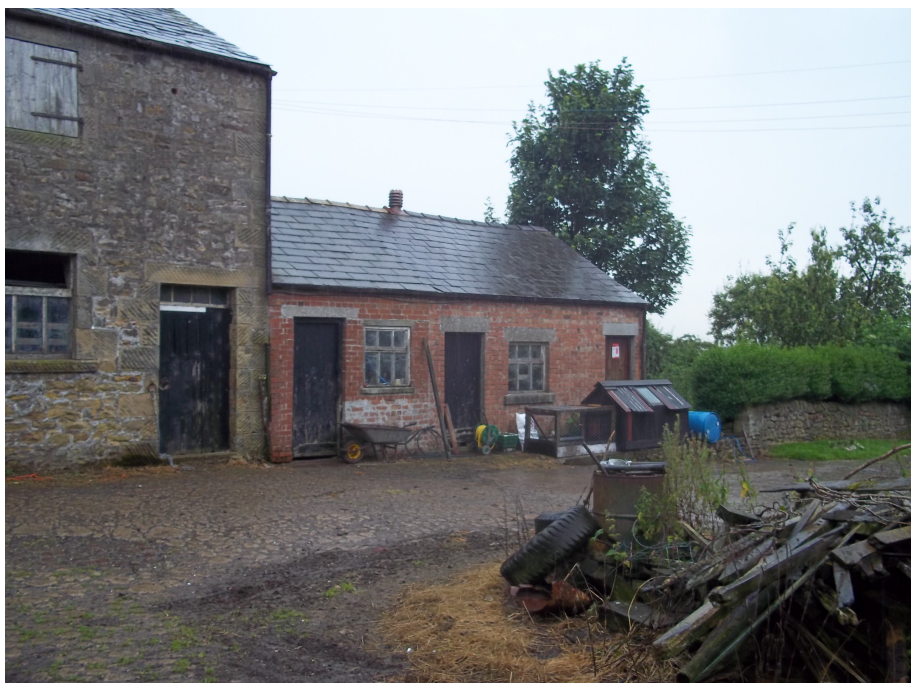
Front Elevation

b) Front Elevation-Right Hand Building

The wall was checked at ground floor level.

The walls are virtually plumb.

The window cills and brickwork coursing are virtually level.

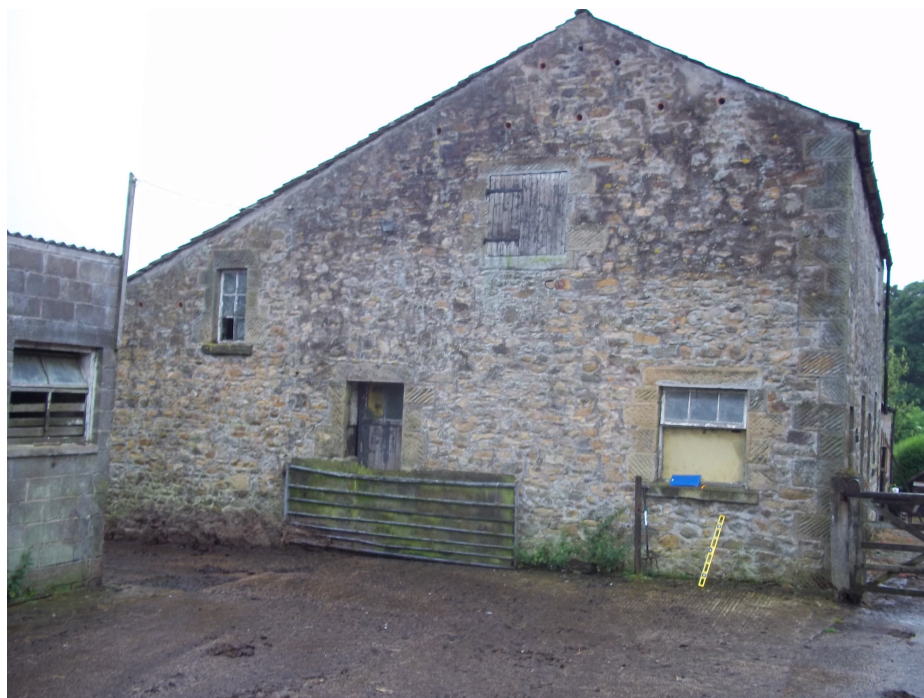
Left Hand Elevation

c) Left Hand Gable Elevation

The wall was checked at ground floor level.

The walls are virtually plumb.

Immediately adjacent to the rear the stone work at low level is loose and displaced.

- 4.05 We recommend that, generally all timber lintels are removed and replaced with either concrete lintels or proprietary galvanised steel lintels.
- 4.06 There is loose stonework in the rear left hand corner. We recommend this localised area is taken down and re-built.
