**APPRAISAL**

**BARNS REF: B2**

**ELMRIDGE FARM**  
**Chipping**

**W/12/550**

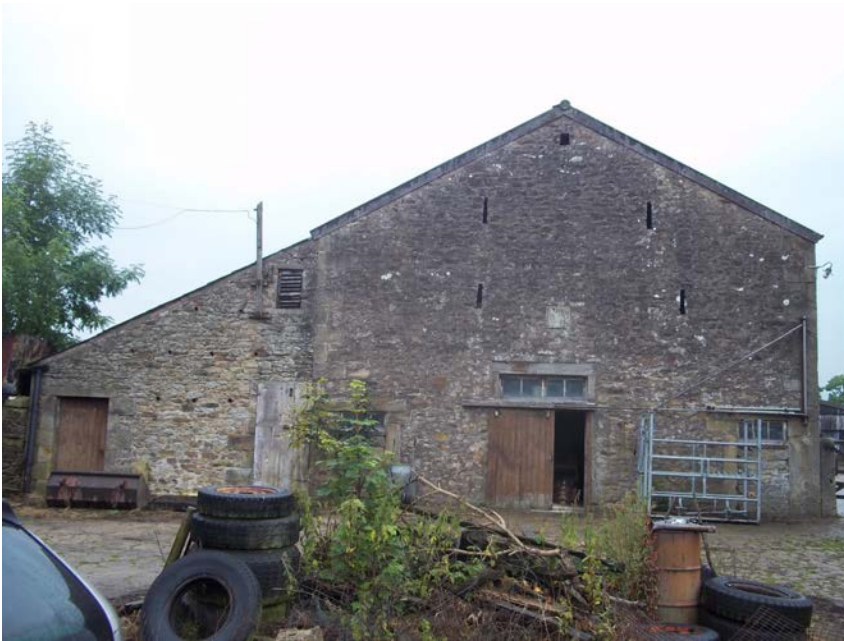
At each corner the wall is virtually plumb; elsewhere the wall leans out at 10 in 1000.

There is slight apparent bulging to the wall above this.

Front Elevation

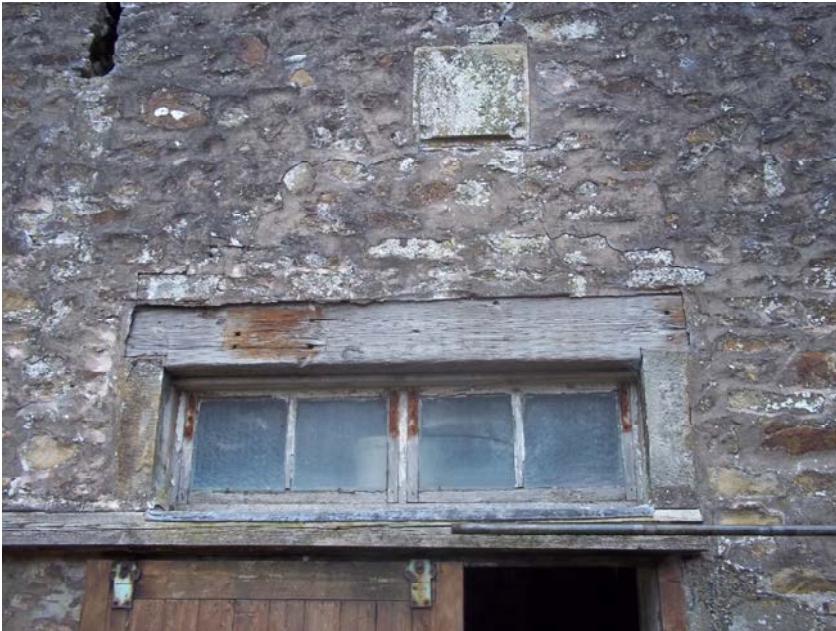
There is cracking over the timber lintel to the main door head.

- 4.07 There is some bulging apparent to the front elevation stonework at higher level, and also minor cracking over the timber lintel.
- 4.08 There is some minor cracking to the arch of the main door on the right hand elevation.

Front Elevation  
Cracking over Door

- 4.09 We recommend that, generally all timber lintels are removed and replaced with either concrete lintels or proprietary galvanised steel lintels.
- 4.10 The cracking above the front elevation should be re-pointed.

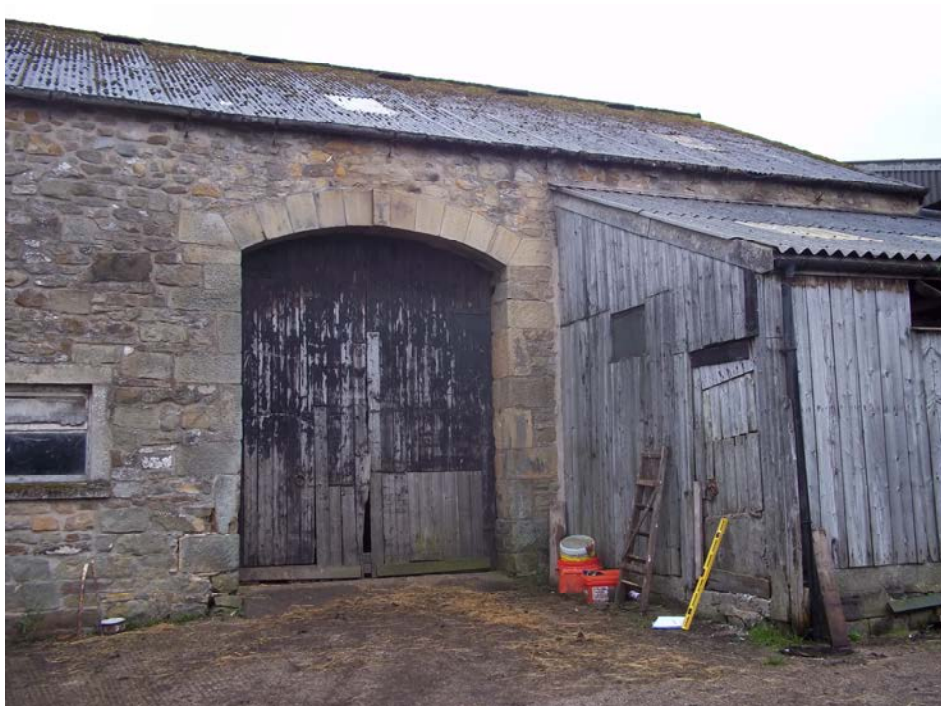
Right Hand Elevation

The walls are virtually plumb.

The window cills are virtually level.

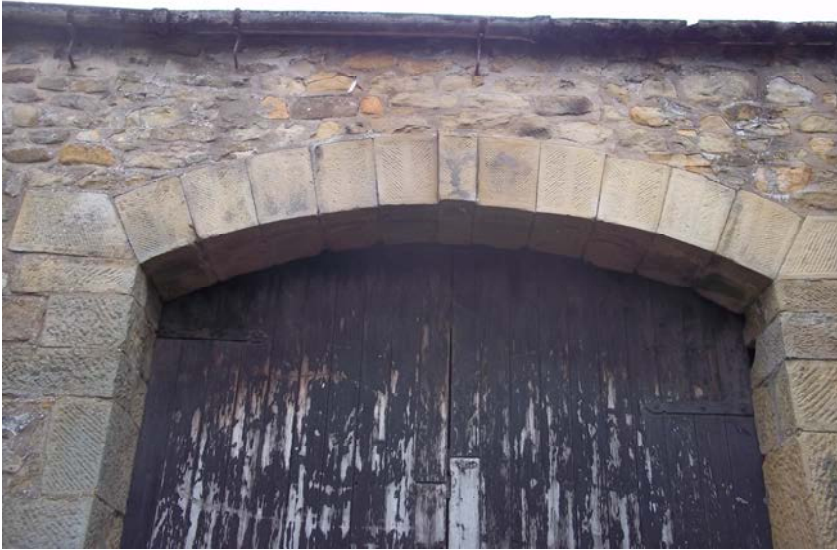
There is a fine crack to the right hand side of the main door arch.

Right Hand Doorway  
Cracking to Right Hand Side

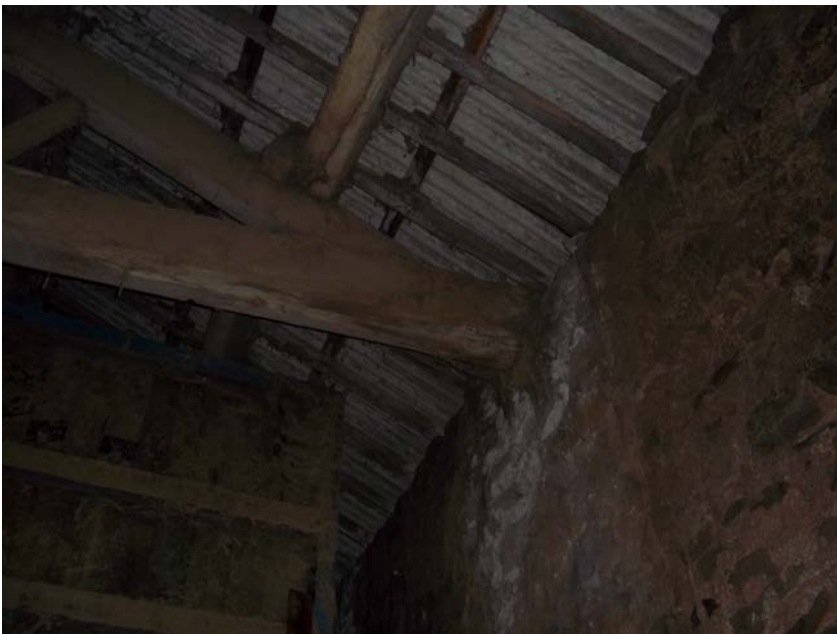
- 4.03 The roof covering will be most likely slates or tiles. The rafters and majority of the purlins will be unsuitable and will require replacing.
- 4.04 The main timber trusses appear generally in reasonable condition with the exception of the end bearings.

Internal Truss Support  
Deterioration of Truss End  
Bulging to Wall

- 4.05 If the trusses are to remain as part of any conversion then remedial work will be required at the bearing positions.
- 4.06 In addition we recommend a timber specialist be engaged to confirm the condition of the timber and recommend appropriate treatment work.

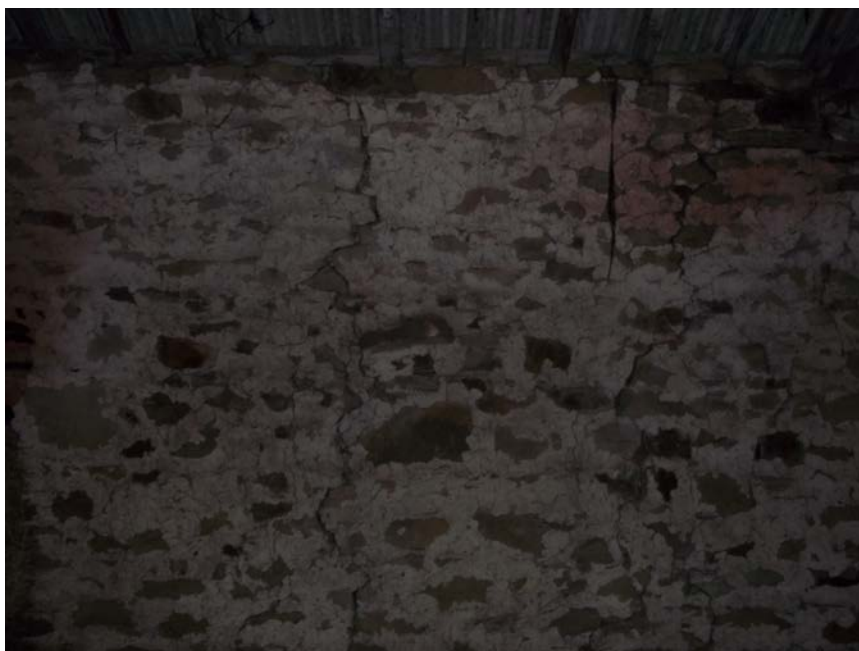
- 4.11 Internally there is near vertical cracking on the left hand wall adjacent to the front.
- 4.12 We recommend bed joint reinforcement is inserted across the crack position prior to the crack being re-pointed.

Cracking to Internal Wall
