**APPRAISAL**

**BARNS REF: B7**

**ELMRIDGE FARM**  
**Chipping**

**W/12/550**

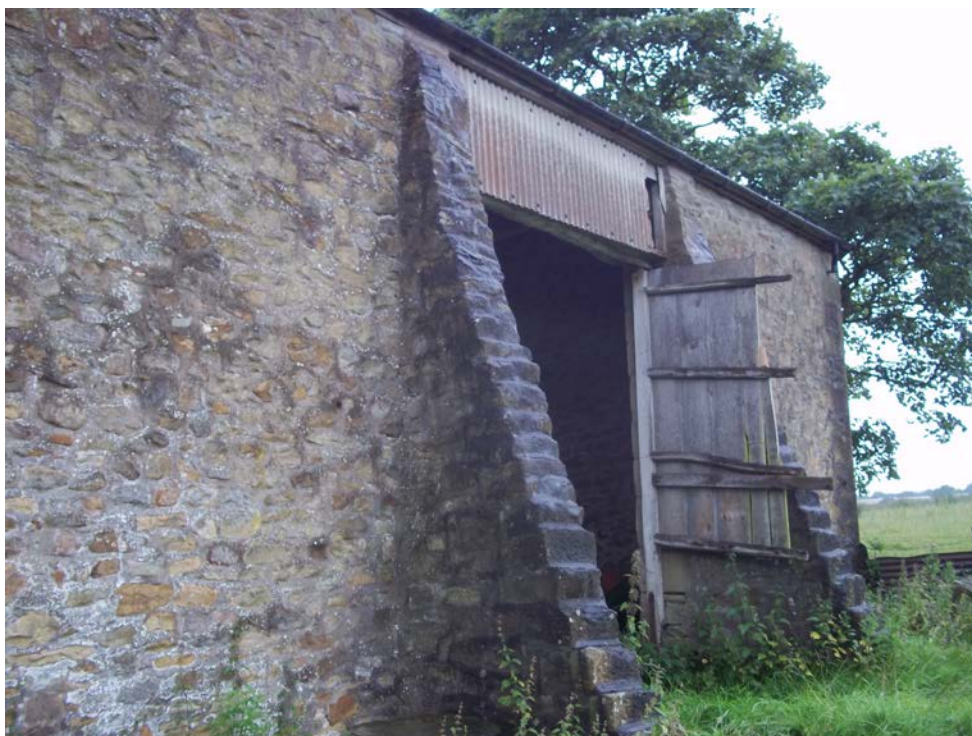
Front Elevation

The wall was checked at ground floor level.  
The wall leans out noticeably at high level becoming virtually plumb adjacent to the left and right hand sides.

- 4.13 The new blockwork lining walls would be tied to the existing external stonework walls thus providing stability.
- 4.14 The front wall displays a noticeable out of plumb.

- 4.15 However there are no obvious indications that this wall is in distress and there are significant buttresses on both sides of the main door.
- 4.16 The construction of an inner lining blockwork wall on this elevation will mean the cavity along the middle of the wall will be significant.

- 4.17 Specialist ties will be required along this section.
- 4.18 There are mature trees immediately adjacent to the right hand wall and the rear left hand corner.

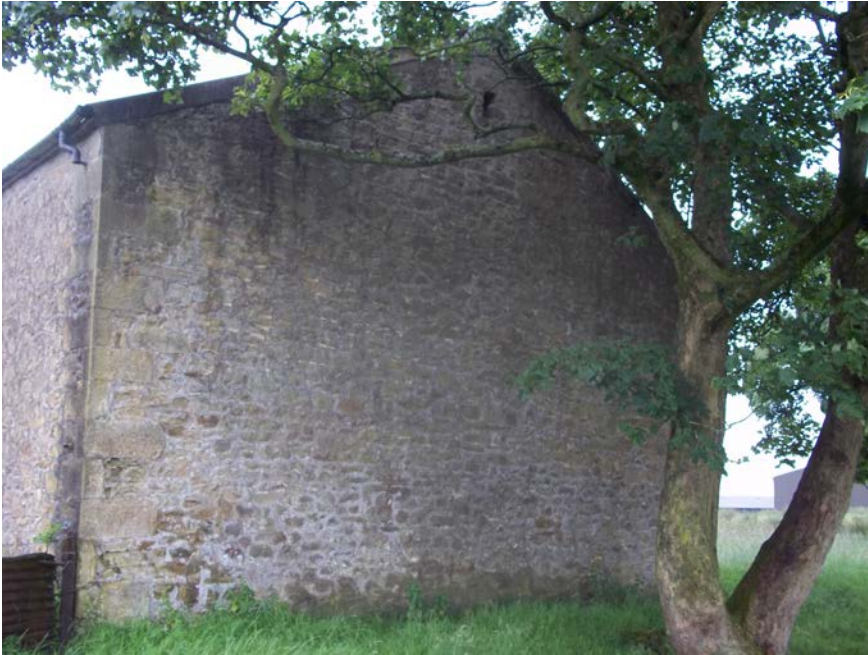
There is a mature tree adjacent to the middle of this elevation

Right Hand Elevation  
Showing proximity of tree

- 4.19 We recommend these are taken down to ensure the foundations are not affected in the future.
- 4.20 From the findings of this limited visual inspection only re-building of an area of the rear wall at high level and the front right hand corner at low level are required.

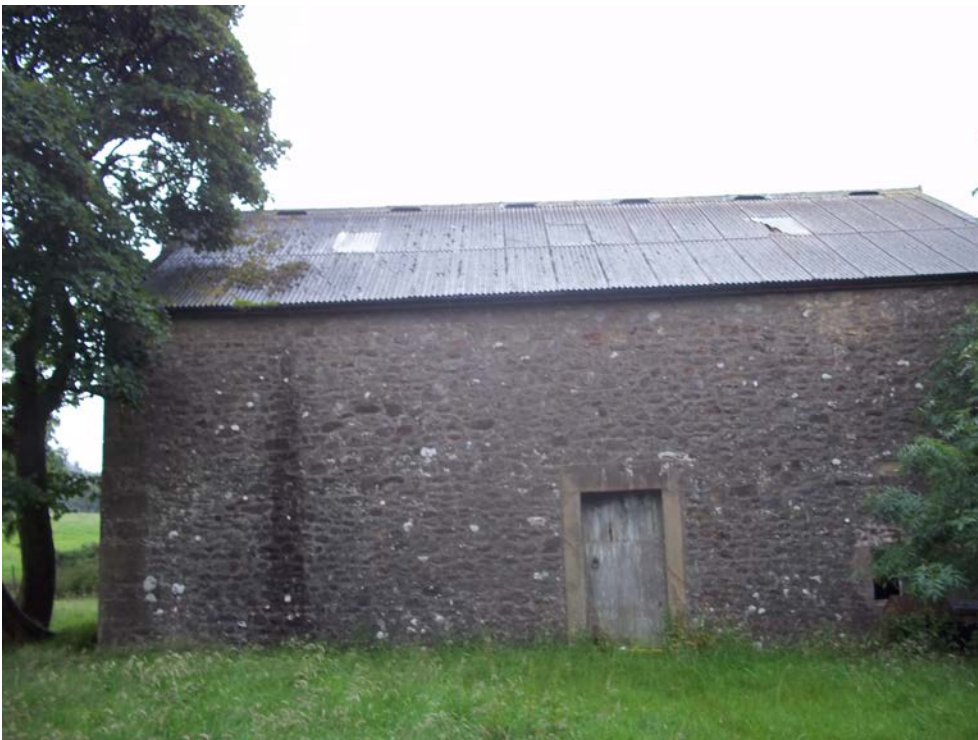
There is a mature tree adjacent to the left hand side of this elevation.

- 4.07 There is noticeable bulging on the rear wall internally at high level.
- 4.08 We recommend this area is taken down and rebuilt.
- 4.09 There is cracking to the front wall immediately adjacent to the left hand wall.

Rear Elevation  
Showing proximity of tree

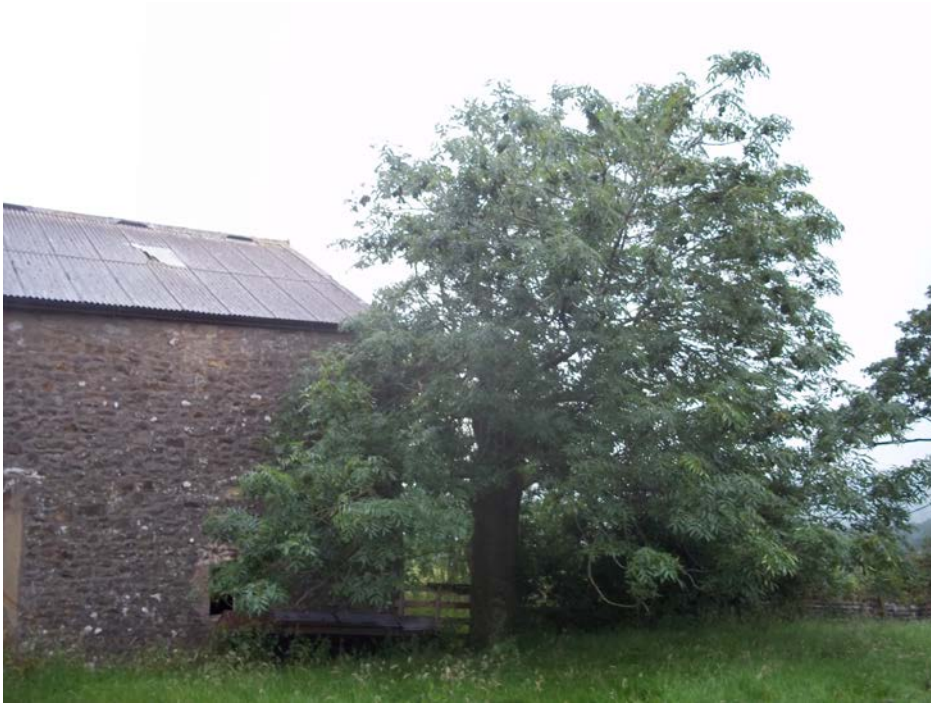
Rear Left Hand Corner  
Showing proximity of tree

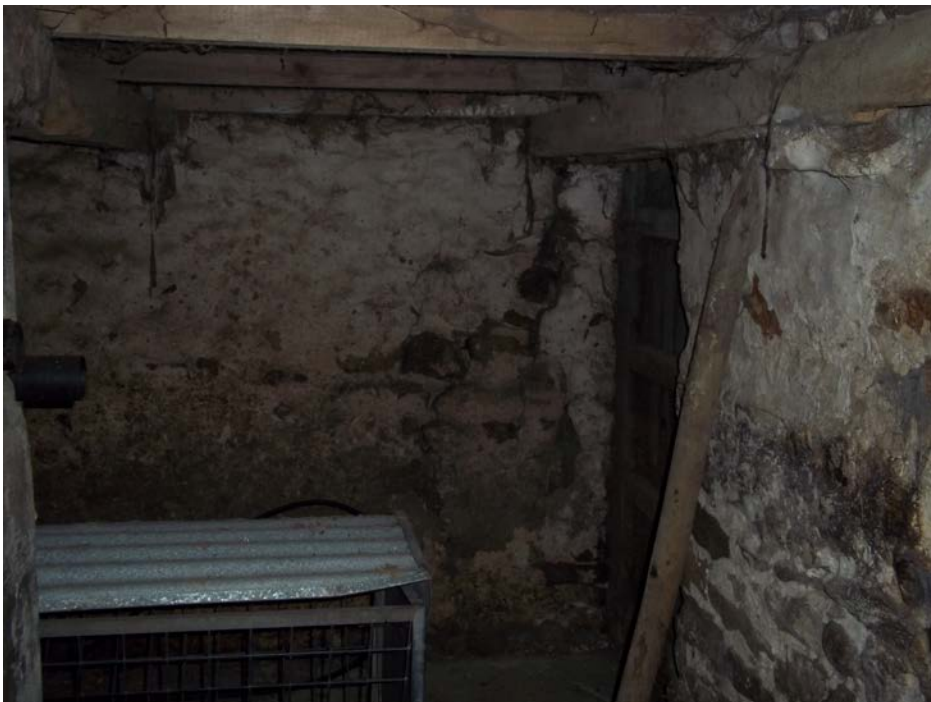
Access was restricted in this area.  
There is a crack on the front wall immediately adjacent to the left hand side.

Internal Cracking

- 4.10 We recommend this area of wall is taken down and rebuilt ensuring an adequate bond with the adjacent walls.
- 4.11 We have no information with regard to the proposed conversion or works associated.
