**REPORT ON INSPECTION
OF
FORMER BARN AT 53 CHAPEL HILL
LONGRIDGE, LANCASHIRE**

Ref 09/027

Report - Inspection Of Former Barn 53 Chapel Hill, Longridge

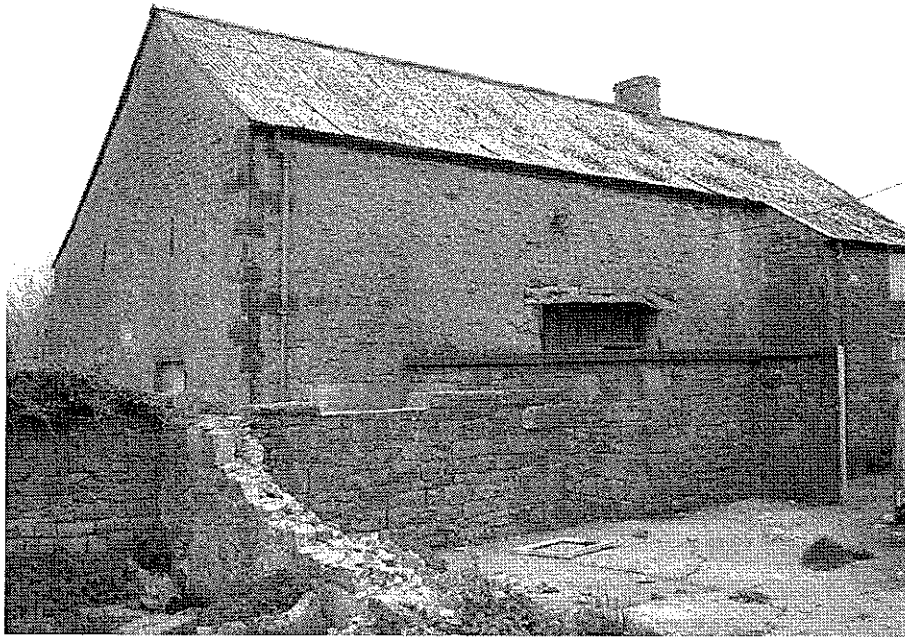
MAIN ELEVATION

The eastern gable is in a reasonable condition with no evidence of structural distress in the form of cracking although some longitudinal distortion has occurred.

A large original timber lintel exists over the barn entrance, which appears to have had a previous use, although substantial in section. The lintel appears to be performing adequately.

We suspect rot exists in the centre section and top due to the open nature of the face, which has a large longitudinal shake.

The elevation is reasonably plumb from ground to eaves.

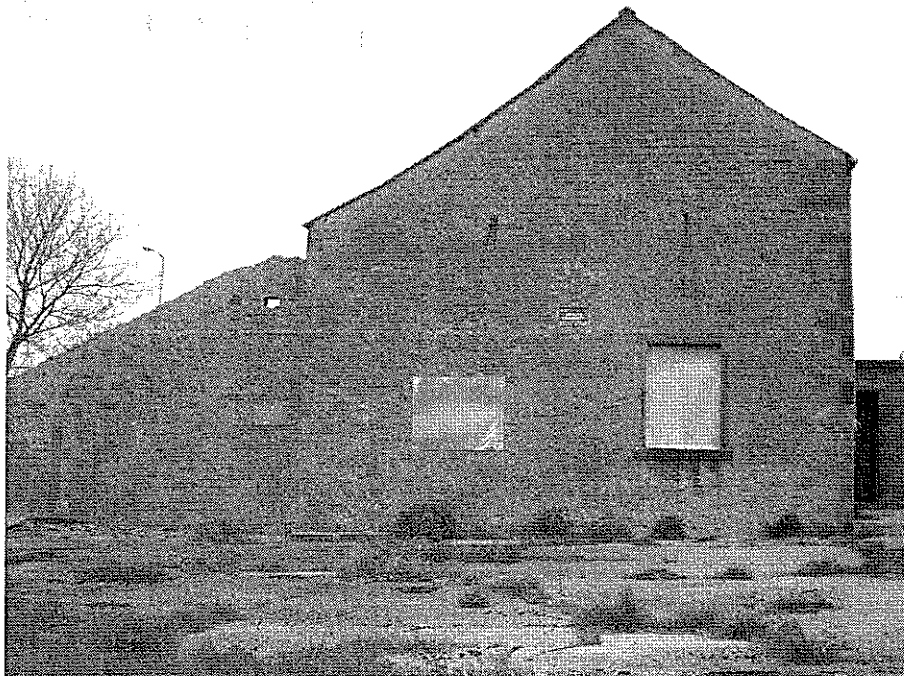
REAR GABLE

The southern gable is in reasonable condition with no evidence of structural distress in the form of cracking. There is evidence of distortion to the gable pike but not to any excessive extent.

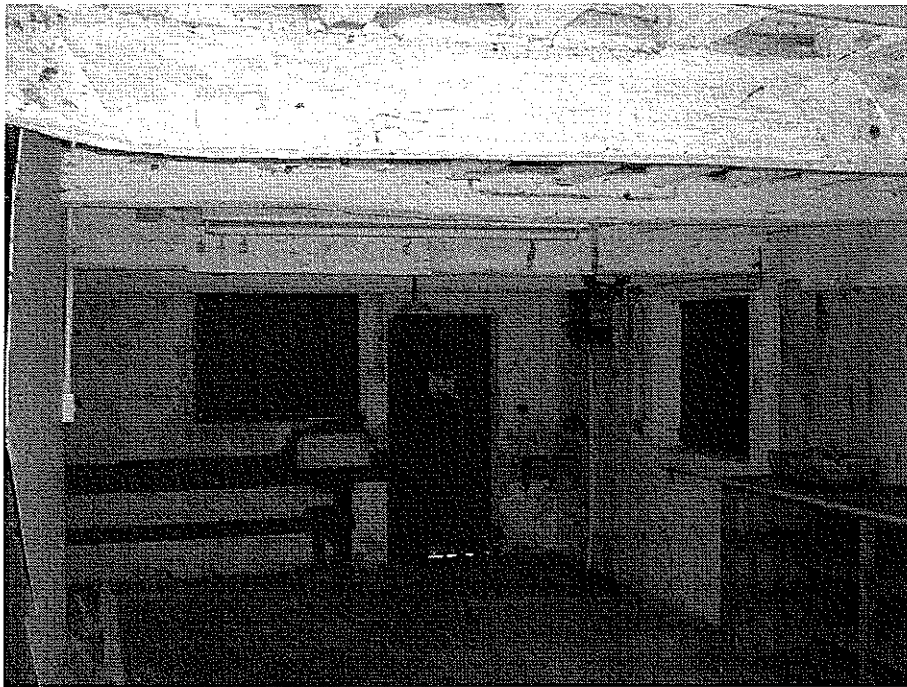
GROUND FLOOR

The floor is solid and uneven throughout again with evidence of damp ingress.

The ground floor construction has settled considerably throughout the area inspected, which we assume will be reflected in the remainder of the barn.

9. Remove existing slabs to floor, excavate and provide 150mm insitu slab reinforced with A14 mesh on insulation and damp proof membrane on compacted clean stone minimum 150mm thick.

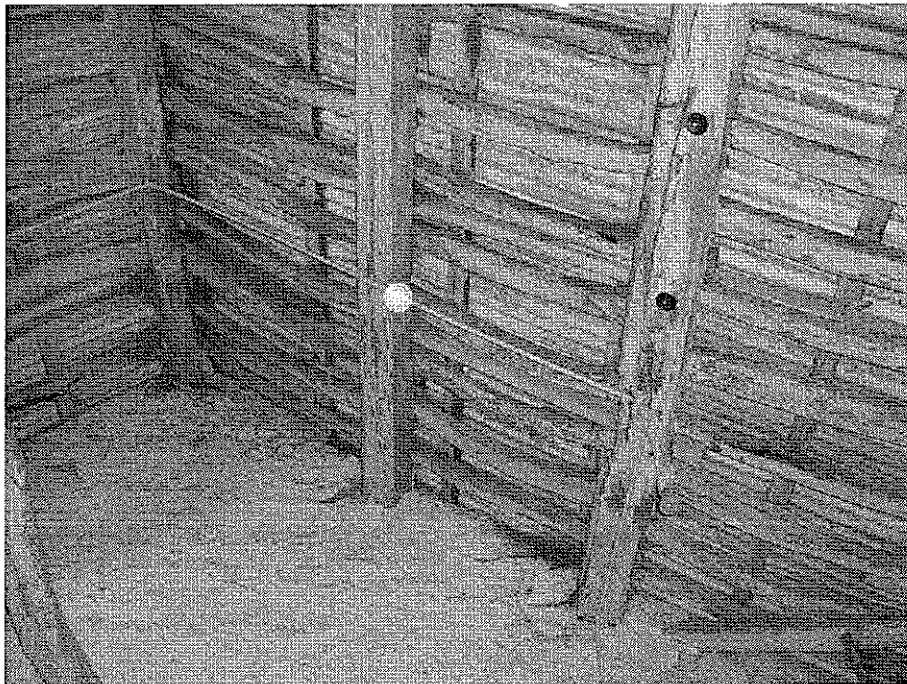
ROOF CONSTRUCTION

Internally, the upper storey of the barn adjacent to the road has the original roof construction exposed. The original rafters are unwroughted at close (300mm) centres spanning over large rounded section timber purlins. The original construction appears to be in reasonable condition.

The original construction appears to be in reasonable condition considering its age although we suspect that some rot may have occurred to the topside of the rafter and purlins.

The roof covering has failed and daylight can be seen in numerous places. The replacement asbestos covering is saturated and covered in moss and lichen growth.

There is limited doubt that extensive wet rot will have occurred in all principle roof timbers, including any wall plate, which may be present.

1. Strip all asbestos sheeting from existing roof.
2. Replace existing rafters with new structure including tanalised battens rafters, insulation and membrane.

3. Allow for new wall plates and rot treatment to adjacent masonry.
4. Allow for strengthening and rot treatment to existing purlins.
5. Remove all residual render and re-paint entire envelope.

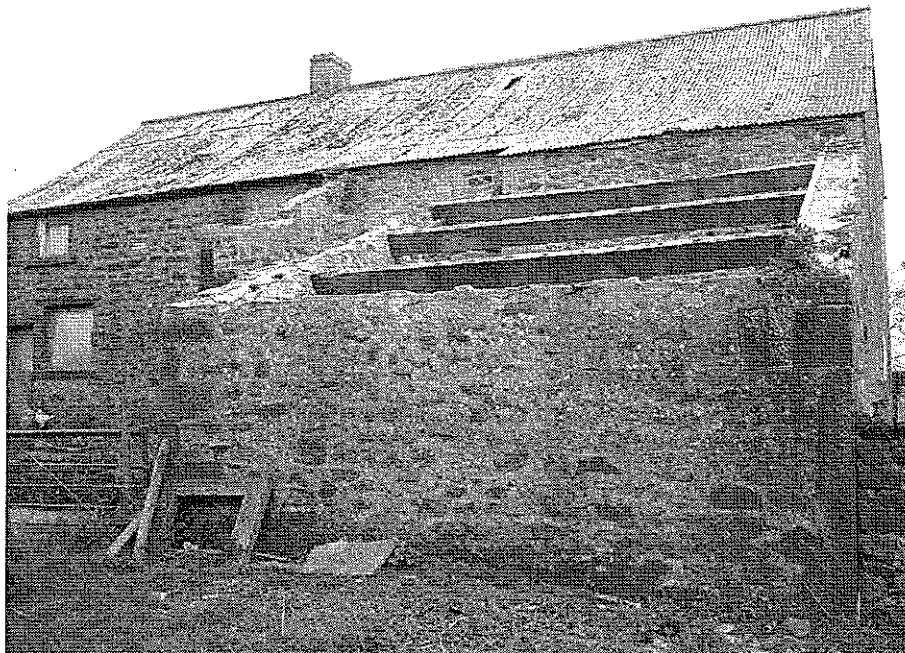
REAR ELEVATION

The western elevation has a single storey lean-to building. The roof construction has been removed leaving a line of three purlins exposed. The walls are approximately 450mm thick and reasonably plumb. The main elevation to the barn has suffered extensive damp, which has eroded the mortar and also areas of stonework at the lower level.

The ground is raised around the outrigger causing damp ingress to the external elevation.

There is a central dividing wall in common brickwork and the doorway to the barn has been infilled with blockwork.

The remainder of the western elevation is in reasonable condition with a minor adaptation around a door / window adjacent to the gable. The mortar has perished to the pier, which is out of plumb and requires re-building.

6. Renew all guttering and rainwater goods.
7. Treat outrigger roof purlin ends for rot and strengthen as necessary.
8. Reduce all external levels to perimeter and provide injected dpc throughout all internal and external walls.

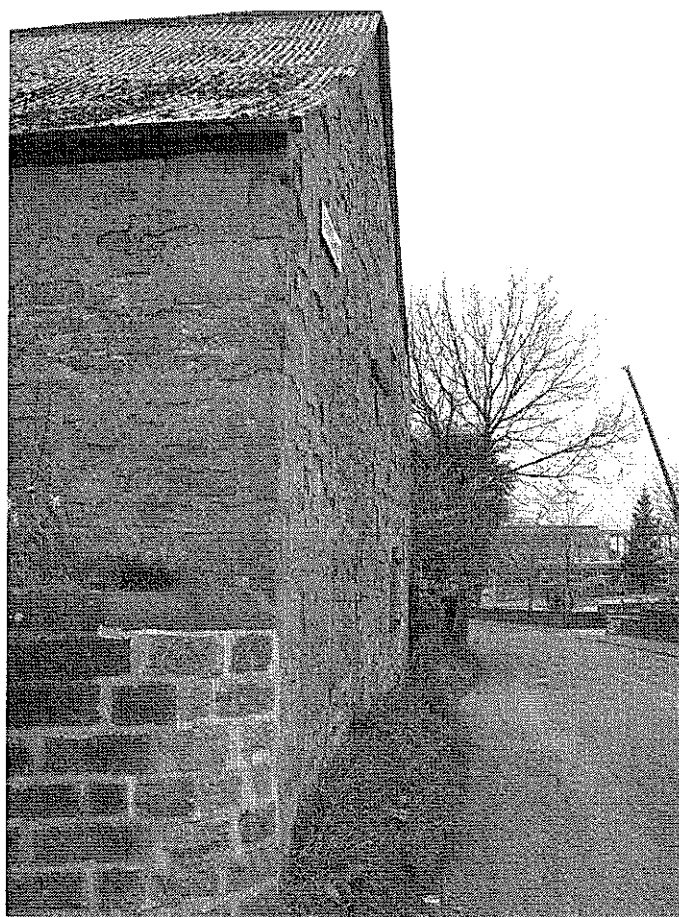
CHAPEL HILL GABLE

Standing at two storeys to the roadside the barn is constructed in stone. The gable to the roadside has previously been rendered and has all but fallen away. A number of original openings have been infilled.

The gable has slight outward movement at first floor level although the walls are quite robust in width. There is no sign of extensive movement in the form of cracking.
