# Bat and Bird Inspection Survey Report

St Pauls Church, Berry Lane,  
Longridge, Preston PR3 3WA

January 2012

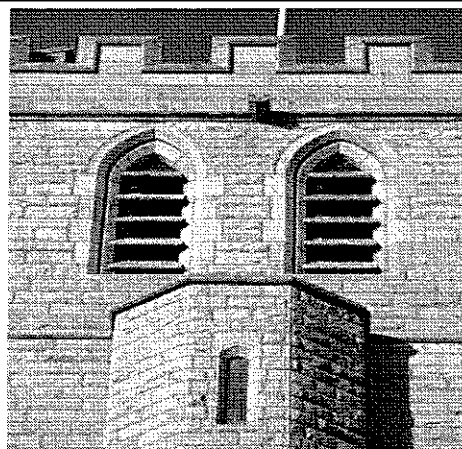
It was not possible to undertake a close inspection of the belfry due to the height of the tower. The gaps between the stone louvres (Photo 2) provided clear access points that birds or bats could use to enter the belfry. No other obvious gaps or crevices were observed on the exterior of the tower.

Photo 2 – A close up of the belfry tower showing the stone louvres. Gaps within these louvres provided easy access for nesting birds.

It is highly likely that birds will nest within the louvres on commencement of the nesting bird season. In order to ensure legal compliance, any works directly affecting potential bird nesting habitat should be carried out outside of the main breeding season (March to August inclusive) if at all possible. Any works during this period would require prior checking for active nests by an ecologist.

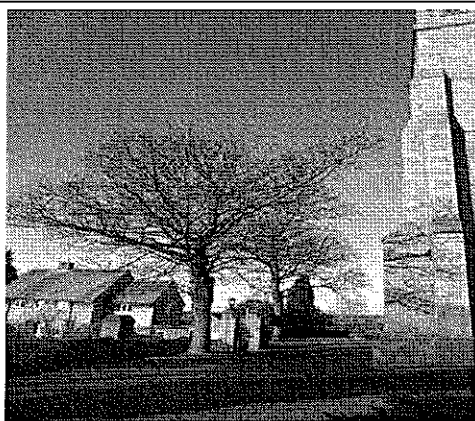
Semi mature trees were located towards the west of the belfry (See Appendix One). The trees were assessed as having a low potential to support bats and there was no visible signs of roosting bats on the exterior of the trees.

Photo 3 – A tree located to the south of the church. The tree was assessed as having low to medium potential for roosting bats.

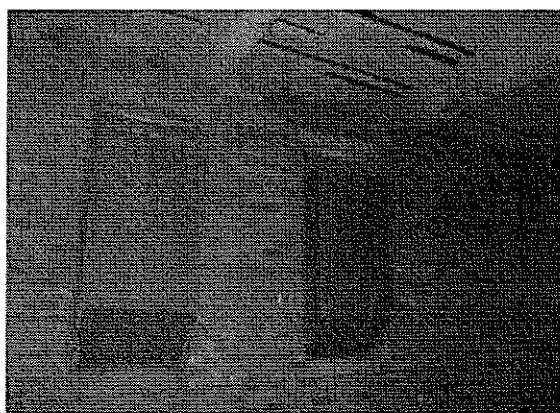
The internals of the belfry revealed a concrete based roof with no entry holes for birds or bats. There were no beams or crevices within the roof space which made it highly unsuitable for roosting bats. There were no visible signs of bats such as dropping, stain markings or food remains. There were large gaps between the louvres and the walls of the belfry, however these gaps were enclosed by wire netting (Photo 5) and it was not possible for birds or bats to enter through these gaps.

Photo 5 - A close up of the louvres. There was metal netting surrounding the gaps between the louvres and the inside of the belfry

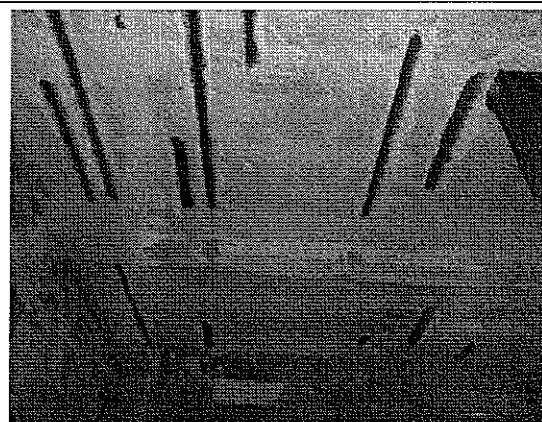
Photo 6 – The roof of the belfry tower. The construction of the roof was highly unsuitable for roosting bats

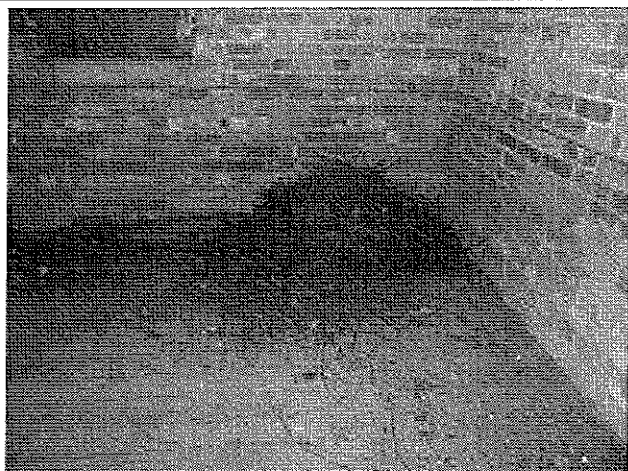
Within the belfry were the remains of old crow nests which had been taken away from the louvres. At the time of survey birds were noted to be within the externals of the louvres. It is highly possible that birds will be nesting within the external basin of the louvres when the nesting season commences.

Photo 7- The inside of the belfry showing old discarded material from nests which had been constructed on the outside of the belfry. The nests are likely to be made by crows.

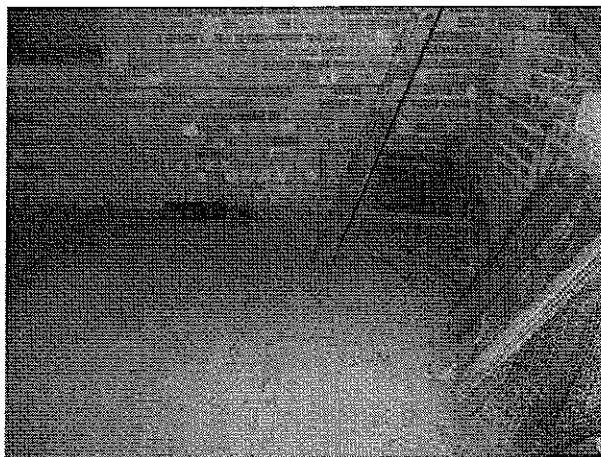
Photo 8- There was no evidence of birds or bats within the internals of the belfry. The walls of the belfry were completely sealed and there were no gaps or crevices in the brickwork leading to the exterior.
