# Design and Access Statement

Reinstatement of Existing Travel Agency  
Shop, Repair of Shop Front and Internal and  
External Repairs.

6 Castle Street  
Clitheroe  
Lancashire  
BB7 2BX  
United Kingdom

# **Design and Access Statement for Internal and External Repairs.**

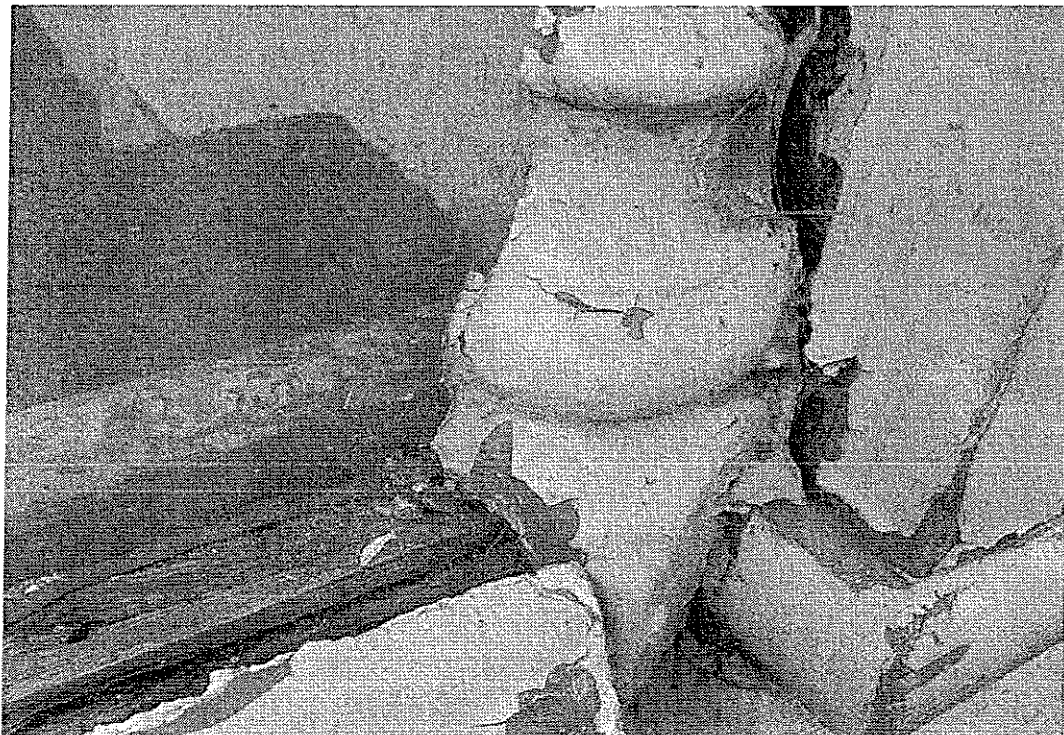
2. Condition of the existing pilaster and mullion detail

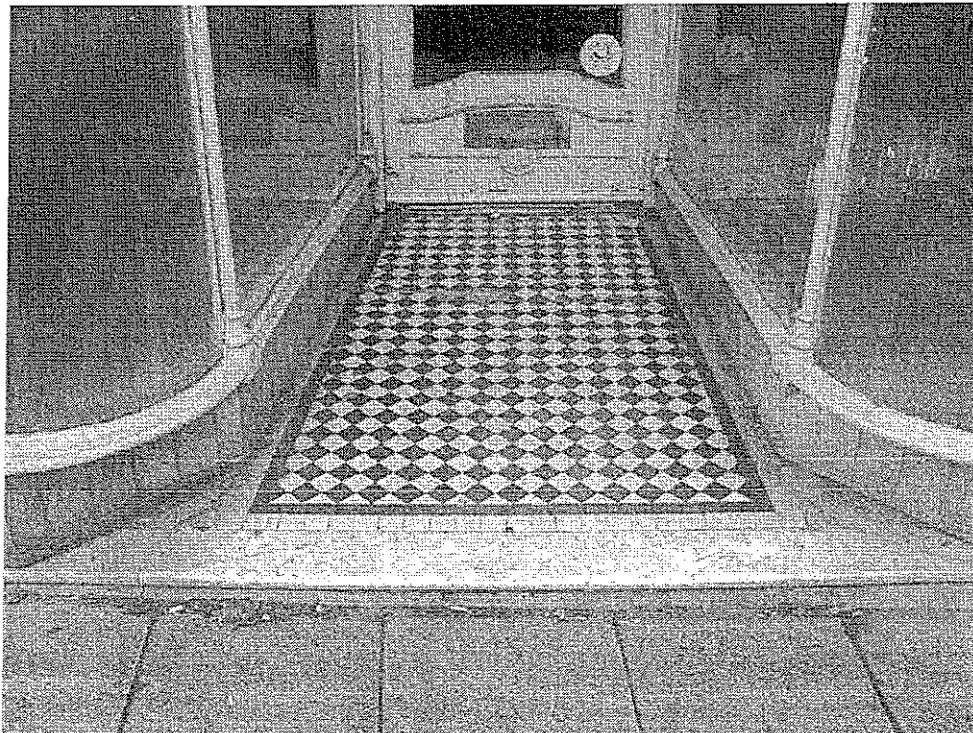
**4. Detail of alcove leading to door to shop front, note step.**

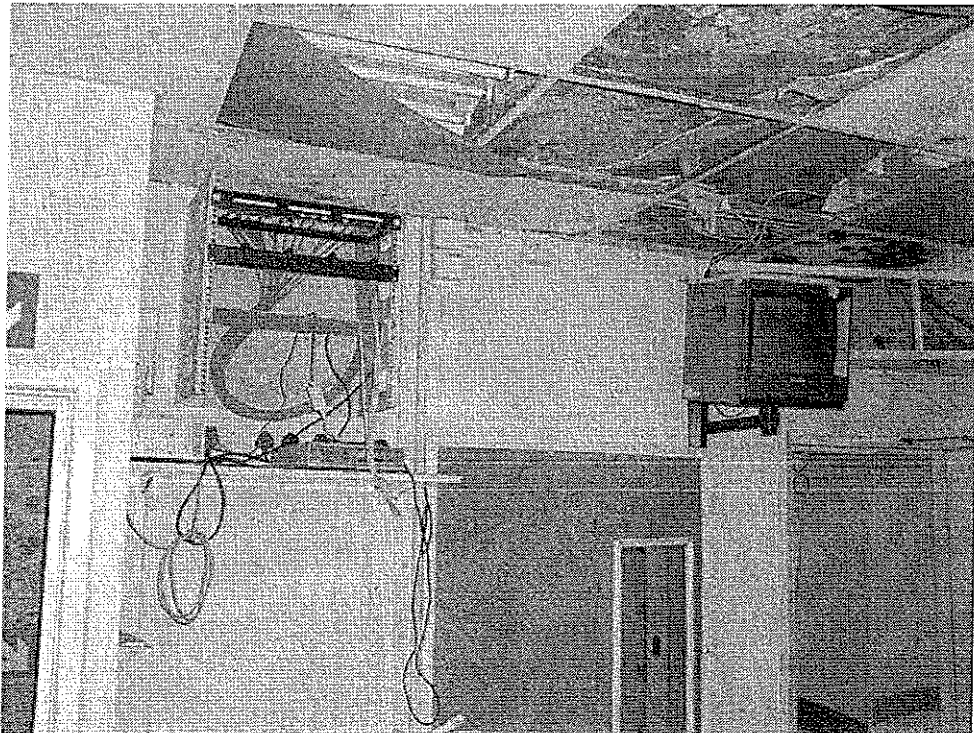
8. Back of house / admin area showing water damage from the flat above.

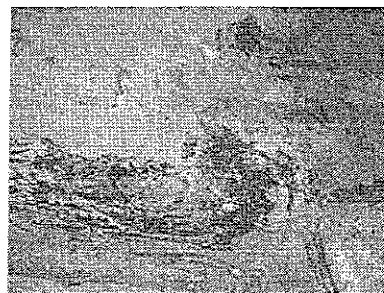
- a. Replacement of gable wall internal embedded timbers, notably to the first floor gable wall

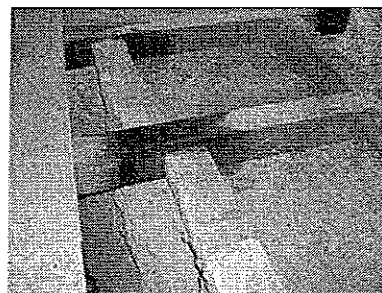
- b. Auger drilling, impregnation and coating of ground or wall bearing timbers affected by wet rot

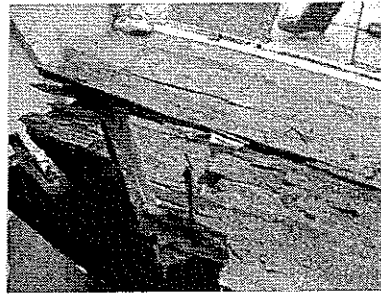
- c. Replacement of the rotten timber ground to first floor staircase; beyond repair due to historic wood boring insect attack and more current wet rot

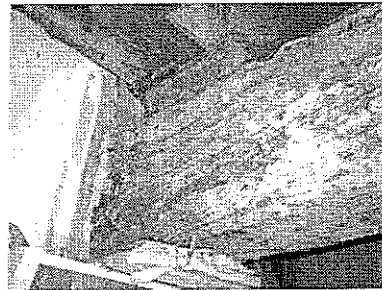
- d. Replacement of the rotten basement joists due to wet rot

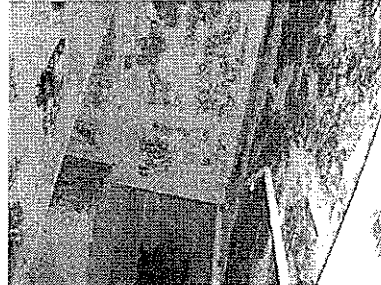
- e. Removal and replacement of water and mould affected plasterboard

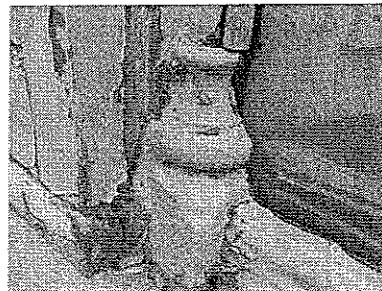
- a. Replacement or refixing of shop front timber mouldings to match the existing. Also filling, preparing and painting to match the existing colours and profiles.

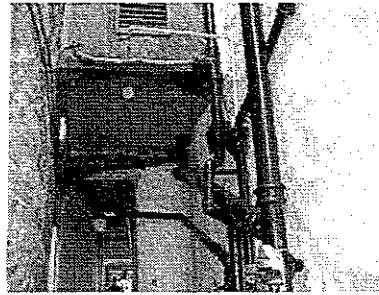
- b. Repairs to plumbing and rainwater goods to prevent dampness to external walls

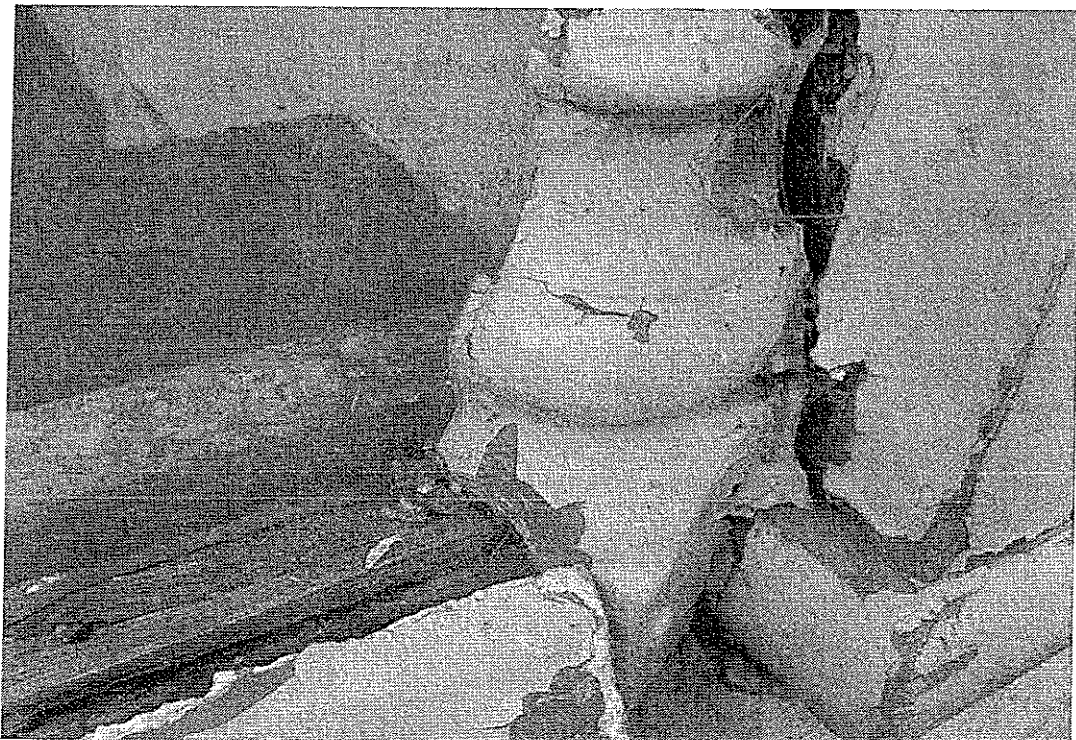
2. Condition of the existing pilaster and mullion detail

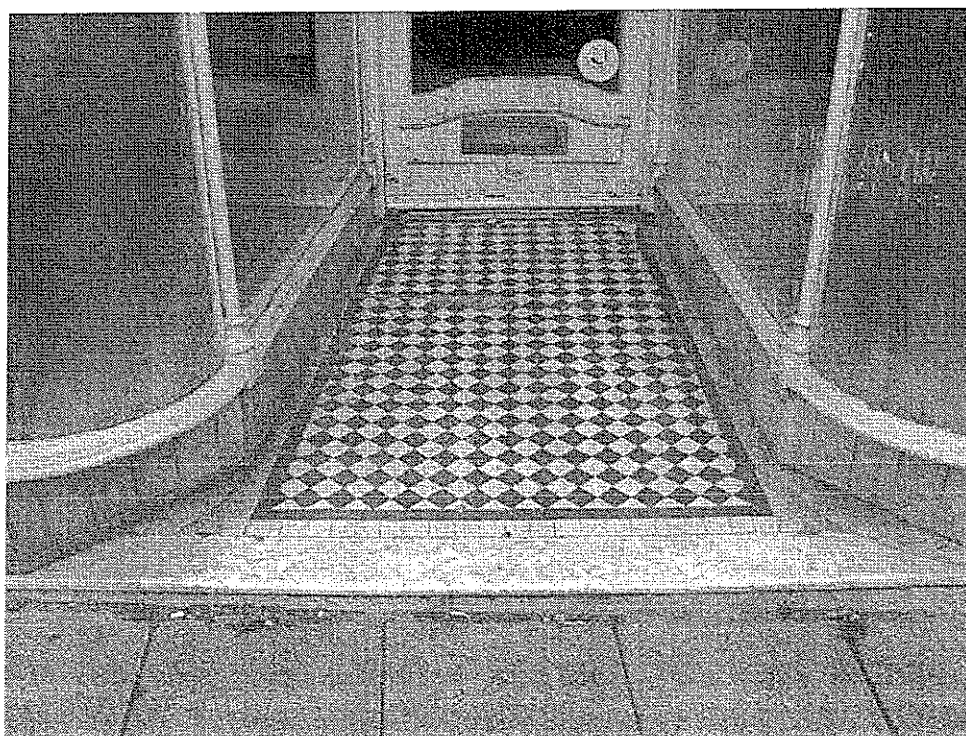
**4. Detail of alcove leading to door to shop front, note step.**

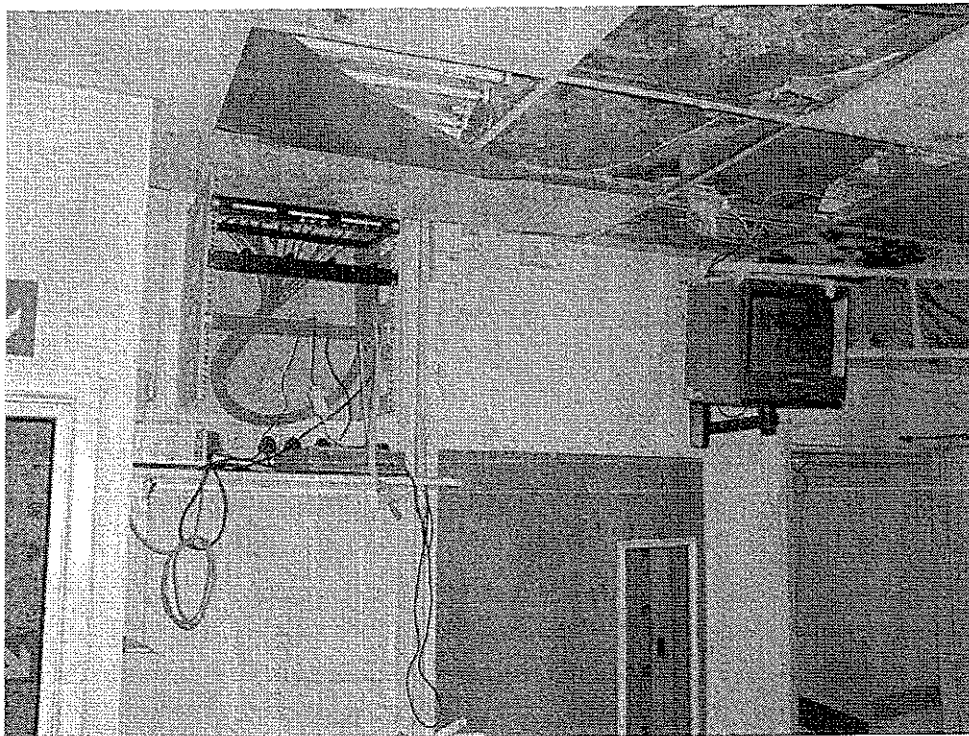
**8. Back of house / admin area showing water damage from the flat above.**

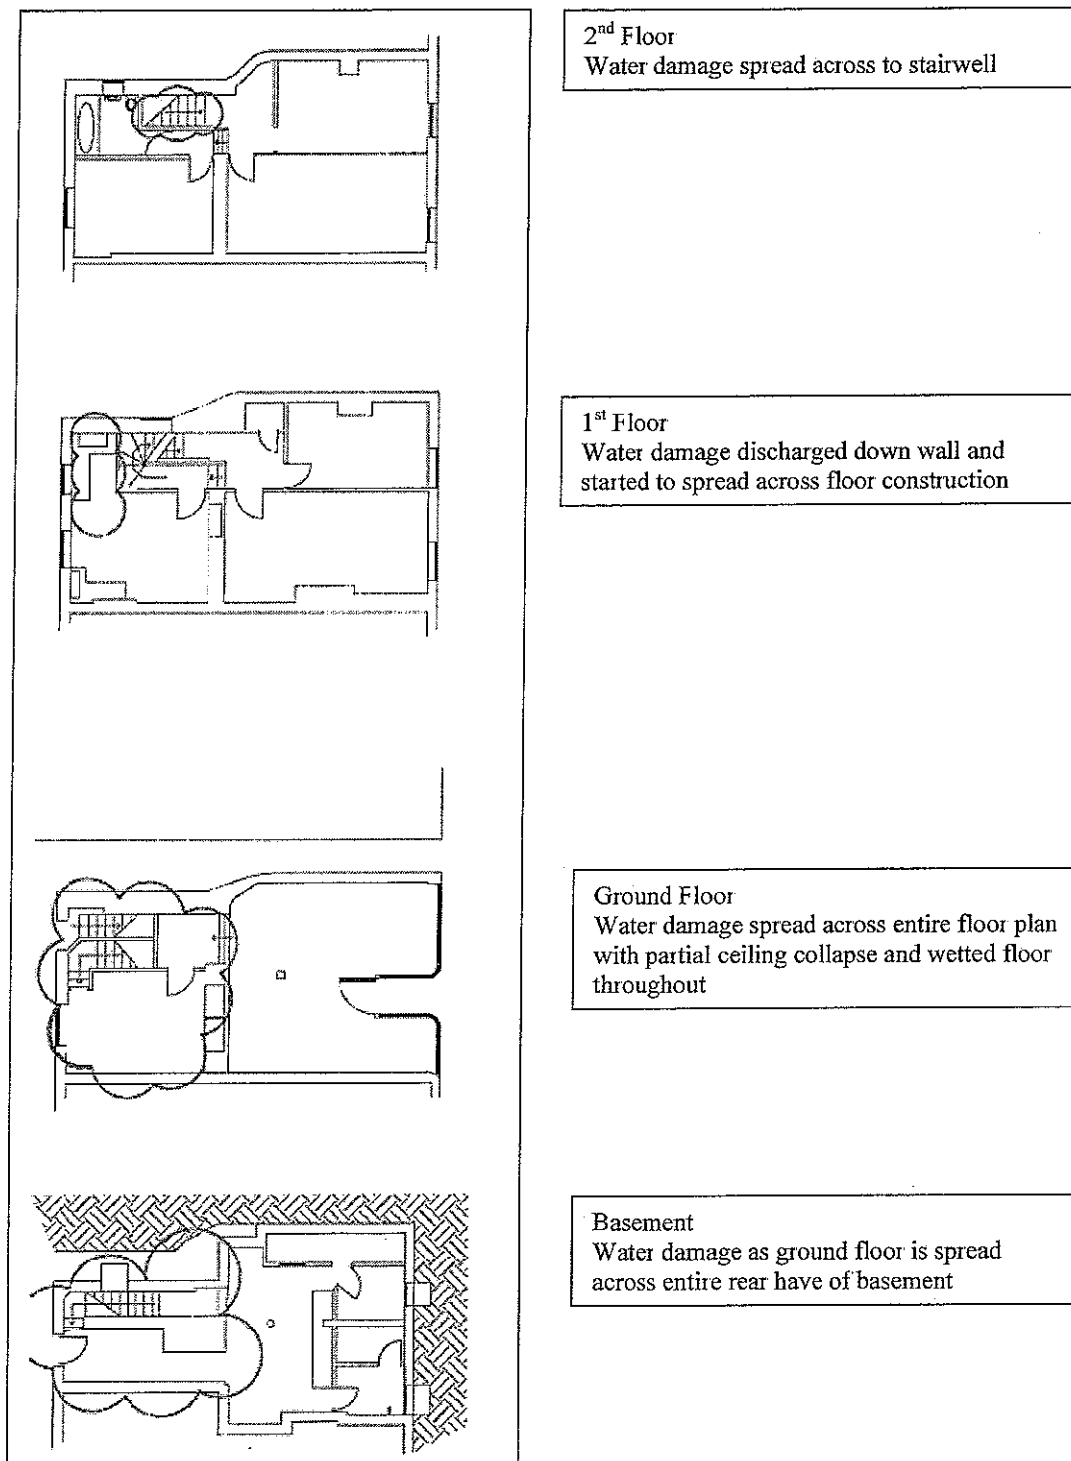
- 4.1 The indicative sketches below show the general spread of visible damage caused by the bathroom leak at the 2<sup>nd</sup> Floor, which illustrates the rear half of the property being the main areas of water damage, with visible water issues increasing in size as the water moves down the property and tracks across floor and ceiling constructions.

- 4.2 The main issue and cause of the damage is as discussed a previous leak at the 2<sup>nd</sup> floor bathroom. The water damage has generally spoiled finishes to walls and floors, contaminated plaster substrates, exacerbated mould growth severely, germinated fungal growth, destroyed ceilings tiles and possibly caused timber decay, and no doubt introduced moisture into the structure that will continue to 'sweat' and cause moisture vapour problems in the long term before it dries down. To address the water damage we recommend the following:

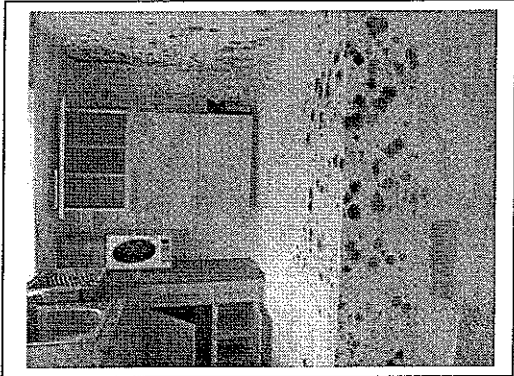
5.

| ITEM | DESCRIPTION | PHOTOGRAPHS |
|---|---|---|
| 6 | The ceiling and wall over the wall mounted cupboard unit has severe mould growth where previously wetted. This area is directly below the bathroom and the plaster substrates are stained and salt contamination is visible, indicating the migration of moisture through the substrates, which will restrict drying down and exacerbating moisture vapour and the formation of mould. | 5 |

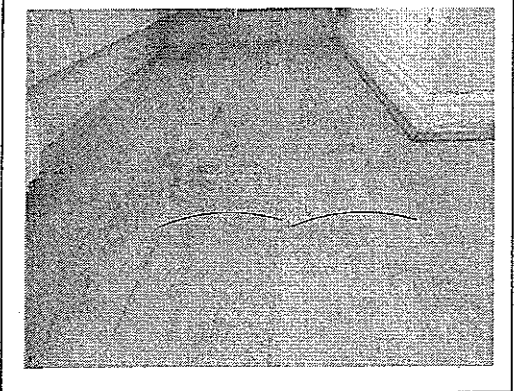
7.

| ITEM | DESCRIPTION | PHOTOGRAPHS |
|---|---|---|
| 8 | The timber laminate floor finish is sagging at the joints and has warped, this indicating where the water has ponded on the finish and migrated through to the floor construction below (if moisture vapour was rising from below, floor finish would be raised at the joints – 'cupping') | 7 |
| 11 | The curved wall detail at the staircase is directly below the bathroom is consequently in a poor condition with delamination of the wall paper finish, damp staining and mould growth evident (including ceiling). If the partitioning includes timber studwork, this will be vulnerable to decay and should be checked to verify its condition. | 7 |

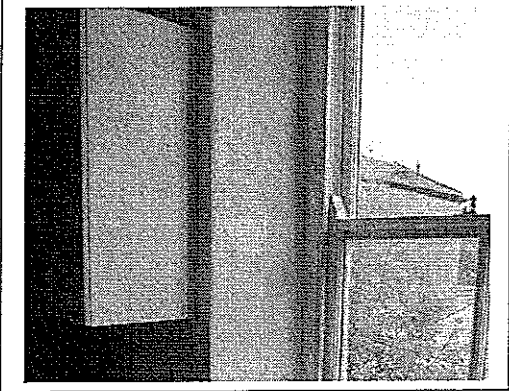
8.

| ITEM | DESCRIPTION | PHOTOGRAPHS |
|---|---|---|
| 9 | The window reveals are stained. This is either caused from ingress at the window opening or from above. This is not directly below the bathroom leak and therefore we suspected that ingress has migrated from the external side of the wall. The external cill was noted to be cracked to its upper edge and decoratively poor. | 8 |

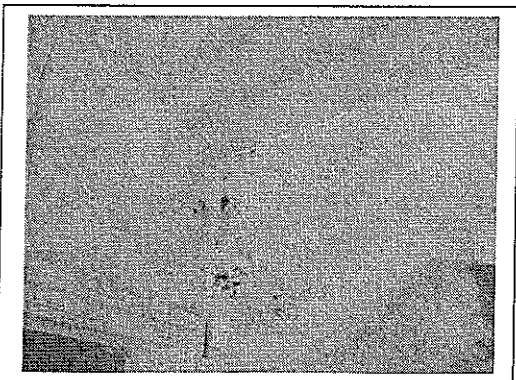
11.

| ITEM | DESCRIPTION | PHOTOGRAPHS |
|---|---|---|
| 13 | Staining at the chimney breast is evident and not immediately thought to be directly related to the wetting from the leak above. However, because of high vapour levels in the air caused by the leak, long term burning of fossil fuels in the flue will have deposited hygroscopic that may have been encouraged to deliquesce and exacerbate the staining. | 11 |

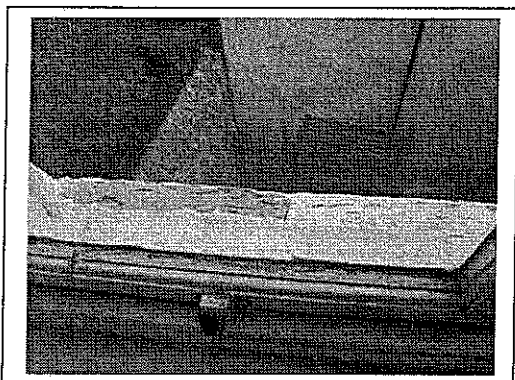
12.

| ITEM | DESCRIPTION | PHOTOGRAPHS |
|---|---|---|
| 10 | The floor area below the leak appears to be generally damp, however is thought to be historic. (water is currently turned off at the property) | 12 |

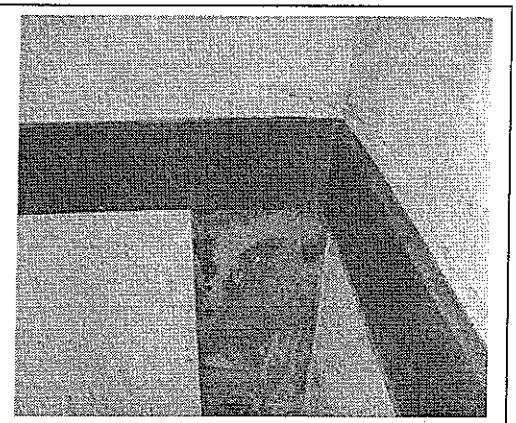
13.

| ITEM | DESCRIPTION | PHOTOGRAPHS |
|---|---|---|
| 15 | Water runs are evident down face of the wall paper finish, with mould growth evident and staining from water damage on the plasterboard substrate. Water damage has spread and largely encompasses the rear half of the property in this area. | 13 |

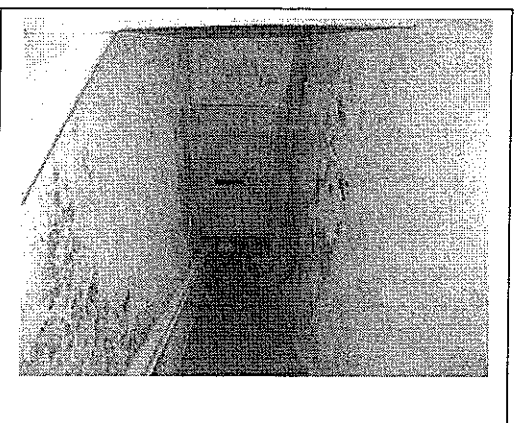
14.

| ITEM | DESCRIPTION | PHOTOGRAPHS |
|---|---|---|
| 16 | At the entrance to the flat at ground floor, the walls have severe mould growth evident and the leak has previously wetted the wall surfaces. | 14 |

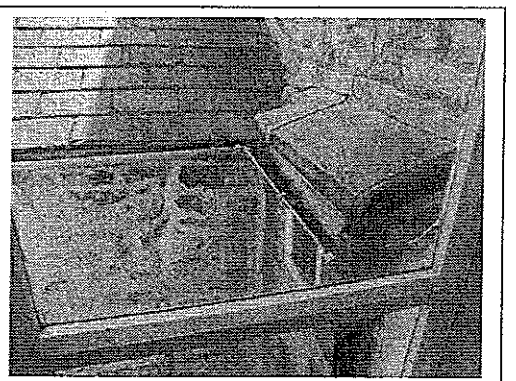
15.

| ITEM | DESCRIPTION | PHOTOGRAPHS |
|---|---|---|
| | It should also be noted that externally, the rainwater goods over the walkway are introducing excessive water onto the wall and this will be causing or exacerbating the dampness at the external wall. | 15-16 |

| ITEM | DESCRIPTION | PHOTOGRAPHS |
|---|---|---|
| 34 | The adjoining building rainwater goods were noted to have sediment and vegetation growth to the guttering and it was reported (by public) that the pipework lower down over the entrance to the walkway leaks onto the path and the ground gully allow water to overflow. The wall externally is spalling at low level and will be causing or exacerbating any dampness at the staircase to the flat accommodation. | 15 |

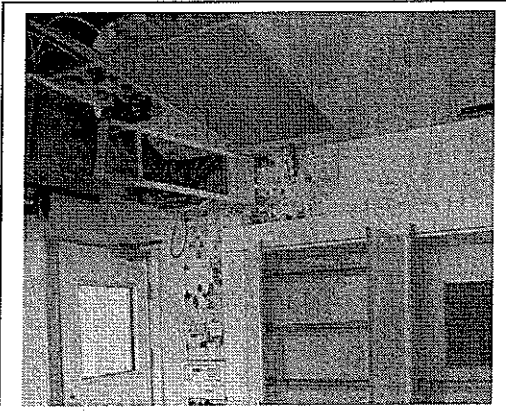
19.

| ITEM | DESCRIPTION | PHOTOGRAPHS |
|---|---|---|
| 19 | Walls have severe mould growth and have been wetted from the pipe leak at 2 <sup>nd</sup> floor. Substrates are contaminated and drying down will be restricted. Wall construction to be exposed and checked for decay. | 19 |

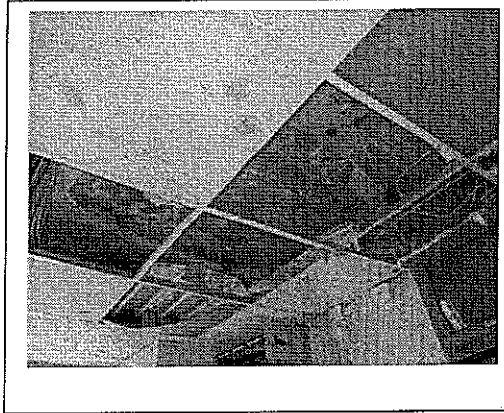
20.

| ITEM | DESCRIPTION | PHOTOGRAPHS |
|---|---|---|
| 20 | The ceiling tiles are stained and have collapsed where moisture from the pipe leak has spread and migrated through the floor construction. The chipboard fixed to the ceiling over the suspended grid has also deteriorated and collapsed, this showing the most severe water damage in the room generally. | 20 |

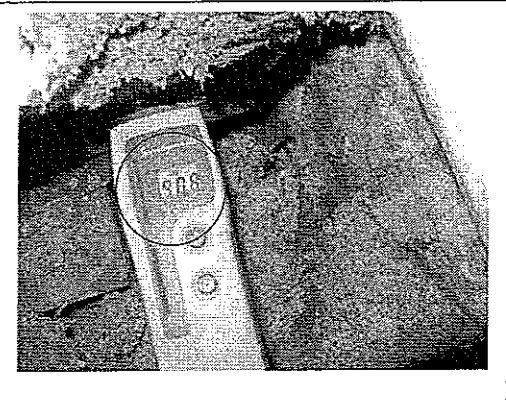
23.

| ITEM | DESCRIPTION | PHOTOGRAPHS |
|---|---|---|
| | The moisture content % of the exposed joist was taken at 90.8%, this essentially showing the timber is saturated and the timbers are at risk to decay, especially during drying down periods. The moisture has sat within the floor void and where moisture has likely spread down into the basement areas, moisture vapour issues are still present. | 23 |

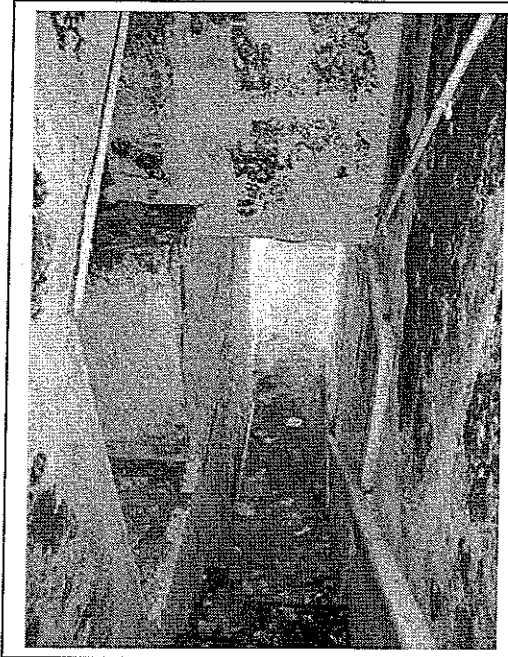
25.

| ITEM | DESCRIPTION | PHOTOGRAPHS |
|---|---|---|
| 25 | <p>The staircase leading to the basement is located below the bathroom leak and the general area, including walls, ceiling and floor is severely damp and has mould growth throughout. Wet rot strands are evident below the stair case to the flat accommodation. The walls have obviously been wetted and moisture vapour issues have caused further condensation to form on the wet substrates and further exacerbated mould growth.</p> <p>Generally the rear area to the ground floor has taken most of the moisture from the bathroom leak, whether it spread across the ceiling or accumulated in the floor void, the dampness is evident across the entire area. The damage is generally worse than at upper floors and all substrates are damp, requiring a full strip out to these areas.</p> | 25 |

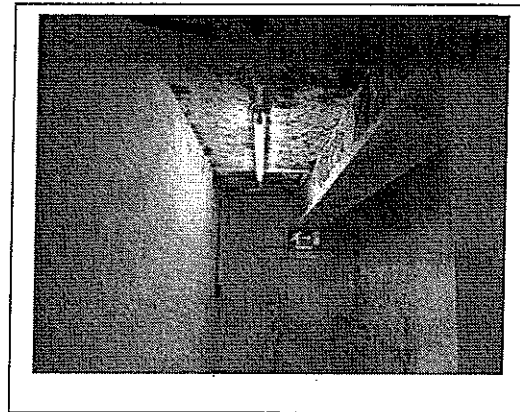
26.

| ITEM | DESCRIPTION | PHOTOGRAPHS |
|---|---|---|
| 26 | The rear half of the basement has severe mould growth to most substrates, including the dry lining to walls, the timber floating floor and ceiling. The moisture from the pipe leak will have spread down the building to the lowest point and acted to wet the substrates on the dry side of the waterproofing system. This will hold the moisture and further increase moisture vapour issues. | 26-28 |

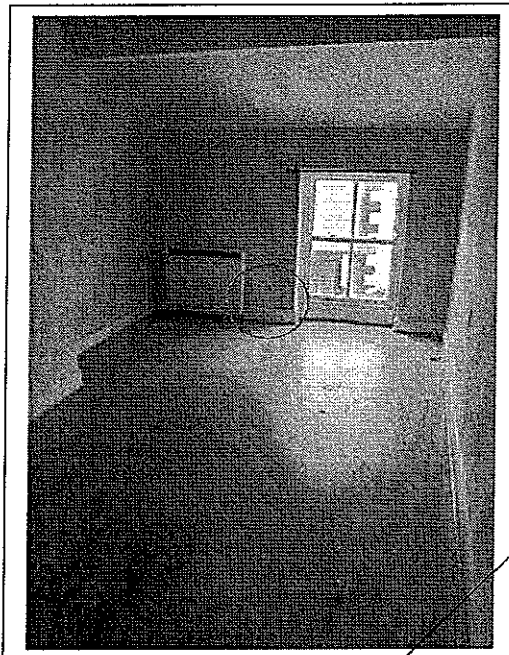
32.

| ITEM | DESCRIPTION | PHOTOGRAPHS |
|---|---|---|
| 30/33 | Minor mould growth noted at low level. Property is unoccupied and unheated, with increased moisture vapour from previous leak, this exacerbating any mould growth in the property on cold surfaces. Item 33 has similarly minor mould growth to the corner. | 32.<br>35 |

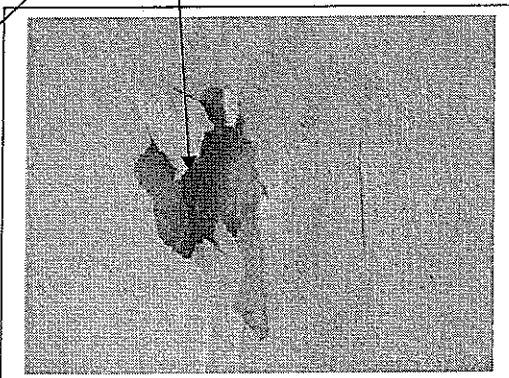
34.

| ITEM | DESCRIPTION | PHOTOGRAPHS |
|---|---|---|
| 32 | Wall to corner below sloping soffit has damp staining noted, this generally looks historic, however it was not raining at the time of inspection. The wall paper is delaminating and is damaged. The rafter ends if previously wetted by ingress and are bearing onto a wet wall, they are at risk of decay and should be exposed and augered to verify their condition. | 33-34 |

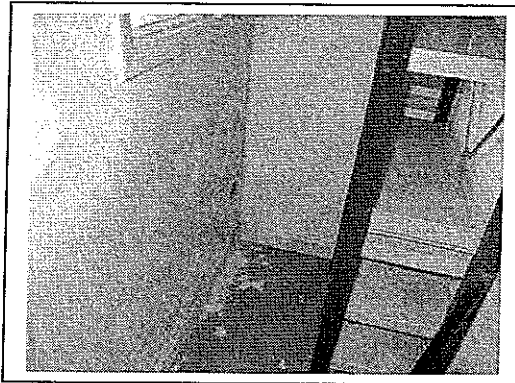
39.

| ITEM | DESCRIPTION | PHOTOGRAPHS |
|---|---|---|
| 37 | <p>The walls that are internal and not ground retaining have not been lined as part of the waterproofing system. It was not established if the wall substrate is a tanking medium or normal plaster substrate. These walls are all damp at low level, suggesting that moisture has migrated up the wall either from ground water below or the pipe leak where water has sat on top of the water proofing membranes. Salt deposits are evident, this again indicating that the moisture has migrated through the wall rather than forming at its surface (not condensation).</p> | 38-40 |

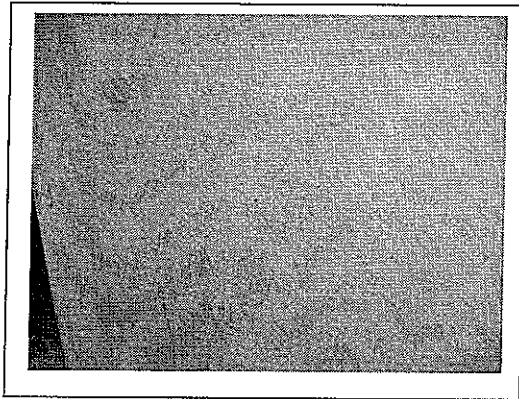
41.

| ITEM | DESCRIPTION | PHOTOGRAPHS |
|---|---|---|
| 38 | Mould is noted to the wall where increased levels of moisture vapour in the basement have exacerbated mould at cold surfaces. | 41 |
