27.10.2011

## **Bat Survey, Industrial Building and Land at Altham Pumping Station, Simonstone**

**Surveyor- Martin Prescott (lic. No. 2010/4226)**

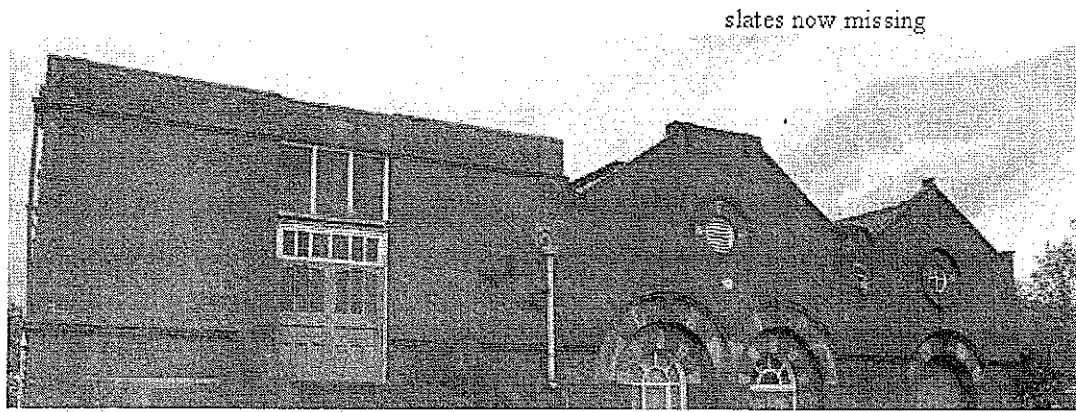
Sections 1, 2 and 3 had gables, front and rear, with parapet, obstructing bat access to these aspects.

Photo, front elevation showing parapet obstructing bat access to the gables

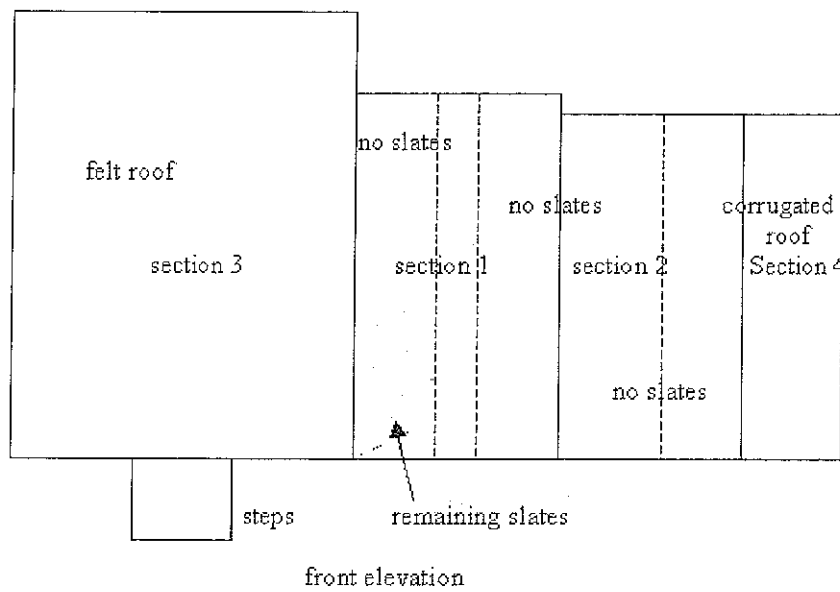
Of the four sections, two had plank-lined slate roofs, with most of the slates missing.

Section 3 had a well sealed felt roof lined with straw blocks of low bat roosting potential.

The fourth section had a roof of unlined corrugated sheeting of negligible bat roosting potential.

The building was considered to have very low potential for a major bat roost, but there were crevices between roof slates in section 1 and in the masonry, all sections, where transitory bats cannot be discounted.

**5.1** It is unlikely that roosting bats will be disturbed during securing and weather-proofing the buildings. This can proceed with minimal risk to roosting bats.

5.2 Demolition should preferably be carried out in winter when bats are likely to be hibernating elsewhere, however as transitory bats cannot be discounted, especially during mild spells, it is recommended that when demolition starts, the removal of the remaining slates is done under the supervision of a suitably qualified bat worker. If signs of a significant bat roost are found, work must stop and further work will be required.
