## **Proposed extensions- Holden Clough House**

## **Design and Access Statement - Holden Clough, Holden, Lancashire.**

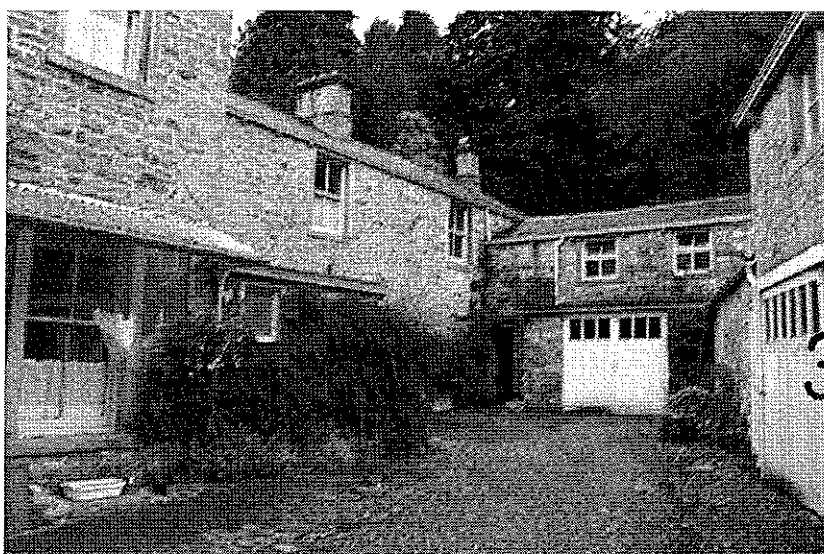
Courtyard with main house  
to the left and store to the  
right, garage to the rear

Very well sealed walls

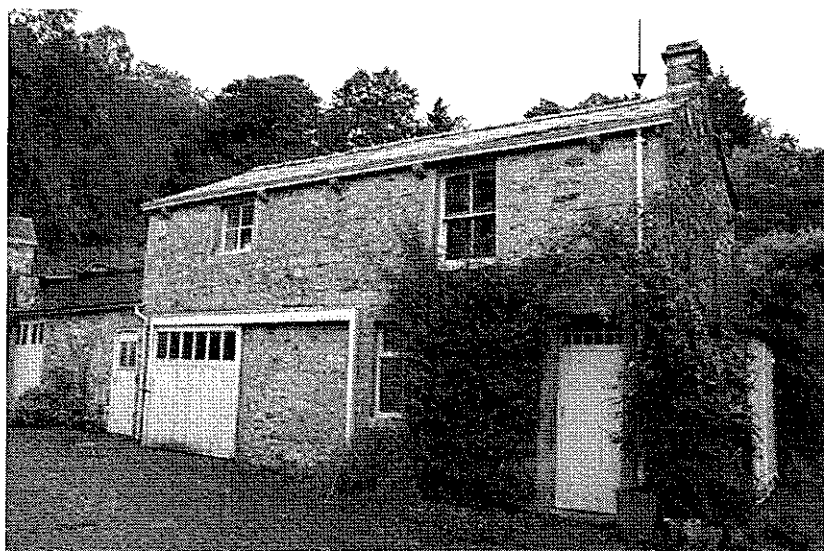
Store with bat roost under  
ridge tile to the side of the  
chimney

Very well sealed walls

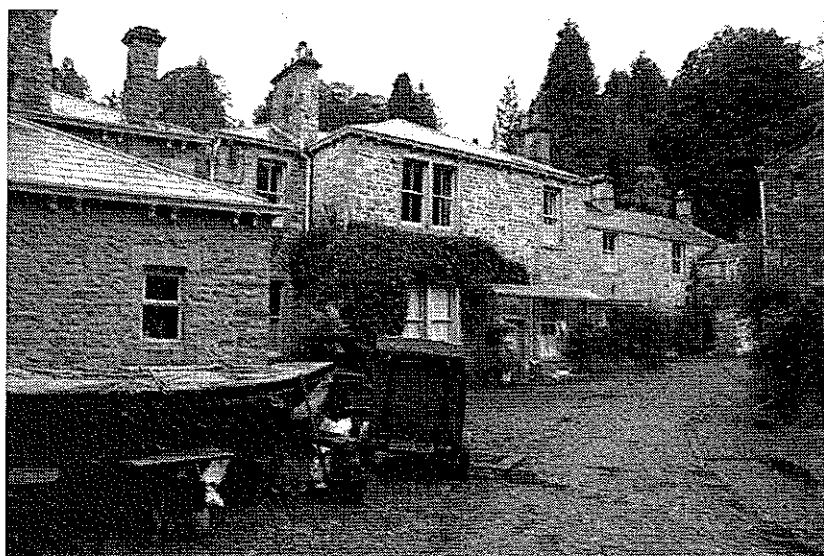
North-east elevation of  
main house

Very well sealed walls

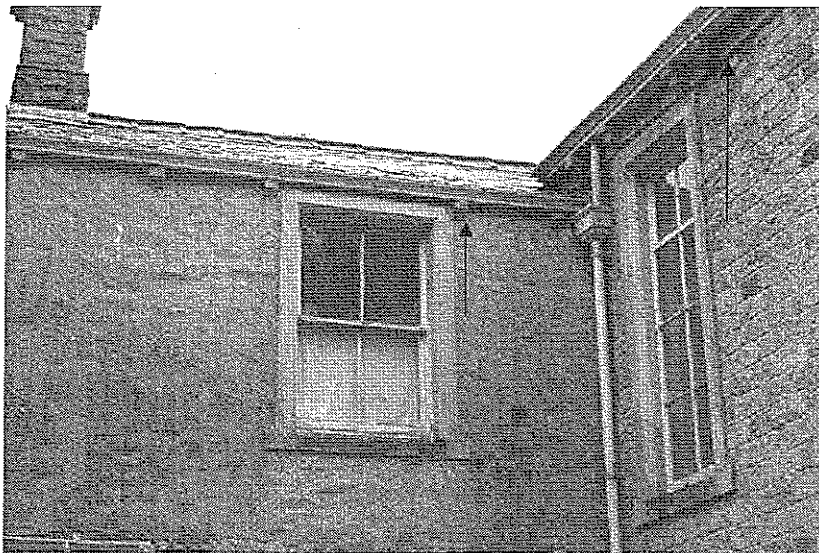
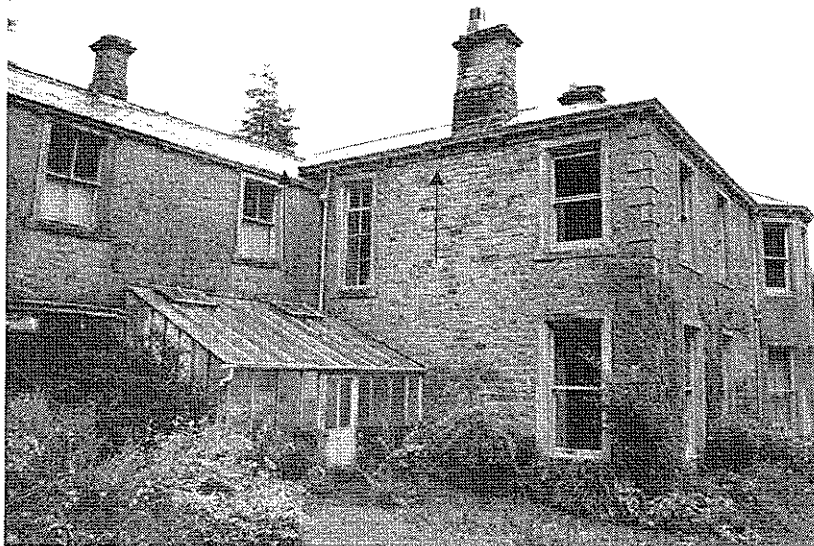
Low numbers of Common and Soprano Pipistrelle bats emerged from the eaves line in two locations on the South-West and North-west elevation here

Arrows show location of two roosts from different angles

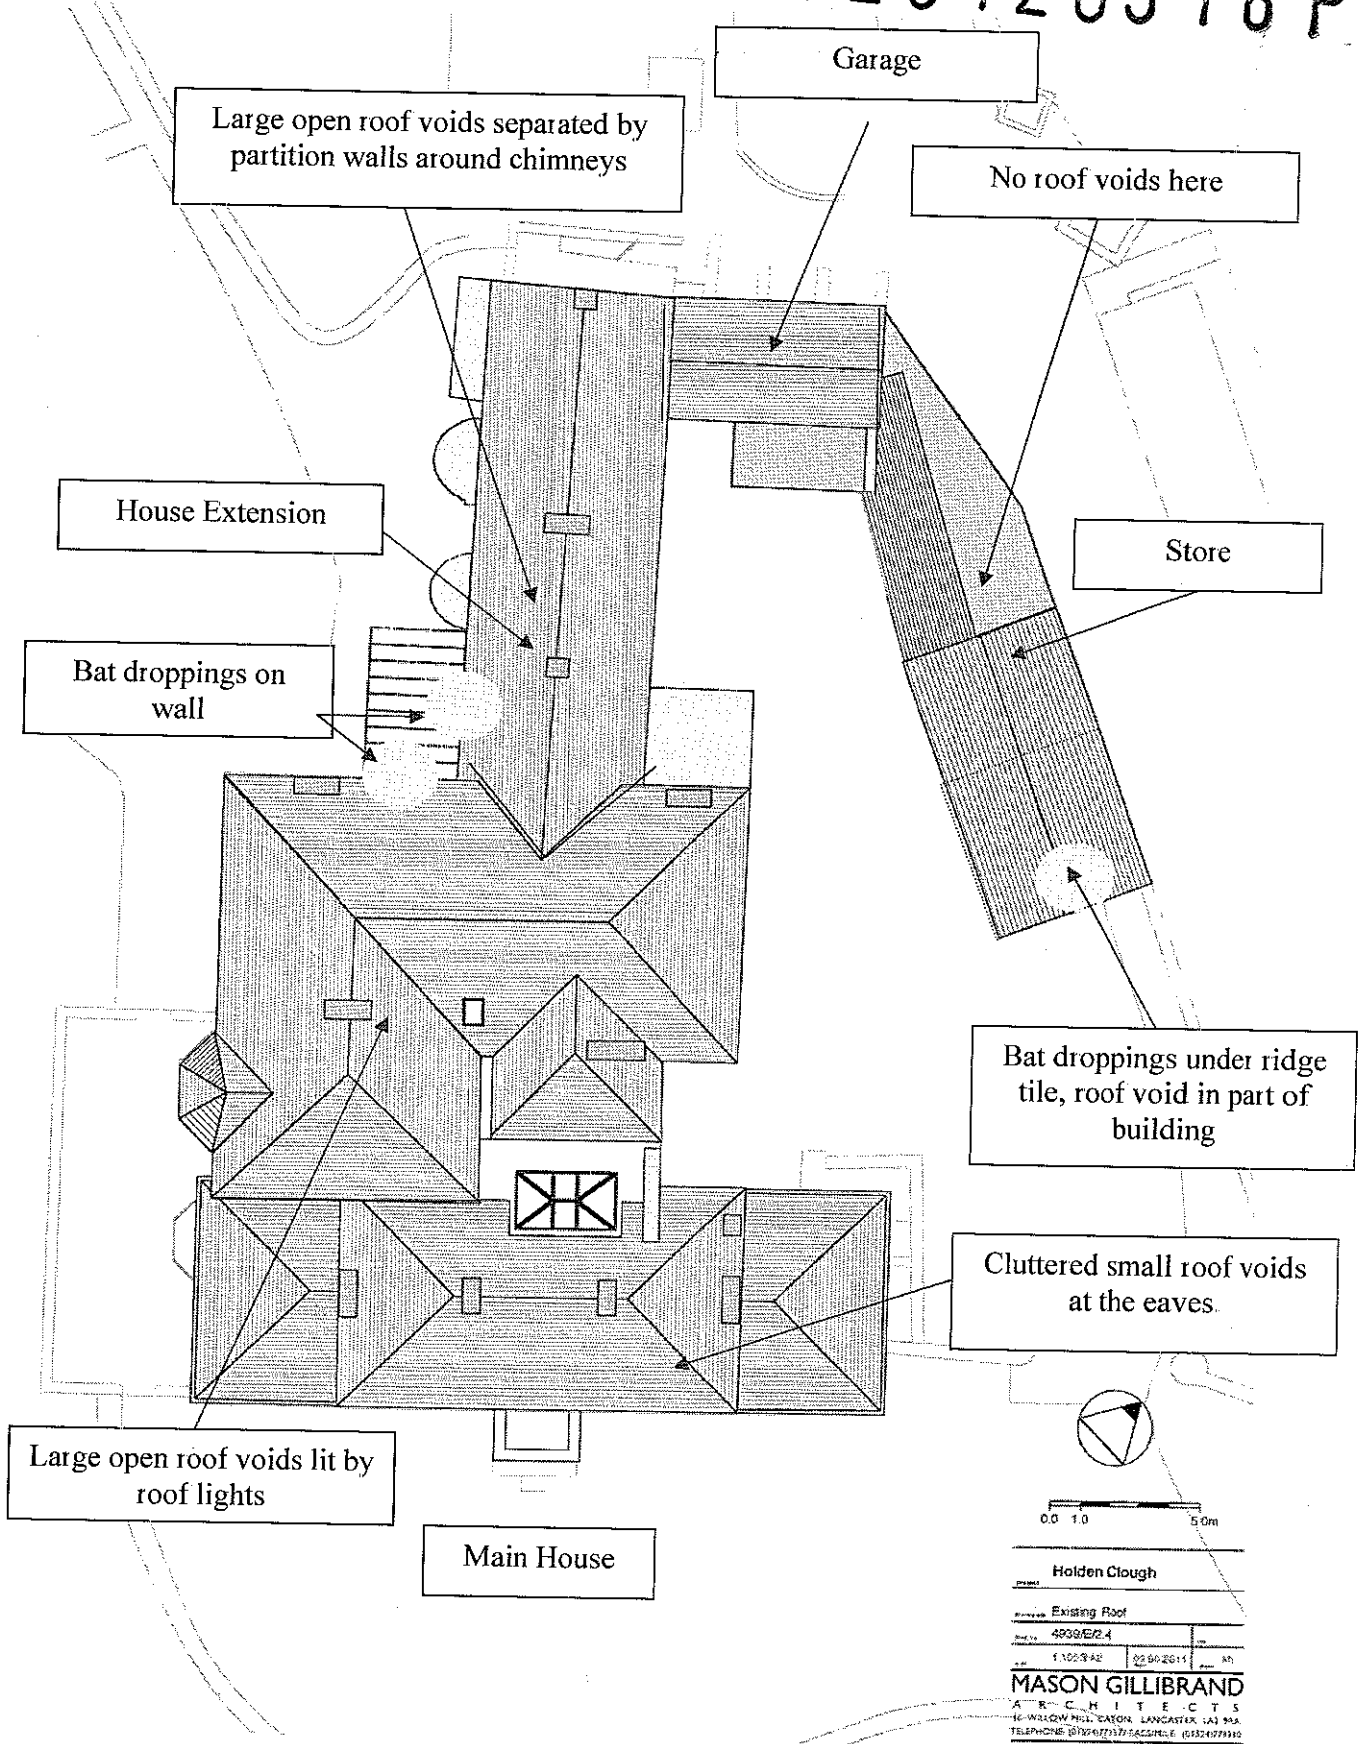
Figure 4

The roof is made of slate and is unlined. The entire roof and eaves line could be easily inspected from the ground with close focus binoculars and a 1,000,000 candle power torch. There is a gap visible beneath the ridge tile on the Southern end of the roof at the apex of the roof. No indication of intensive use of the roof by bats such as lichen staining, grease or scratch marks could be found. There were droppings visible beneath the ridge tile externally.

Integrally a small roof void was found on the South side of the store, below the raised ridge tile. Droppings were also visible within the roof void where they had dropped through from the ridge tile above. No bats were found within the ridge tile gap or roof void. Droppings numbered approximately 200-300 and were consistent with Whiskered or Brandt's bats being larger than Pipistrelle Sp, and not twisted such as Brown Long-Eared.

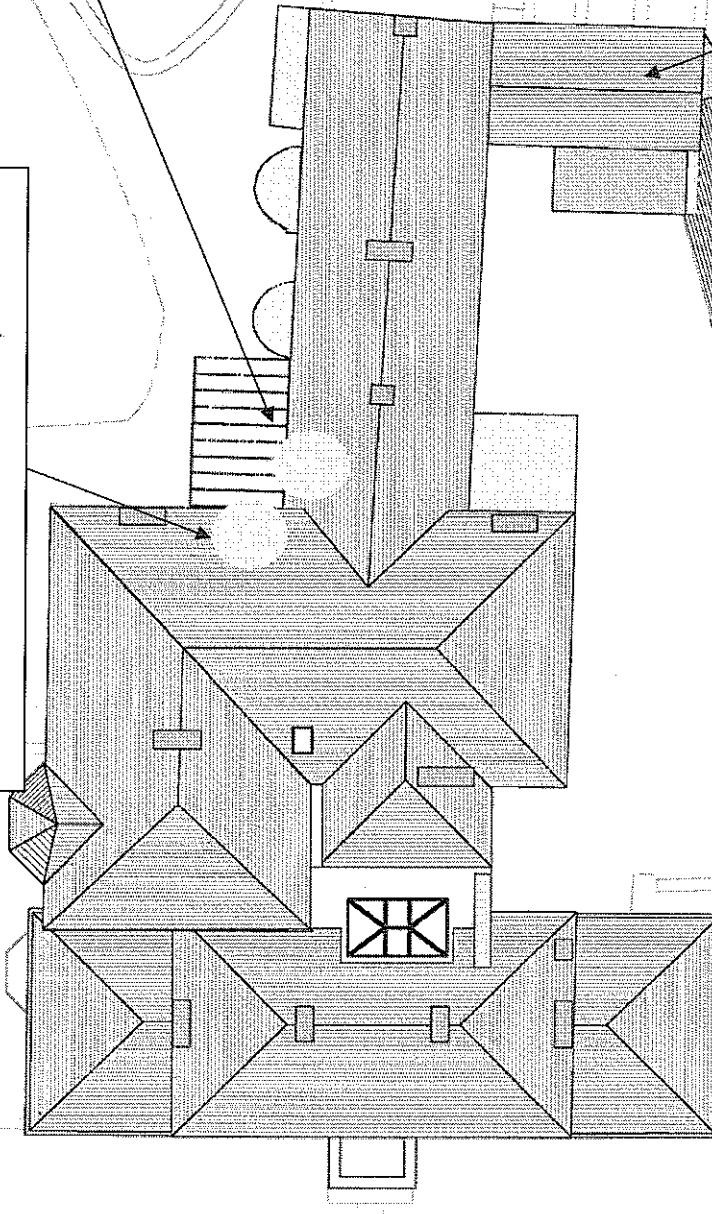
Main House roof to be replaced. Transitional, bachelor bale or non-breeding female roost **retained** here. Low- medium significance.

Possible maternity roost **modified** here CEF not affected. Low- medium significance.

Disturbance unlikely to be significant if work to roof and chimney undertaken in winter
