**ANDERTON GABLES**

Main Barn/Outbuildings -  
Dwelling 2 and Garage  
Greengore Farm  
Hurst Green  
Cliteroe  
BB7 9QT

PREPARED FOR: Mr and Mrs Kay  
PREPARED BY: Daniel March  
DATE: 11<sup>th</sup> May 2012  
REFERENCE: AG637 Rev A

Barn 1, 2 and Outbuilding  
Greengore Farm  
Hurst Green  
Cliteroe  
BB7 9QT

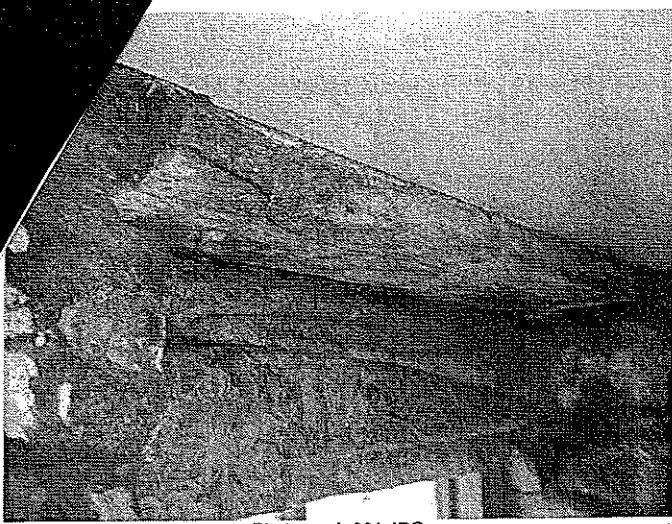
Photograph 001.JPG

Some original timber lintels remain (See Photo 1), whilst others have been replaced in modern concrete (See Photos 10 & 12). It is likely that some decay will exist to the timber lintels where they are built into the wall.

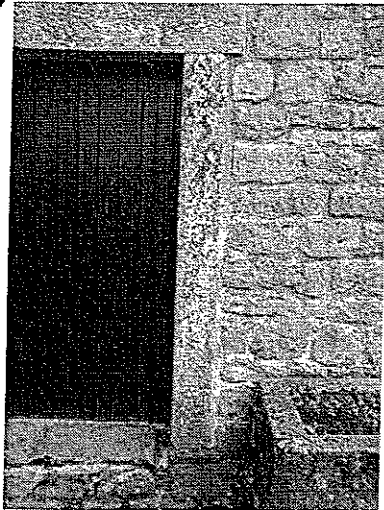
Photograph 017.JPG

Vertical cracking is evident towards to south west corner running at two positions, the first to the right side of the doorway up the eaves level, the second to the left side of the doorway up to around mid-height. The cracks taper in width from around 1mm to 4mm, with their greatest width at the top (See Photos 17 & 18).

The cracks do not appear recent in origin or obviously progressive. The vertical crack adjacent the gable may have suffered some recent movement, but this is likely to be due to deterioration of the pointing following some water penetration through cracks rather than continuing movement. It is likely that a small area of re-building and re-pointing will be required in this area.

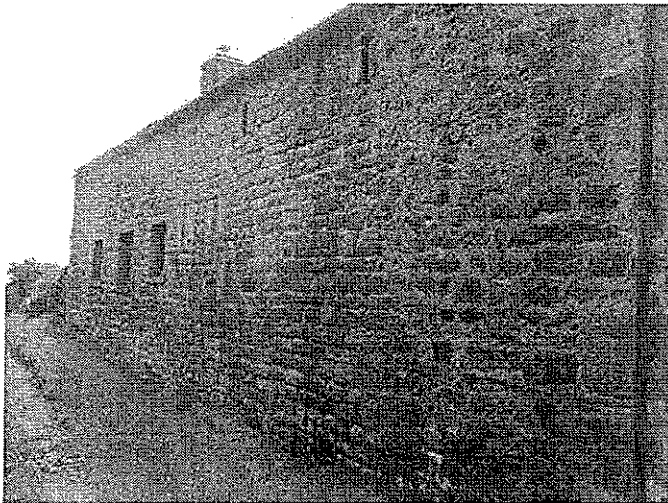
Photograph 027.JPG

The external walls are weathered, but serviceable. Areas of re-pointing are required to the rear elevation (See Photo 27), where the mortar has deteriorated.

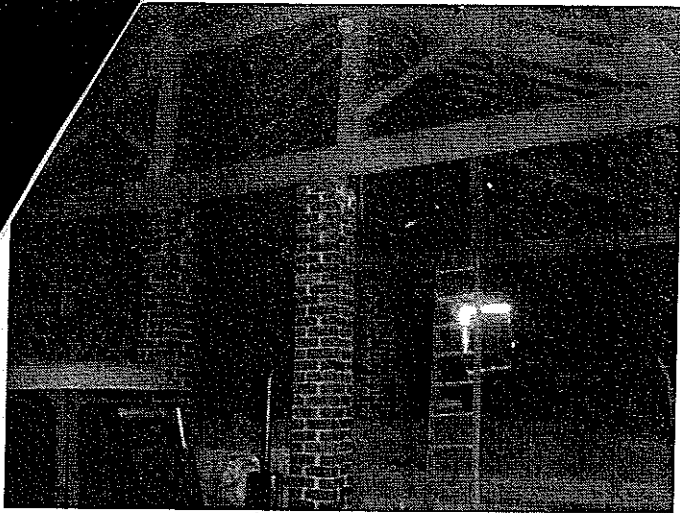
Photograph 033.JPG

It is proposed to replace the concrete tiles with a slate covering. It is likely that the use of much heavier concrete tiles has necessitated the introduction of the brick columns internally to assist in support (See Photo 33). Replacement of concrete tiles with much lighter slates should allow removal of the brick piers. This should be confirmed by calculation by structural engineer prior to these works being undertaken.

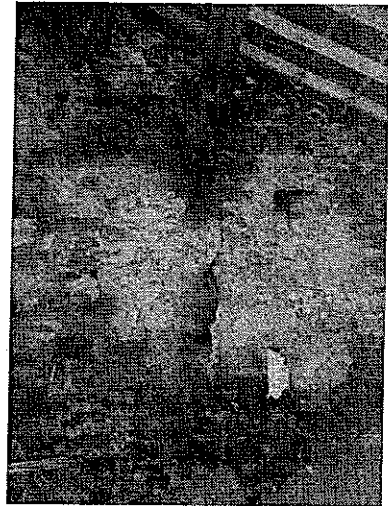
Photograph 036.JPG

Vertical cracking is evident internally to the backing section of stone adjacent purlin positions due to point loads (See photos 36-40). No cracking is evident externally. These are of significant age and loading in these areas would be significantly reduced following introduction of the new loadbearing inner leaf. The cracks do not appear recent in origin or generally progressive, but it would be advisable that any cracked areas of stonework are repaired.

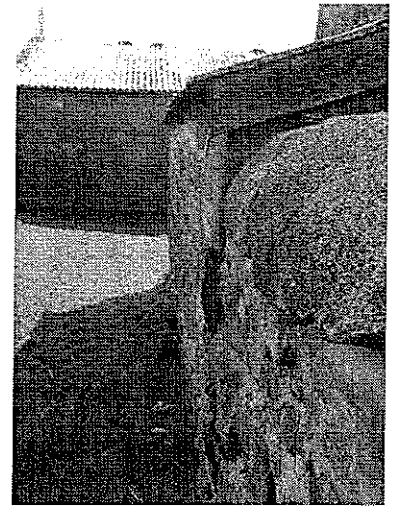
Photograph 044.JPG

Rotation has occurred to the outside wall of the northern single storey portion. This is likely to be due to failure of the foundation in this area (See Photo 43 & 44). It is proposed to demolish this portion.

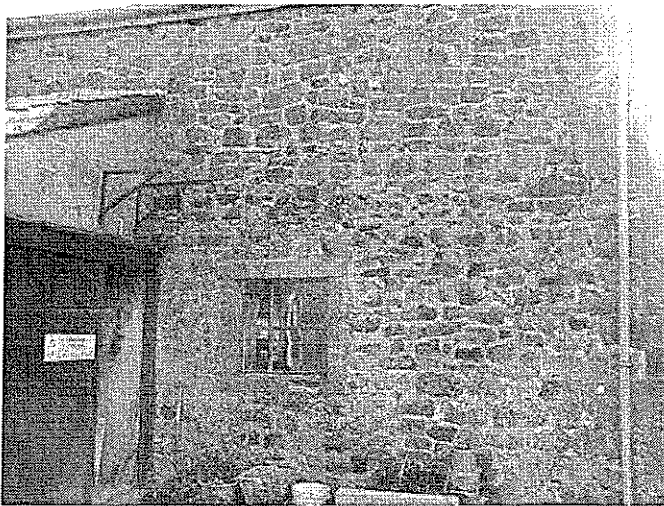
Photograph 045.JPG

The external walls are weathered, but serviceable. Areas of re-pointing are required to the all elevations where the mortar has deteriorated (See Photo 45).

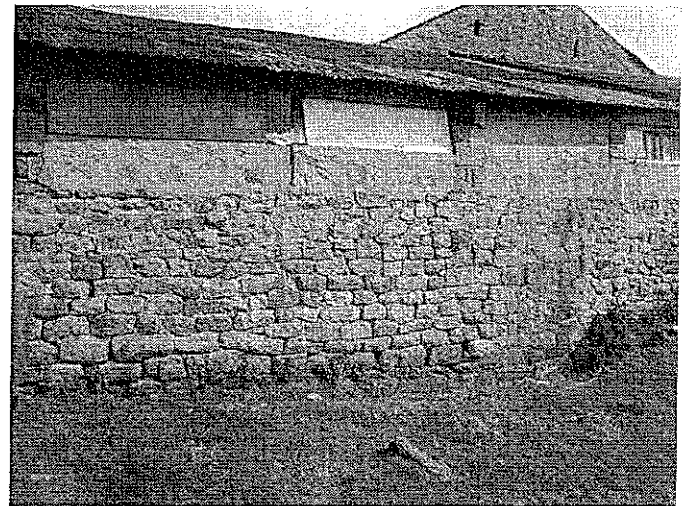
Photograph 046.JPG

The rear and right hand elevation have suffered movement due to failure of the foundation and it is proposed to re-build these sections of wall off new foundations continuing up to eaves height to improve support to the roof (See Photos 46-50).
