**Proposed Development of
Land adjacent to Petre Wood Close**

Tree Survey and Implications Assessment - Draft

**Prepared by SEP Ltd on behalf of Hargreaves Contracting
Limited**

Sept 2012

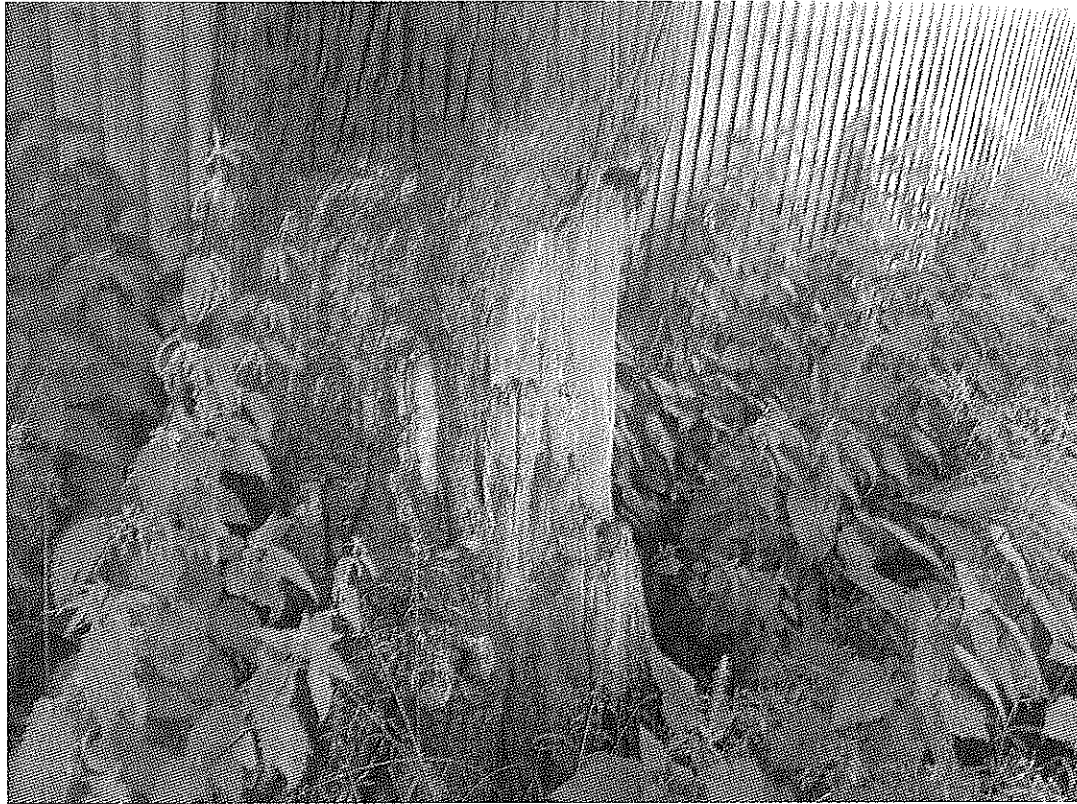
Fig 1. Tree No 6, mature Oak in poor condition.

Under current development plans a number of trees are earmarked for removal. However, it is encouraged that developers compensate this loss by incorporating blocks of trees of local provenance throughout the development were possible. It is also envisaged that the client will adequately compensate for the loss of tree 6 by planting a number of mature trees of the same species on or around the site.
