# Repair of Delaminated or Separating Masonry in a Rubble-Filled or Solid Wall using CemTies

**Re: Parkhouse Farm Gisburn Road Bolton-By-Bowland Clitheroe BB7 4LS**

Following the recent communications the writer visited the above property on Tuesday 8th January 2013 for the purpose of inspecting the structural timbers and reporting on the areas of damp wallplaster at Ground Floor level.

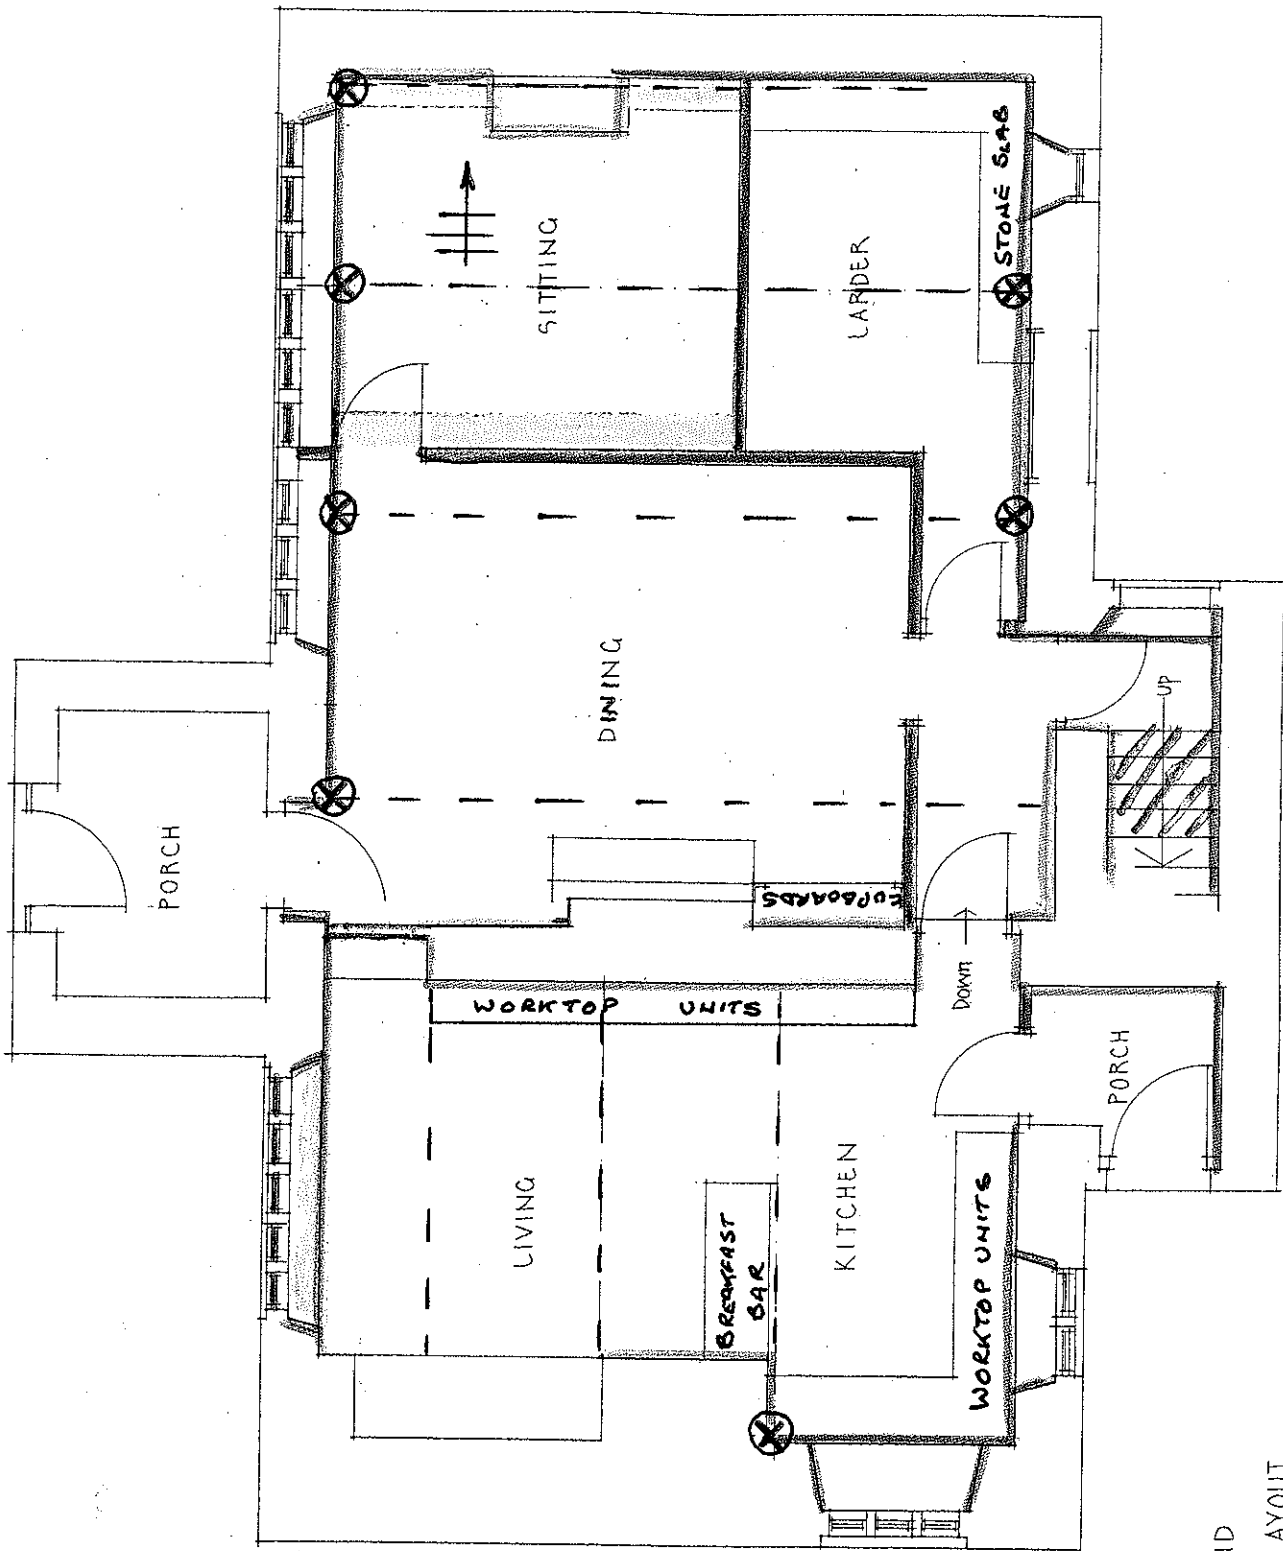
PARKHOUSE FARM  
BOLTON BY BOWLAND  
GROUND FLOOR LAYOUT  
SCALE 1:50 @ A3

Note: In an attempt to simplify the reading of the following method statement we have taken copies of the plan you kindly provided and with the aid of coloured inks we have highlighted specific areas and against each colour is a brief description of the proposed remedial works.

**Damp Proofing Treatments**  
**Orange**

- Remove the skirting boards, fixing plugs and wallplaster, cutting the wallplaster 1000mm up from the floor.
- Supply and fix a damp proofing membrane with mesh to the face of the exposed brickwork and masonry.
- Overlay the membrane with a backing coat of Carlite Bonding and leave to cure. Dub out with a further coat of bonding then apply a high impact skim coat finishing plaster.
- Provide fit and fix new pre-treated 175 x 25mm softwood skirting boards.

**Red**

- Carry out the identical treatment as previously described however in this area between the floor and the ceiling.

**Green**

- Lift the floorboards to determine the true condition of the floorjoists on completion of this work a decision will have to be made on the necessary solutions available.

**Black Cross**

- During the course of the damp proofing treatments (Red) our technician will hack off the wallplaster and break out the stonework as necessary to enable an inspection to be made of the carrier beam seatings.
- Probe and percussion tests will be made of the bearing ends and if sound apply liberally woodtreat fungicidal paste as a precautionary measure then re-instate the disturbed stonework.

**Yellow**

- Remove the chipboard window bottoms and dispose of same.
- Machine shape and fix new softwood window bottoms using pre-treated timber.

### Turquoise

- Remove all the existing timbers of the decayed window seat and dispose of same.
- Reconstruct a new window seat from pre-treated softwood.

### Purple

- Remove the existing decayed window frames and dispose of same.
- Produce new pre-treated softwood window frames to match the existing incorporating new single glazing.

### Grey Hatching

- Cut and remove the lower 4 No treads and 4 No riser boards setting aside small sections as patterns for replacement.
- Cut and remove the right and left hand wall string timber between the No4 tread and No5 riser board.
- Transfer all sections to the joiners shop where an identical replacement section of staircase will be produced.
- Collect the new sections of staircase from the workshop, then fit and fix to the original.
- Provide additional support below the repaired staircase by installing a short dwarf wall in timber studding overlaying with plasterboard sheeting.
