BAT SURVEY

SPRINGFIELD WHITEACRE LANE BARROW

DATE AND TIME OF VISIT 25th Nov 2013 2.00pm external inspection. 27th Nov 2013 11.00am Internal inspection

REFERENCE NO. 4291

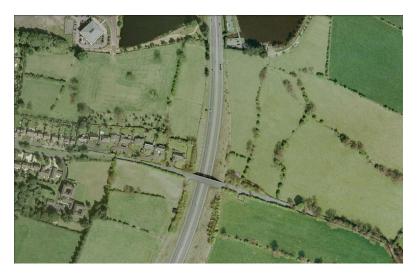
COMMENTS: The bungalow is located in a large garden with its eastern boundary being adjacent to the A59.It is the last house within the settlement area of Barrow off Whiteacre lane the road leading to Wiswell.

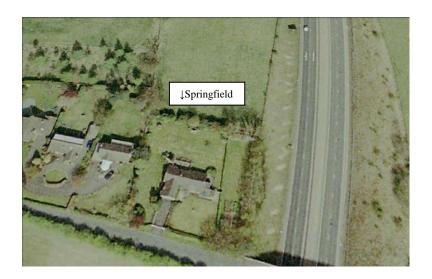
COMMENTS: The garden boundary is lined with a mixture of mature trees and leylandii, various potential foraging routes (lines of trees) radiate in a southern and westerly direction from the property. The route to the east is broken by the A59.

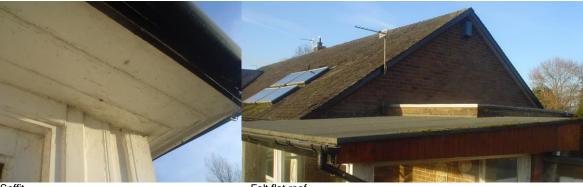
Soffit Felt flat roof

COMMENTS: The pitched roofs are slate with overhanging eaves with soffits which are boarded to the underside.

The porches both have felt flat roofs.

COMMENTS: The condition is generally reasonable with just a couple of slates missing near to the eaves adjacent to the flat roofed porch. It was possible to inspect quite closely the missing slates, there was no evidence of bats using the crevice.

The boarded soffits as can been seen in the photograph above are in good condition, all are tight fitting.
