320140618P

ARBORICULTURAL DEVELOPMENT REPORT

TREES LOCATED AT OLD RD CHATBURN, CLITHEROE

June 2014

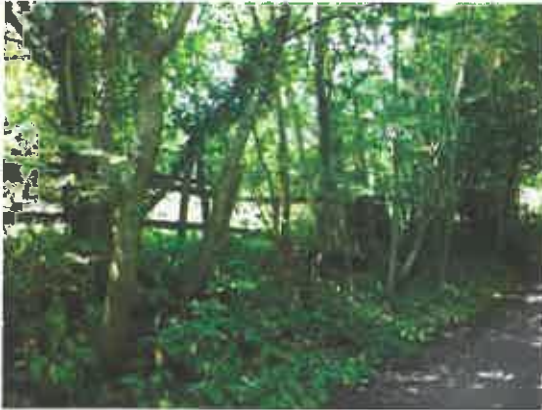
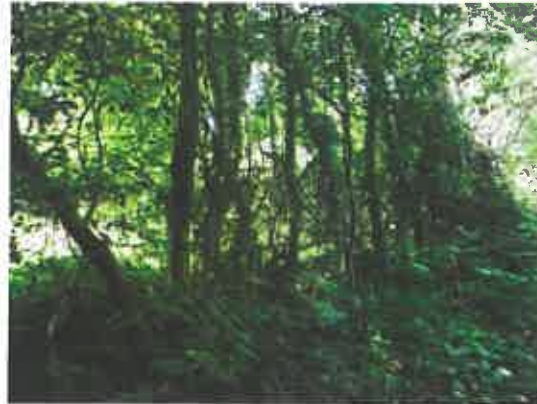
- The hedge is 100m long and is probably over 150 years old given the species spread. The hawthorn in the hedge was laid 30-50 years ago but has become suppressed by the other species especially sycamore, elm, ash and holly which now dominate.

- The overall height of the ash and sycamore is 7-10m. If left the trees in the hedge line and on the other side of Old Road will dominate the access road and darken both the road and the proposed gardens beyond

- The ash and elm species have a limited predictable future life cycle because of the effects of elm bark beetle and the potential effect of Chalara Fraxinea (Ash dieback)

Current condition of the Chatburn Old Rd hedgeline

- Discussion with a hedge laying contractor suggests that laying of most of the trees will be possible and once more light has been made available infill planting of other native hedge species will bring the hedgeline back to a maintainable state within 7 years

- Given this treatment we would propose a linear root protection zone for the hedge of 3m. Services within Chatburn Old Road road up to the point where they will divert into the site will need to take account of the need for protection of the hedge root range.

- Hedge laying will need to take place from November to March and incorporate compensatory planting to augment the existing hawthorn.
- The closest distance of the proposed properties to the hedge will be 6m. The proposed laid hedge once regrown will need to be maintained at 2-4m to suit the owners. Allowing selected single trees to grow on is optional but would darken gardens given the woodland already existing on the eastern side of Chatburn Old Rd.

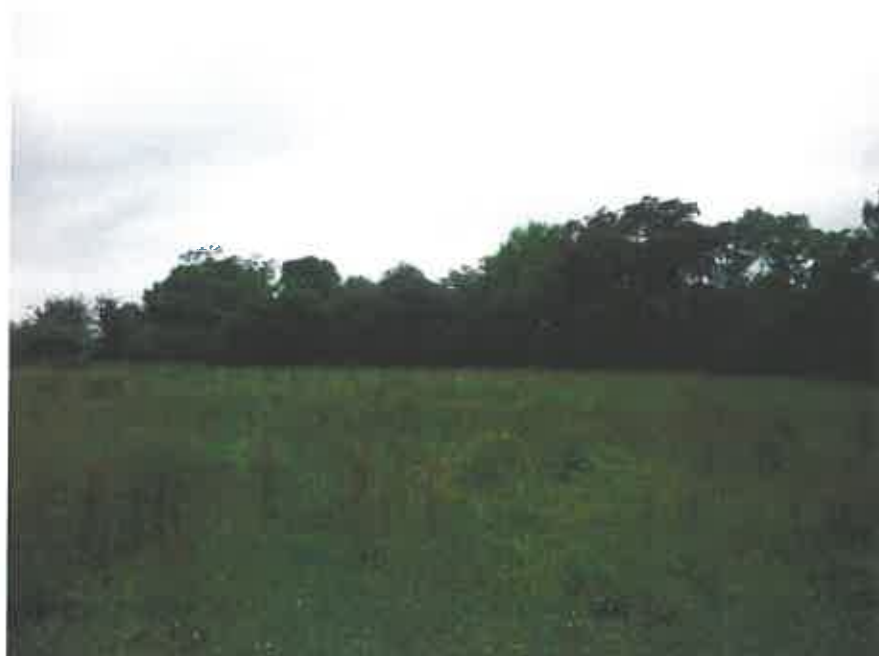
2. A very defined screening line of early mature trees are located behind the properties on Crowtrees Brow and on the southern slope of the site. This has been detailed on the topo plan and on the constraints plan as Tree Group A and form very useful visual screen between the Development and the properties on Crowtrees Brow.

The photo shows the view of the trees in TG1 from the rear fenceline of the Crowtrees Brow Properties

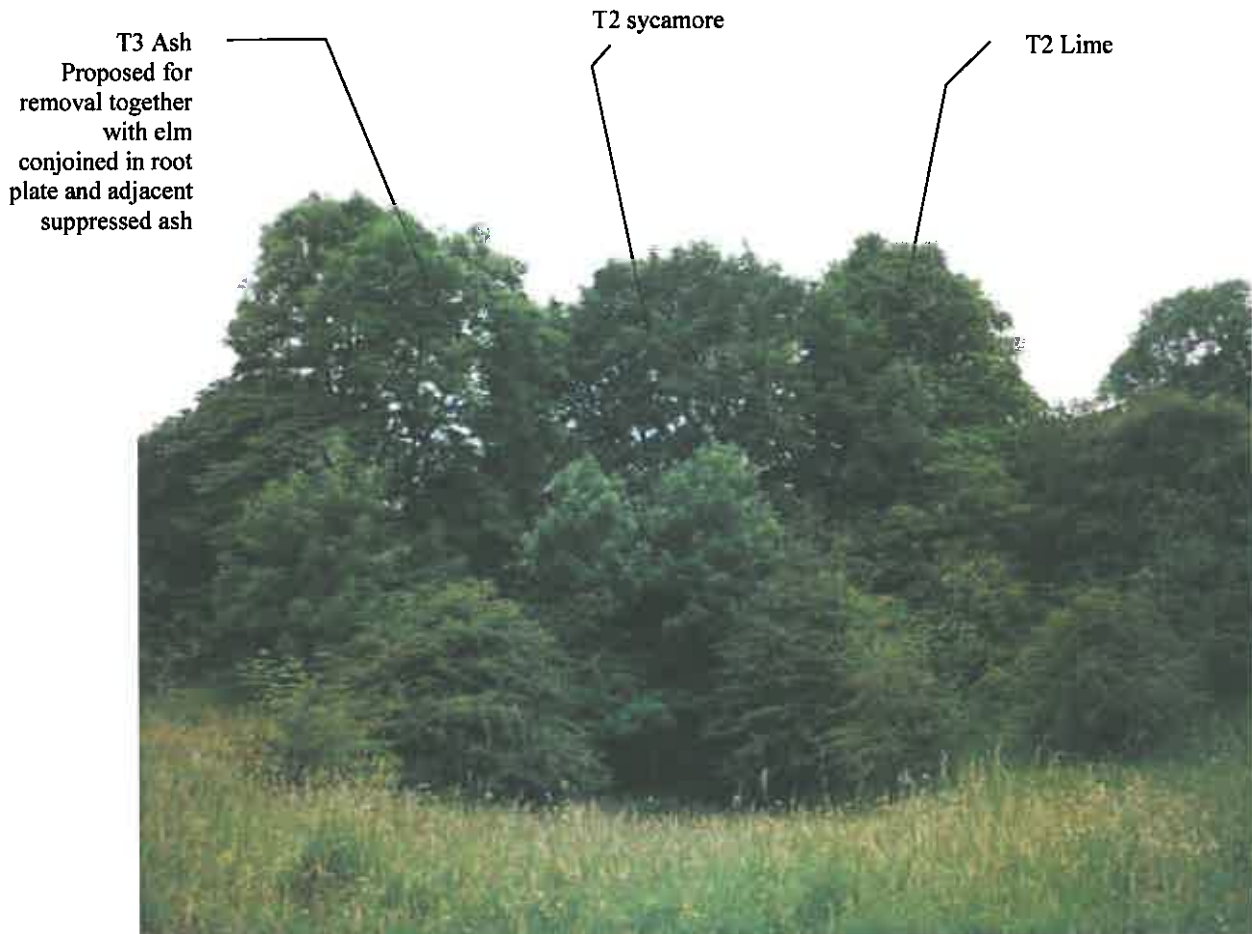
3. The construction of the property on plot 6 will require the loss of an ash and a subsidiary elm and suppressed ash. While T3 has a high rating on the BS scale both T2 and T3 will remain as a significant canopy profile providing scale to Plot 7 to the north and the other properties in the foreground
