BAT SURVEY

**AT
The Moorcock inn
Waddington
Clitheroe
Map ref. SD 720467**

**DATE AND TIME OF VISIT
14th June 2014 9.15pm -1 hour after dusk**

REFERENCE NO. 4512

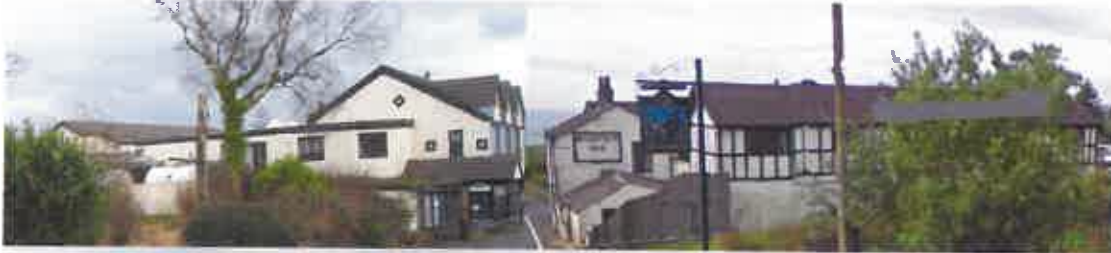
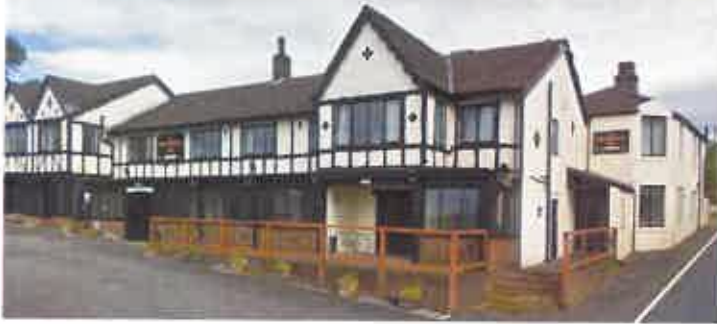
COMMENTS: The original Public house building has been extended over the years to include a function room. The building has been closed a number of years and has deteriorated significantly.

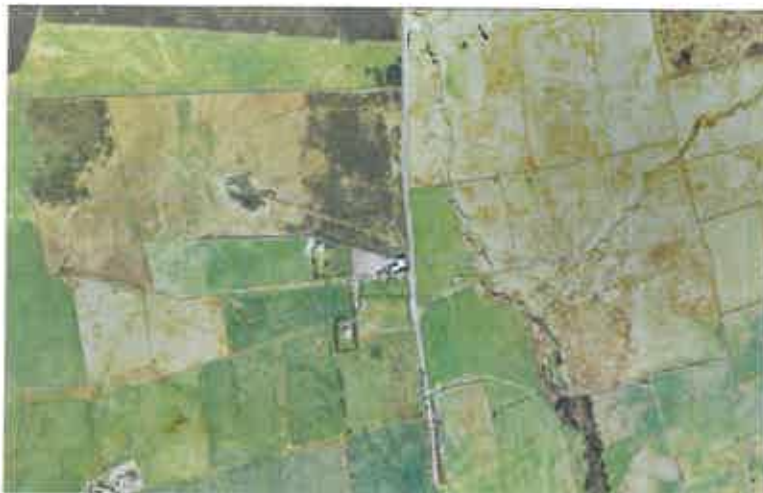
COMMENTS: The public house is remote from the village of Waddington located next to Fell road at 250m above sea level. A detached house is located approx 100m to the North west of the Moorcock.

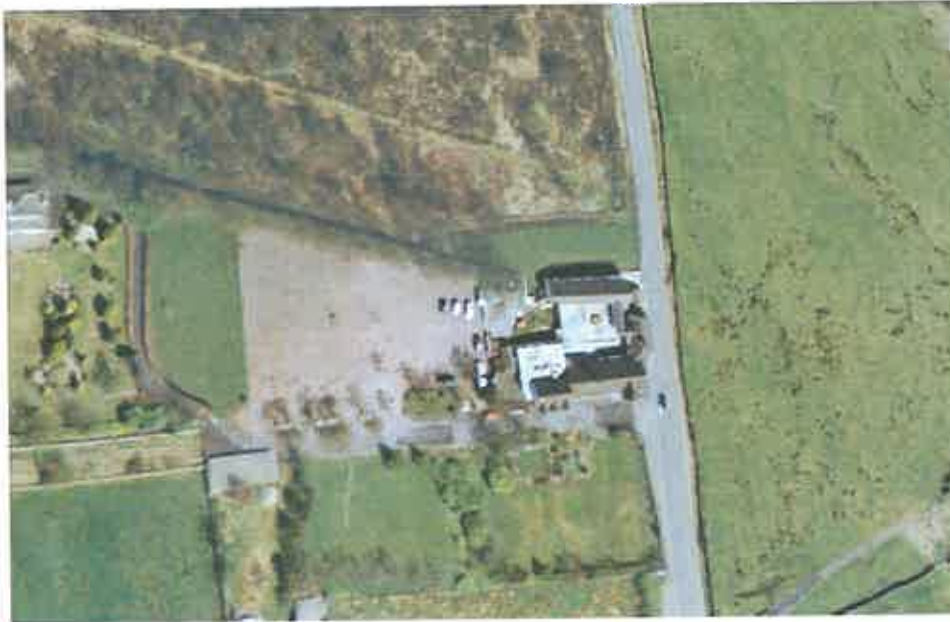
COMMENTS: The land to the east of the road is moorland and pasture land to the west. A plantation of trees extends from the rear (north) of the pub forming the rear boundary of the site in a westerly direction towards the detached house. Mature trees line the lawned areas to the front (south). Scattered garden shrubbery forms the garden boundary of the nearby house. See below. The nearby roosting and foraging potential moderate to the west, low to the East.

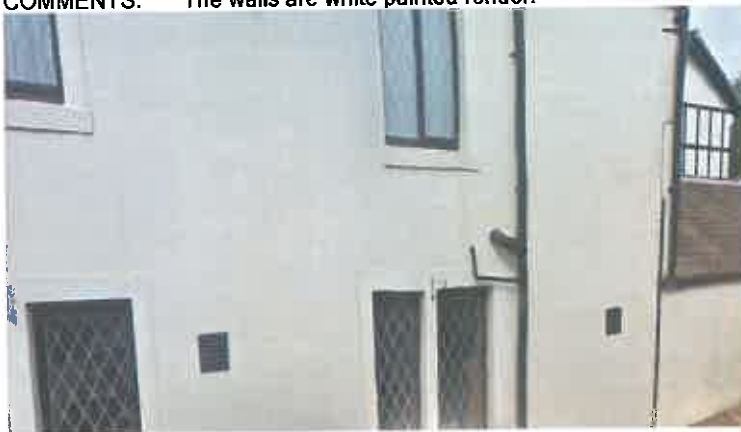
Wall adjacent to Fell road

COMMENTS: The walls are white painted render.

COMMENTS: There are no access points in the walls, however a number of windows have been broken on the west elevations allowing free access to the interior.

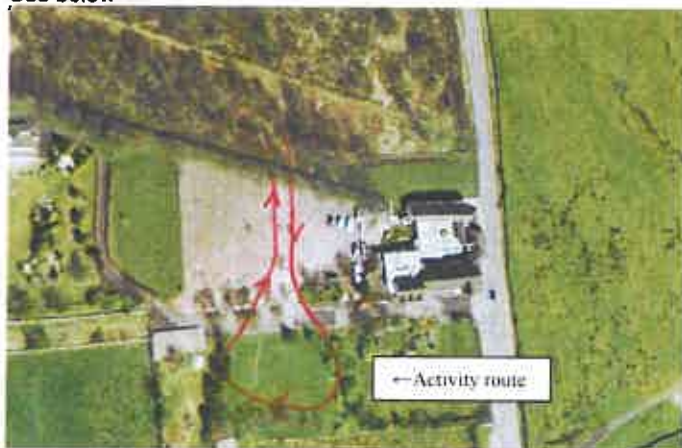
COMMENTS: Low level Pipistrelle activity was recorded starting at 9.45 pm they emerged from the plantation of trees to the north and travelled south over the car park to forage in the trees in the front garden areas. No emergence from the building was recorded. See below
