**BAE SAMLESBURY  
BAE TRAINING FACILITY**

**SITE REVIEW**

**REPORT 6715  
REVISION S1**

**Prepared for  
WILSON MASON**

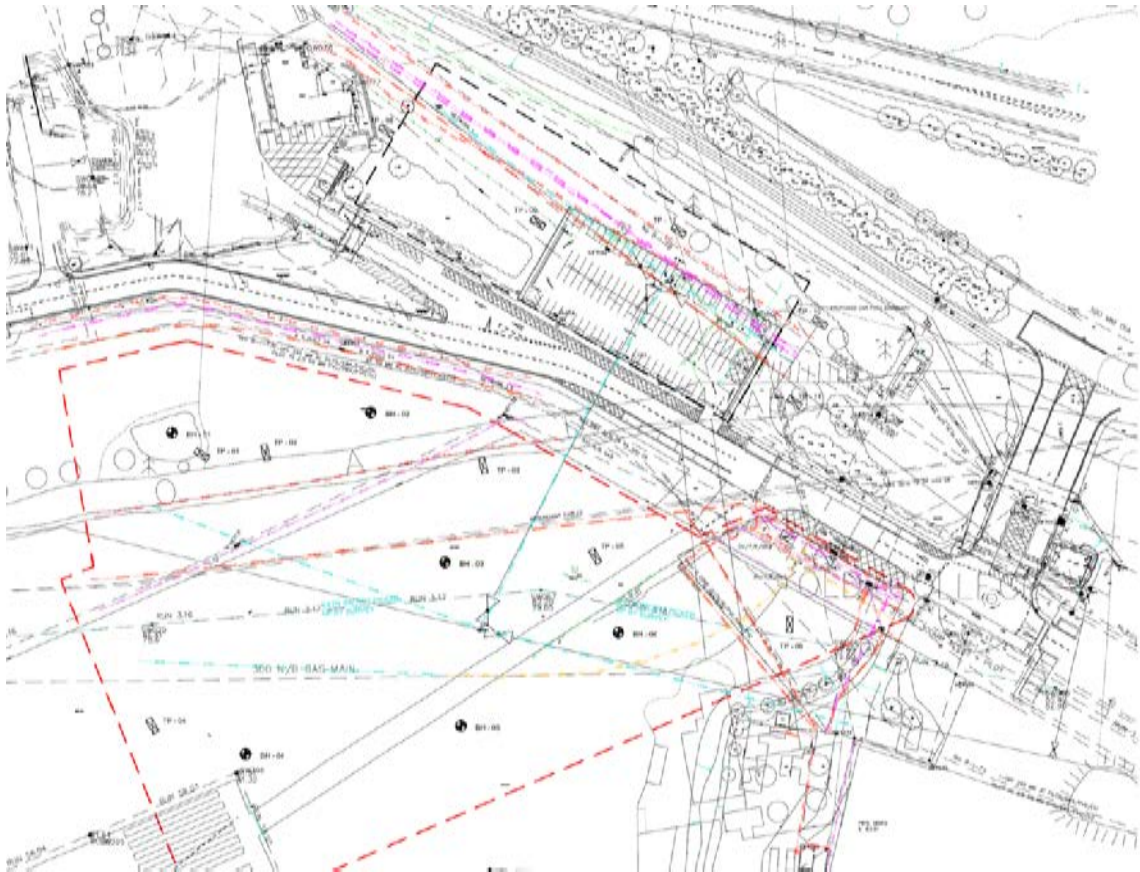
Figure 1: Trial pit and borehole location plan

The boreholes and trial pits confirmed the general succession of superficial strata to comprise turf and topsoil to depths of 0.3-0.4m overlying firm and firm to stiff boulder clay. Deeper areas of fill were encountered as expected in the area of the former pond. The pond is located in the northern western area of the site which is proposed to be car parks and is remote from the building footprint.

Ground conditions in the vicinity of the proposed training centre building footprint are represented by the findings from boreholes BH3, BH4, BH5 and trial pits TP4 and TP5. Ground conditions in this area comprise 200-300mm of topsoil overlying firm and stiff brown silty gravelly clay.

Based on a review of the gas monitoring results however, it is apparent that the only borehole in which carbon dioxide levels exceed the 5% threshold was BH1 which is located within the footprint of the former pond. The pond location is remote from the proposed building footprint and the organic matter which provides the source of the gas will be removed as part of future car park construction. It is therefore considered that Characteristic Situation CS1 is more appropriate to the design of the phase 1 development.
