DESIGN AND ACCESS STATEMENT

Higher Lickhurst Farmhouse, Leagram, Chipping
December 2014 (rev. d)

Application for Listed Building Consent

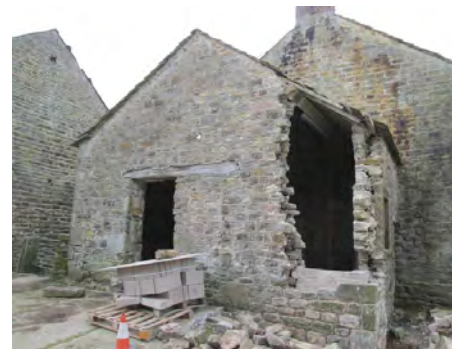
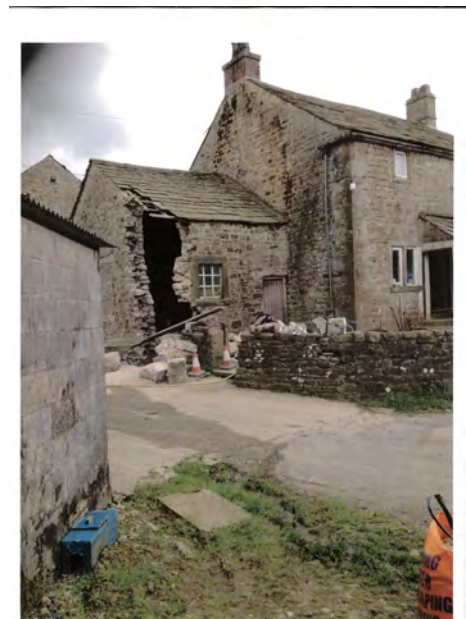
Initially IWA Architects were not engaged to provide on-site monitoring of the works, however in May 2014, the Building Contractor contacted IWA Architects to say that whilst underpinning of the North wall of the outbuilding, there had been a sudden collapse of the North East corner, only moments after an operative had been working nearby. A site visit was made to document the condition of the building it was suggested that a Structural Engineer was asked to prepare a report, before any further work took place.

- *The attached outbuilding is a former shippon and has an earth floor, partly cobbled. The walls are built directly off the clay with only a nominal foundation close to ground level. Underpinning has been proposed to avoid undermining the walls when levels are reduced for construction of the new floor. During underpinning, the North East corner of the outbuilding collapsed.*

Images showing collapse of the North East corner during the underpinning works.

- *No further underpinning should be carried out. The walls are too fragile for this to be done safely. The depth of excavation could be minimised by raising the floor level or reducing the thickness of the slab, hardcore and insulation. Any excavation taken deeper than the existing foundations should be carried out in short lengths and the excavated material replaced immediately with compacted hardcore or concrete.*

- *The existing east wall should be married into the re-built north east corner, with new and existing stonework bonded together as much as possible. The wall should be shored when the roof is removed to prevent possible collapse when horizontal support is lost*

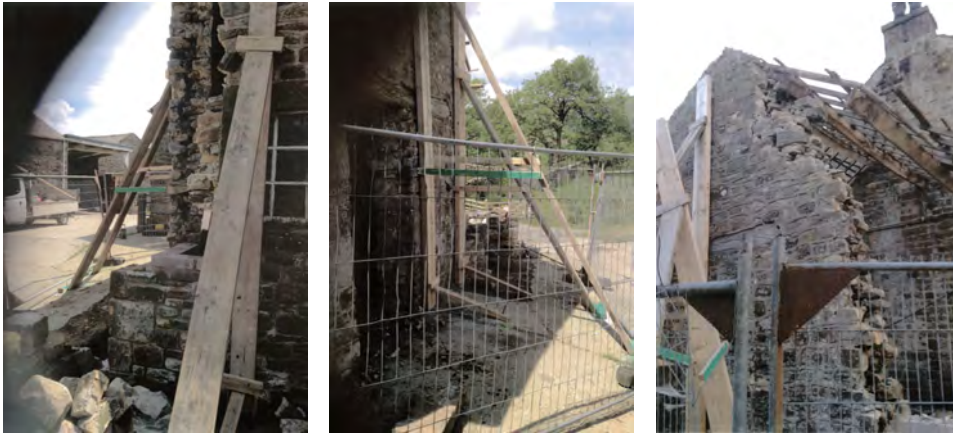
In accordance with the Structural Engineer's recommendations, the Building Contractor shored up the walls of the outbuilding, immediately prior to any further work taking place, particularly to the roof structure. However, due to the 'fragility' of the walls and the fact that they were not constructed off adequate foundations, IWA Architects were contacted to say that further, more substantial collapse had occurred, in the process of attempting to strengthen the existing walls. Any remaining masonry was not physically attached to the main house and deemed too unsafe to remain standing - it was therefore carefully dismantled, to at least retain suitable stone for use in the rebuild.

Images showing shoring to existing outbuilding walls, the rebuilding of the North East corner and the start of the roof works.

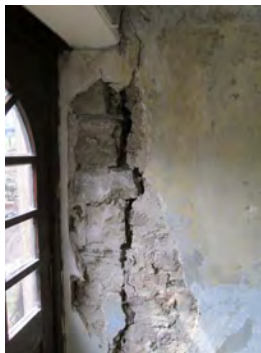
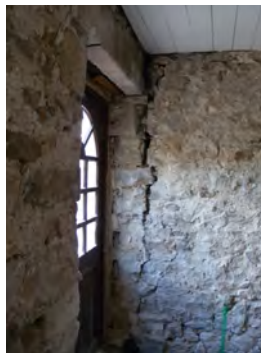
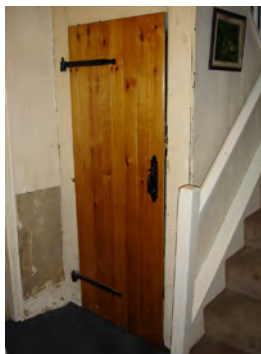
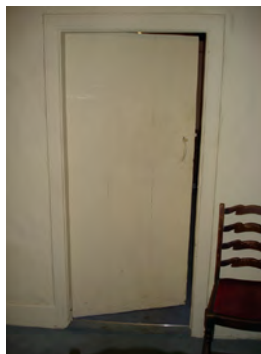
It was obvious from initial visits to the property at the start of IWA Architects' involvement in February 2011, that the fabric of the building had suffered from dampness, due to it not being occupied on a regular basis and therefore being heated, to prevent deterioration to the internal finishes and structure. In the intervening period of time that it took to obtain Planning and Building Regulations Permission, the general state of the building will have deteriorated further and this was evident once the contractor began his work. A number of substantial internal cracks in the walls were apparent (see top left Photo below, showing wall between Proposed Lounge and Dining Room, abutting South external wall). Most of the ground floor internal walls were wallpapered (see bottom two photos) and despite the contractor's best endeavours, the 'historic' plaster finishes behind, crumbled and came away with the paper in the process of it being stripped - exposing further areas of damaged stonework and cracking. This will probably be the case at first floor level also.

Images showing exposed structural issues (above).

Images showing existing wallpapered internal walls (left).

Once again the assistance of John Reid of Reid Jones Partnership was sought in respect of dealing with the various structural issues and he has produced a drawing detailing the required methods of repairing and strengthening the existing cracks, etc.

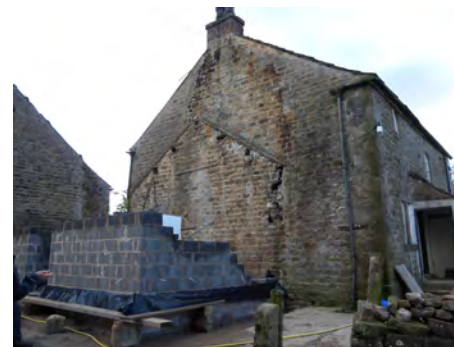
Image showing extent of rebuild to the single storey outbuilding

Although additional structural issues in the condition of the property have only become apparent since the work began, necessitating the rebuilding of the single storey outbuilding, the proposals intend that the appearance of the 'new build' will reflect that of the original, with much of the former's stone and roof slate having been salvaged for re-use. There is no intention to increase the size of the outbuilding or alter any of its window and door positions.
